NDIC Brine Pond Study

Phase II: Site Assessments

June 25, 2018

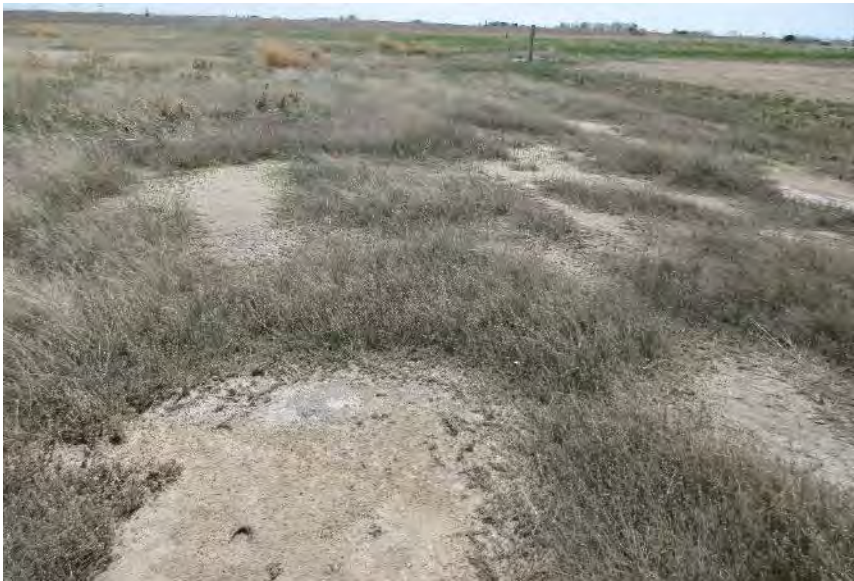
Photograph facing southwest off of an oilfield lease road showing a visually impacted area. Cracks and salt crusts were observed.

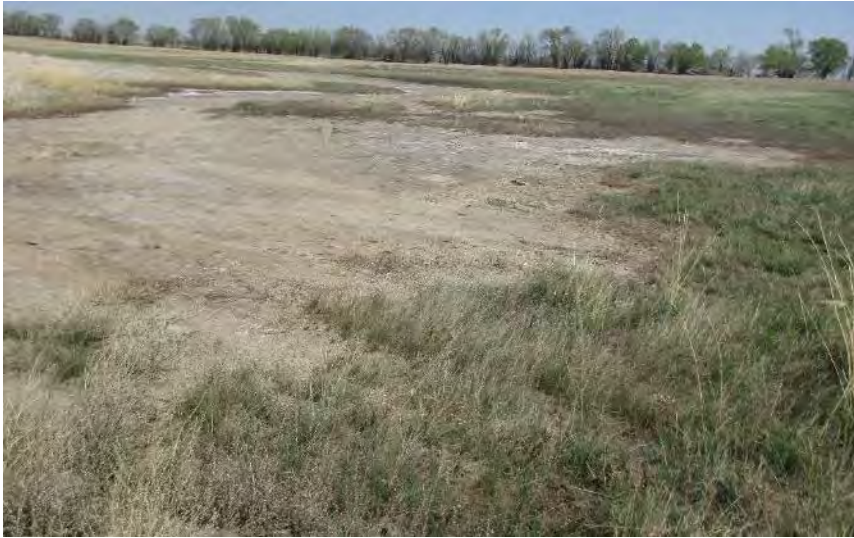
B1-14

Photograph facing northeast off of an oilfield lease road showing a visually impacted area including barren areas with no vegetation. The impacted area is approximately 200 feet by 175 feet. Oil pipeline risers are located southwest of site.

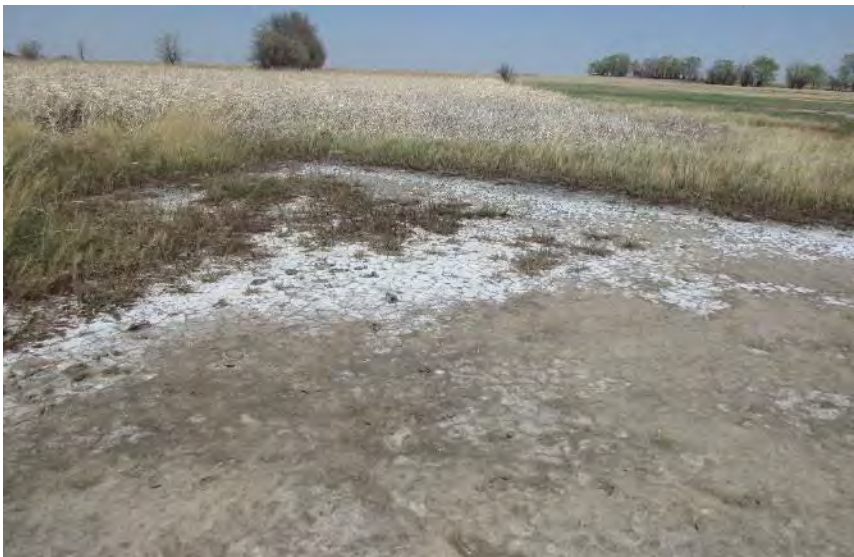
Photograph facing northeast off of oilfield lease road showing salt crusts and soil cracks on site. The site is adjacent to a wetland measuring approximately 300 feet by 100 feet.

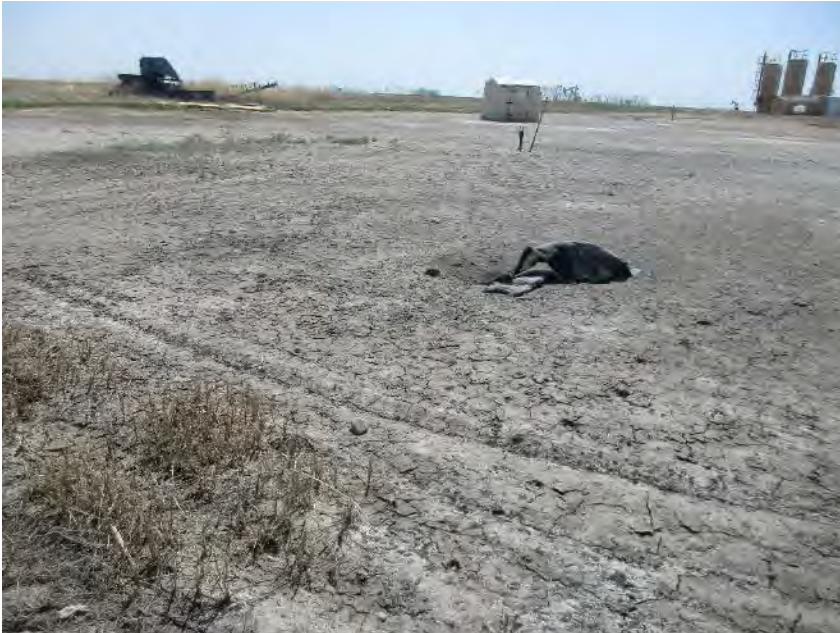
Photograph facing southwest from the northeast corner of the site, showing visual impacts, including salt residues, barren soils and stressed vegetation, within the oil & gas pad.

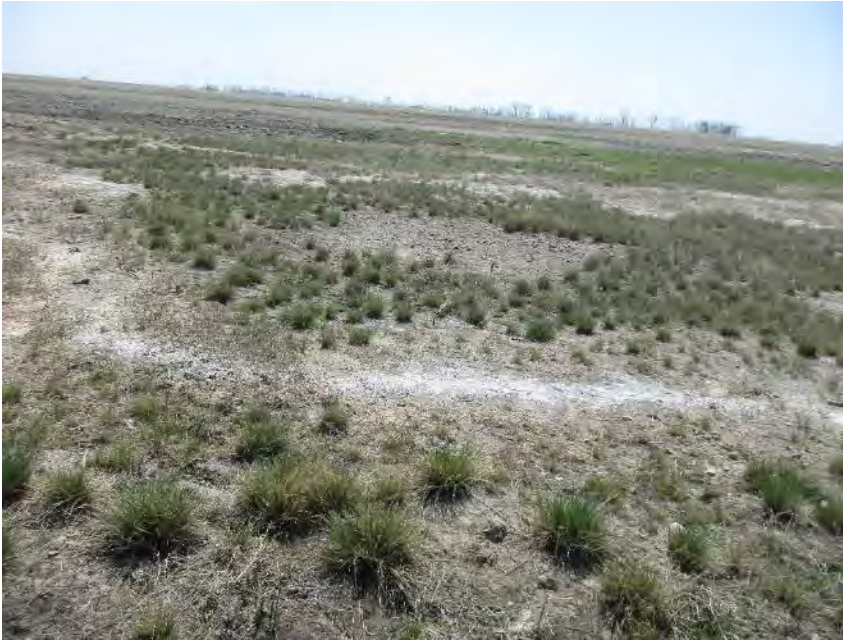
Photograph facing east of site conditions off of 19th Ave NW. Visual impacts including barren soils with little to no vegetative growth and salt crusting were observed.

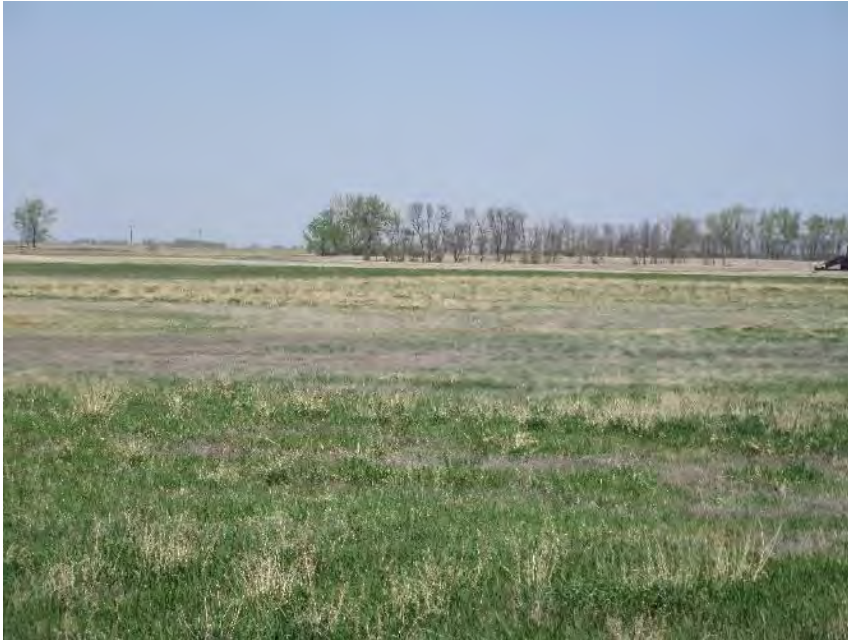
Photograph facing northwest off of an oilfield lease road. An area of stressed vegetation, measuring approximately 100 feet by 100 feet can be seen in the center of the photograph.

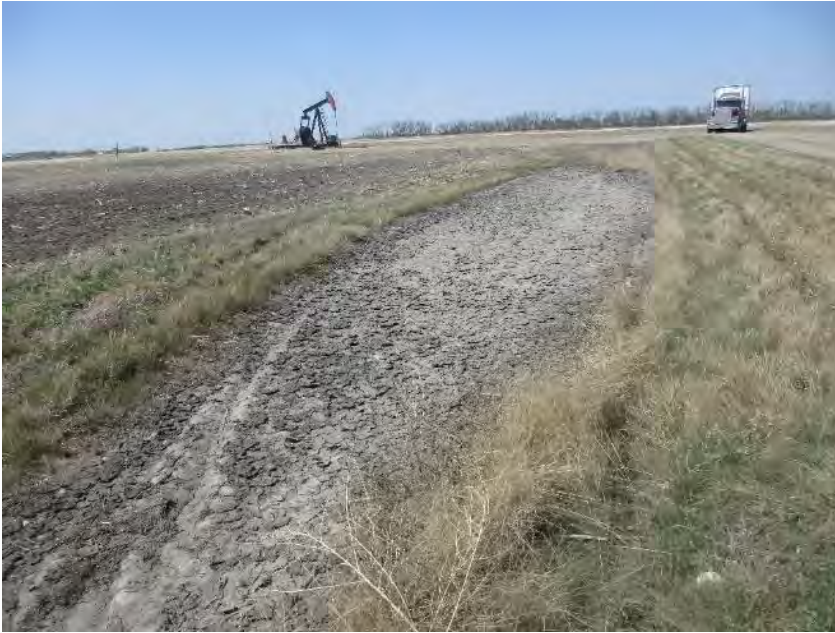
Photograph facing northwest off of an oilfield lease road. Barren soils with no vegetation and salt crusting was observed in an area approximately 75 feet by 15 feet.

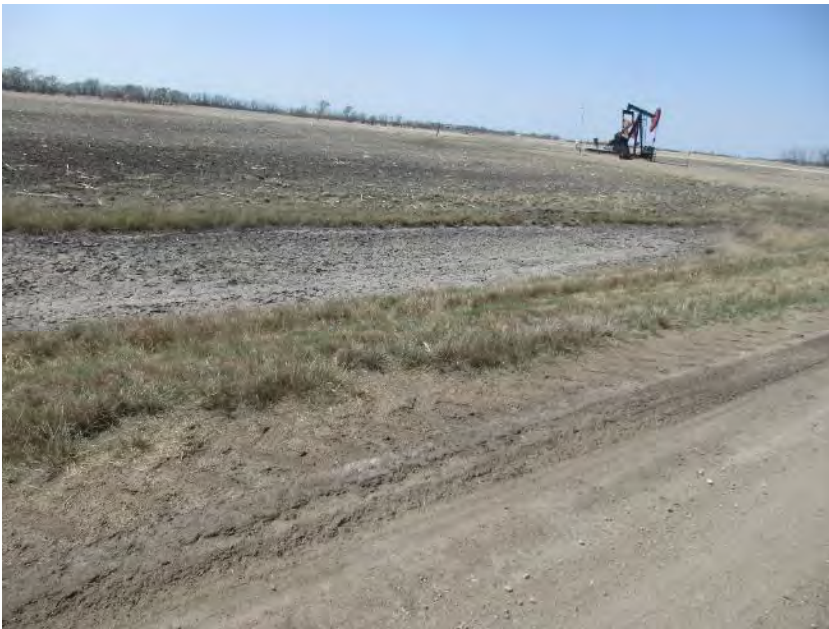
Photograph facing west/northwest off of an oilfield lease road. Visual impacts were observed within the road ditch.

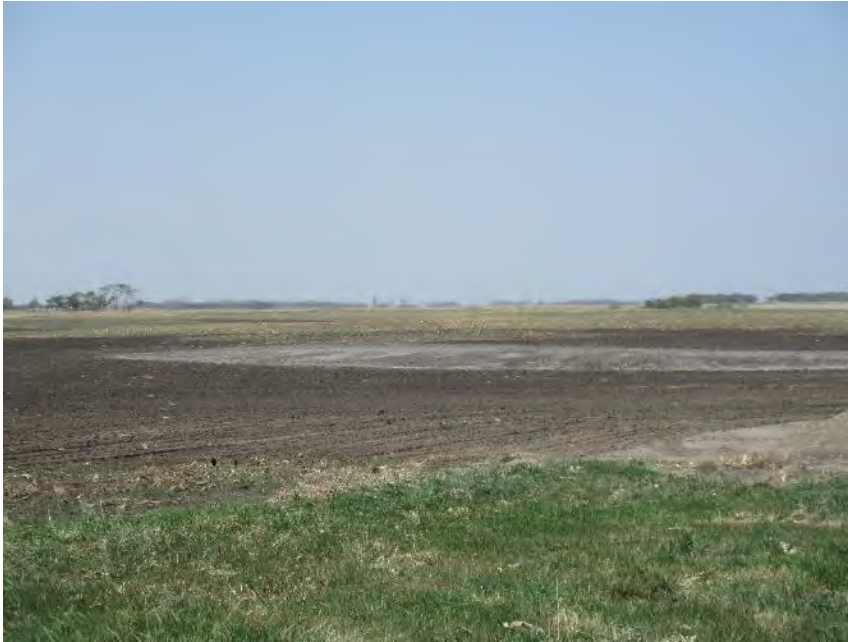
Photograph facing northwest off of an oilfield lease road. Visual impacts were observed, including barren soils and salt residues.

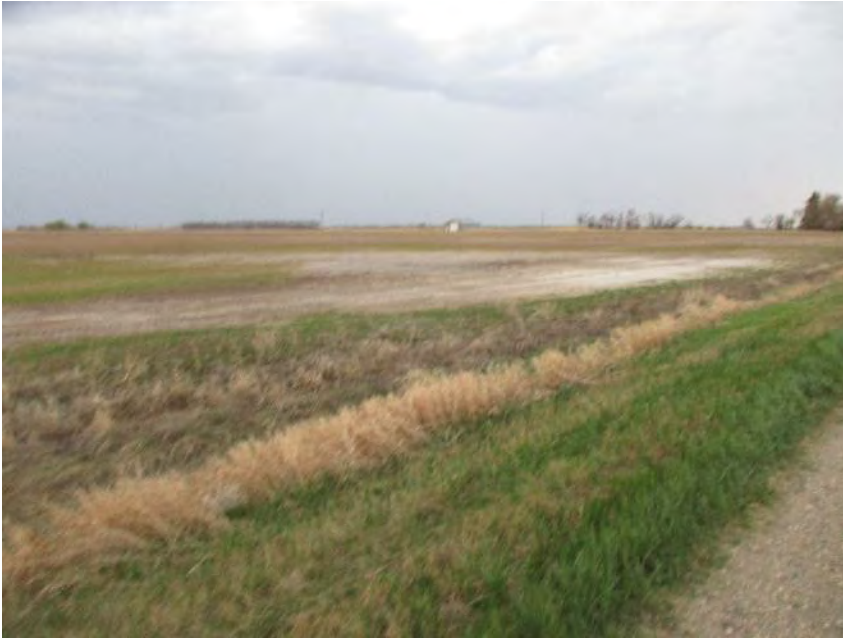
Photograph facing southwest off of 108th St NW. Barren soils with little to no vegetation and salt residues were observed.

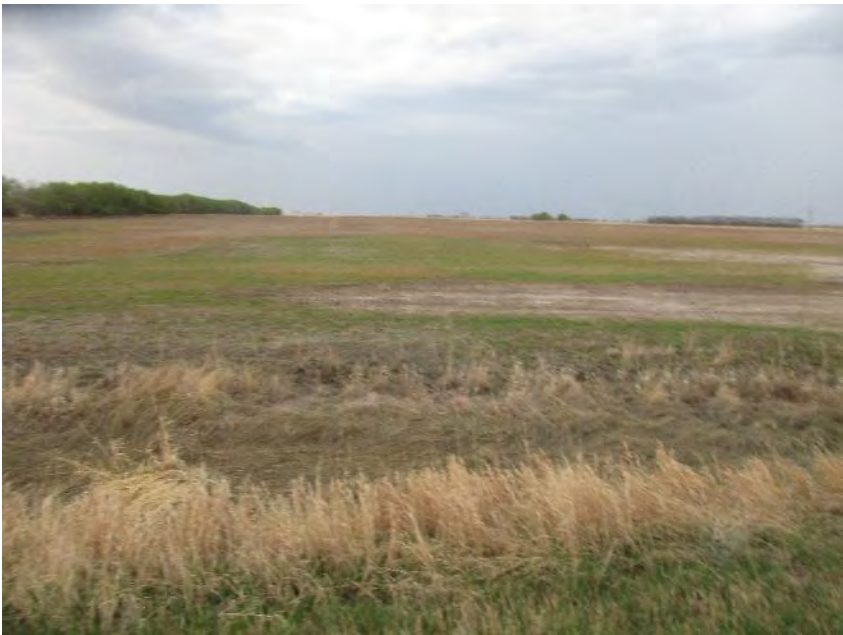
Photograph facing south off of 108th St NW, showing the eastern extent of the area of visual impacts.

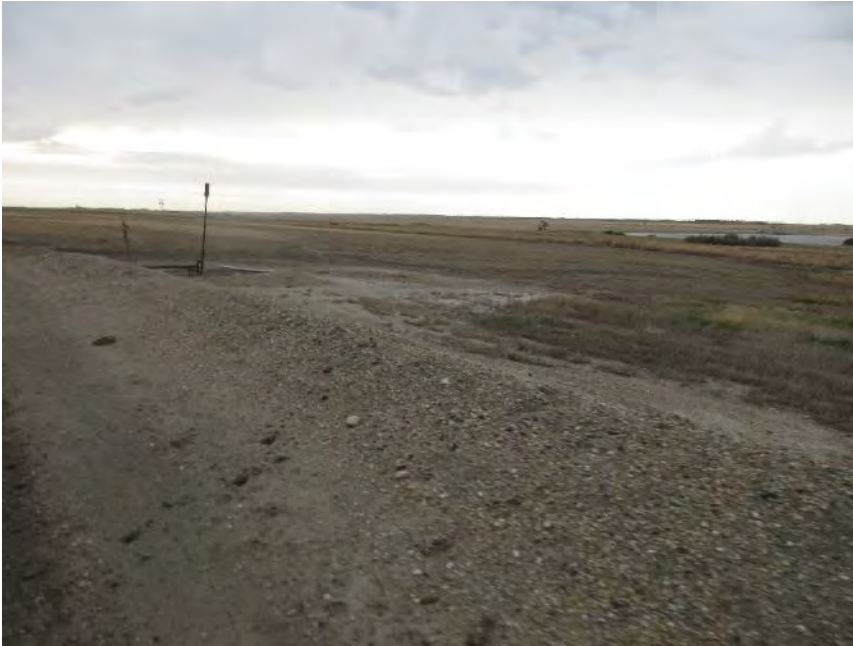
Photograph facing east off of an oilfield lease road, showing an area of stressed vegetation and salt residues.

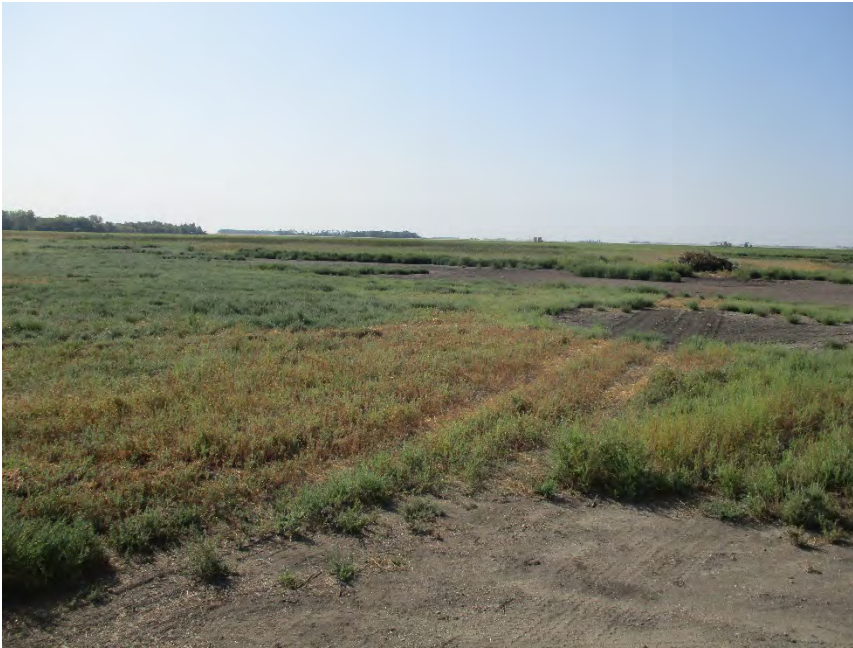
Photograph facing south off of an oilfield lease road showing a visually impacted area. Barren ground and stressed vegetation were observed in an area measuring approximately 100 feet by 50 feet.

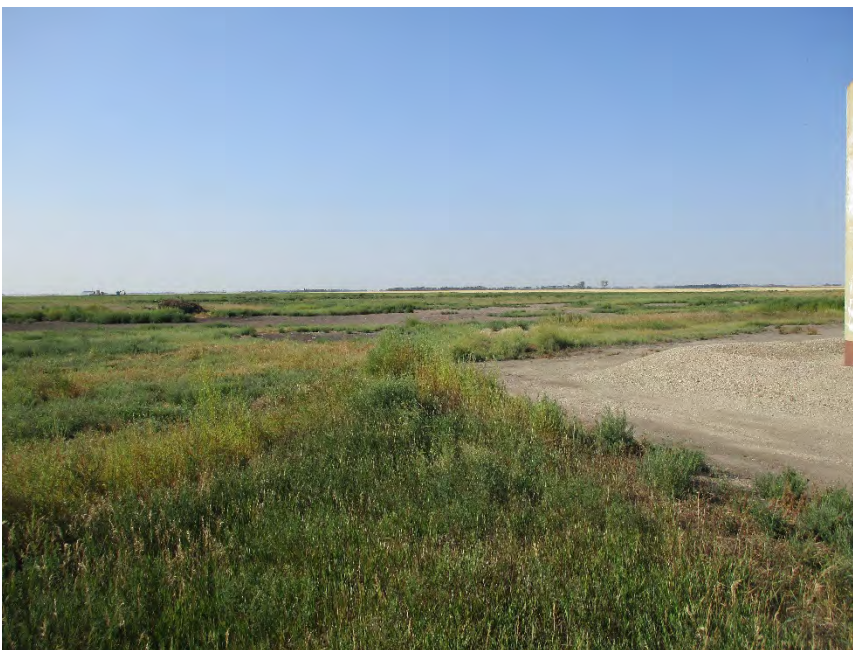
Photograph facing southeast off of an oilfield lease road showing a visually impacted area. Aboveground storage tanks are visible to the right of the picture, located north of the site.

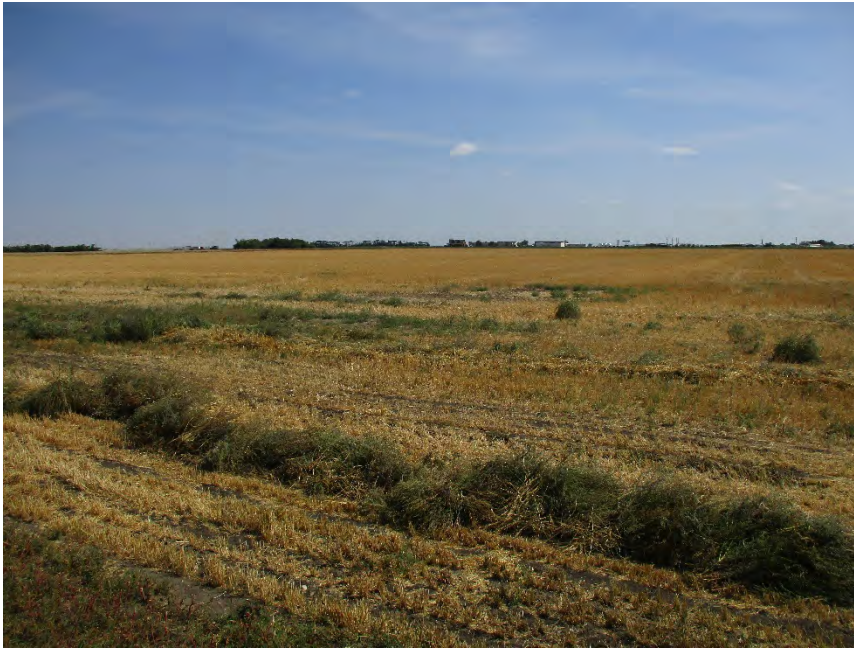
Photograph facing east off of an oil and gas facility showing a visually impacted area. Patches of barren ground and stressed vegetation were observed in an area measuring approximately 50 feet by 20 feet.

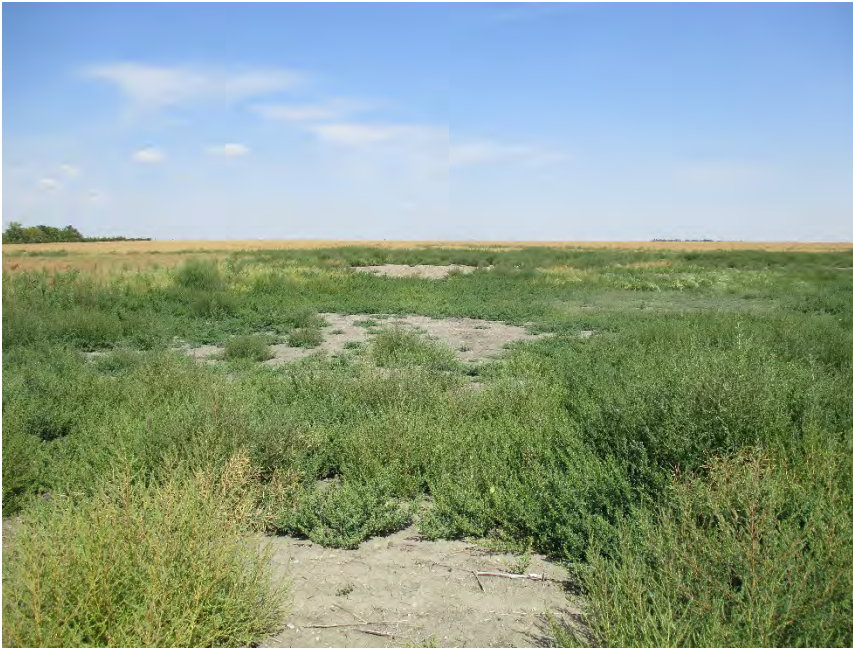
Photograph facing north off of 97th St. NW. The site is located approximately 100 feet north of 97th St. NW in a field used in agricultural production. Visual impacts consisting of barren ground and stressed vegetation were observed in three distinct areas.

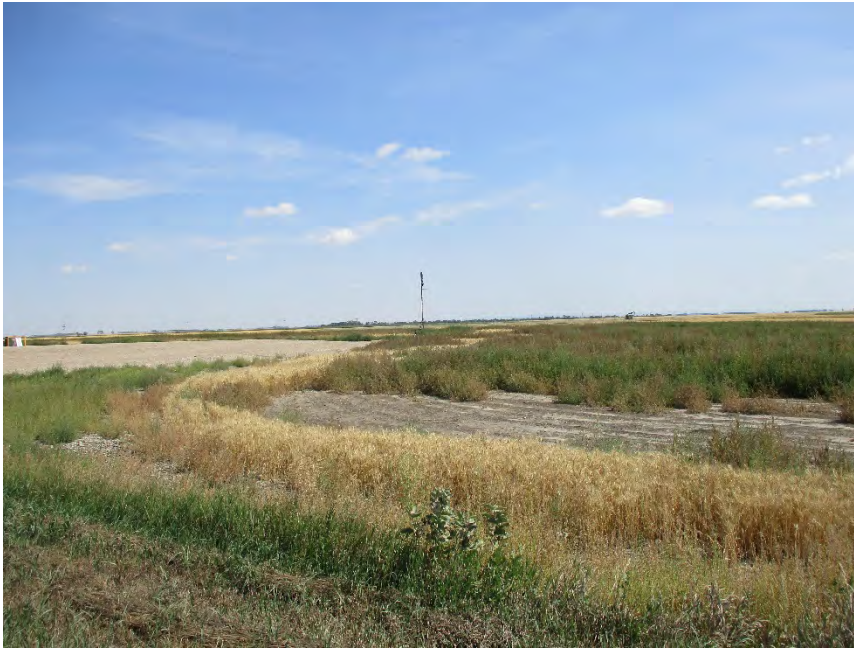
Photograph facing northeast off of 12th Ave NW showing a visually impacted area. Barren ground and stressed vegetation were observed in an area measuring approximately 75 feet by 10 feet.

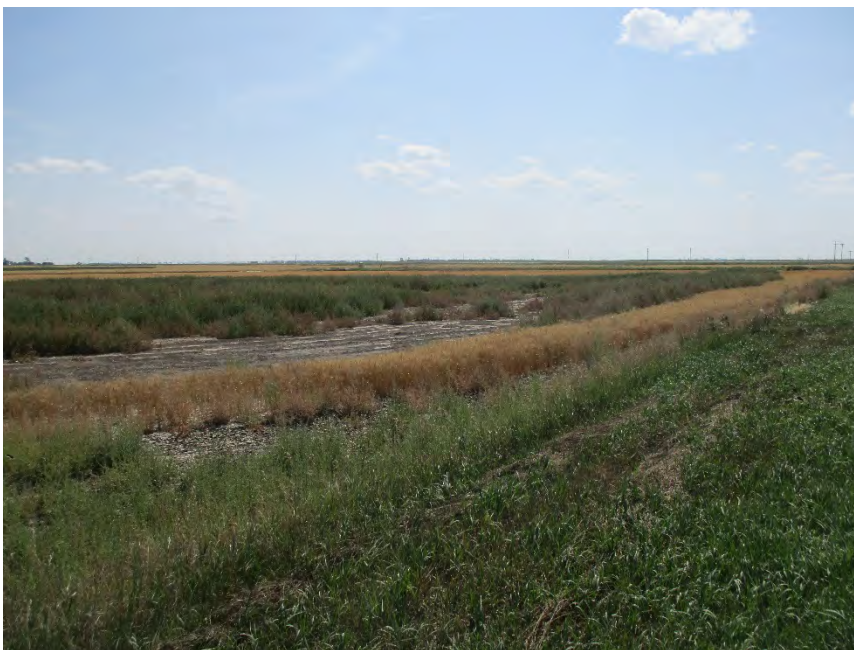
Photograph facing southeast off of 12th Ave NW showing the visually impacted area.

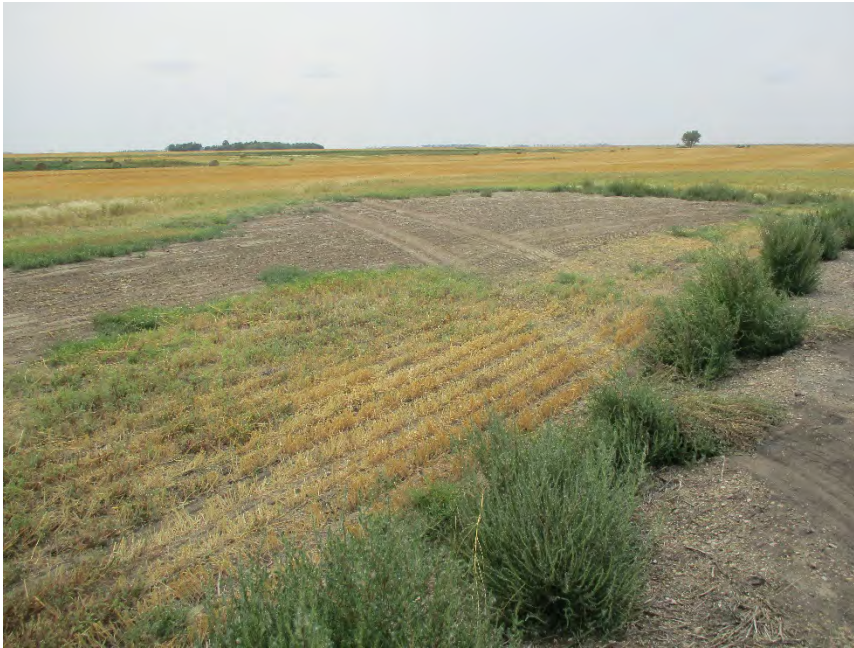
Photograph facing southwest off of an oilfield lease road showing a visually impacted area. Barren ground and stressed vegetation were observed in an area measuring approximately 50 feet by 20 feet.

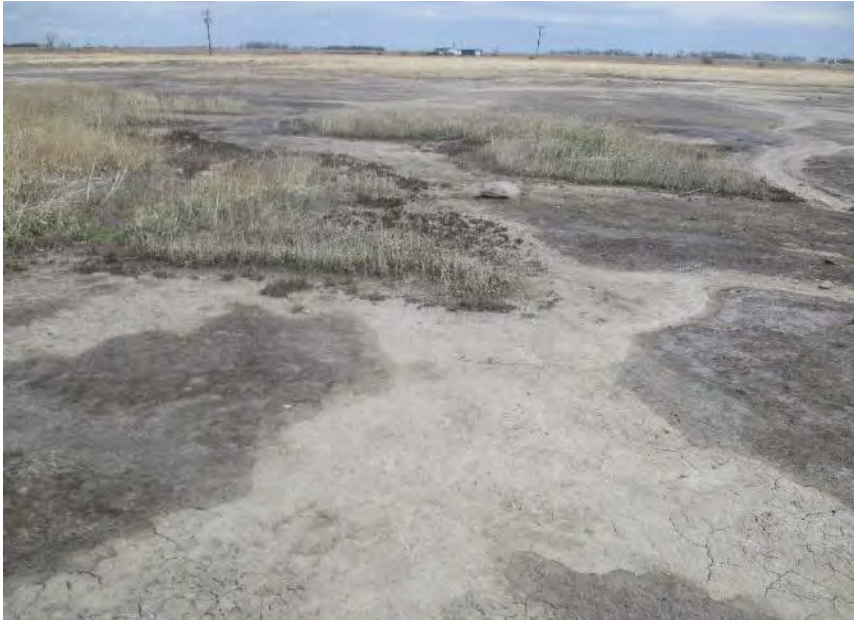
Photograph facing northeast off of an oilfield lease road showing visually impacted area. Extensive dead zones, salt crusts, and soil cracks were observed. The site is on native grassland adjacent to agricultural land. Residential areas and wetlands were observed to the northeast.

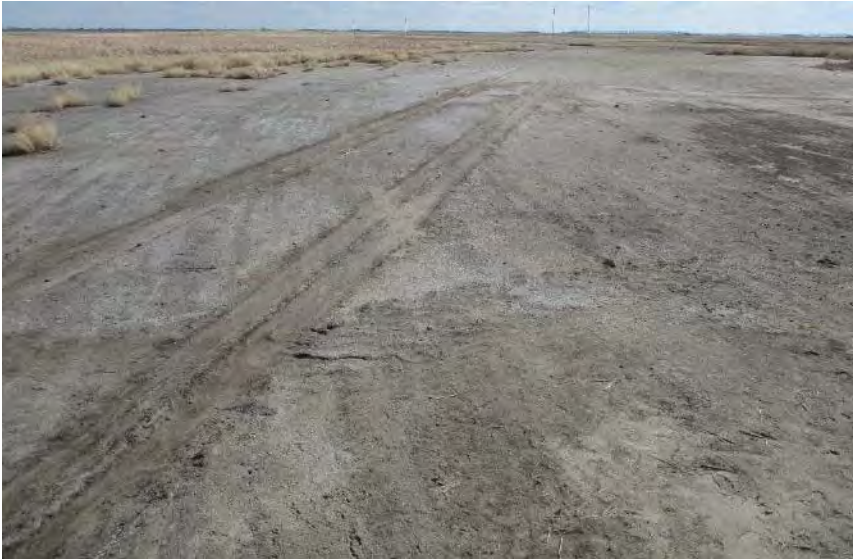
Photograph facing southwest off of an oilfield lease road showing extensive barren ground, soil cracking, and salt crusts.

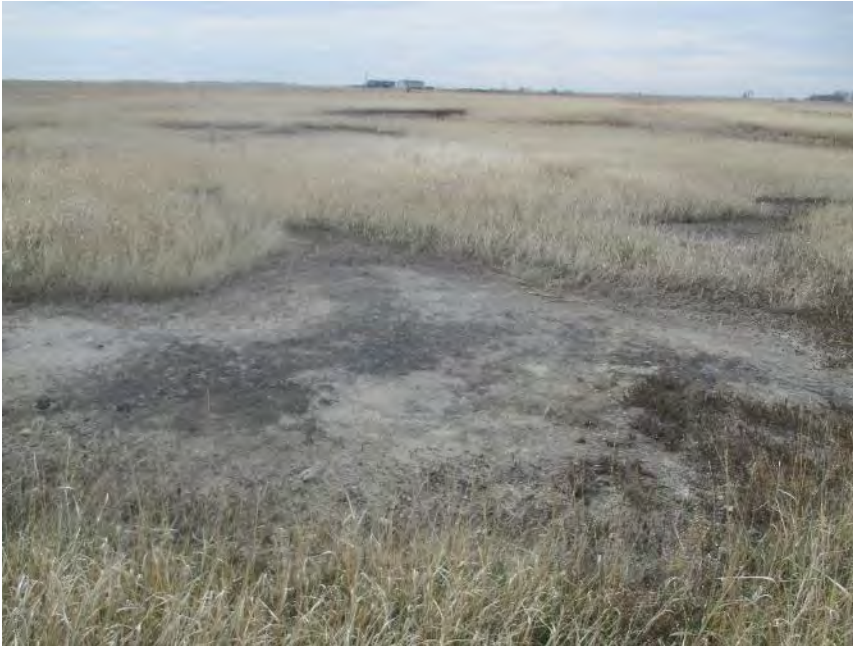
Photograph facing southeast off of an oilfield lease road showing multiple visually impacted areas of dead zones and stressed vegetation.

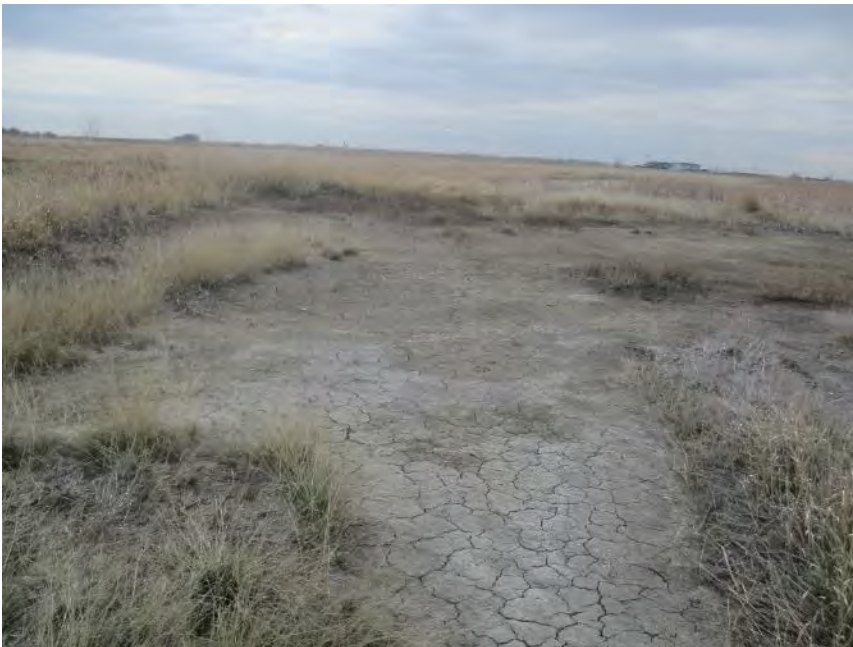
Photograph facing southeast off of oilfield lease road showing dead zone and soil cracks in impacted area.

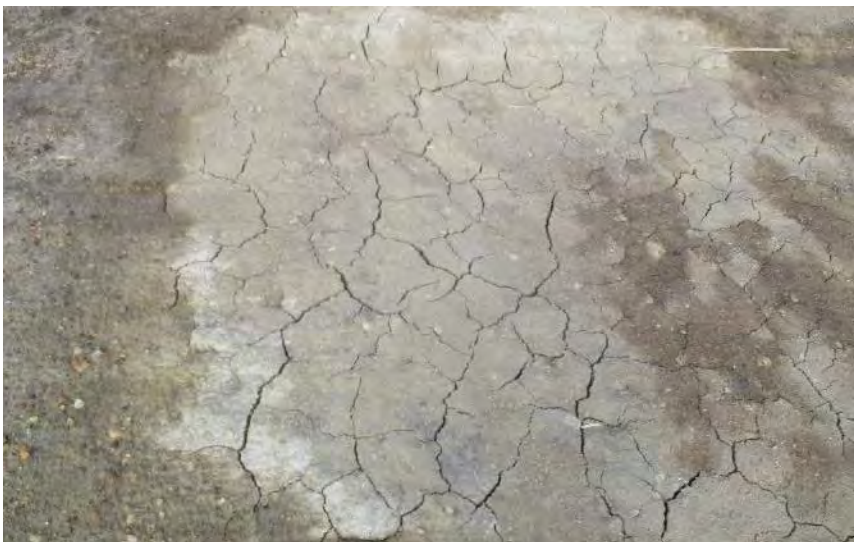
Photograph showing a closer view of soil cracks with slight salt crusts on site.

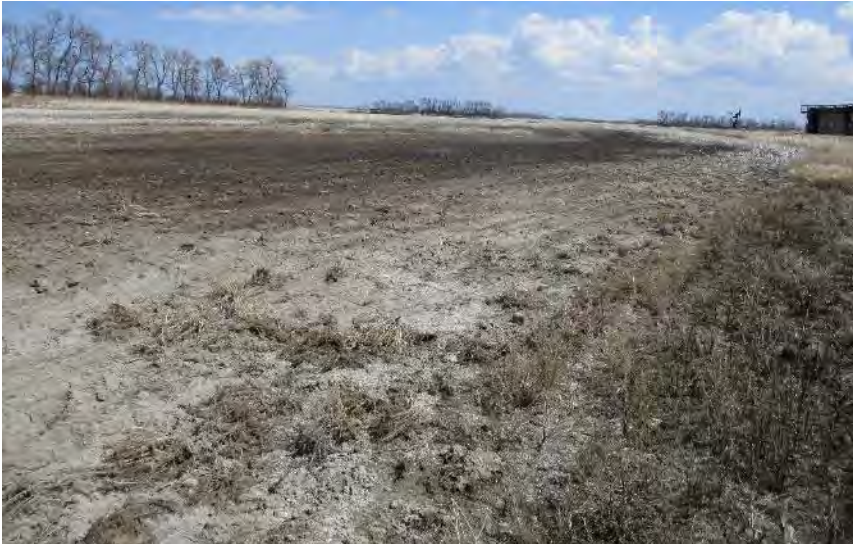
Photograph facing northeast off of an oilfield lease road showing stressed vegetation, white residue, and salt crusts. Aboveground storage tanks are visible on an oilfield production pad in the background.

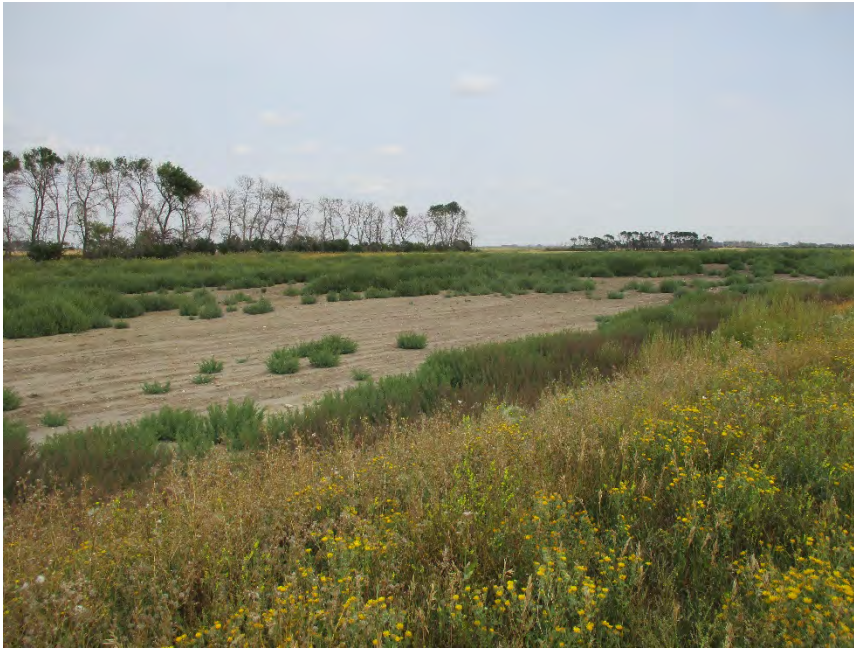
Photograph facing northeast off of an oilfield lease road showing the eastern portion of the visually impacted area. Barren ground and stressed vegetation were observed in an area measuring approximately 500 feet by 100 feet.

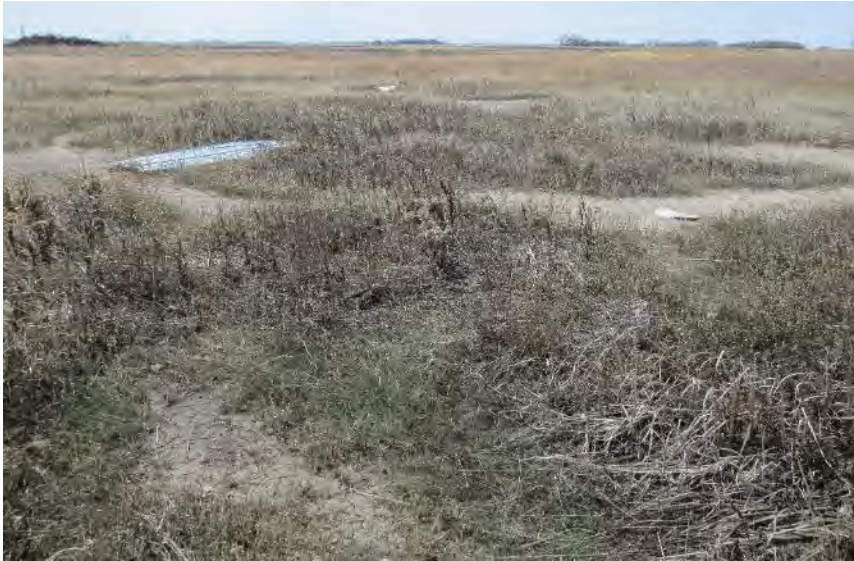
Photograph facing south off of an oilfield lease road showing the site. Patches of barren soil and dead zones were observed in an approximately 50 feet by 20 feet area.

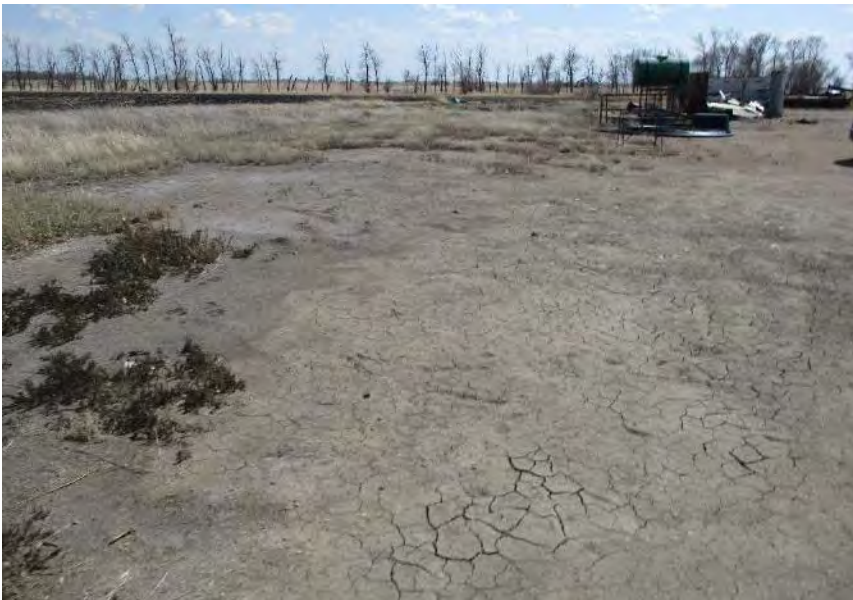
Photograph facing south off of the oilfield pad showing extensive dead zones, soil cracks, salt crusts and stressed vegetation along the perimeter of the pad.

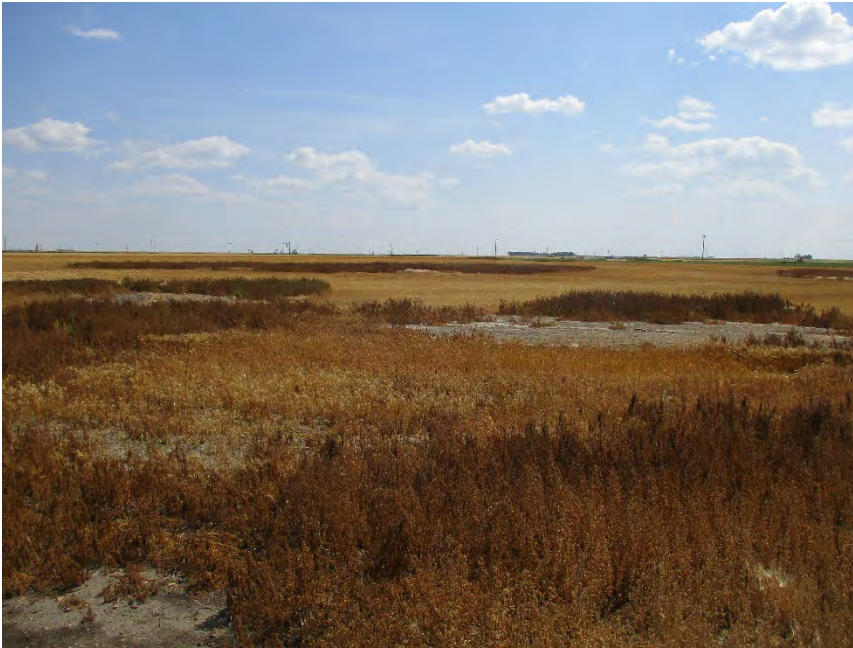
Photograph facing southeast off of an oilfield lease road showing a visually impacted area. Stressed vegetation was observed in an area measuring approximately 30 feet by 30 feet.

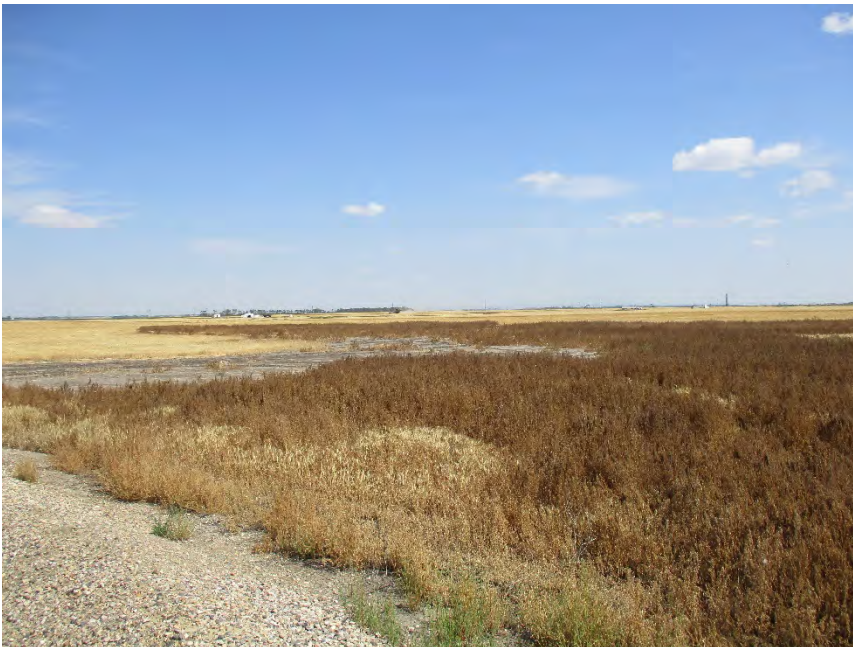
Photograph facing northeast off of an oilfield lease road showing visually impacted area. Barren ground and stressed vegetation were observed in an area measuring approximately 100 feet by 100 feet.

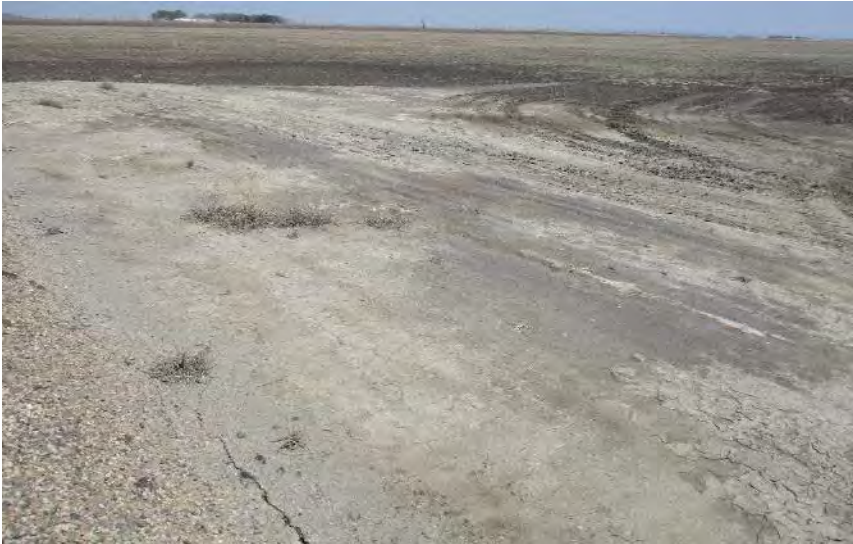
Photograph facing northeast off of an oilfield lease road showing the visually impacted area. Dead zones, salt crusts, and soil cracks are visible.

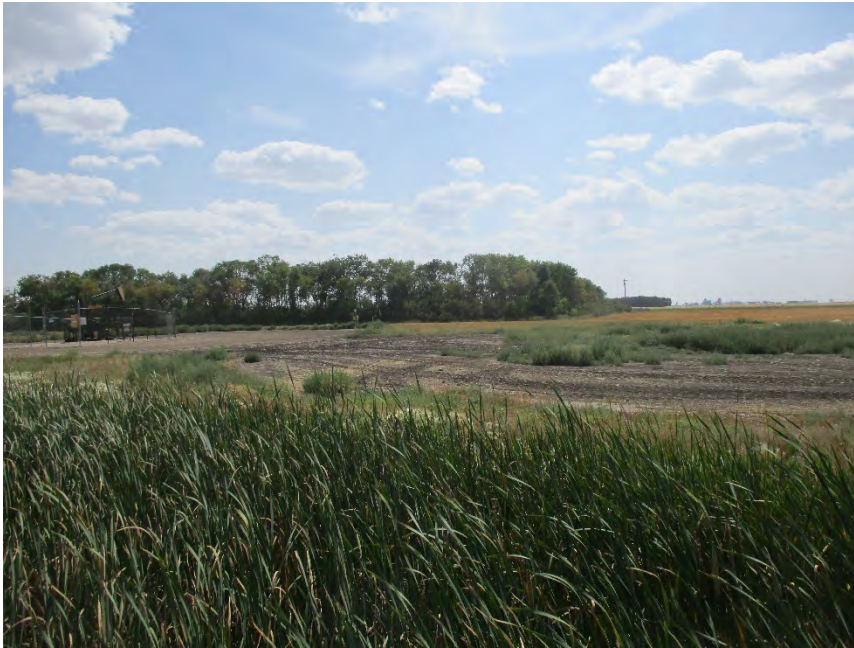
Photograph facing southeast off of an oilfield lease road showing the eastern portion of the visually impacted area. Barren ground and stressed vegetation were observed in an area measuring approximately 200 feet by 30 feet.

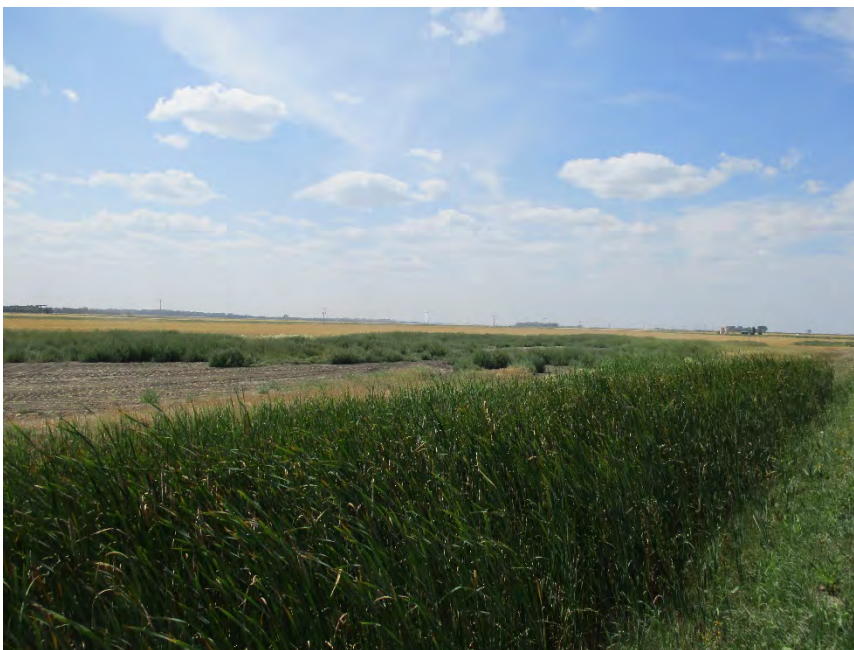
Photograph facing southwest off of an oilfield lease road showing the western portion of the visually impacted area.

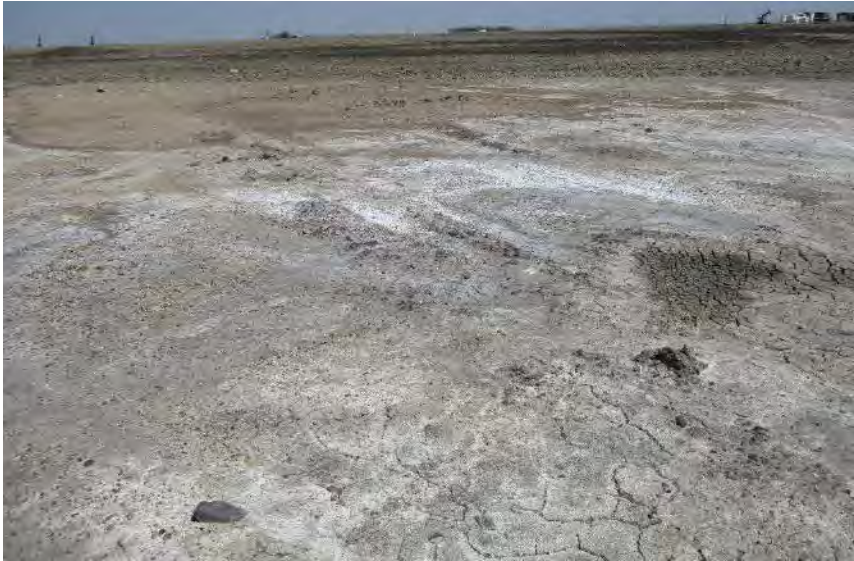
Photograph facing east off of an oilfield lease road showing the visually impacted area. Barren ground, dead zones, soil cracks, and salt crusts are visible in an approximately 500 feet by 20 feet area. Oil & gas facilities are located west of site.

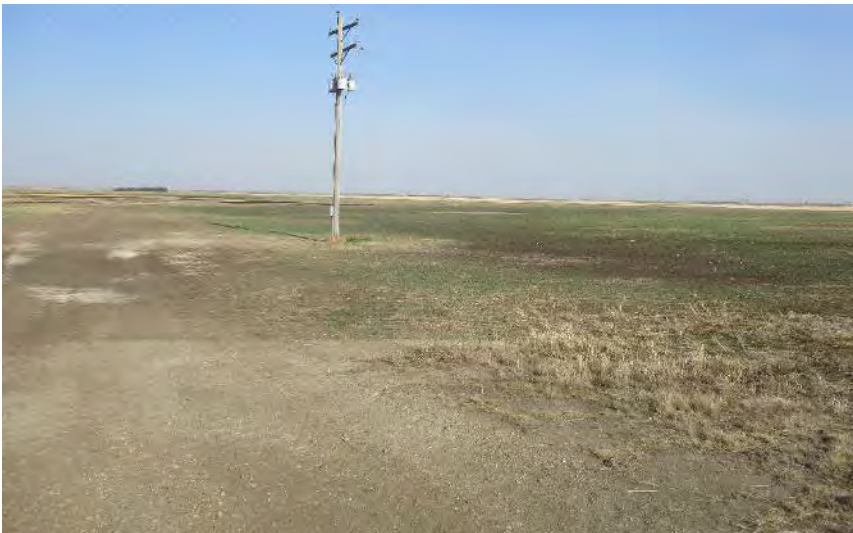
Photograph facing northwest off of 5th Ave NW showing potentially impacted area. Aboveground powerlines were observed along 5th Ave NW.

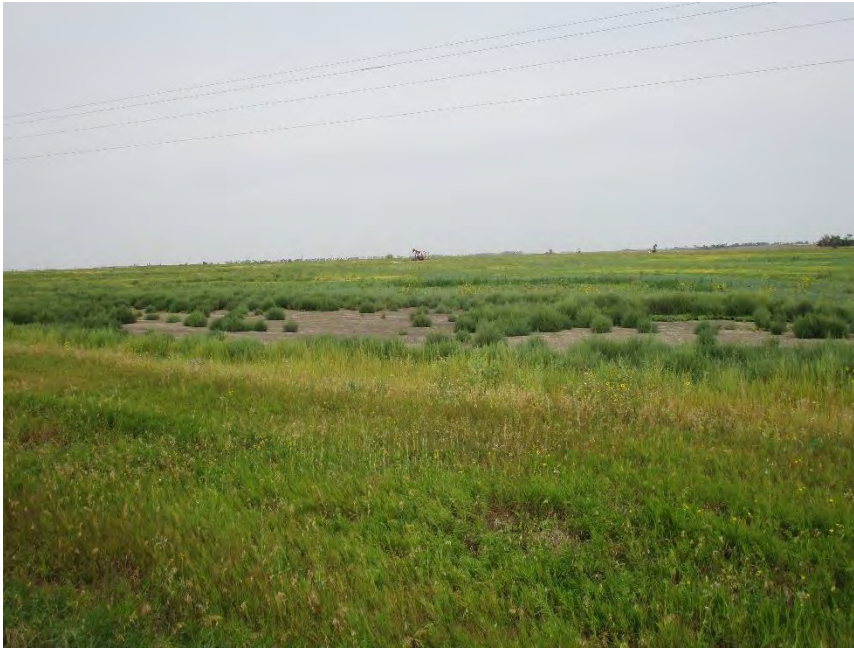
Photograph facing northwest off of 109th St NW showing the visually impacted area. Barren ground and stressed vegetation were observed in an area measuring approximately 50 feet by 20 feet.

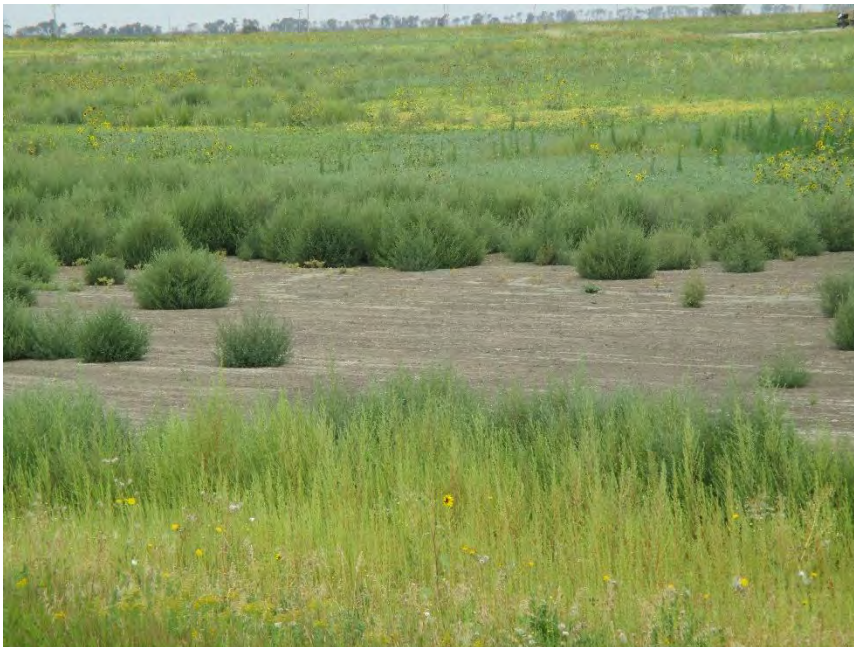
Photograph facing northeast off of 109th St NW showing barren ground and stressed vegetation.

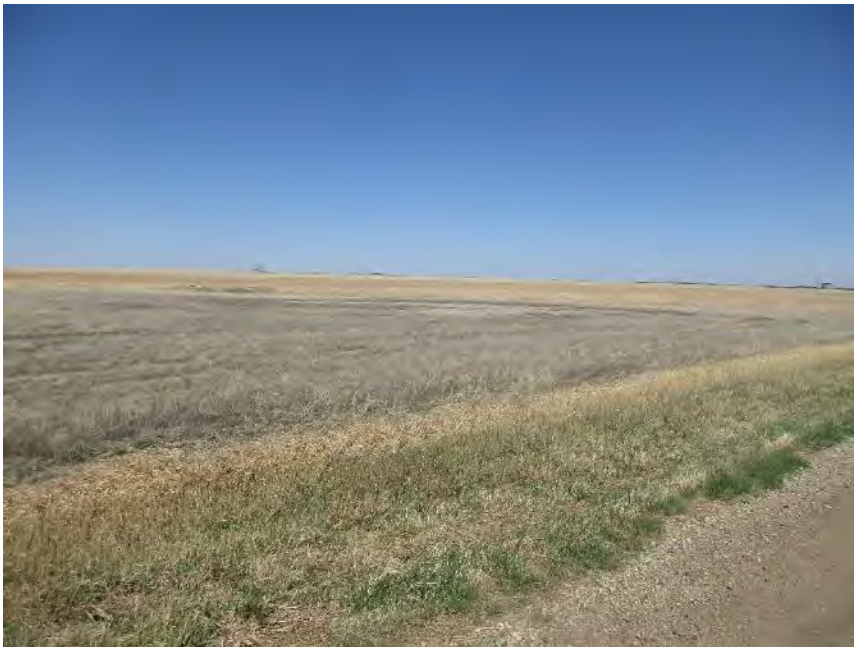
Photograph facing northwest from 101st St NW showing a small area of potentially stressed vegetation in the field.

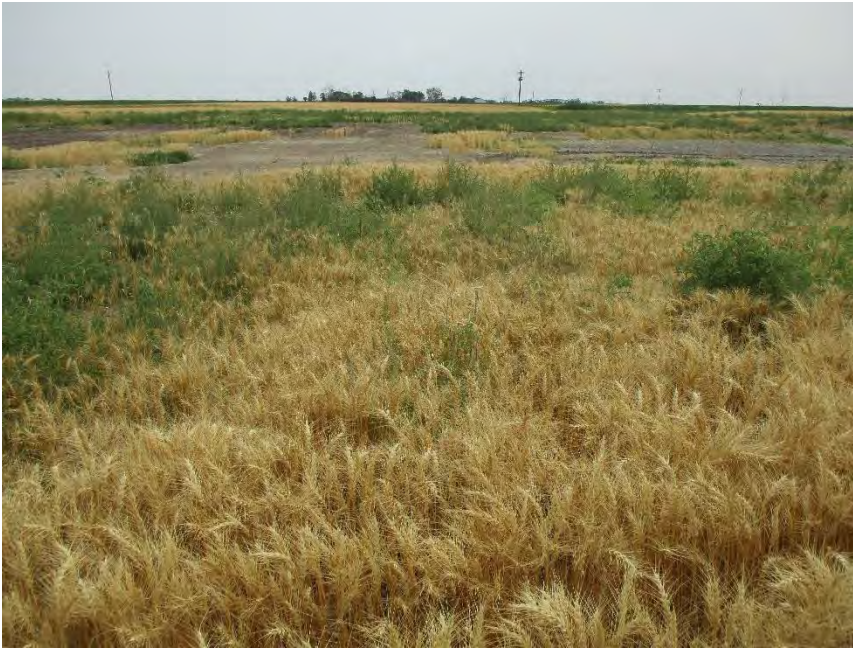
Photograph facing south showing the visual impacts at the site. Barren ground and stressed vegetation are visible in an approximately 100 feet by 100 feet area.

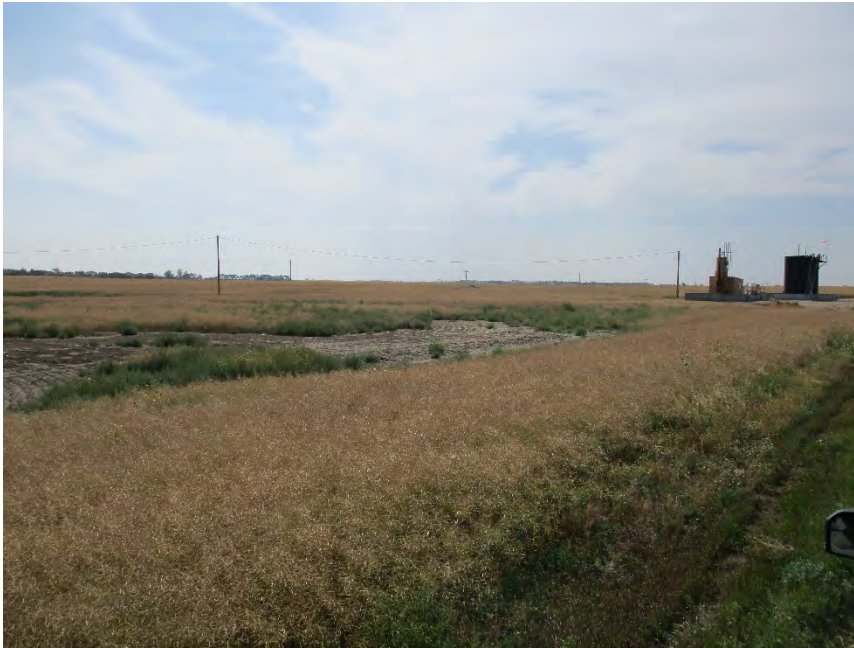
Photograph facing southwest off of an oilfield lease road showing the visually impacted area. Barren ground and stressed vegetation were observed in an area measuring approximately 100 feet by 100 feet.
