NDIC Brine Pond Study

Phase II: Site Assessments

June 25, 2018

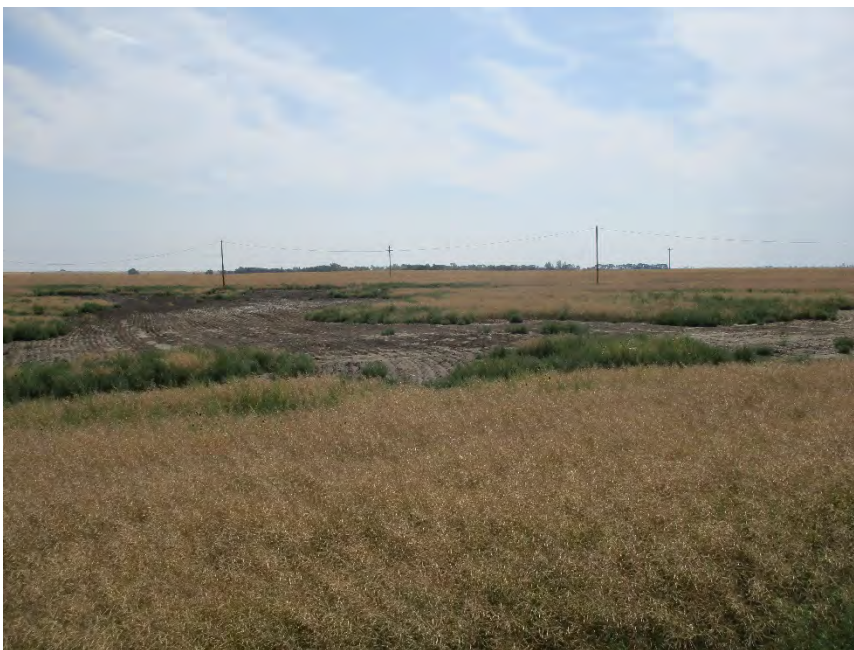
Photograph facing west southwest off of an oilfield lease road showing the visually impacted area.

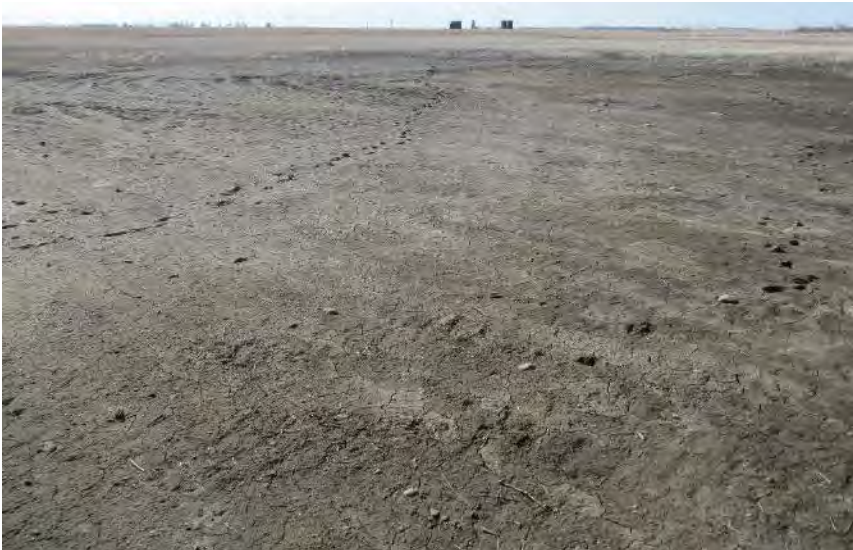
Photograph facing southwest off of an oilfield production pad showing soil cracks, salt crusts, and dead zones.

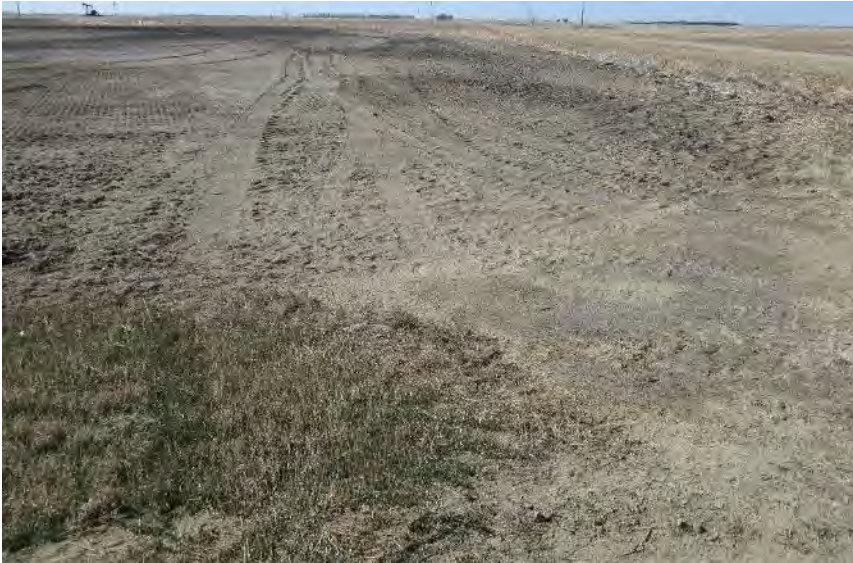
Photograph facing south off an oilfield lease road showing visual impacts, including dead zones, salt crusts, and soil cracks.

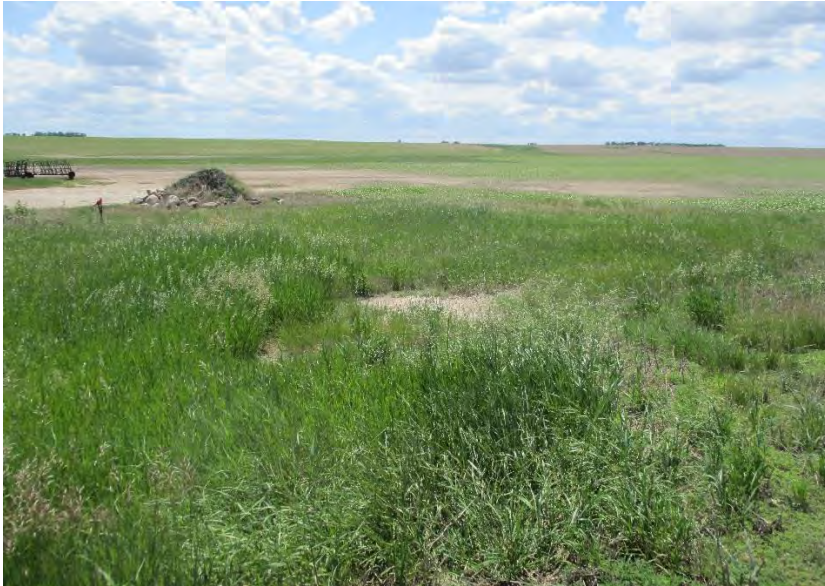
Photograph facing southwest from the oil & gas facility towards the Ward-1 site. Visual impacts including barren soils with salt crusting can be seen adjacent to the rock pile. The 3 feet by 3 feet area containing surficial oil staining can be seen in the center of the photograph.

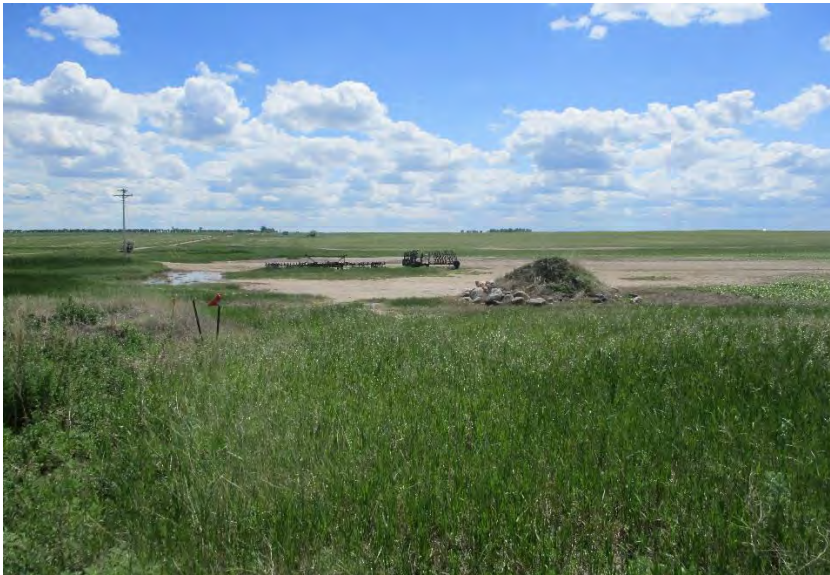
Photograph facing south from the oil & gas facility of the visually impacted area. Note the crude oil pipeline marker as well as the aboveground powerlines. The wetland located to the south of the site can be seen on the left side of the photograph.
