# River Road Rubble

*Levi D. Moxness*

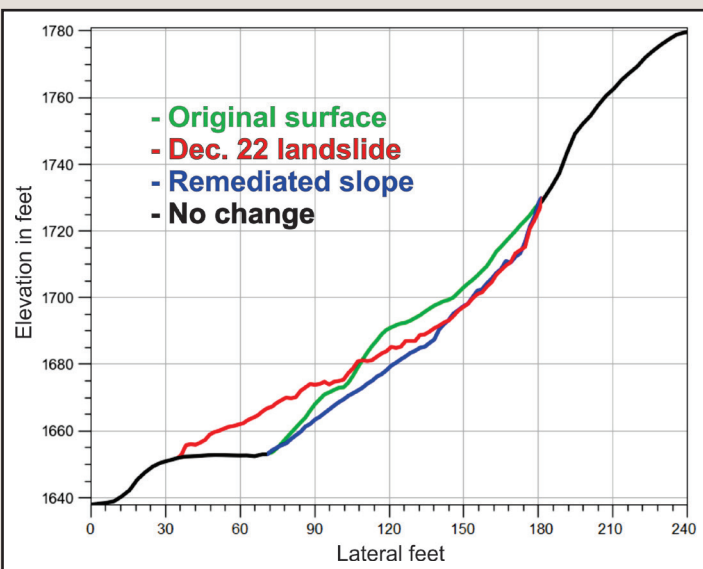
In order to elevate the roadway above the Missouri River floodplain, River Road was constructed on the base of the valley wall (fig. 1). At points this required cutting into the base of the slope. Whether via natural erosion or human construction, sediment removal from the toe of a slope removes support for the overlying material and often triggers failure, especially when it involves weak sedimentary units. The slope in the Bismarck area is predominantly comprised of poorly cemented mudstone, siltstone, and sandstone of the Cannonball Formation. The mudstones contain appreciable shrink-swell clays such as montmorillonite and illite (Fenner, 1974), which destabilize slopes

**Figure 1.** The changes to the slope are shown on topographic profiles through the center of the slide area. Profiles were extracted from 2009 LiDAR data (green) and NDGS drone photogrammetry immediately after the collapse (red) and after the failed material was removed (blue).

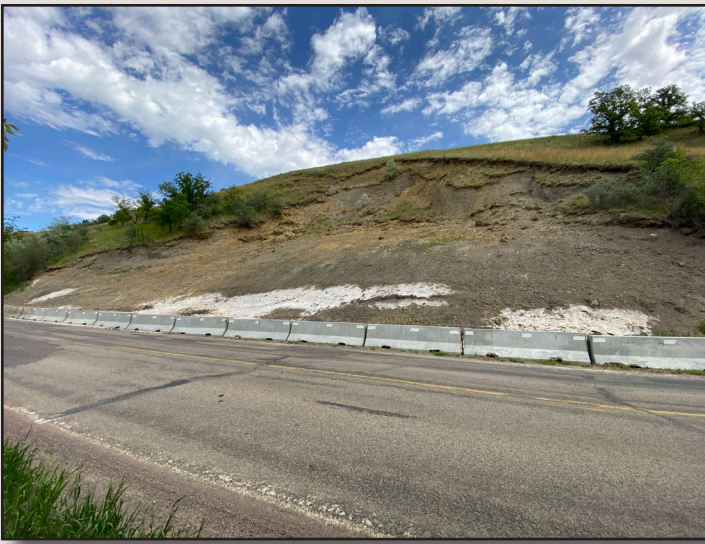
**Figure 2.** Groundwater seeping out of the base of the remediated hillslope along River Road in June of 2020. White-colored alkali minerals show where groundwater reaches the surface and evaporates. This flow was likely a significant factor in the collapse of the slope.

as they expand and contract during cycles of wetting and drying. Groundwater moves through zones that contain higher amounts of sand and silt, which can reduce the friction and cohesion of the sediment. It can also destabilize a slope as it adds weight and exacerbates frost wedging if the surface experiences freeze-thaw cycles. Groundwater seepage is readily apparent along the base of River Road (fig. 2). 2019 was the wettest year in Bismarck since 1876 (NWS, 2020), although this area has a history of slope failure even without record precipitation. Older landslides are present to the north and south of this locality along the Missouri River valley wall, including previous movement in the same spot (note the existing scarp in 2009; fig. 3A).

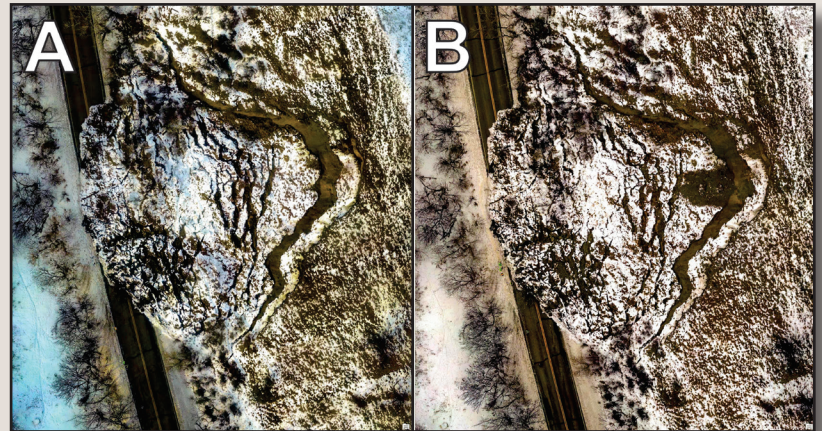
**Figure 4.** Orthophotos taken three hours after the initial collapse on December 22 (A) and two days later on December 24 (B). A digital comparison of these images showed the slide was stable aside from a small topple off the scarp.

slope was imminent. The NDGS imaged the slide again two days later to monitor for additional movement. The only change was a small topple off the scarp visible in both the orthophotos (fig. 4B) and the differential elevation map (fig. 5). The Burleigh County Highway Department began remediation on Dec. 26, removing several thousand tons of material and resloping the hillside as far as they could safely do so. As spring arrived and material thawed, debris began to roll onto the roadway, and it was closed again on March 3. The NDGS flew the site again on March 4 (fig. 3C), and the origin of the new collapsed material was again easily visible on the differential elevation map. Little additional debris fell, and the roadway reopened that day with jersey barriers installed to prevent smaller collapses from reaching the driving lanes.

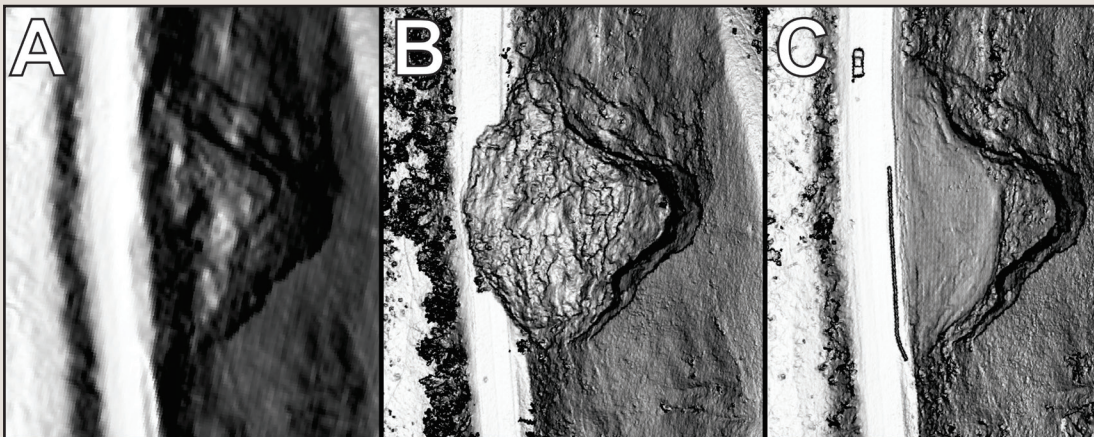
NDGS geologists were able to collect 3D photogrammetric data within three hours of the initial collapse on Dec. 22 (figs. 3B & 4A). At the time, there were questions about whether the main slide body would continue to settle and if additional failure of the

**Figure 3.** Hillshade models of the River Road landslide area produced with airborne LiDAR collected in May 2009 (A) and NDGS drone-based photogrammetric models taken immediately after road closures on December 22, 2019 (B) and March 4, 2020 (C).

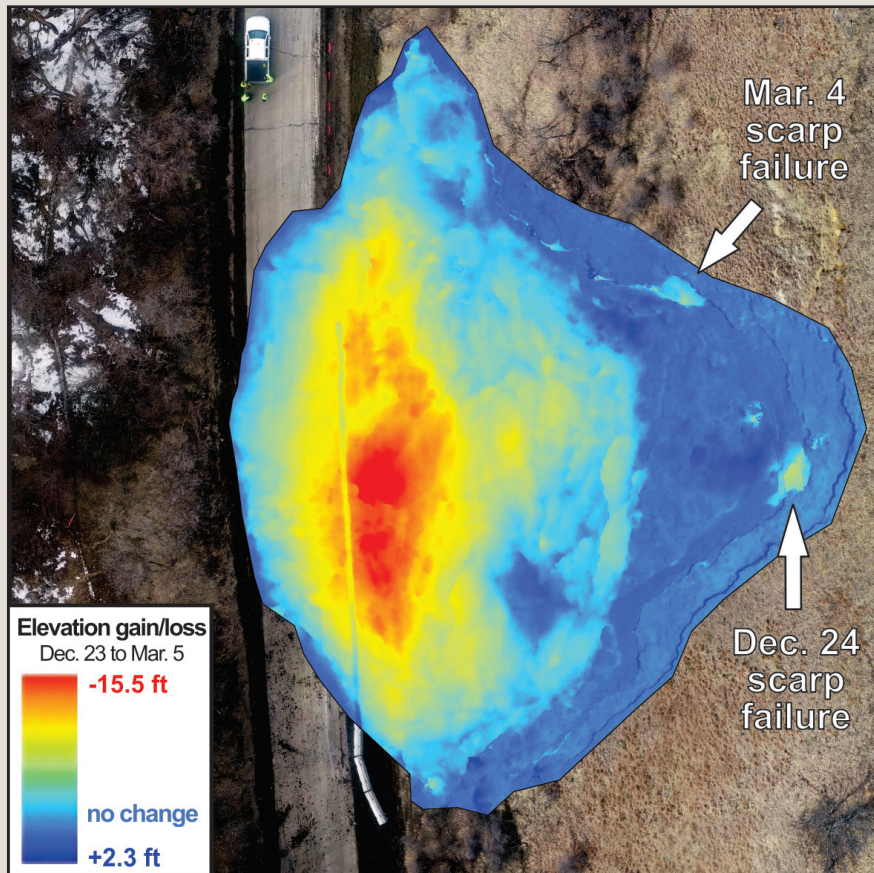
**Figure 5.** A map showing the elevation difference between the initial landslide (December 22, 2019) and the slope after it was remediated and closed for a second time (March 4, 2020) (models B and C in figure 3).

Although the drone imagery did not capture any substantial additional failures at this site, there was also an opportunity to compare its volumetric calculations to real-world figures. The photogrammetric model estimates 3,480 cubic yards (2,660 cubic meters) of material was removed from the roadway and slope, with a maximum depth of about 15.5 feet (4.7 meters). This is about 27% less than the actual amount trucked away estimated by the Burleigh County Highway Department (4,790 cubic yards / 3,360 cubic meters), suggesting a reasonable compaction ratio for the mudstone and siltstone in the slide as it became loose material upon removal.
