Corrective Action Report

NDIC Site #6 – NW¼-SW¼-S11-T156N-R103W
Bonetrail, Williams County, North Dakota

June 10, 2016

Terracon Project No. M1167061

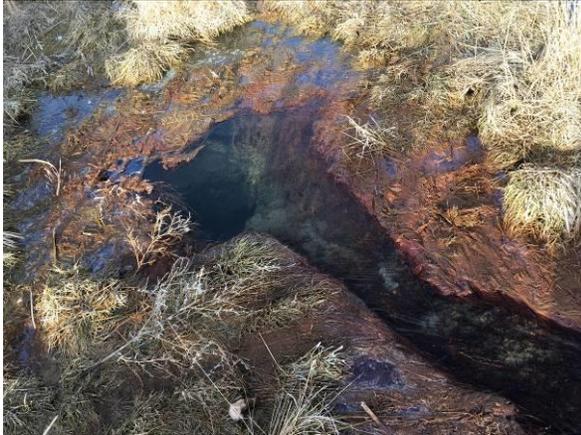
Photo #1 View (looking northeast) of borehole (March 2016).

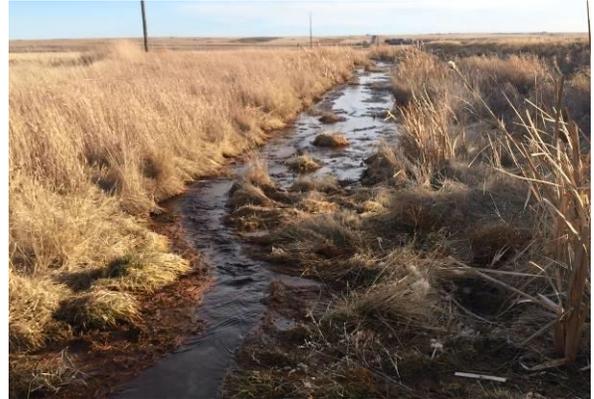
Photo #2 View (looking south) at impacts of a borehole (March 2016).

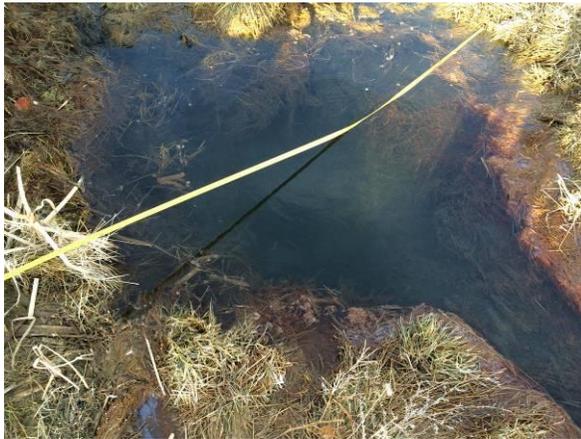
Photo #3 Measuring the width, approximately 6 feet, of borehole (March 2016).

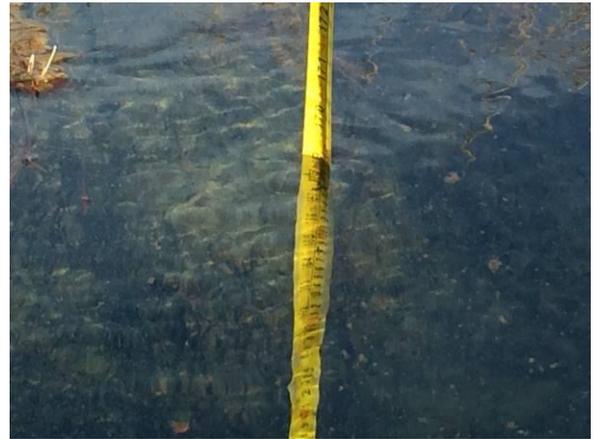
Photo #4 Measuring the depth, approximately 16 feet below grade surface, of borehole (March 2016).

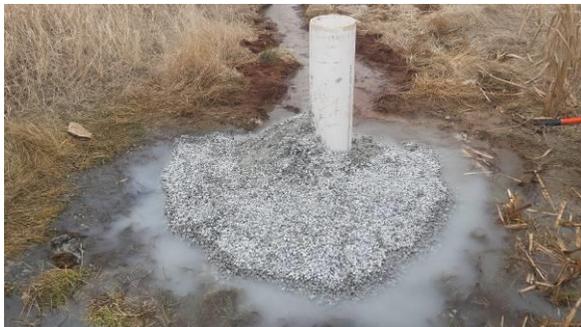
Photo #5 View (looking south) of borehole after being grouted and cased (March 2016).

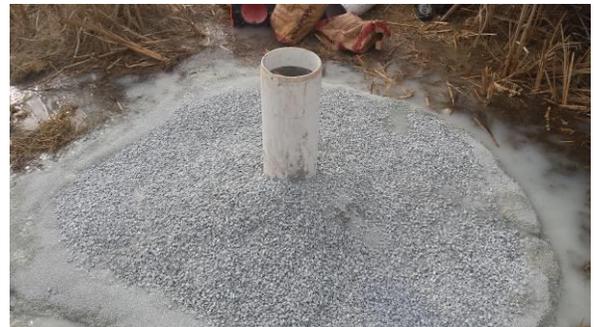
Photo #6 View (looking west) of borehole after being grouted and cased (March 2016).

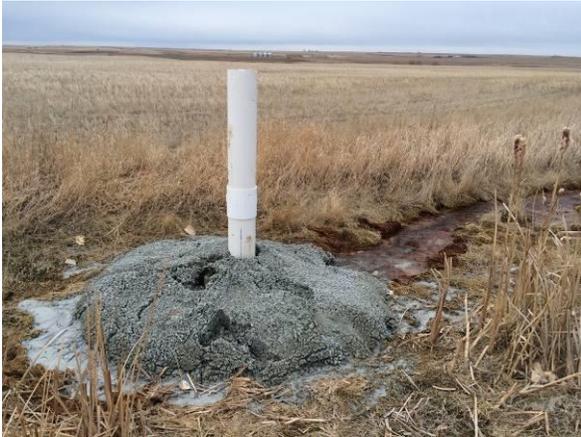
Photo #7 View (looking southeast) of grouted and cased borehole (March 2016).

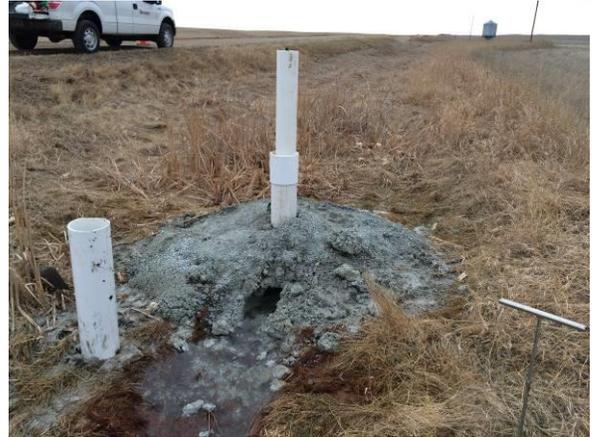
Photo #8 View (looking north) of second casing and hole created for the piping (March 2016).

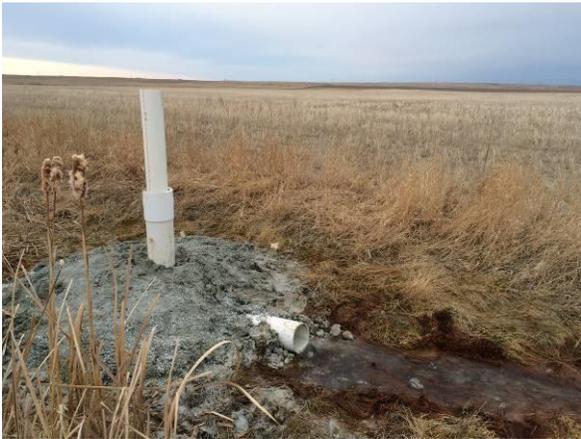
Photo #9 View (looking northeast) of second casing and piping inserted for water flow to help with erosion (March 2016).

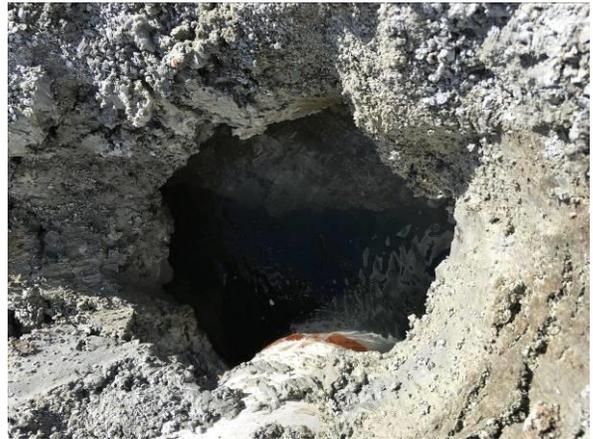
Photo #10 View at hole made on the south side of casing for downhole camera (March 2016).

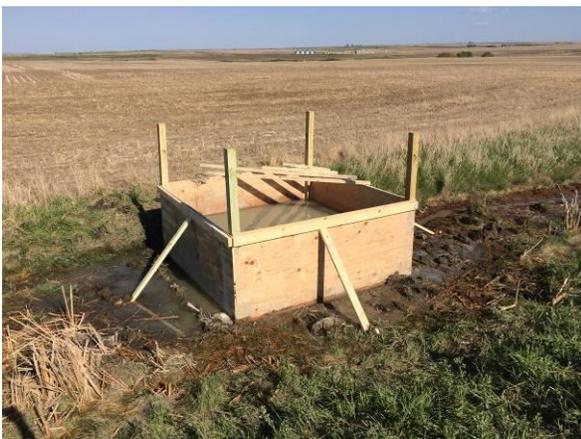
Photo #11 View (looking southeast) of installed wooden piling walls around cased borehole (May 2016).

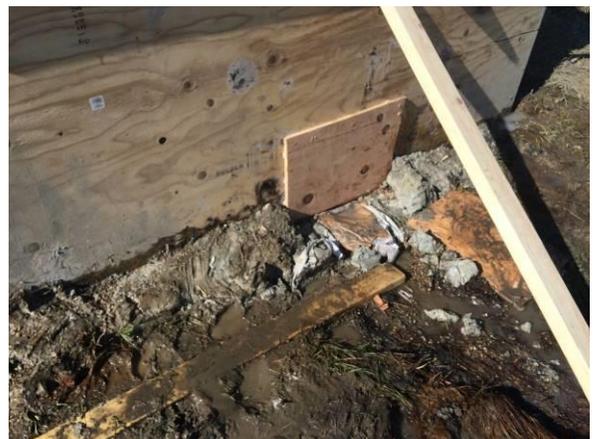
Photo #12 View at closed trap door attached to the wooden piling walls (May 2016).

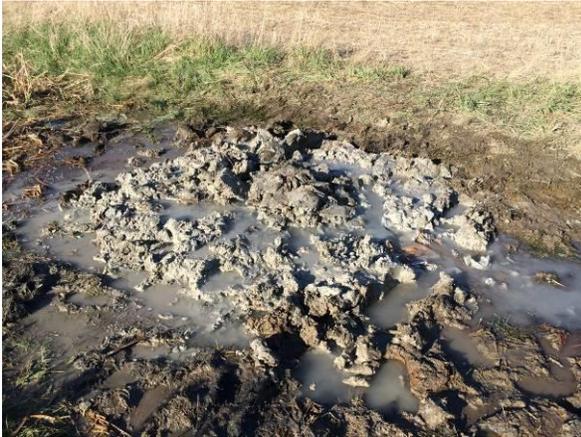
Photo #13 View (looking northeast) of impacts after removing the wooden piling walls (May 2016).

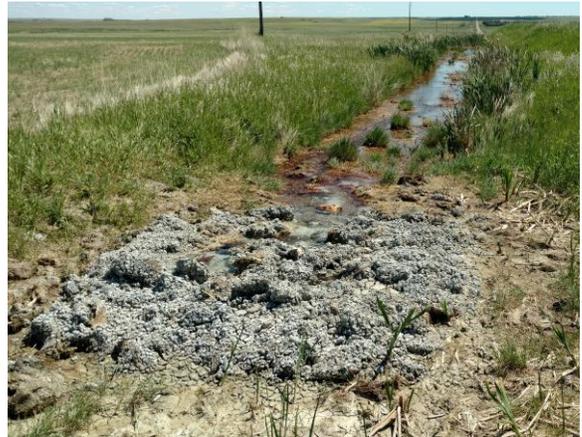
Photo #14 View (looking south) of impacts after removing the wooden piling walls (June 2016).

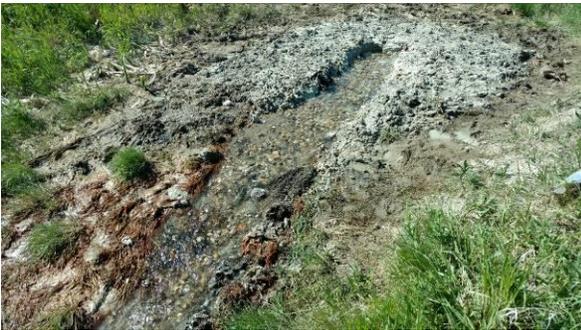
Photo #15 View (looking northwest) of the trench dug for proper drainage (June 2016).

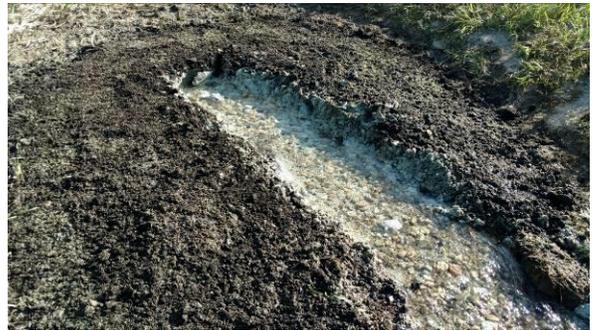
Photo #16 View (looking northeast) of trench and topsoil placed around borehole (June 2016).

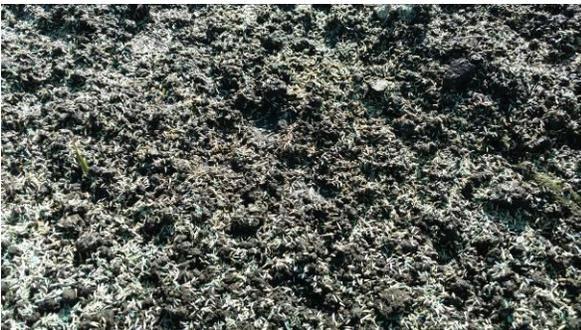
Photo #17 View of seed disbursement on topsoil (June 2016).

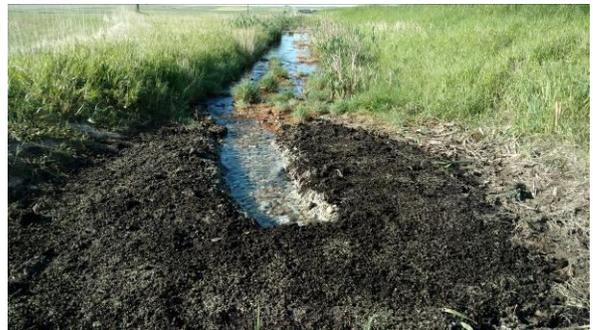
Photo #18 View (looking south) of completed reclamation activities of borehole (June 2016).

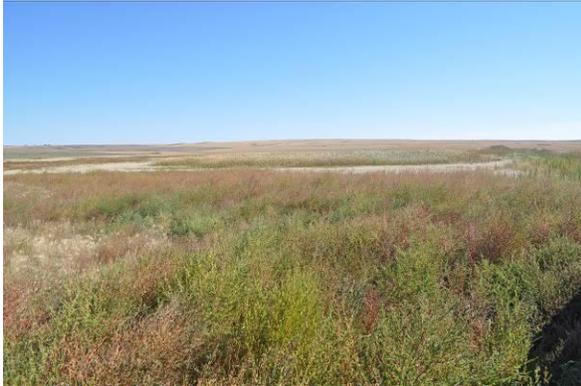
Photo #1 View (looking east) of borehole Berg 2 (Sept. 2015).

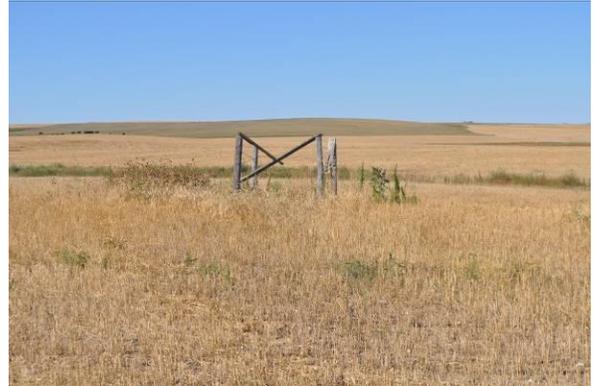
Photo #2 View (looking north) of a borehole developed by the landowner (Sept. 2015).

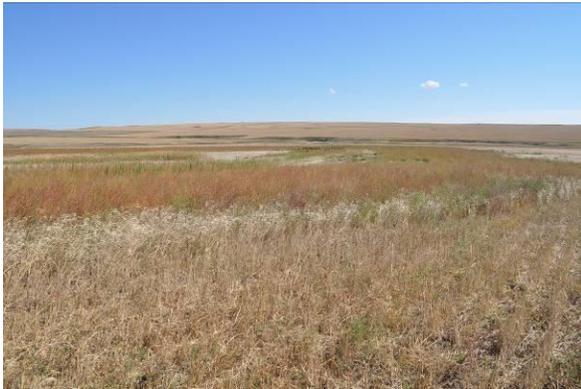
Photo #3 View (looking east) of surface impacts caused by borehole Berg 3 (Sept. 2015).

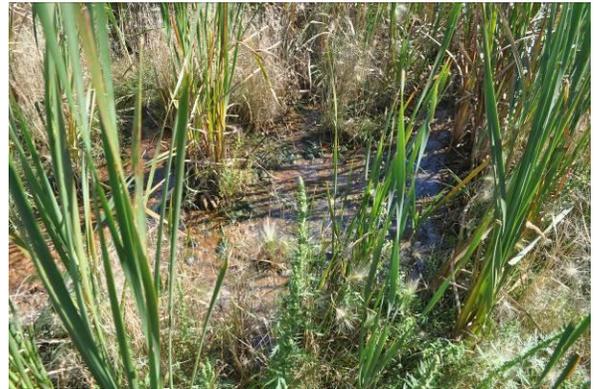
Photo #4 View (looking east) at borehole Berg 3 (Sept. 2015).

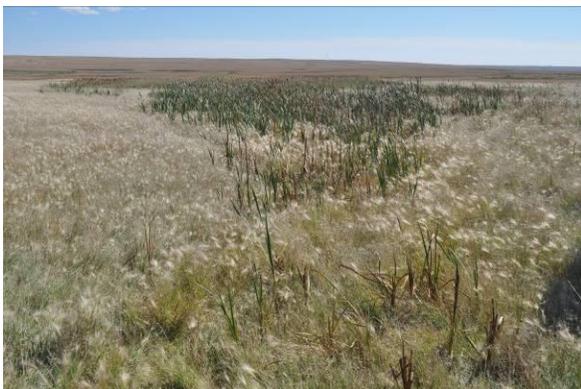
Photo #5 View (looking east) of surface impacts caused by borehole Berg 1 (Sept. 2015).

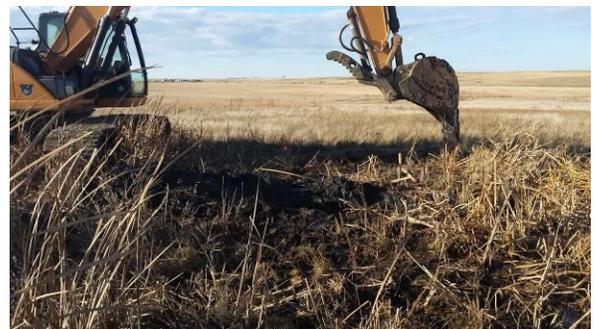
Photo #6 View of dewatering activities at borehole Berg 3 (Oct. 2015).

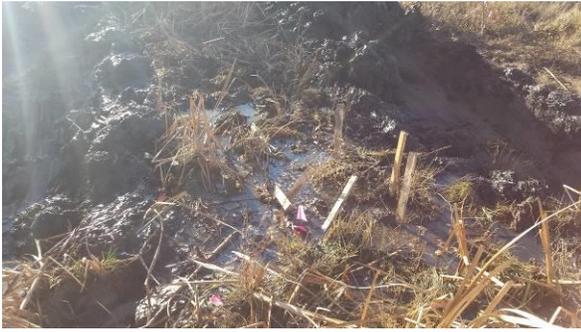
Photo #7 View of borehole Berg 3 (Oct. 2015).

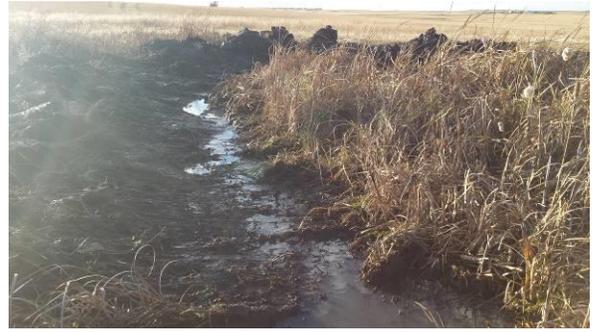
Photo #8 View of impacts from dewatering activities at Berg 3 (Oct. 2015).

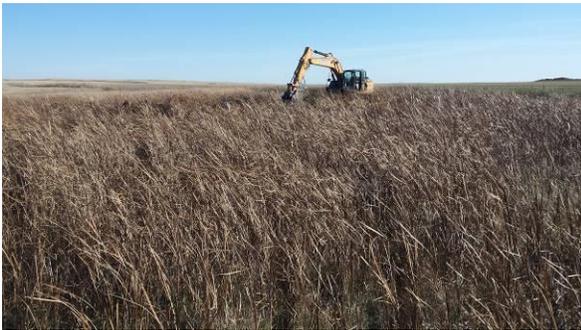
Photo #9 View of dewatering activities at borehole Berg 2 (Oct. 2015).

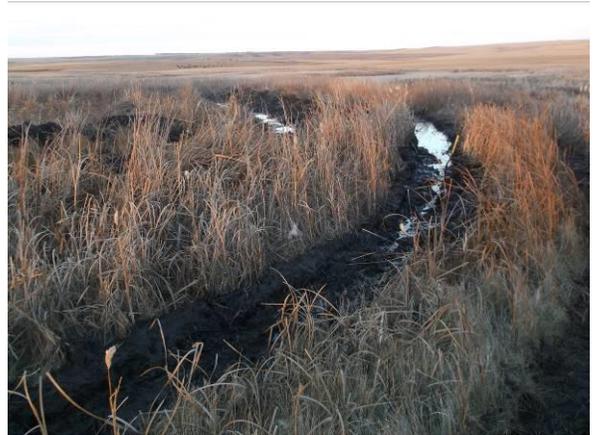
Photo #10 View of impacts from dewatering activities at Berg 2 (Oct. 2015).

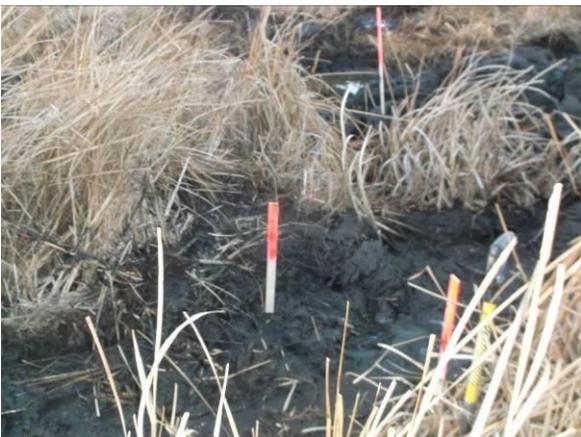
Photo #11 View of borehole Berg 2 (Oct. 2015).

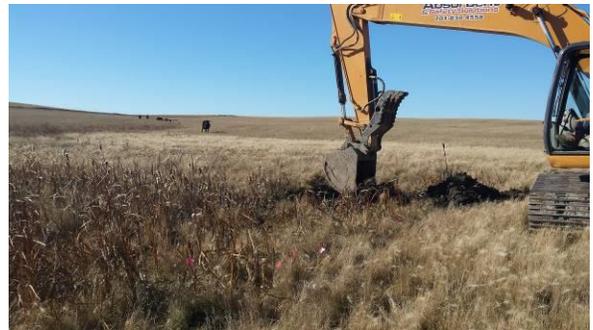
Photo #12 View (looking west) of dewatering activities at borehole Berg 1 (Oct. 2015).

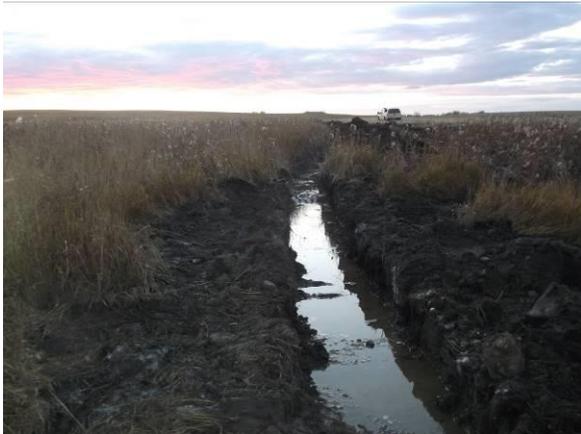
Photo #13 View (looking west) of dewatering activities at borehole Berg 1 (Oct. 2015).

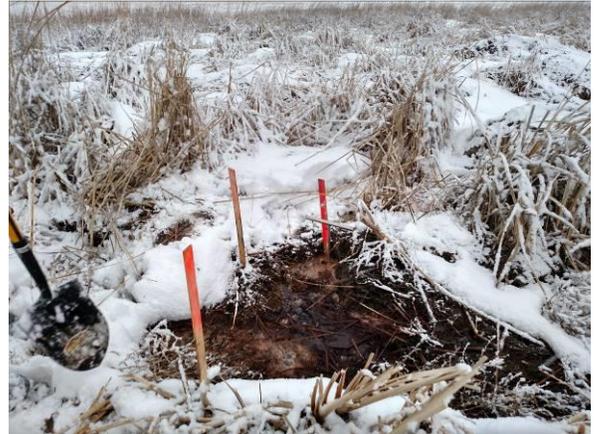
Photo #14 View of borehole Berg 2 (Feb. 2016).

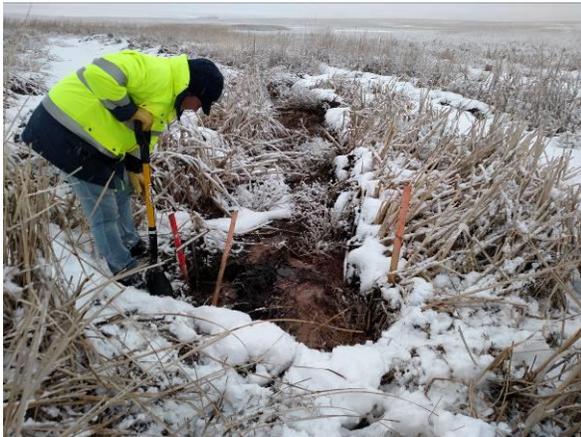
Photo #15 View (looking north) of borehole Berg 2 (Feb. 2016).

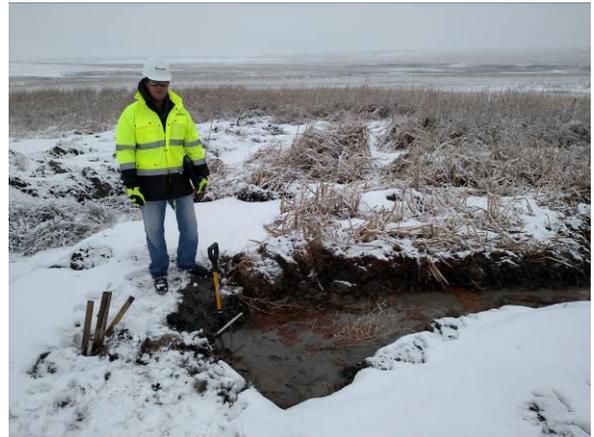
Photo #16 View (looking north) of borehole Berg 3 (Feb. 2016).

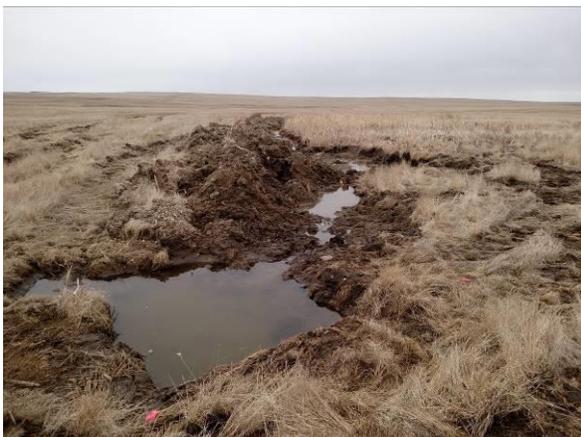
Photo #17 View (looking east) of impacts from dewatering activities at Berg 1 (March 2016).

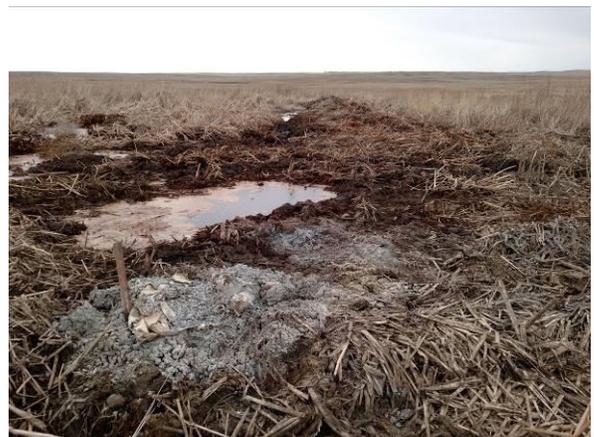
Photo #18 View (looking north) of borehole Berg 2 surface impacts after plugging (March 2016).

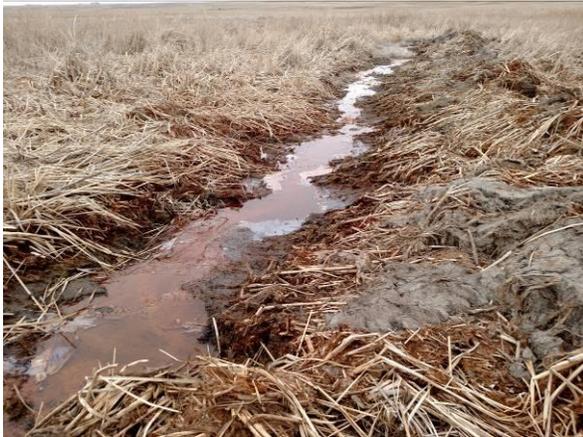
Photo #19 View (looking north) of borehole Berg 2 surface impacts after plugging (March 2016).

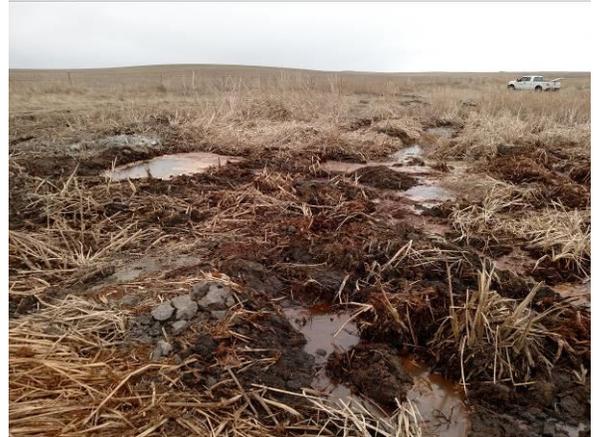
Photo #20 View (looking west) of borehole Berg 2 surface impacts after plugging (March 2016).

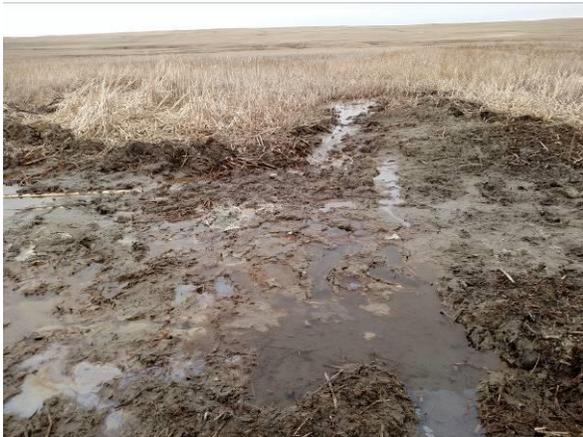
Photo #21 View (looking east) of borehole Berg 3 surface impacts after plugging (March 2016).
