“Mudlumps” in the Red River Valley

By Lorraine A. Manz

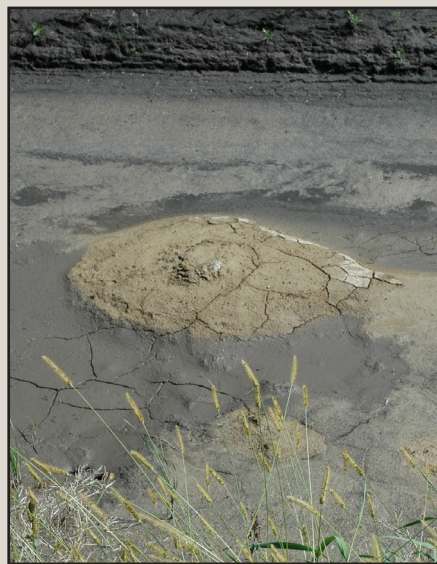
Figure 1. Mounded clay extrusion in a freshly dug ditch near Minto in Walsh County. The floor of the ditch was perforated by dozens of these features that ranged from a few inches to about two feet in diameter. This is one of the larger mounds. When I revisited this site a year later, the ditch was already overgrown with reeds and other vegetation.

Slope failure does not explain the mound-like features I described at the beginning of this article. The ditch near Minto had been recently dug, it was relatively shallow, and the roadside embankment seemed to be intact. Nevertheless, the appearance of these curious structures indicates that conditions in and around the ditch are not entirely stable.

Given the location (fig. 2B), the most likely origin of the mounds is the Brenna Formation and its propensity to flow. Clayton believed as much about the origin of his “injection mounds” except they were formed in till rather than lake sediment. Although not as deep as the Johnstown ditch (11 feet), the setting in the one near Minto was essentially the same: unconfined weak sediment

adjacent to a surface laden with the weight of a road, which in this case, had been raised several feet as a precaution against seasonal flooding, or perhaps in repair of damage from earlier slope failures. In addition, several heavy downpours in the weeks preceding the mounds' discovery had made the ground in the area very wet.

The excavation of the ditch evidently did not expose the unit underlying the Sherack, although the contact between them was probably not more than a few feet below its base. After so much rain, the combined weight of undisturbed sedimentary material and the gravel road above it became too much for the underlying water-saturated clay and it began to flow toward the ditch. Following the path of least resistance, once there, it was forced upward, breaking the surface wherever the overlying sediment was weakest (fig. 7) much like the mudlumps on the Mississippi Delta, only much smaller (Morgan and others, 1968).

Readers familiar with the Brenna Formation will know that it is typically described as grayish brown to very dark gray, even black, in color when wet (Arndt, 1977; Harris and others, 2020), yet the mounds were light yellowish brown, which suggests oxidation. Evidence of oxidation was observed in the upper 10-11 inches of the Brenna Formation in cores from the Fargo area (Liu and others, 2014) but not at the type and reference sections in Grand Forks and Oslo, MN (Harris and others, 2020). Compaction ridges associated with the West Fargo Member of the Poplar River Formation, which was deposited during the low-water Moorhead Phase of Lake Agassiz (12.6 to 10.6 thousand years ago) and which unconformably overlies the Brenna, are common in central Grand Forks and Walsh Counties, including the areas around Minto, and Johnstown, and their presence is strongly indicative of subaerial exposure. There are none within a few miles of the Red River in, and north of Grand Forks in the deeper part of the basin, where lake water may have persisted throughout the Moorhead Phase, leaving the submerged sediment unaltered.

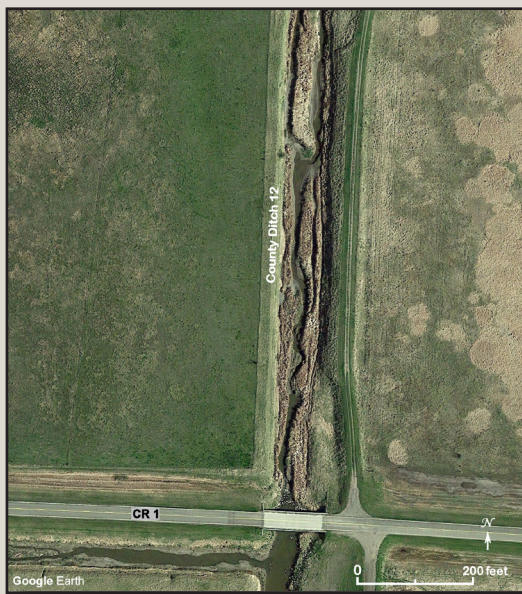
The persistent instability of the Johnstown ditch is due in part to its unfortunate location. The ditch was constructed in a part of Grand Forks County where the Sherack Formation is relatively thin (Arndt, 1977). I am unsure whether or not the excavation actually cut into the underlying till, but it doesn't really matter because the outcome was going to be the same. The removal of overburden and lateral support with the opening up of the channel, and the weight of nearby County Road 1 bearing down on it, meant that failure of the ditch's sloping roadside embankment was inevitable.

Slumping along the Johnstown ditch became a recurring problem that was eventually mitigated for a time until North Dakota entered a wet cycle in 1993. It is still an issue, and particularly troublesome is the 1-mile stretch of County Ditch 12 immediately north of County Road 1 where it joins ditch 19 (fig. 6). Here, frequent slumping has forced the relocation of the adjacent gravel road, and embankment gradients have been reduced from 6:1 to 2:1 in an attempt to mitigate the situation (R. Axvig, personal commun., 2021).

Figure 6. Slumping along Grand Forks County Ditch 12 just north of where it joins ditch 19 (bottom left) near County Road 1.
