Corrective Action Report

NW ¼ of SW ¼ of Section 11, T158N R82W

Glenburn, Renville County, North Dakota

Terracon Project No. M1197039

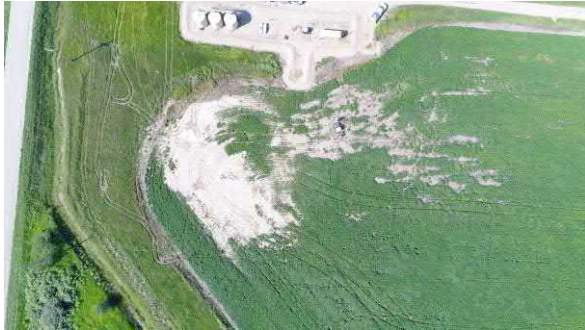
Photo #1 View of remediation area prior to commencing work.

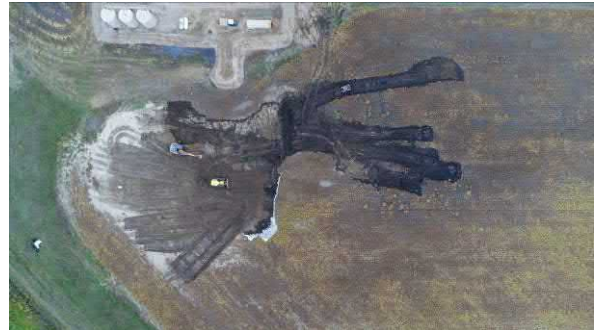
Photo #2 Initial earthwork and removal of topsoil.

Excavation was initiated downgradient to the east of the historical brine pit where additional impacts were encountered. Excavation continued to the west and south toward the location of the historical brine pit. The remediation area was excavated to approximately three feet bgs to install the capillary break and drainage system. Contaminated soils were stockpiled on impermeable plastic sheeting until used for backfilling after installation of the gravel capillary break and drain tile. Impacted topsoil and subsoil were separated during excavation to be used as backfill in their respective layers after capillary break installation.

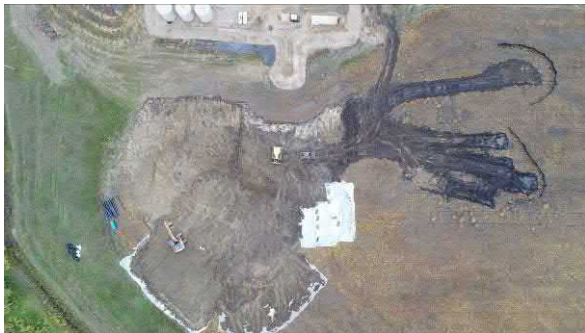
Photo #3 Stockpiling topsoil and excavated contaminated soil.

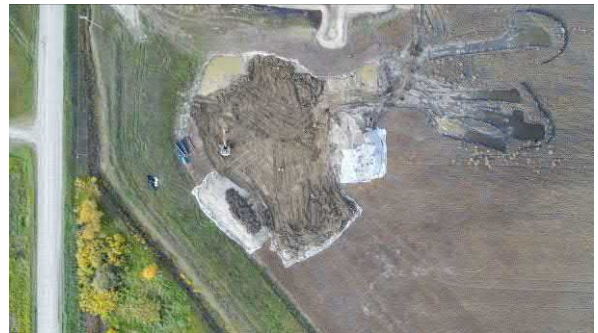
Photo #4 Soil Excavation.

Excavation of impacted material continued until the extent of the impacts had been removed. Once the remediation area was fully excavated; the phytoremediation cell area was excavated on the northwest corner of the site. The non-impacted soils excavated from the phytoremediation cell were used to build up the south and east side of the remediation area to aid in the drainage of surface water towards the phytoremediation cell to the northwest.

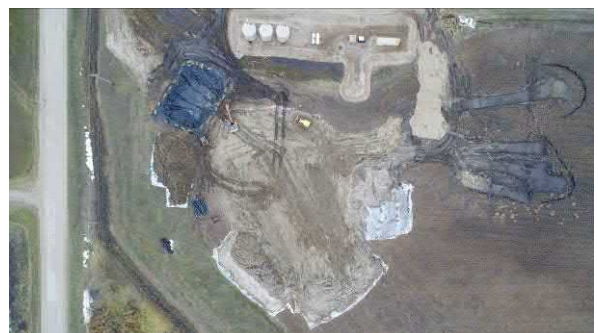
Photo #6 Installation of capillary break.

Once the impacted soil was removed from the remediation area, the capillary break was installed. The capillary break was constructed with filter/separation fabric (geotextile) installed directly on the excavated ground surface followed by an approximately six-inch layer of gravel. A drainage system consisting of four-inch PVC drainage piping laid within the gravel layer followed by a filter/separation fabric (geotextile) on top of the final gravel grade.

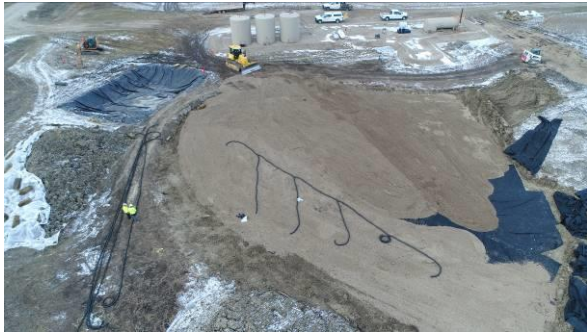
Photo #7 Installation of PVC drain tile in the capillary break with filter fabric.

The PVC drainage system was designed and installed to have a dendric design with a flow to the northwest into the phytoremediation cell. The phytoremediation cell was excavated in the northwest corner of the site and was an approximately 45 by 60-foot excavation to an approximately eight-foot depth and lined with a geomembrane. A single six-inch PVC outfall pipe connected to the PVC drainage system was installed through the geomembrane liner and sealed to prevent water migration in and out of the phytoremediation cell. After the capillary break was completed, the excavation was backfilled as described in the following section.

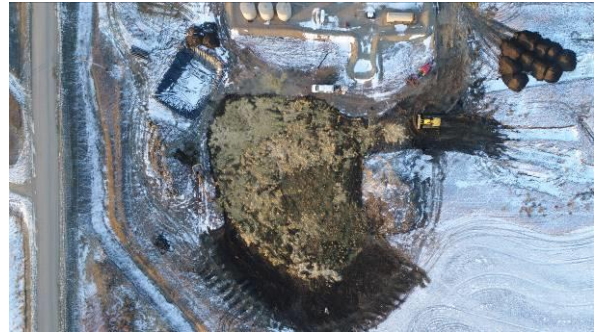
Photo #8 Placing gypsum and straw amended soil over capillary break.

Following the installation of the capillary break and drainage system, the excavation was backfilled from November 5, 2019 through November 7, 2019. The backfill material consisted of the original stockpiled impacted soil from the remediation area amended with straw and powdered gypsum. The backfill was graded to allow for surface runoff to flow to the northwest toward the phytoremediation cell and limit the surface flow to the adjoining properties while minimizing potential erosion. The amended backfill was surfaced with a combination of stockpiled topsoil from the area remediation area with an additional 260 tons delivered by Sundre Sand & Gravel, Inc. from an approved off-site location. The delivered topsoil was field screened prior to delivery to check for impacts.

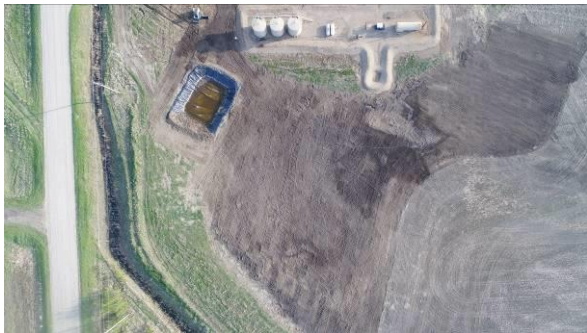
Photo #9 Remediation area with hoses and sprinklers laid out.

The Upper Souris Water District installed an access line near the northwest corner of the site for use in the flooding process. A system of surface hoses and portable sprinklers were utilized to saturate the ground (flooding). Prior to commencing the flooding activities, Terracon completed an EC grid to monitor the changes in soil conditions throughout the process and is included in Appendix A and B as Exhibit 3 and Table 1 respectively.

The rate of watering was adjusted based on weather conditions and amount of standing water. The sprinklers were set up with timer devices to allow for various sections to be watered for a specific duration and area of the remediation cell. On average, the site had water spraying for 18 hours per day, one sprinkler at a time in rotation. The sprinklers were also relocated based

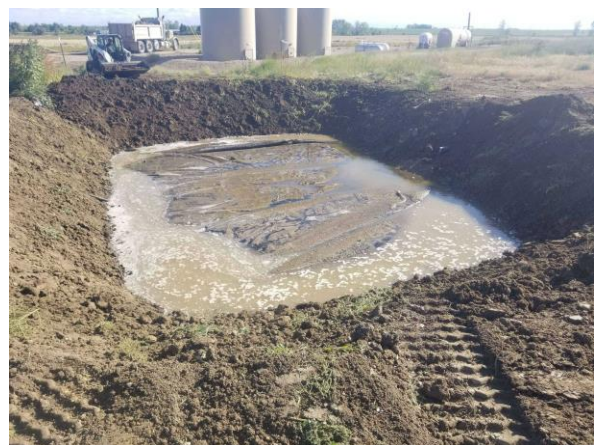
Photo #12 Placing soil cover over the Phytoremediation pond.

Approximately 115 tons of clay soil was provided by Sundre Sand & Gravel Inc. (Big D Excavating) and placed on the sides of the phytoremediation cell covering the geomembrane to allow for plant growth.
