Ice Jams, Landslides, and the Northern Pacific Railway Bridge at Bismarck

by Ed Murphy

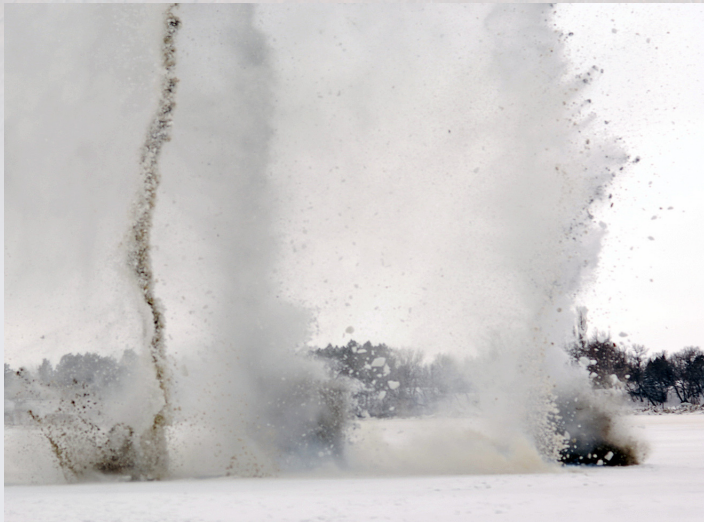
Figure 1. Demolition crews set off a series of charges to weaken the southern ice jam on the Missouri River at Bismarck on March 25, 2009. A second series of charges and salt were used to further weaken the ice. Photo courtesy of the Bismarck Tribune.

Two ice jams on the Missouri River near Bismarck, one to the south and the other to the north, dominated local and national news in March of 2009 (fig. 1). The southern ice jam caused flood waters from the Missouri River to rise to 1,634 feet (above sea level). An elevation of 1,634.28 feet (a 16 foot-reading in the Bismarck stream gauge) is considered flood stage. This was the highest river level seen at Bismarck since 1952, one year prior to completion of Garrison Dam. The dam is located on the Missouri River 75 miles upstream from Bismarck. The northern ice jam, ten miles north of Bismarck, held water back and, in all likelihood, prevented the flood waters at Bismarck from rising to higher elevations.

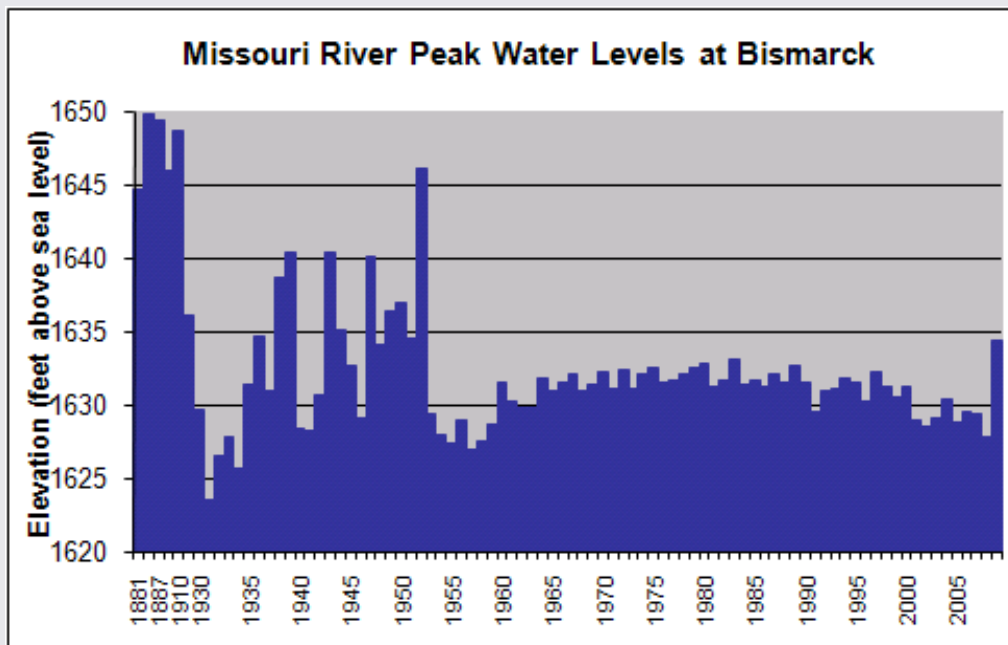
Figure 4. A graph of annual peak heights of the US Geological Survey gauging station on the Missouri River at Bismarck. Peak heights from 1929 - 2009 are from the US Geological Survey gauging station at Bismarck. Garrison Dam was completed in 1953.

The Northern Pacific Railway Bridge at Bismarck was witness to many spring ice jams and floods between the years 1882 and 1953. Nine major flood events (above the 1,637.28 foot elevation) were

recorded in Bismarck during that time period (fig. 4). Morison did not have to wait long to see how his bridge would stand up against high water. The Missouri River reached a record high of 1649.88 feet in 1883 followed closely by a near-record level of 1,649.38 in 1887 (fig. 5).

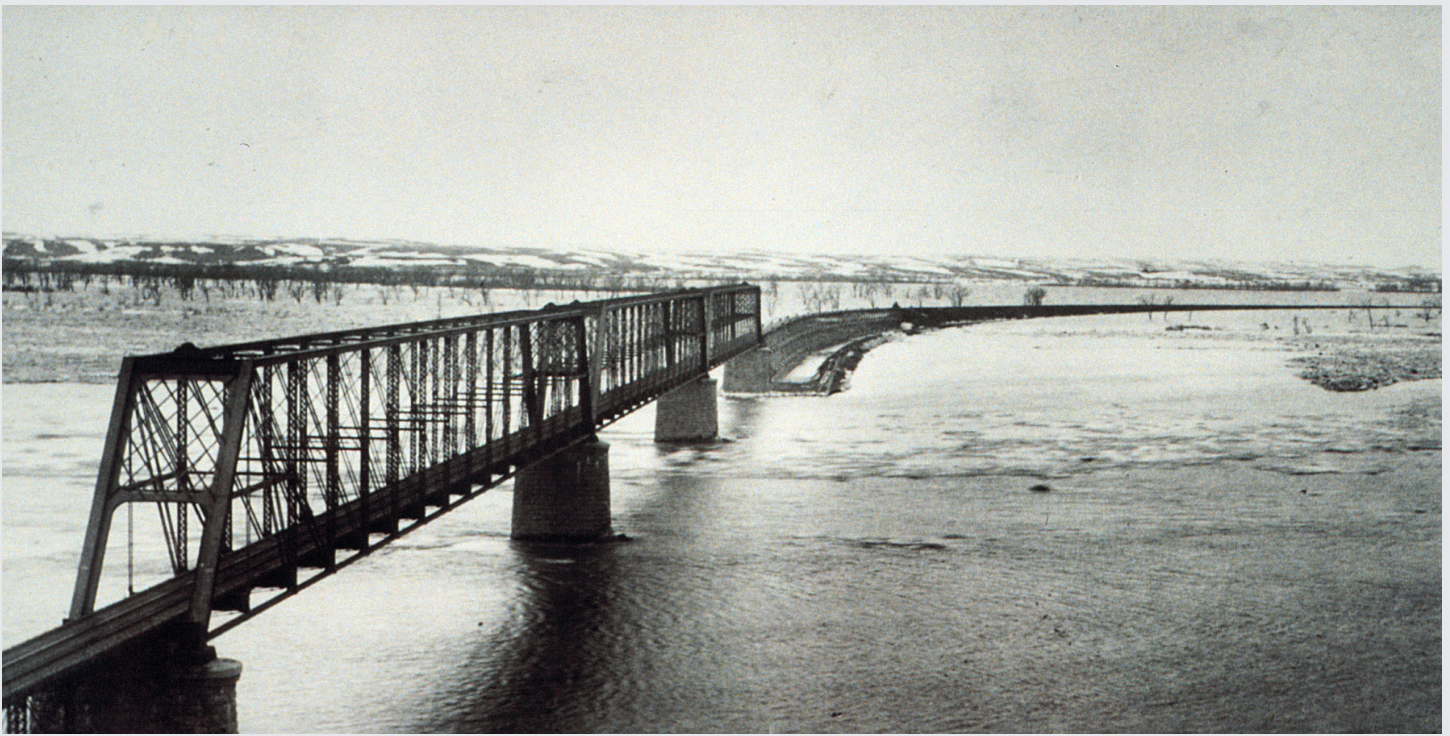
Figure 5. The Missouri River flooding in the spring of 1884. Water extends all the way from the railroad bridge west to the present location of ND Highway 1806 south of Mandan. The ice breakers on the middle piers are under water indicating that the water level exceeded 1,644.4 feet. These original bridge spans were replaced in 1905 because they could no longer safely support the ever-increasing weight of locomotives. Photo courtesy of the State Historical Society of North Dakota.

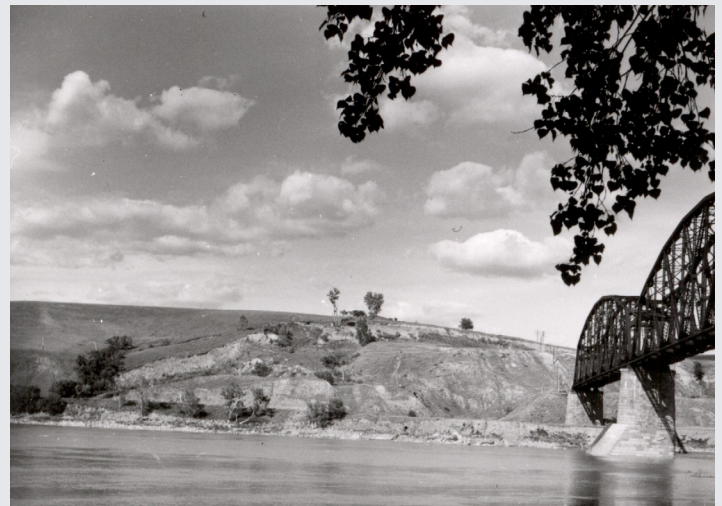
Figure 6. Several landslide scarps are visible along the east slopes of the Missouri River Valley above the Bismarck Railroad Bridge. The top of a City of Bismarck water reservoir is visible just below the largest tree at the top of the east slope. Photograph taken by Ralph Peck in 1951.

problems and almost lead to abandonment of his bridge. Shortly after the railroad bridge was completed, the east pier began sliding towards the river. For the next 68 years, Northern Pacific engineers applied a variety of slope stabilization techniques in an attempt to stop the pier from moving. As a result of their efforts, the bridge offers an interesting historical review of geotechnical theories and applications. These techniques included excavating a pit above the bridge site to isolate the pier from the sliding material, the keying of the rock above and below the sliding zone with blocks of concrete in an effort to lock the material together

and thus stabilize the slide, extending the east pier's foundation to a greater depth to get below the sliding zone, erecting a cofferdam around the pier to isolate it from the landslide, and construction of a groundwater intercept tunnel to stabilize the area by reducing pore water pressure. Ultimately, all of these attempts to stabilize the area failed.
