Landslides in North Dakota

Ed Murphy

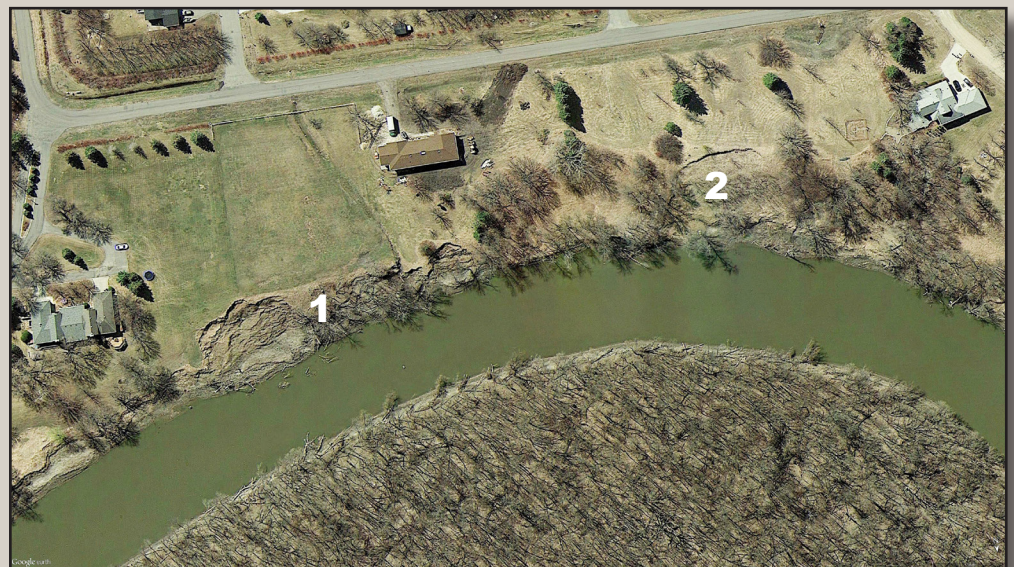
Figure 3. A series of landslides along 76th Avenue South in Fargo. One of the disturbed areas (1) extends for 500 feet and is up to 100 feet wide. The scarp of another landslide (120 x 160 feet in area) is visible midway between the two homes on the right (2). Nine homes had to be abandoned in this area due to slope stability problems including the home situated between 1 and 2. Photograph from GoogleEarth dated April 2014, looking south/southwest.

four general categories: 1) glacial lake clays, 2) glacial sediments, 3) alternating layers of Tertiary or Cretaceous age rocks, and 4) Cretaceous shales (fig. 2). The clays that were deposited by glacial Lake Agassiz in the Red River Valley and glacial Lake Souris in north-central North Dakota can be very unstable (fig. 3). There are a number of small landslides along the Red

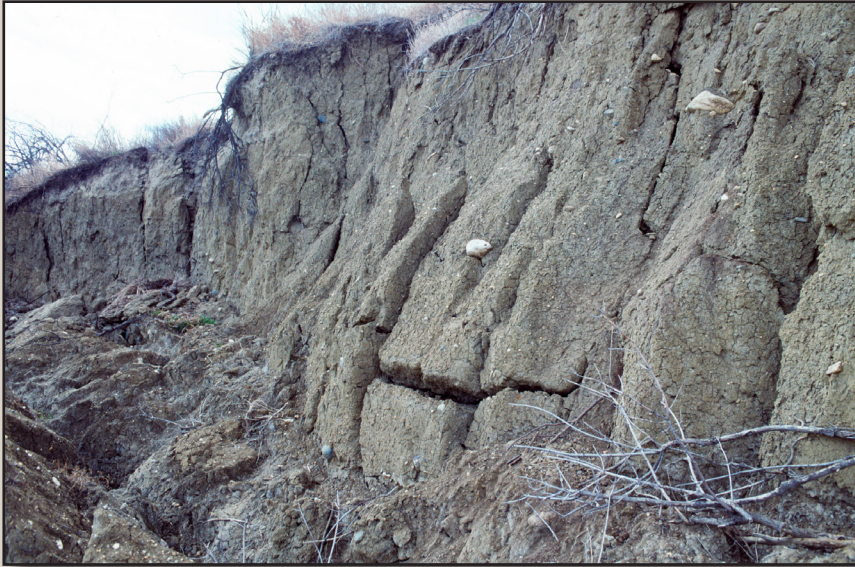
Figure 4. Jointed till in the scarp of a landslide north of the BNSF railroad tracks southwest of Williston. The slope below was littered with blocks of till that had toppled down the slope. I was investigating this slope in 1996 when the vibrations from a passing freight train caused a 6 x 8 foot block of till to topple from the scarp in the background.

River Valley that contain evidence of flow (Schwert, 2006). The glacial sediments across much of the state are primarily till, an unsorted mixture of sand, silt, and clay containing rocks ranging in size from pebbles to cobbles to boulders. Whereas most landslides in till are rotational slumps, till in steep, non-vegetated slopes is susceptible to toppling. Till in North Dakota often contains vertical joints or fractures. When till is present in steep outcrops, blocks of this glacial sediment tend to break off in chunks along these joints and roll or topple down the slope (fig. 4).

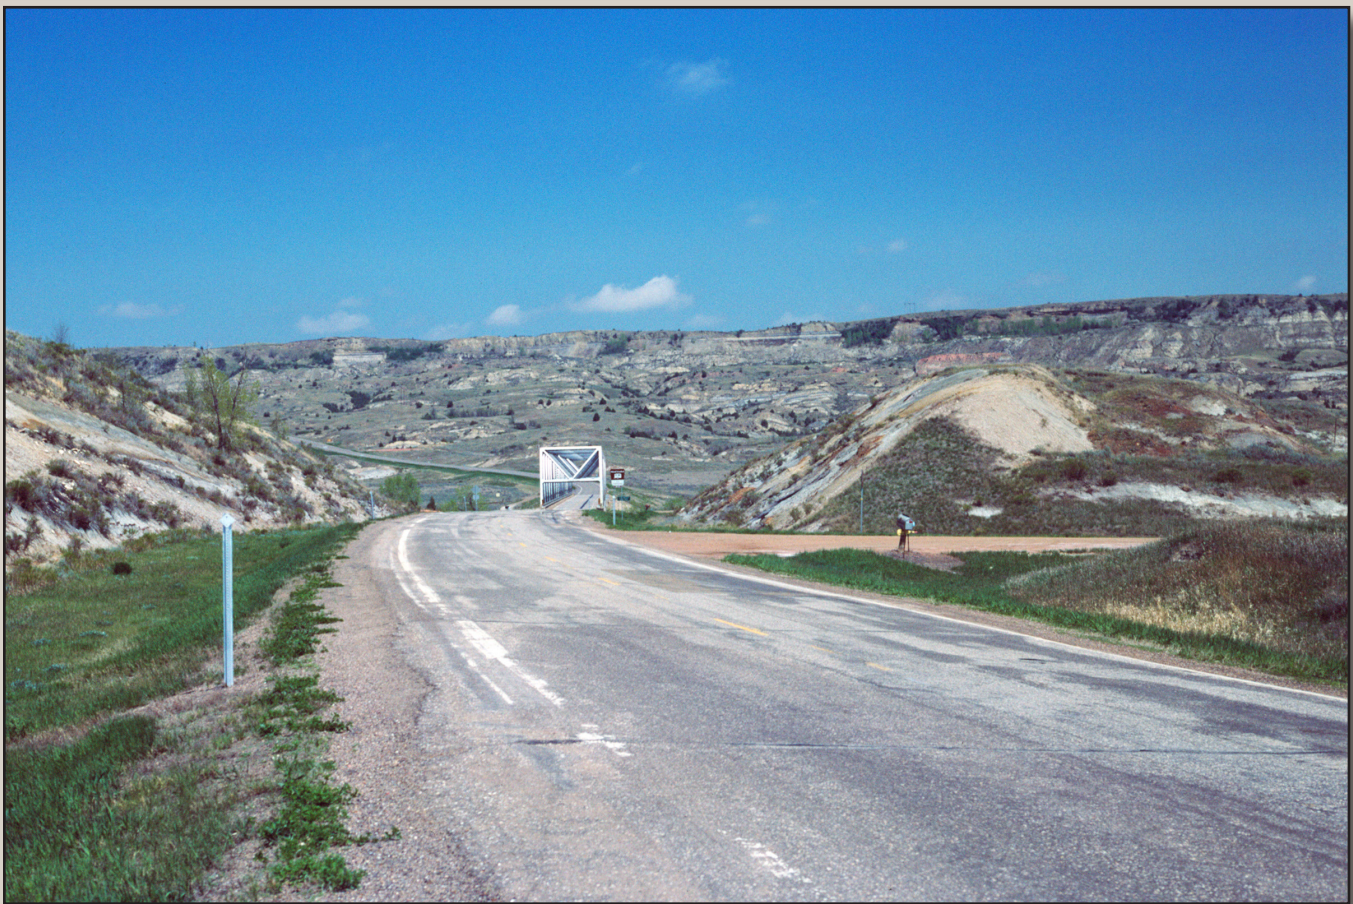
Figure 5. US Highway 85 crosses the Long X Bridge over the Little Missouri River Badlands just south of the North Unit of the Theodore Roosevelt National Park. All of the rocks in this photograph, except for those along the north rim, are part of landslides (Murphy, 2004). Photograph taken looking north.

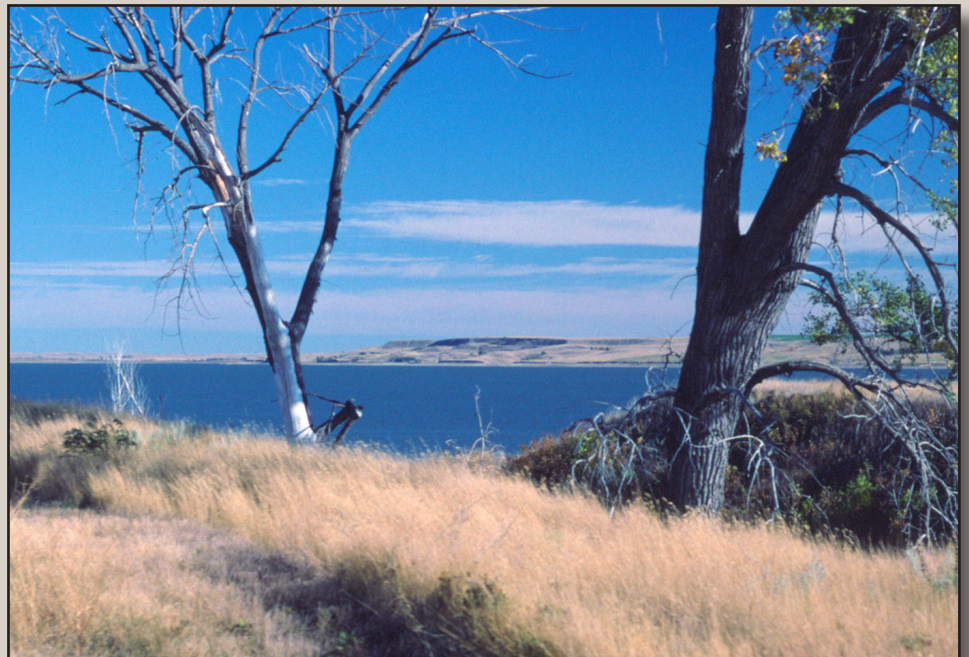
Figure 6. A landslide complex along the Oahe Reservoir five miles north of the South Dakota border. The prominent scarp across the reservoir consists of rocks of the Fox Hills Formation and the body of the slide is in shale of the Pierre Formation. This landslide complex covers nearly 600 acres. Photo looking northeast.

The Pierre Formation is only present at the surface in a few relatively small areas in southwestern, south-central, southeastern, and northeastern North Dakota. Yet because of the relative instability of this shale, some of the largest landslides or landslide complexes in the state occur within rocks of the Pierre Formation (fig. 6).

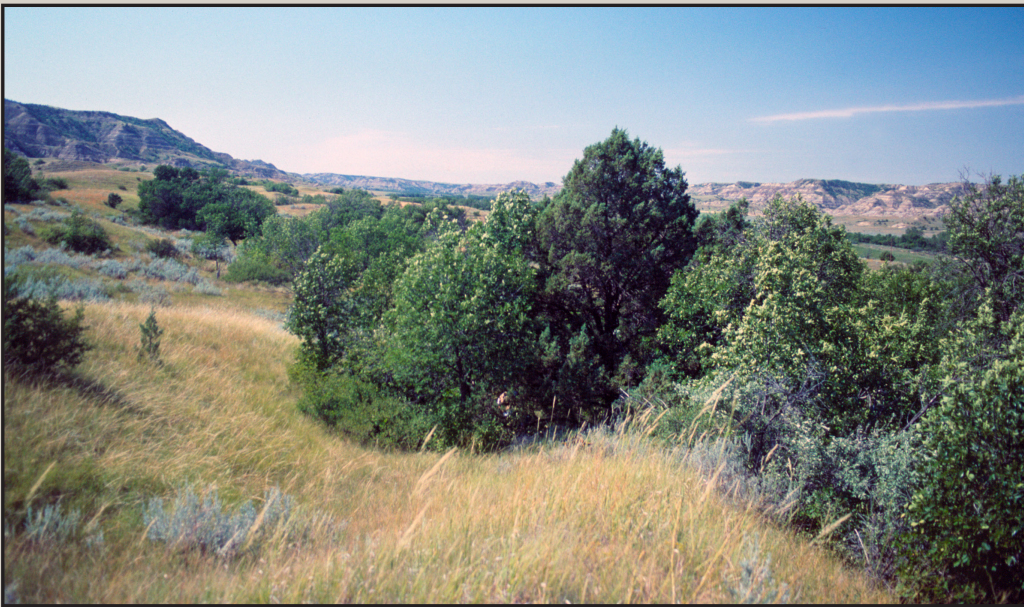
Figure 7. Trees are aligned in depressions on the surface of a landslide complex along the south valley of the Little Missouri River in McKenzie County. This landslide complex is characterized by a well-vegetated undulating surface, is a half mile wide, three miles long, and covers a total area of about 1,000 acres.

within a broken, jagged slope or where slope failure has exposed springs. In these types of settings, the trees or vegetation often line up parallel to the edge of the slope (fig. 7).
