Edward C. Murphy 2004

General Information on Landslides

Γhe Stanley Sheet

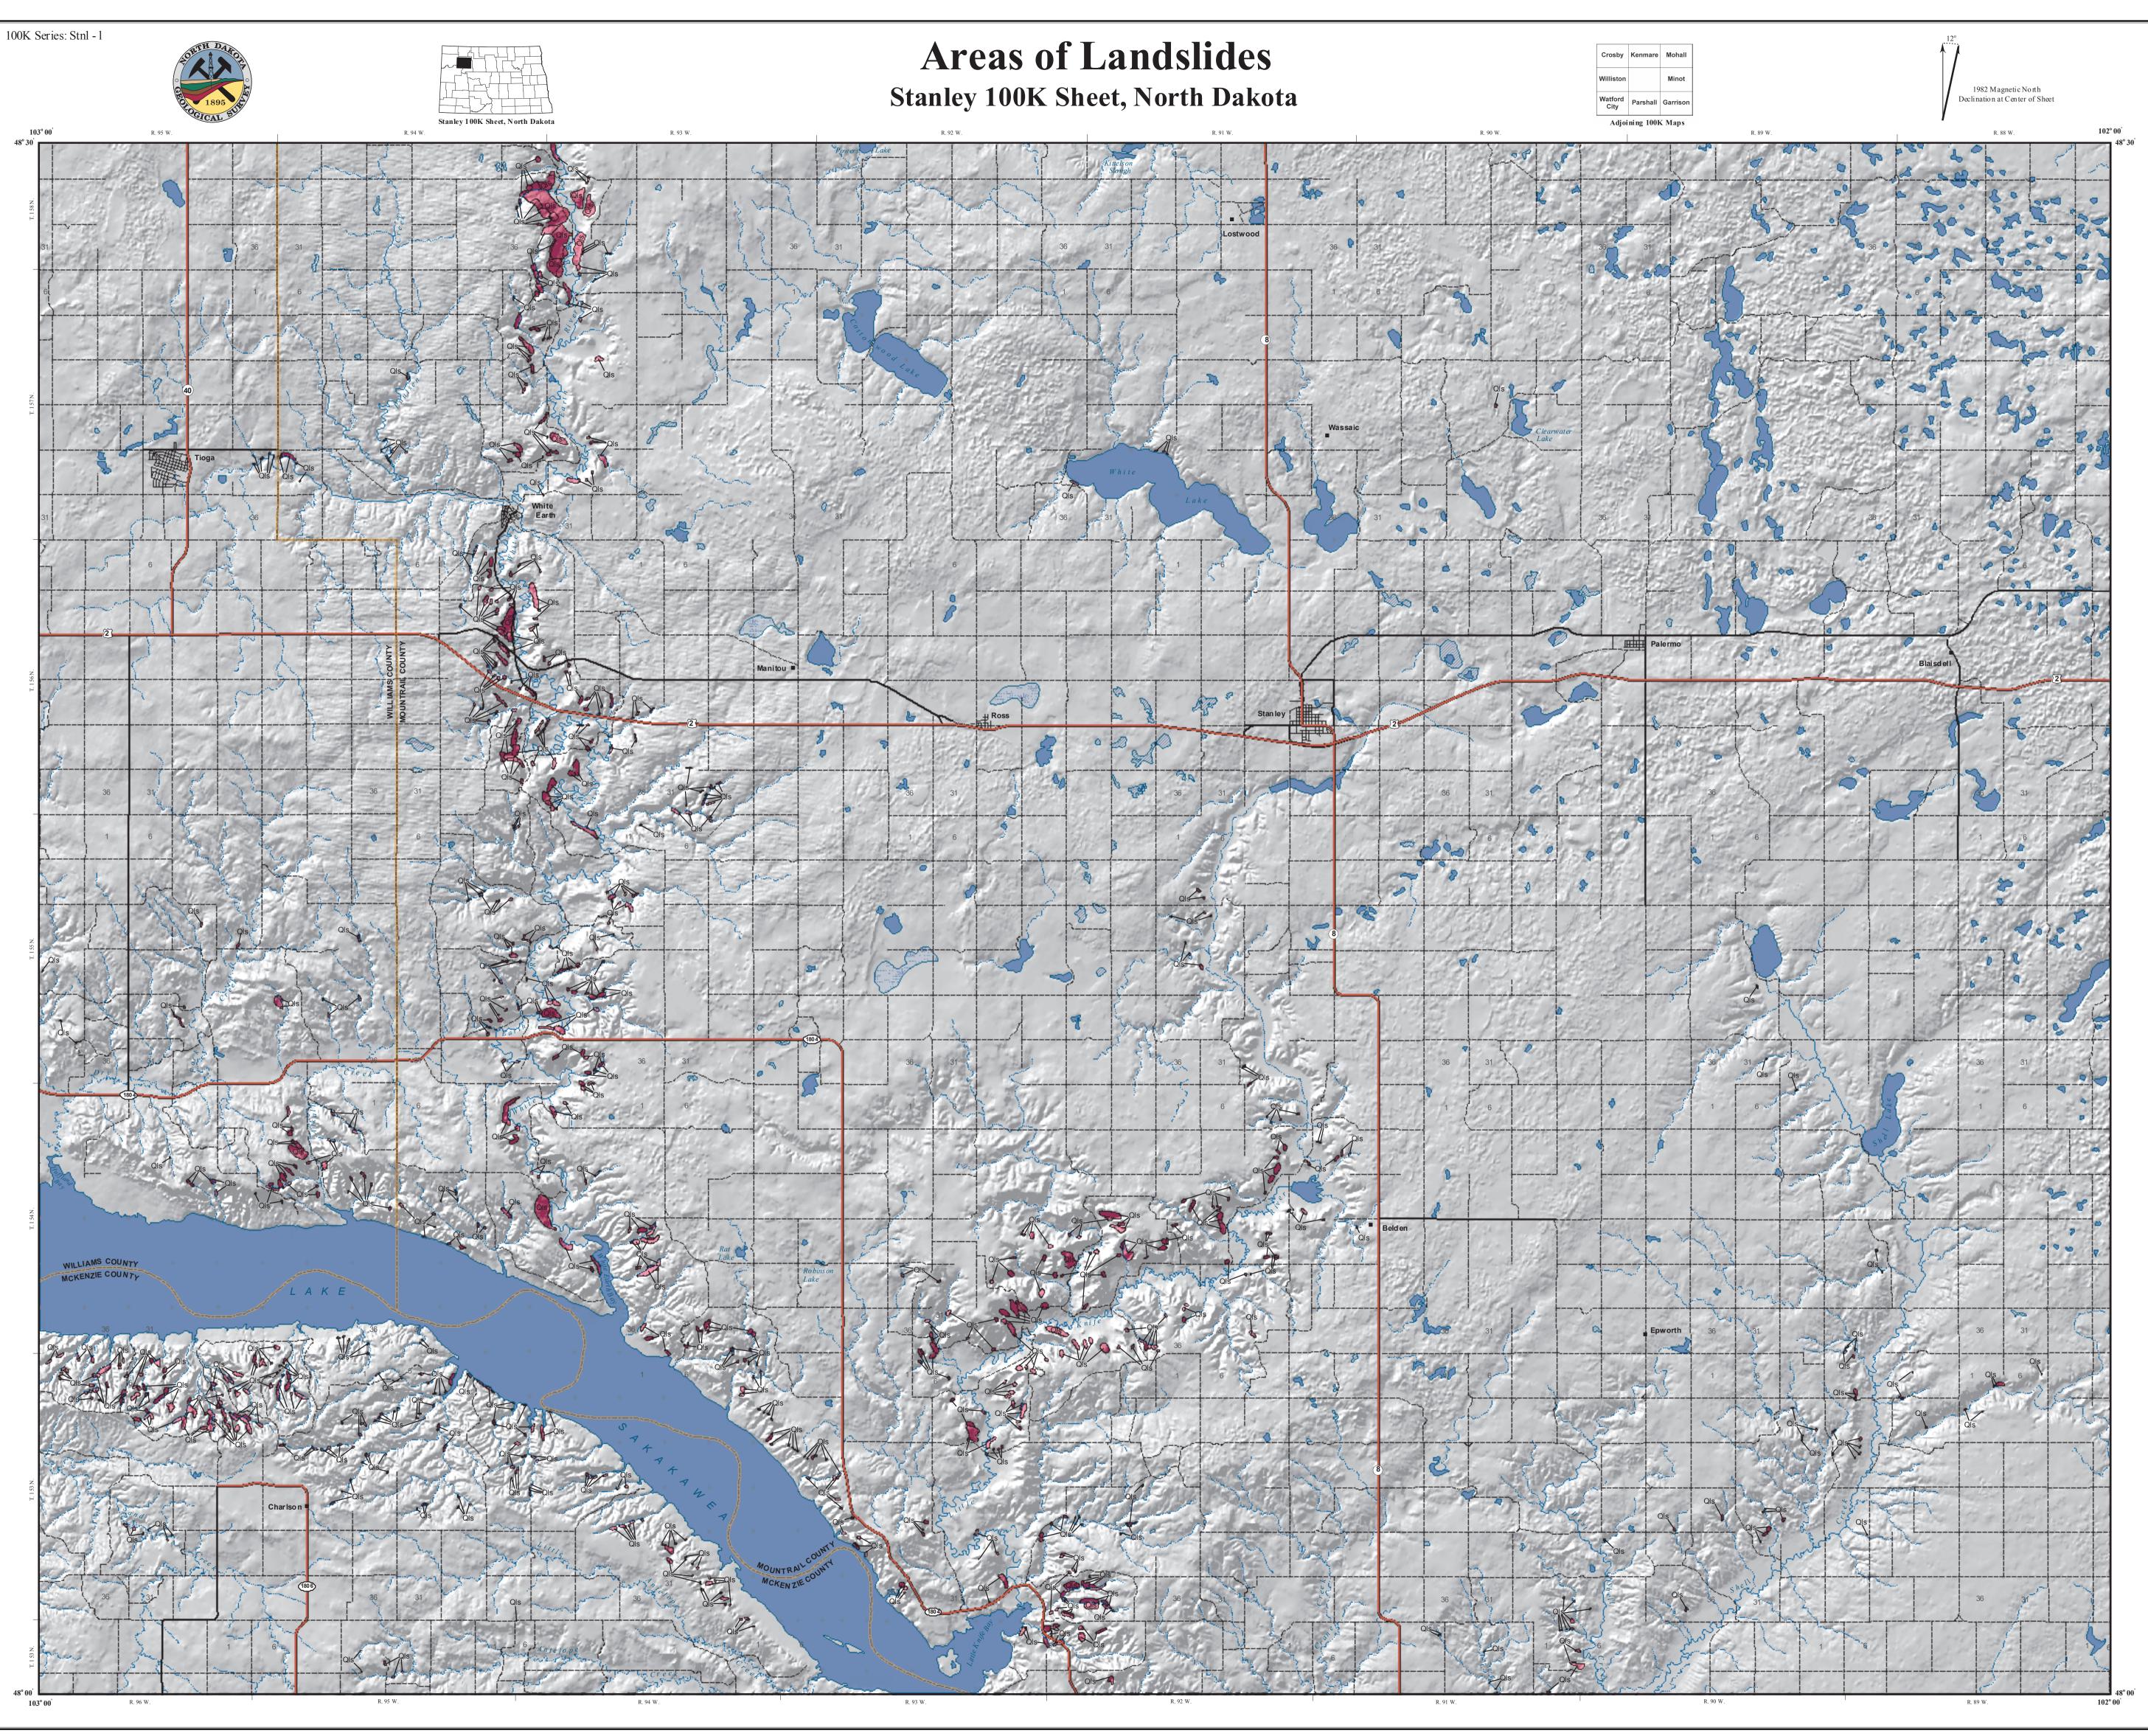
Landslides are most readily identifiable from the air. The landslides mapped on the Stanley Sheet were identified from a set of aerial photographs (1:20,000 scale) that were flown between June and September of 1958. It is unfortunate that these photographs were taken when leaves were on the trees because groves of leaf-bearing trees tend to obscure landslides, especially small ones. On the other hand, leaves can sometimes make it easier to identify these features. Trees and bushes are often aligned within very distinct parallel-, transverse-, and/or semi-circular-depressions that generally occur within the body of the landslide.

Landslides are virtually nonexistent in the rolling glacial topography that dominates the area shown on this map. Instead, landslides are concentrated in four main areas: the badlands topography adjacent to Lake Sakakawea, the White Earth River Valley, the valley of the Little Knife River and, to a lesser degree, the valley of Shell Creek. The 888 landslides identified on this map sheet represent approximately one half of one percent of the total map area. Most of these landslides are 20 to 40 acres in size, but a handful of landslide complexes in the northern segment of the White Earth River Valley exceed 200 acres. Predictably, the poorly lithified strata tend to fail in the areas of highest topographic relief. Landslides are concentrated along the lower reaches of the White Earth and Little Knife rivers where relief is highest at 300 to 400 feet. Landslides are also prevalent throughout the middle and upper reaches of the White Earth River Valley where relief averages about 200 feet. Landslides are rare throughout the Shell Creek River Valley and in the middle to upper reaches of the Little Knife River Valley where relief is typically 100 feet. The highly sinuous nature of the White Earth River Valley contrasts sharply with the smooth, slightly sinuous Shell Creek River Valley and, to a lesser degree, with the Little Knife River Valley. This may account for the propensity for landslides in the White Earth River Valley.

Landslides identified on this sheet were mapped from stereo pairs, black and white 1:20,000 scale aerial photographs flown between 6-6-58 and 9-7-58. As a result these maps can be used to identify areas that are vulnerable to slope failture, but are not an up to date assessment of all landslides for the area.
