Areas of Landslides

Mandan Quadrangle, North Dakota

Edward C. Murphy

1999

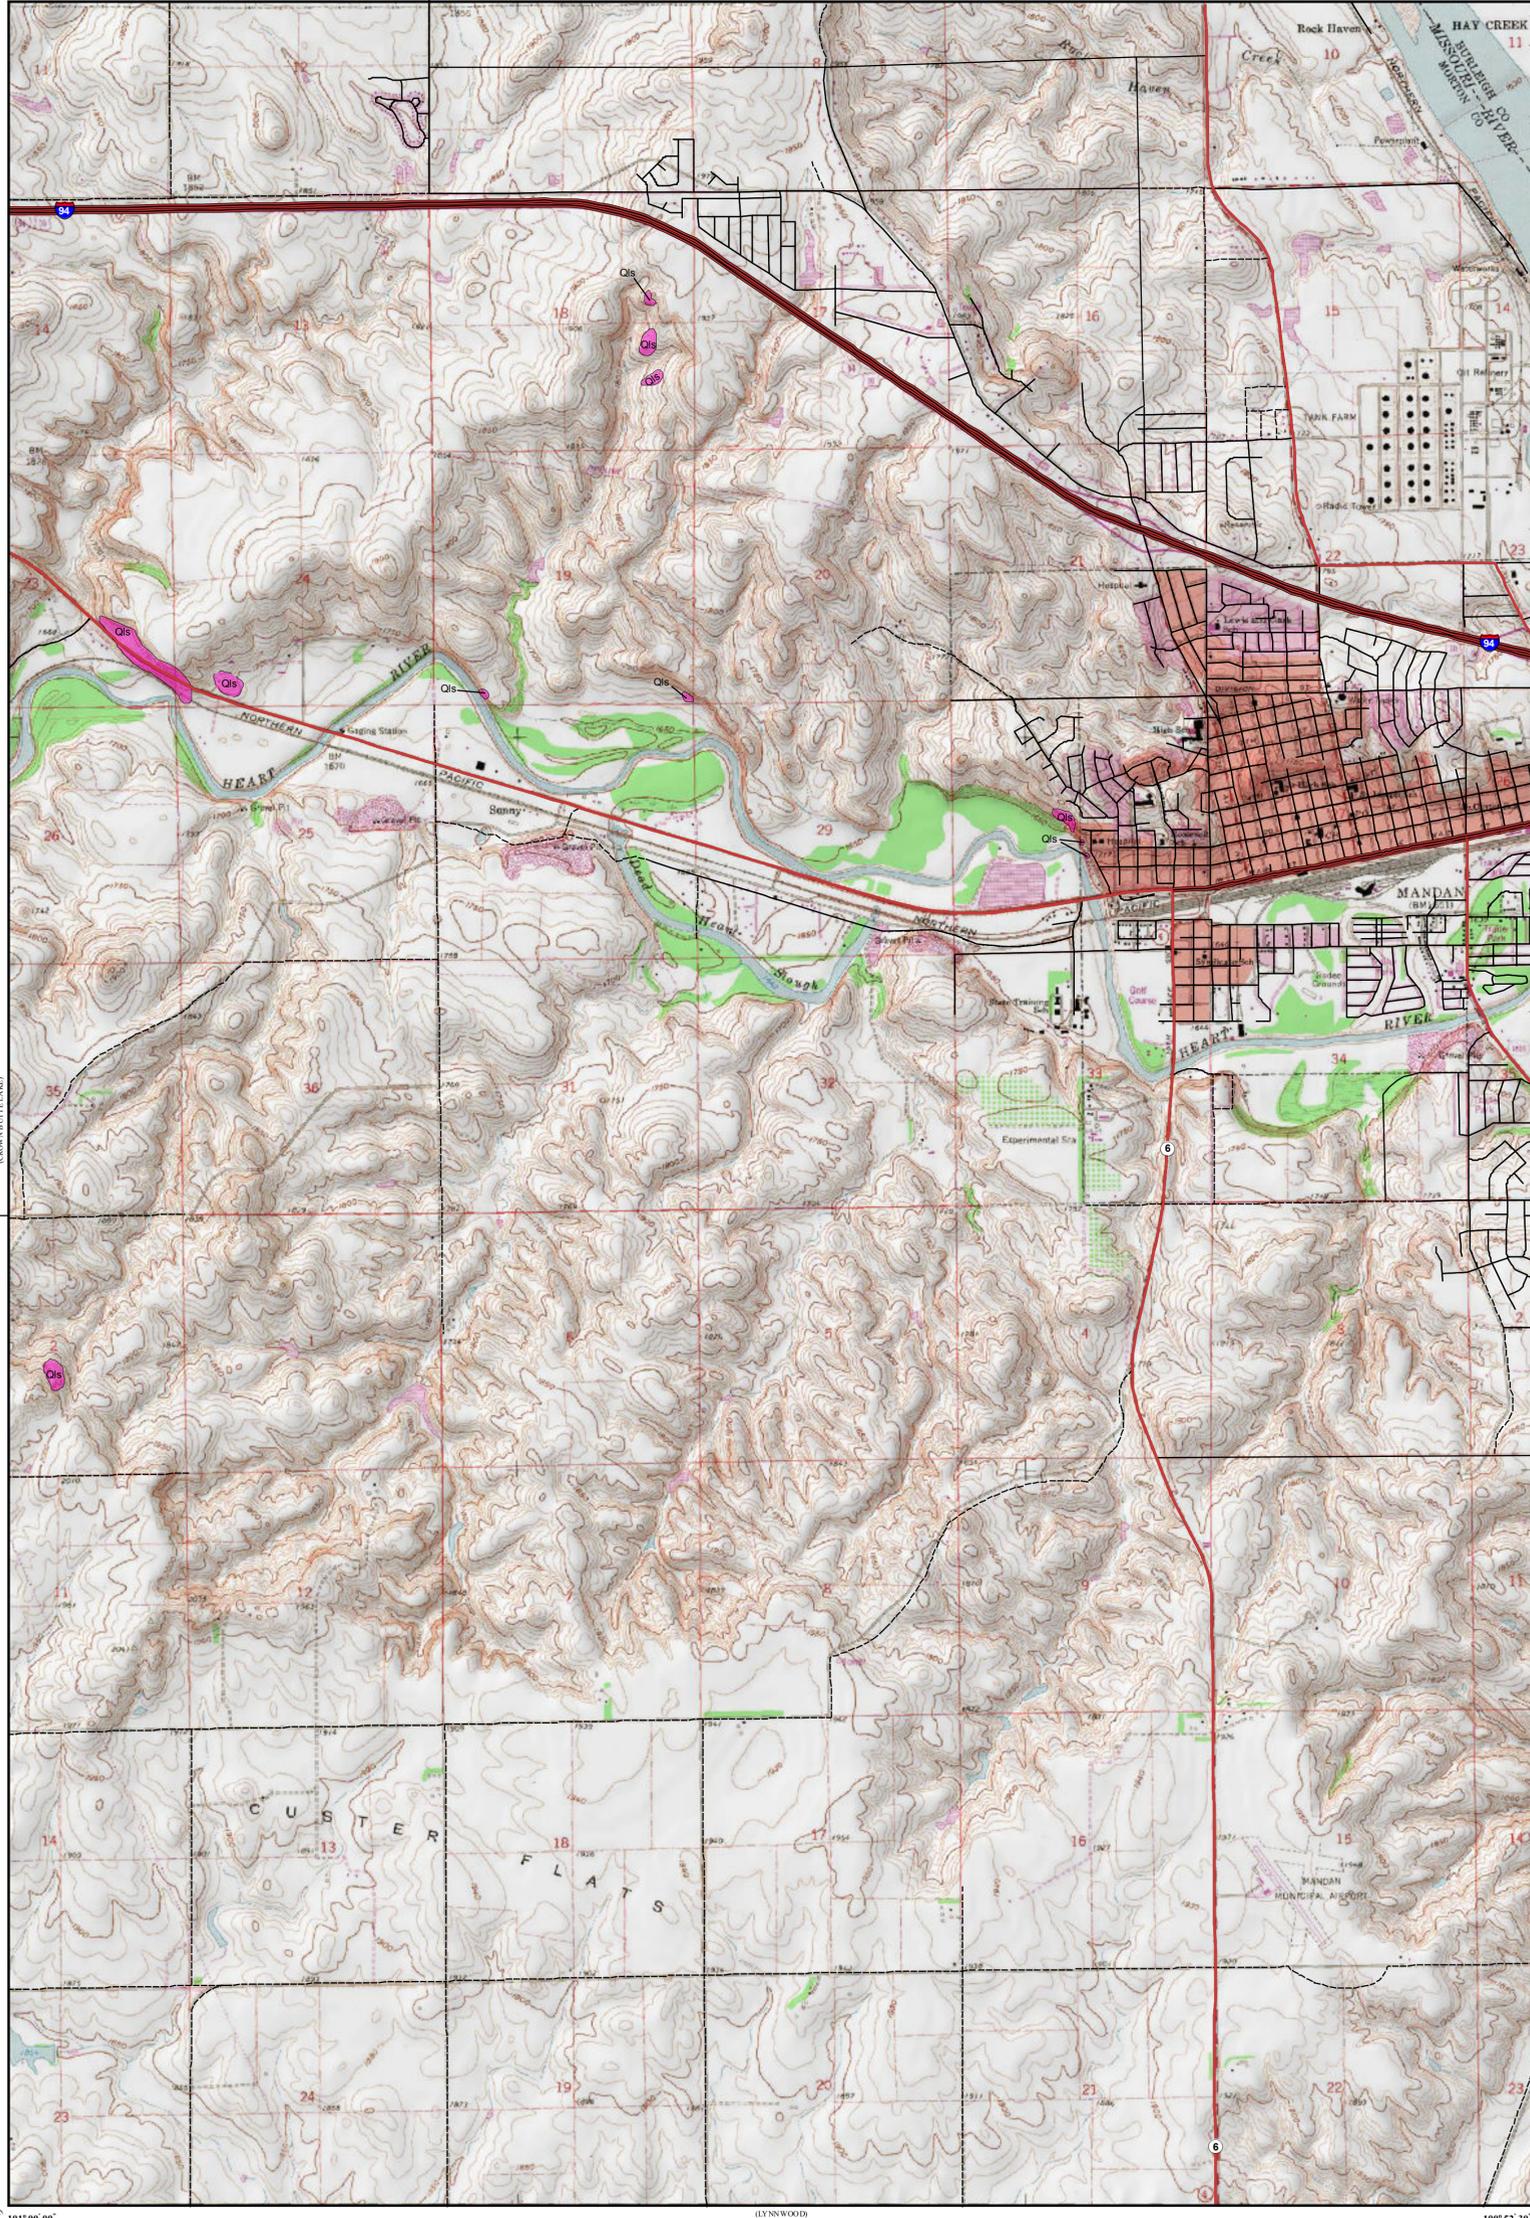
Mandan Quadrangle, North Dakota

Landslides identified on this quadrangle were mapped from stereo pairs, black and white 1:20,000 scale aerial photographs flown between 6-21-58 and 9-7-58. As a result these maps can be used to identify areas that are vulnerable to slope failure, but are not an up to date assessment of all landslides for the area.
