Areas of Landslides

Stewart Lake Quadrangle, North Dakota

Christopher A. Maike
&
Levi D. Moxness

2024

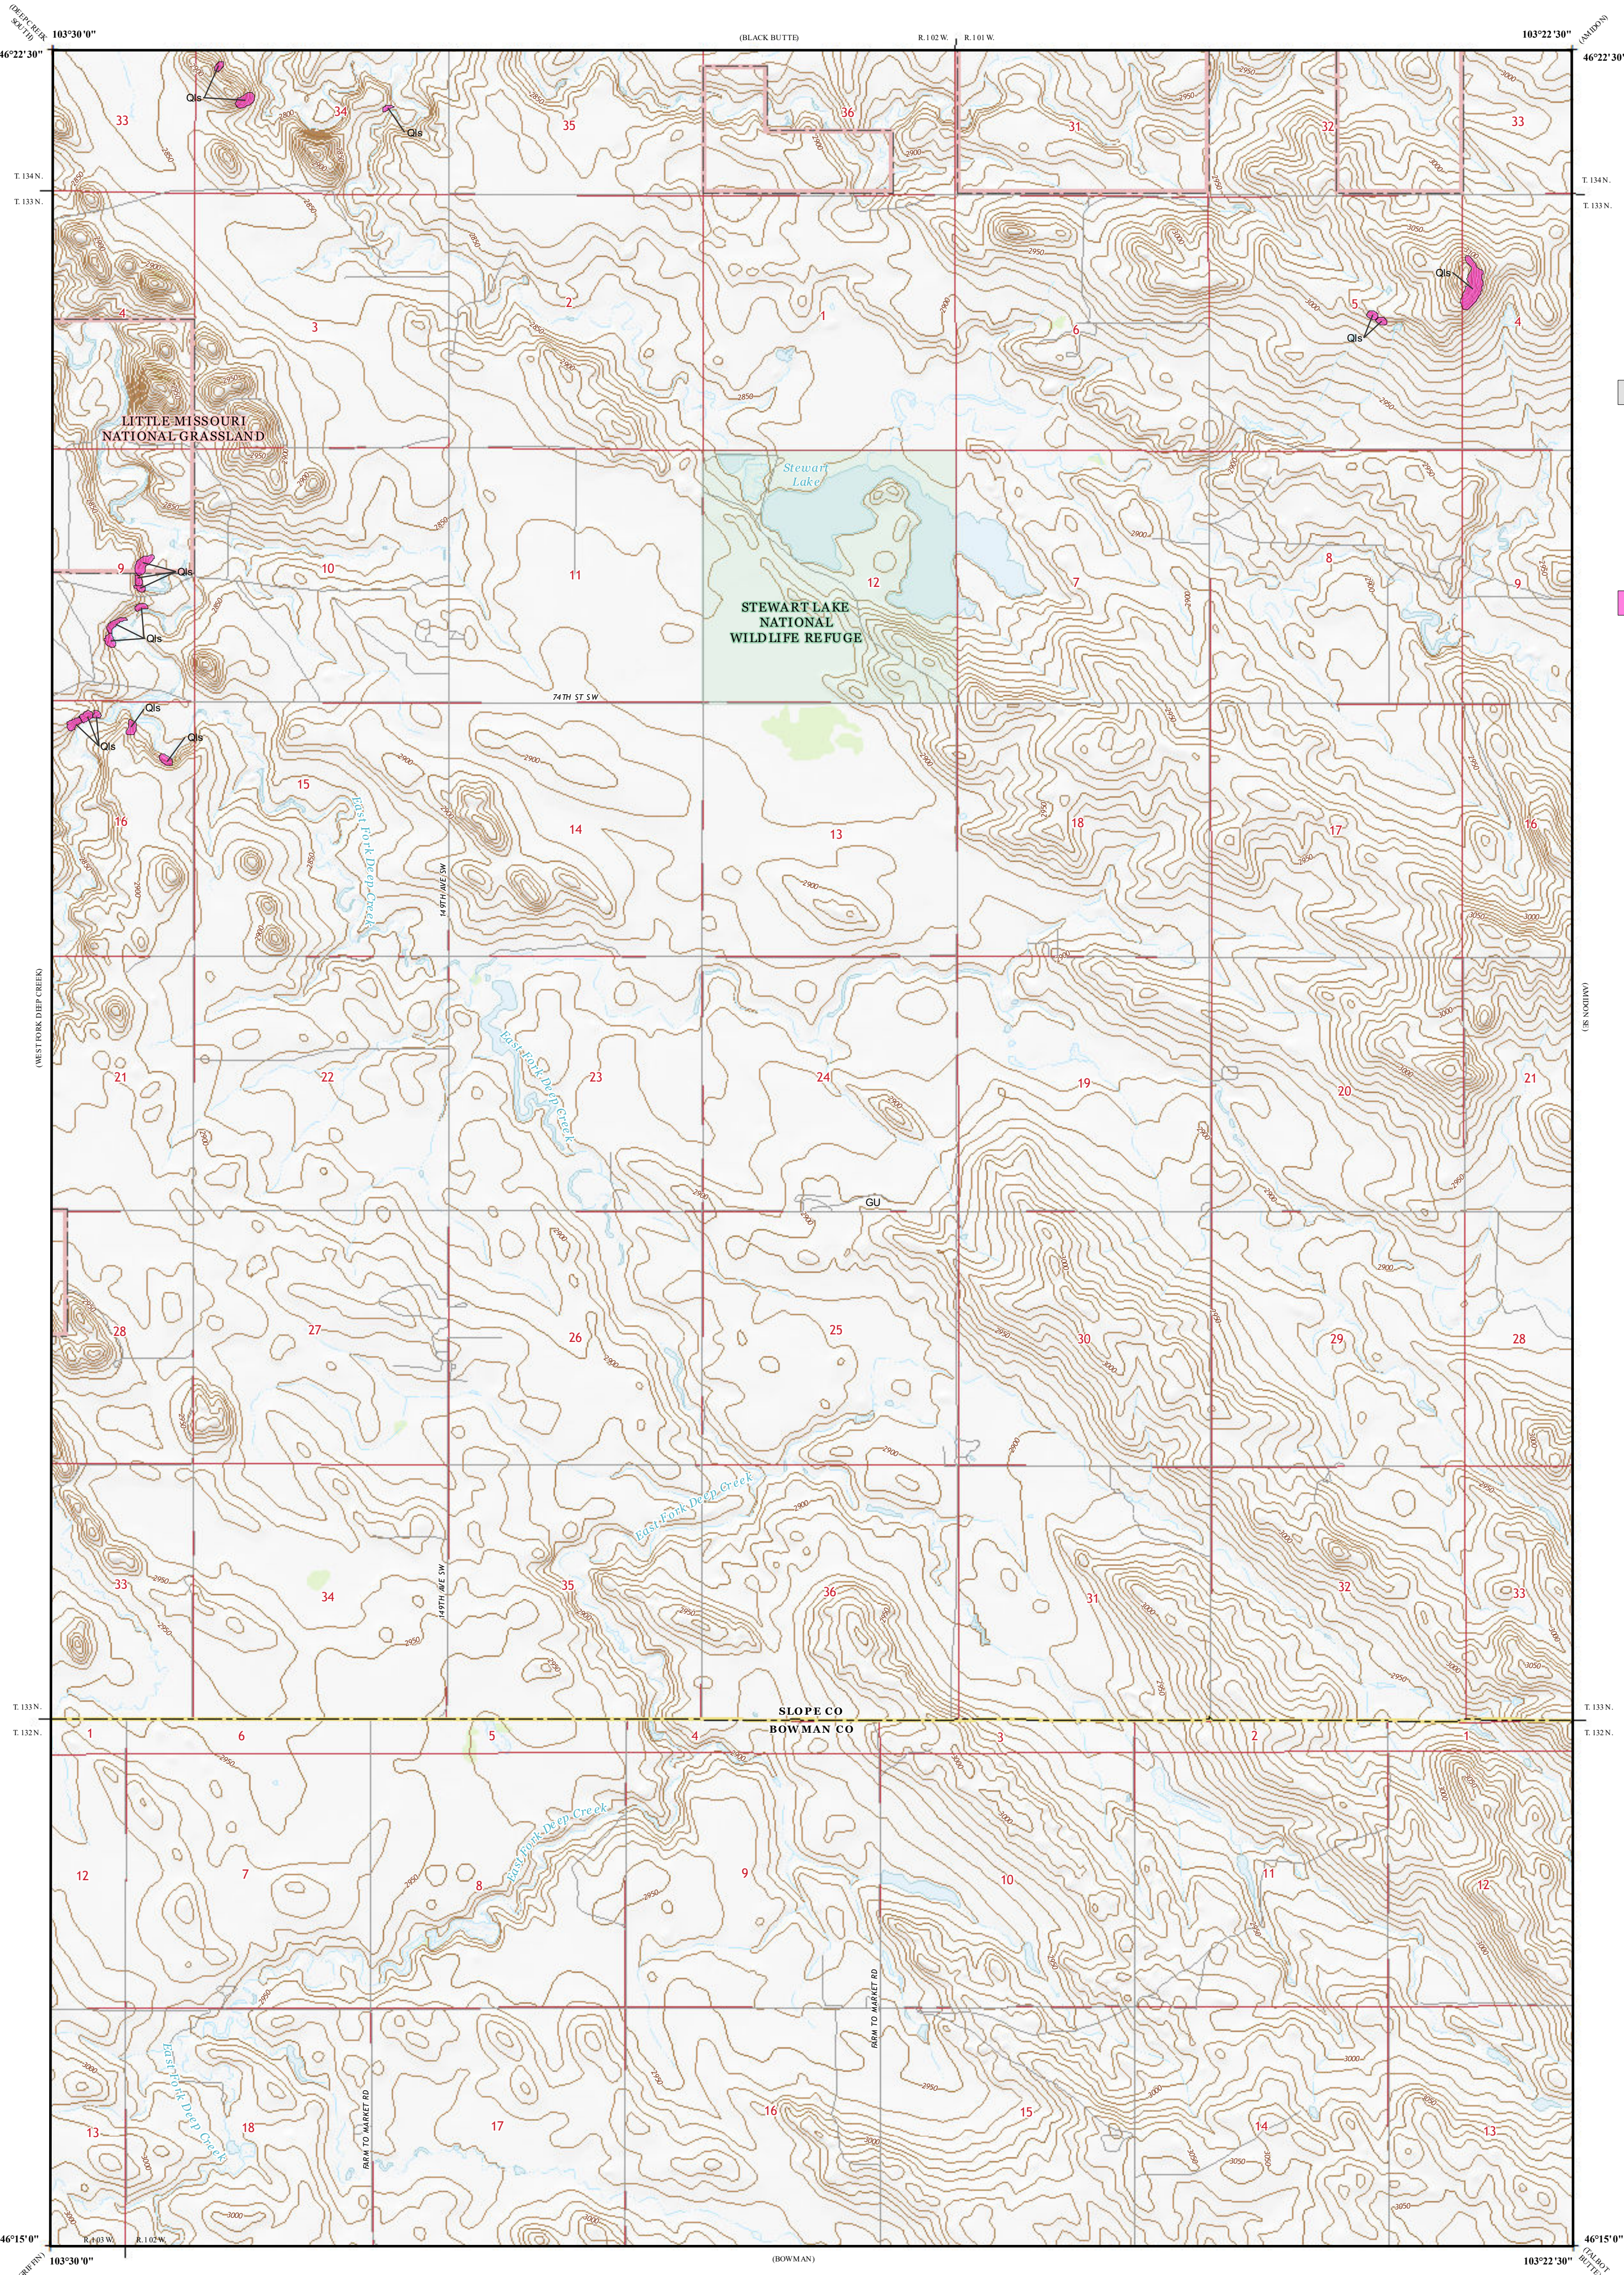
Stewart Lake Quadrangle, North Dakota

Qls Landslide Deposits

A mass of material that has moved downslope. Includes earth flows, slumps, and areas of soil creep.

Landslides identified on this quadrangle were mapped from stereo pairs, black and white 1:20,000 scale aerial photographs flown in July 1957 by the United States Department of Agriculture (USDA). Additional data sources include digital orthophotography from the USDA National Agriculture Imagery Program (NAIP) flown in August 2022 and the North Dakota Geological Survey LiDAR Map Series, which compiles raw data flown in November 2021 from the North Dakota State Water Commission.
