Areas of Landslides Ehler Lake Quadrangle, North Dakota

**Christopher A. Maike
&
Levi D. Moxness**

2025

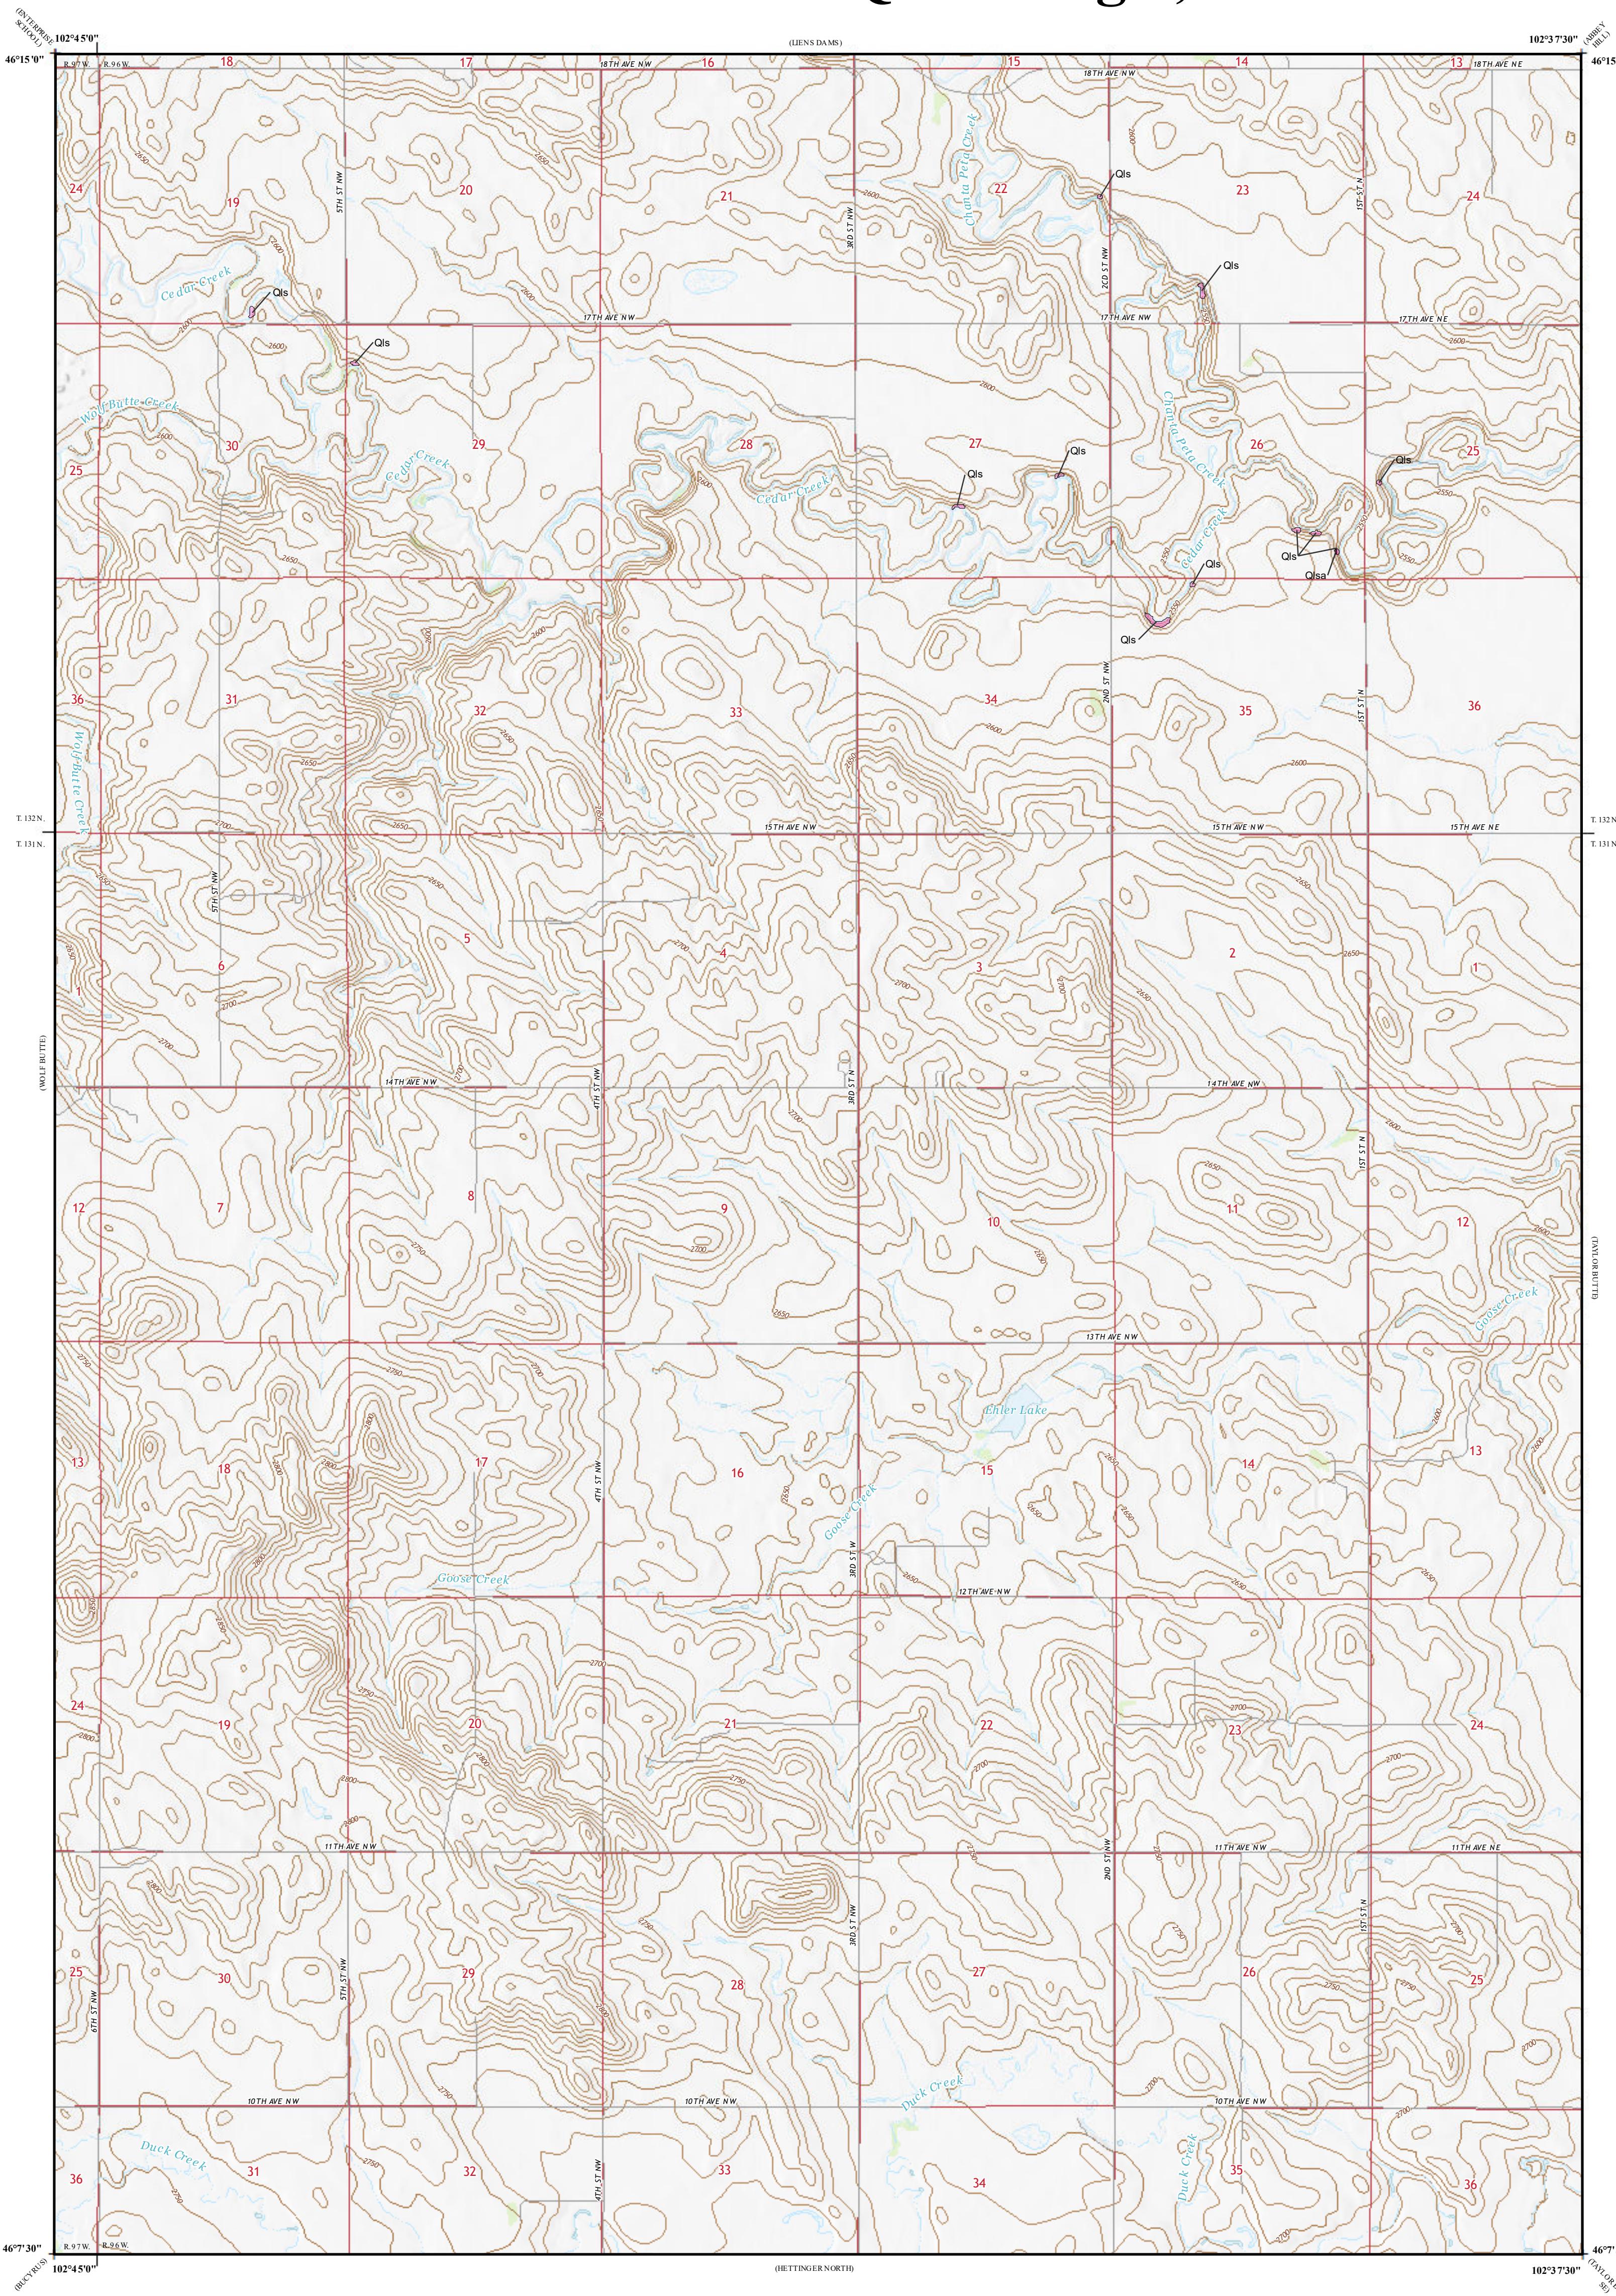
Qls Areas of Recently Active Landslides

Landslide areas showing movement between 2008 and 2021.

Qls Landslide Deposits

A mass of material that has moved downslope. Includes earth flows, slumps, and areas of soil creep.

Landslides identified on this quadrangle were mapped from stereo pairs, black and white 1:20,000 scale aerial photographs flown in July 1957 by the United States Department of Agriculture (USDA). Additional data sources include digital orthophotography from the USDA National Agriculture Imagery Program (NAIP) flown in August 2022 and the North Dakota Geological Survey LiDAR Map Series, which compiles raw data flown in November 2021 from the North Dakota State Water Commission.

Areas of recently active landslides (Qls) mapped on this quadrangle were identified from changes between the 2008 and 2021 LiDAR elevation datasets observed on an elevation subtraction raster. Noise introduced from data precision (typically within a foot between the LiDAR datasets) is removed on this raster by excluding the signal from elevation change in the +/- 1 foot interval. Geologists interpret areas of landslide movement in geomorphic context (typically a decrease in elevation near a landslide headscarp paired with an increase in elevation downslope near the toe) and delineate those areas within the larger landslide dataset. Landslides not identified as recently active may have also experienced movement relatively recently, but did not show discernible signs of movement during the 2008 to 2021 window between LiDAR collects.

| Slope Failure Statistical Summary | | | | |
| Map Unit | No. of Landslides | Mapped Landslide Area acres | Mapped Landslide Area m ² | Map Area % |
| Total Landslides (Qls & Qlsa) | 4 | 7 | 28,691 | 0.02 |
| Recently Active Landslides (Qlsa) | 1 | 0.1 | 537 | 0.001 |
| 1.8% of the mapped landslide area was active between 2008 and 2021 | | | | |
