# Areas of Landslides

## Carpenter Lake Quadrangle, North Dakota

Carpenter Lake Quadrangle, North Dakota

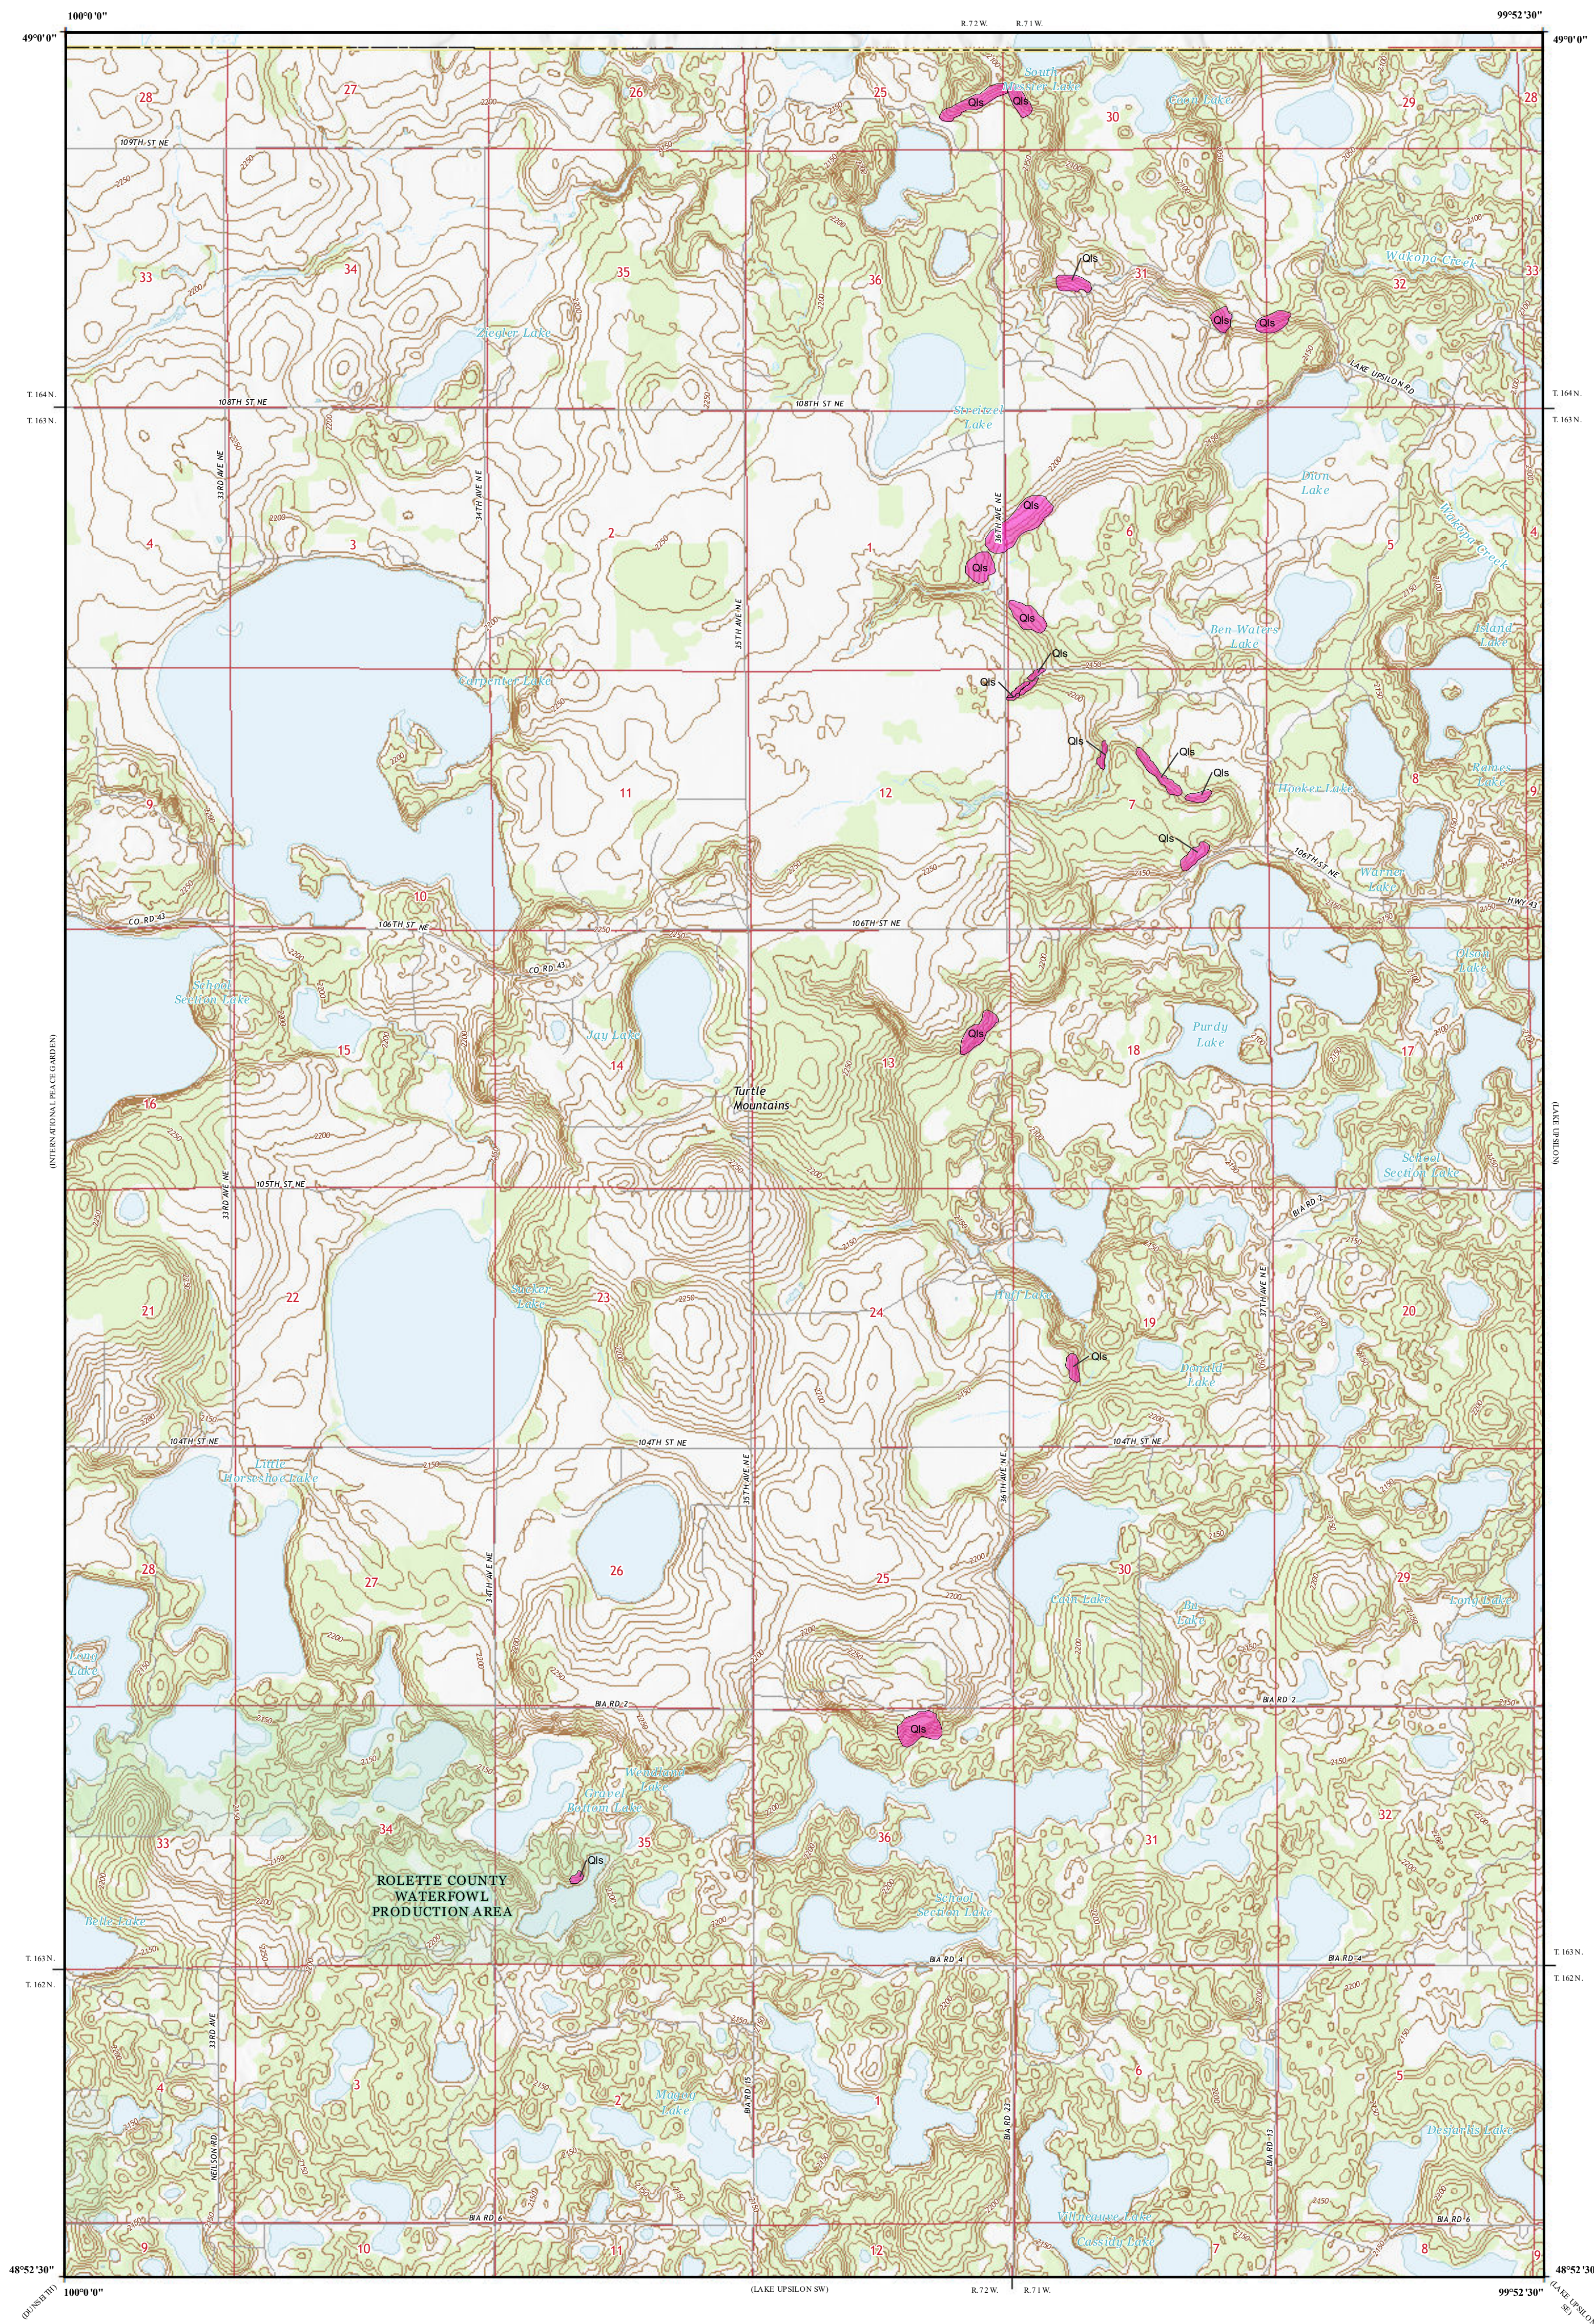
A mass of material that has moved downslope. Includes earth flows, slumps, and areas of soil creep.

Landslides identified on this quadrangle were mapped from stereo pairs, black and white 1:20,000 scale aerial photographs flown in 1962 by the United States Department of Agriculture (USDA). Additional data sources include digital orthophotography from the USDA National Agriculture Imagery Program (NAIP) flown in August to September 2024, and the North Dakota Geological Survey LiDAR Map Series, which compiles raw data flown in May 2019 to May 2020 from the North Dakota State Water Commission.
