Areas of Landslides Fairview Quadrangle, North Dakota

Edward C. Murphy

2010

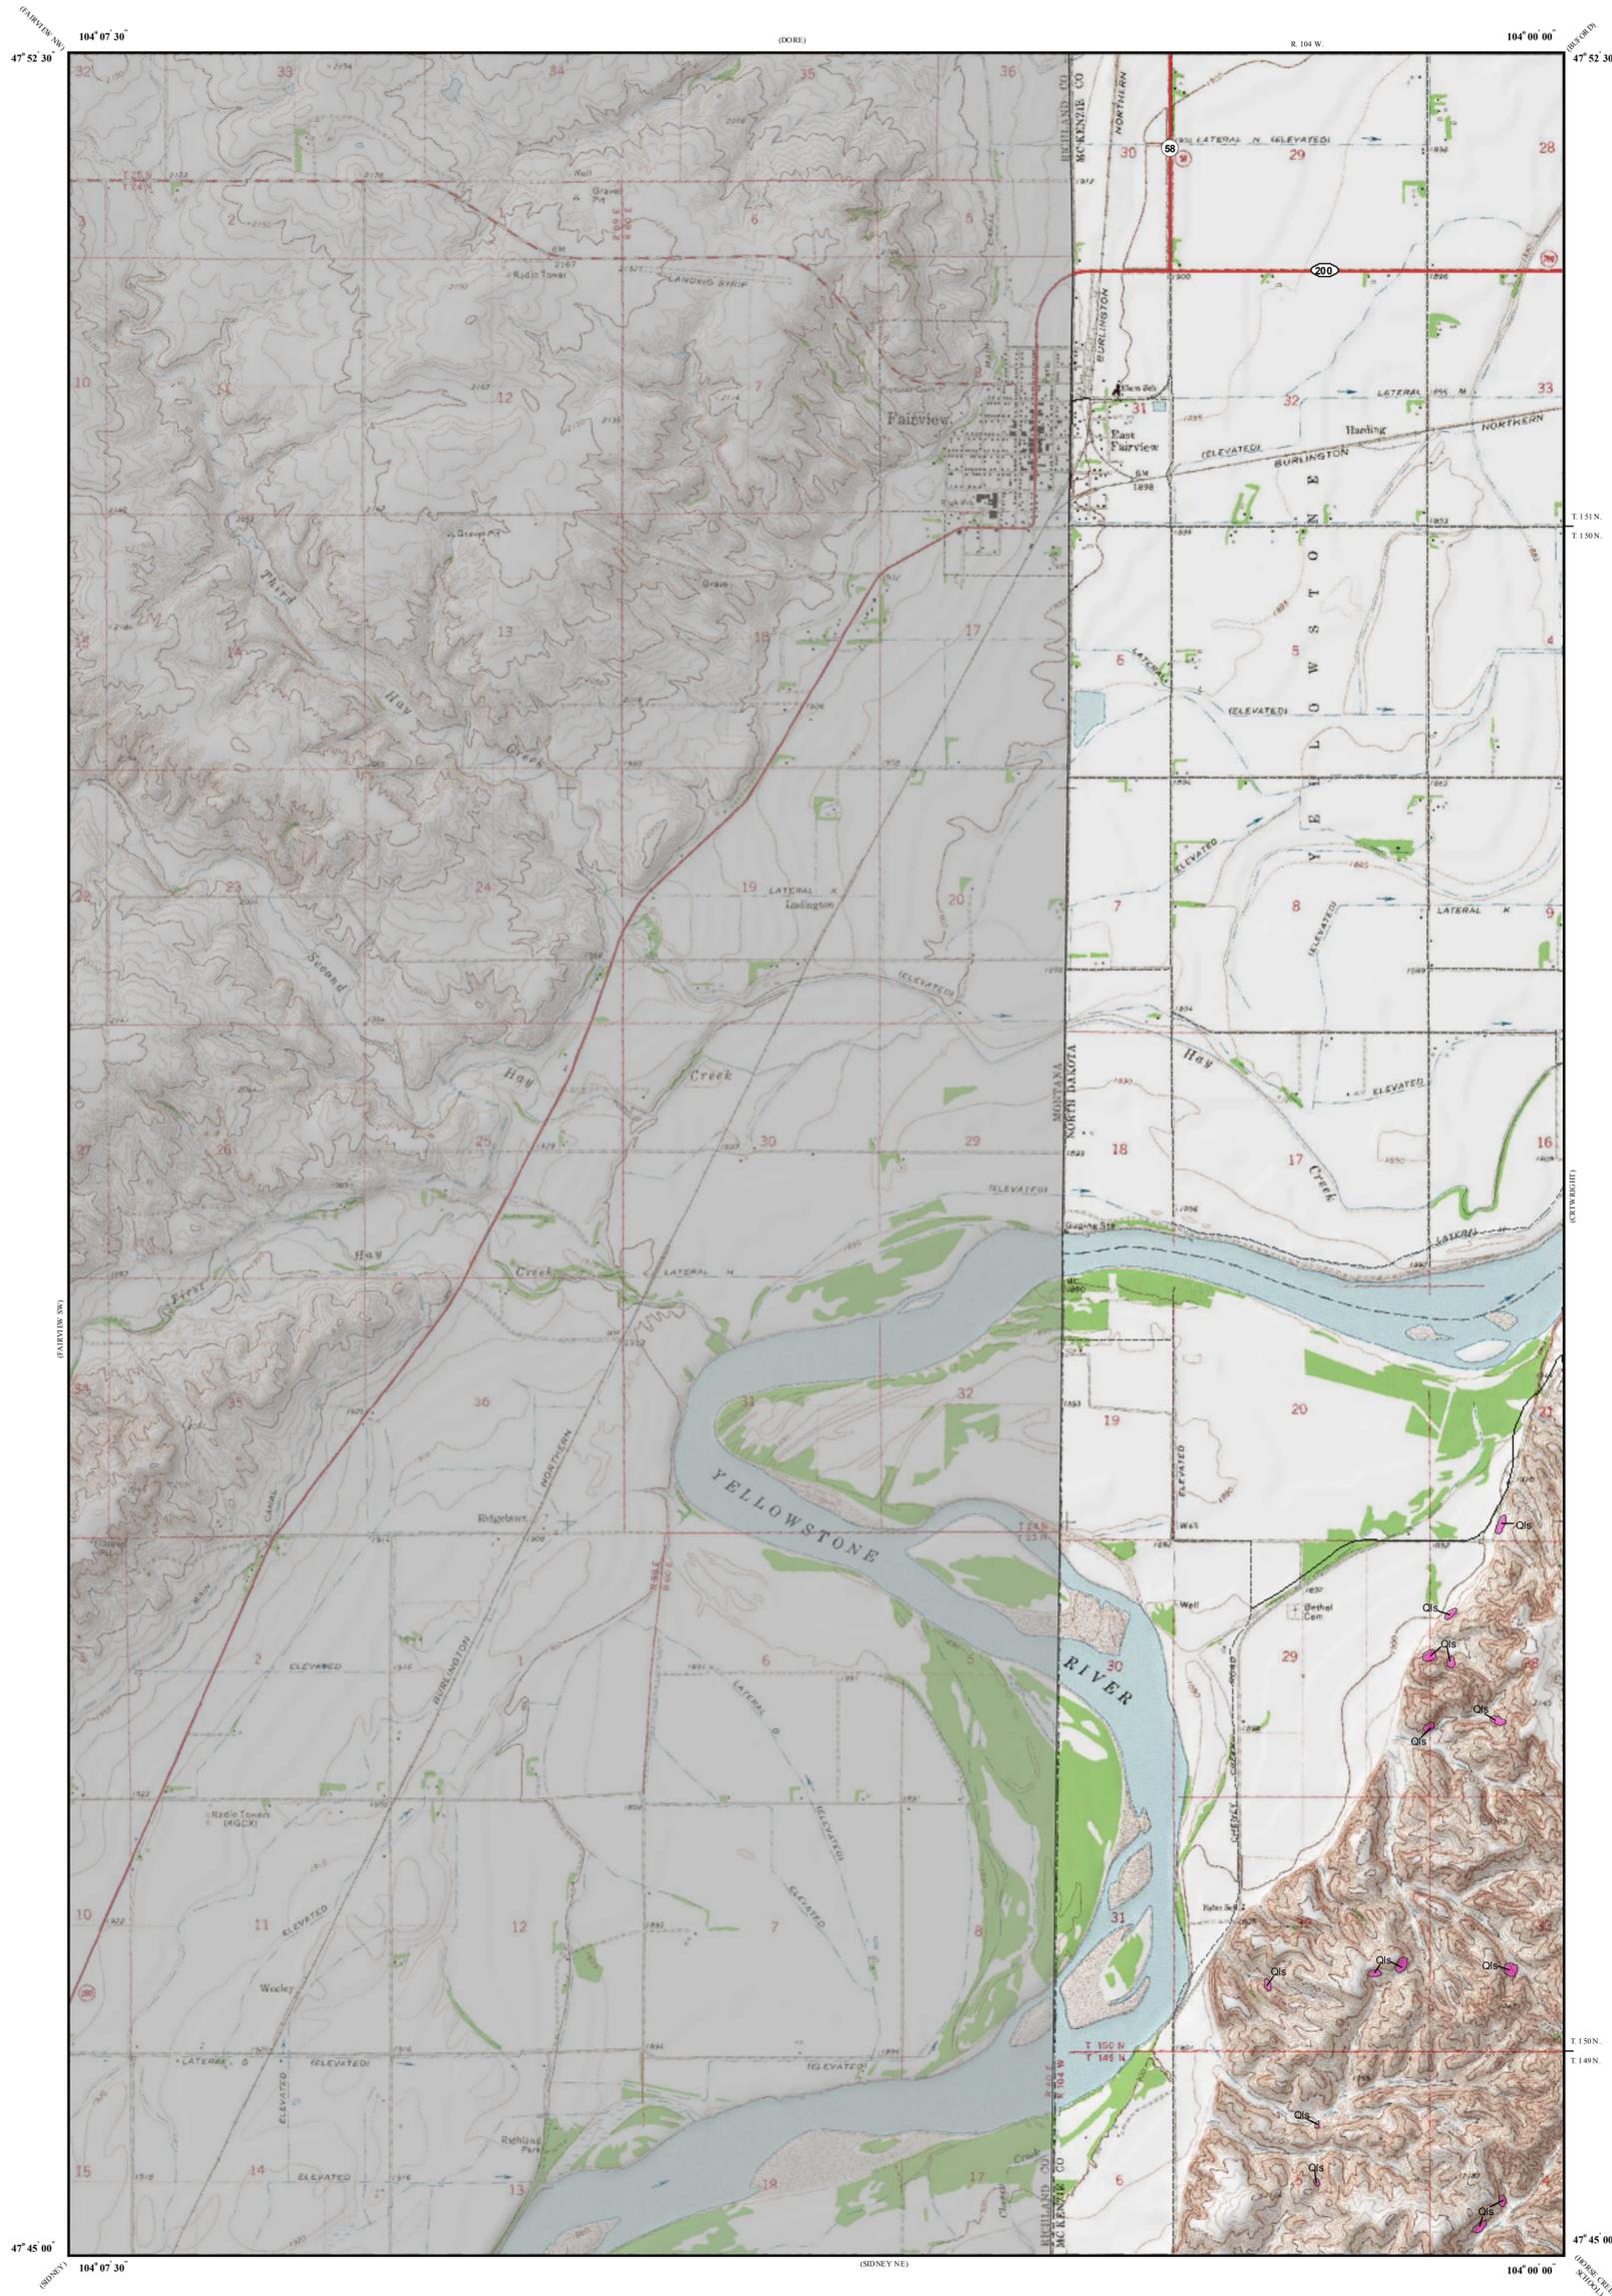
- Qs** Landslide Deposits
Variable mixture of strata and deposits that have slid to the base of steep slopes. Most of the landslides in this area are hundreds, if not thousands, of years old.

Landslides identified on this quadrangle were mapped from stereo pairs, black and white 1:20,000 scale aerial photographs flown between 6-21-58 and 9-7-58. As a result these maps can be used to identify areas that are vulnerable to slope failure, but are not an up to date assessment of all landslides for the area.

Note: Landslides were only mapped on the North Dakota portion of this map.
