Areas of Landslides

Red Bank Creek Quadrangle, North Dakota

Edward C. Murphy

2012

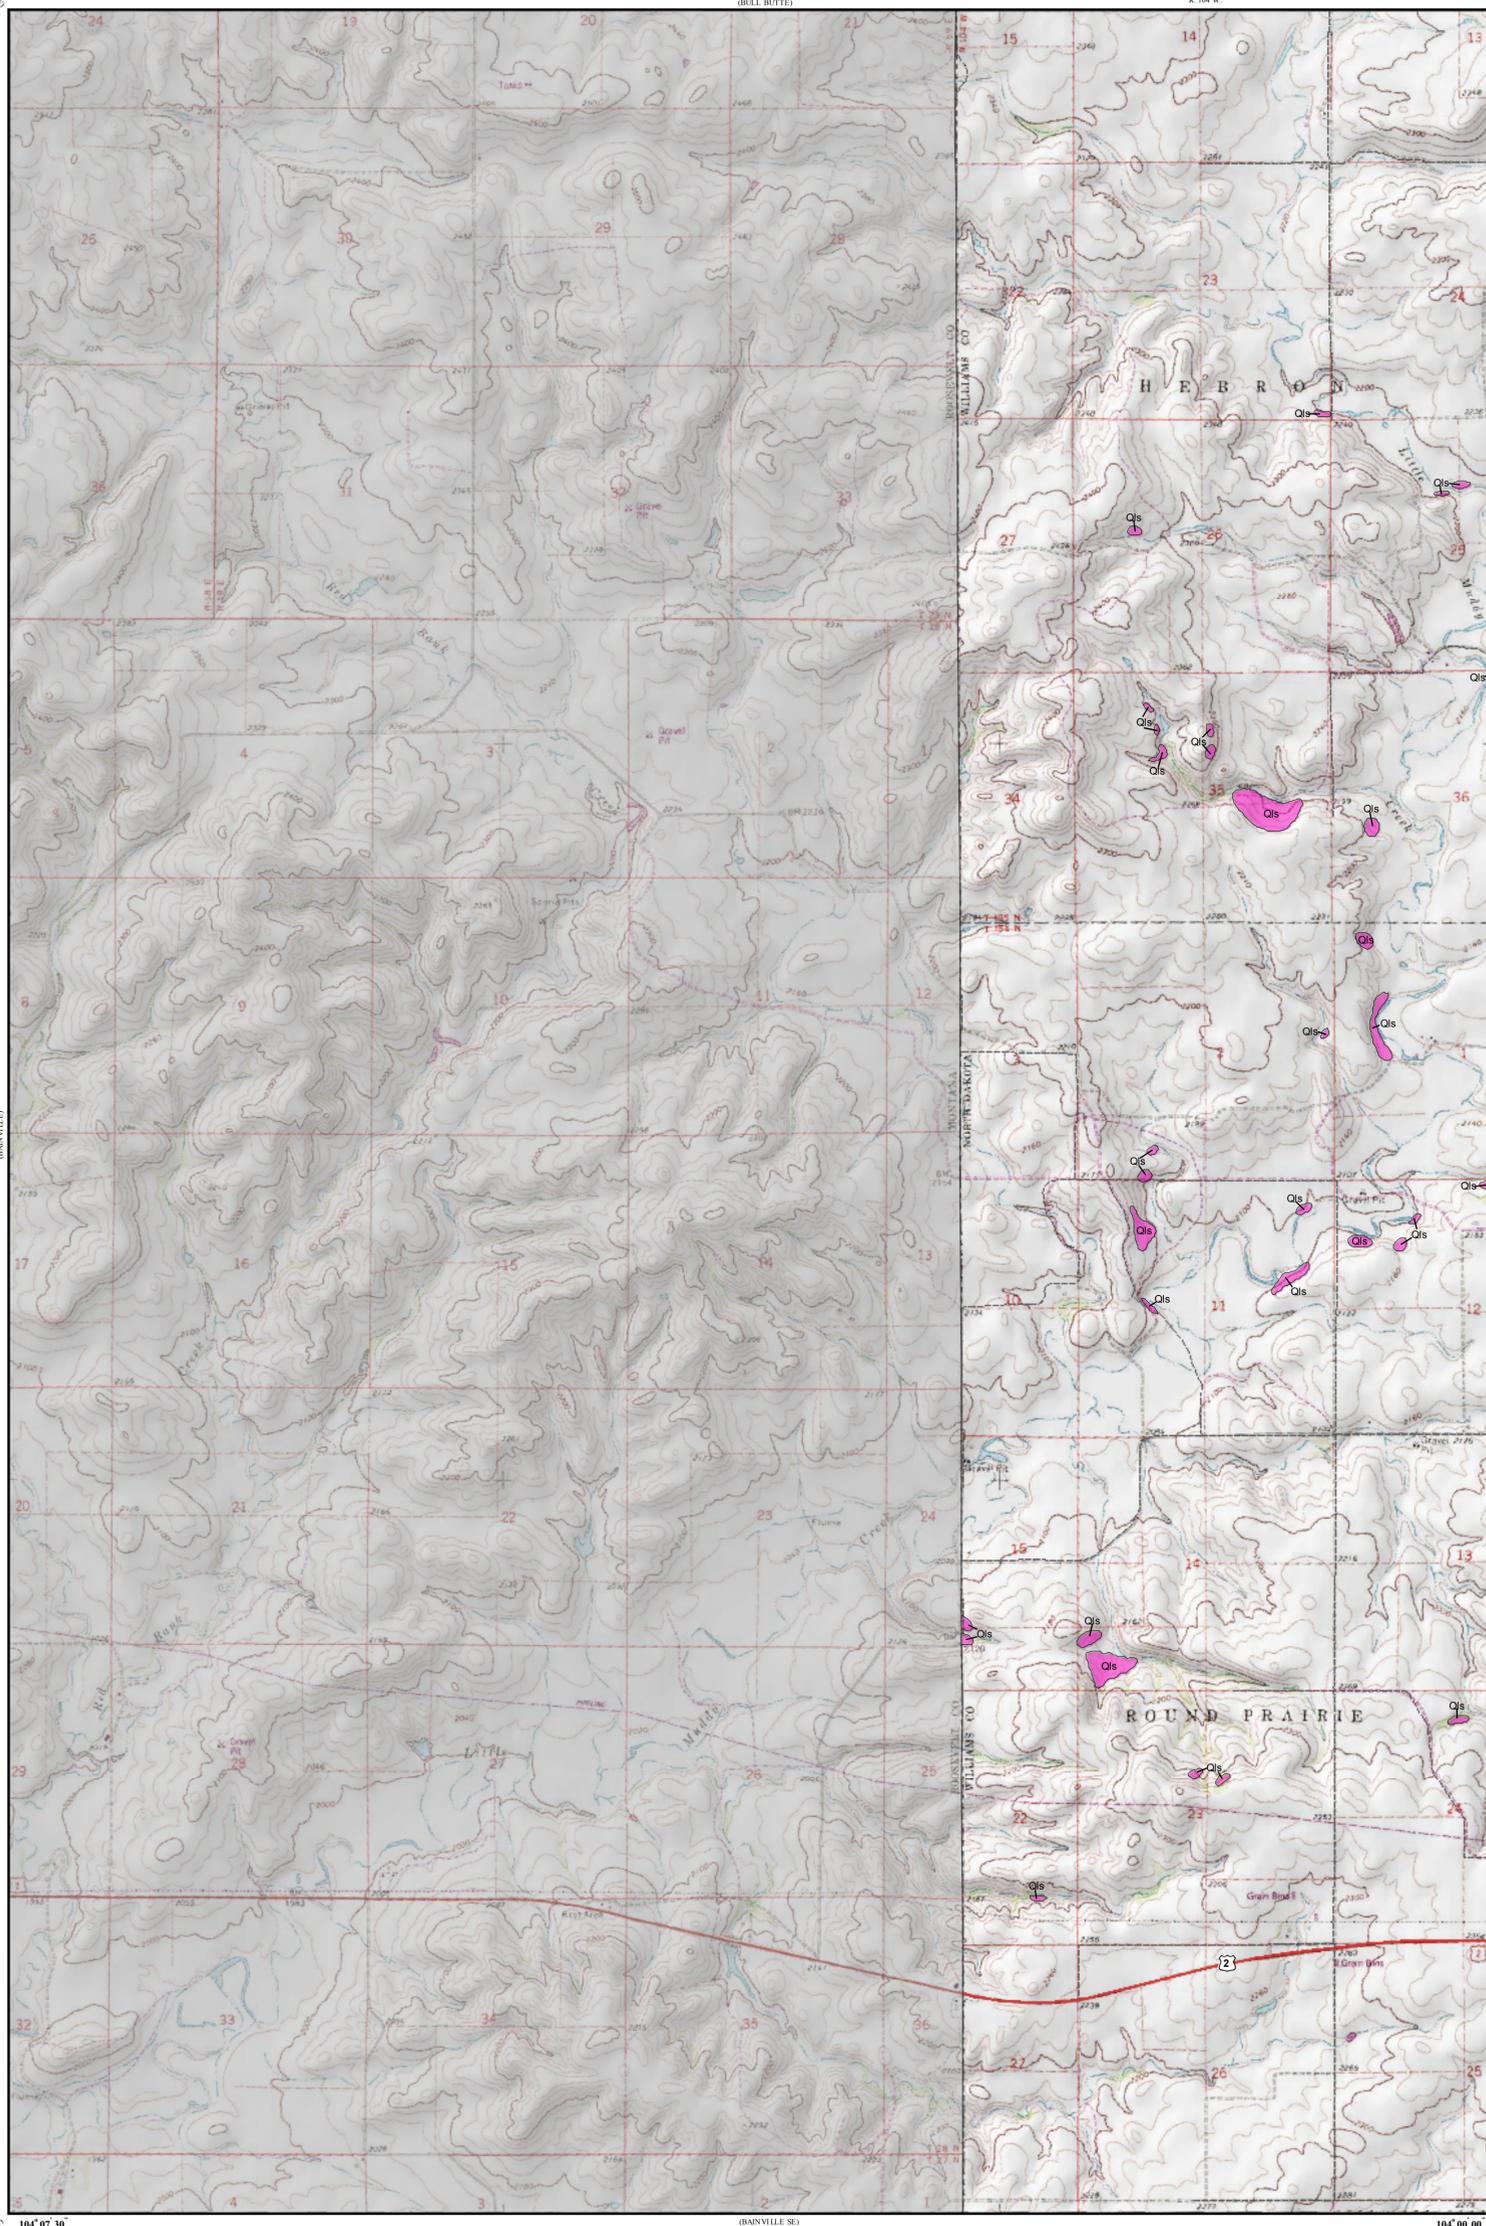
Qls Landslide Deposits

Variable mixture of strata and deposits that have slid to the base of steep slopes.

Landslides identified on this quadrangle were mapped from stereo pairs, black and white 1:20,000 scale aerial photographs flown between 6-21-58 and 9-7-58. As a result these maps can be used to identify areas that are vulnerable to slope failure, but are not an up to date assessment of all landslides for the area.
