ORGANIC AND INORGANIC CONTAMINANTS IN SHALLOW GROUNDWATER AT SIX MUNICIPAL LANDFILLS IN NORTH DAKOTA

REPORT OF INVESTIGATION NO. 94

NORTH DAKOTA GEOLOGICAL SURVEY

1992

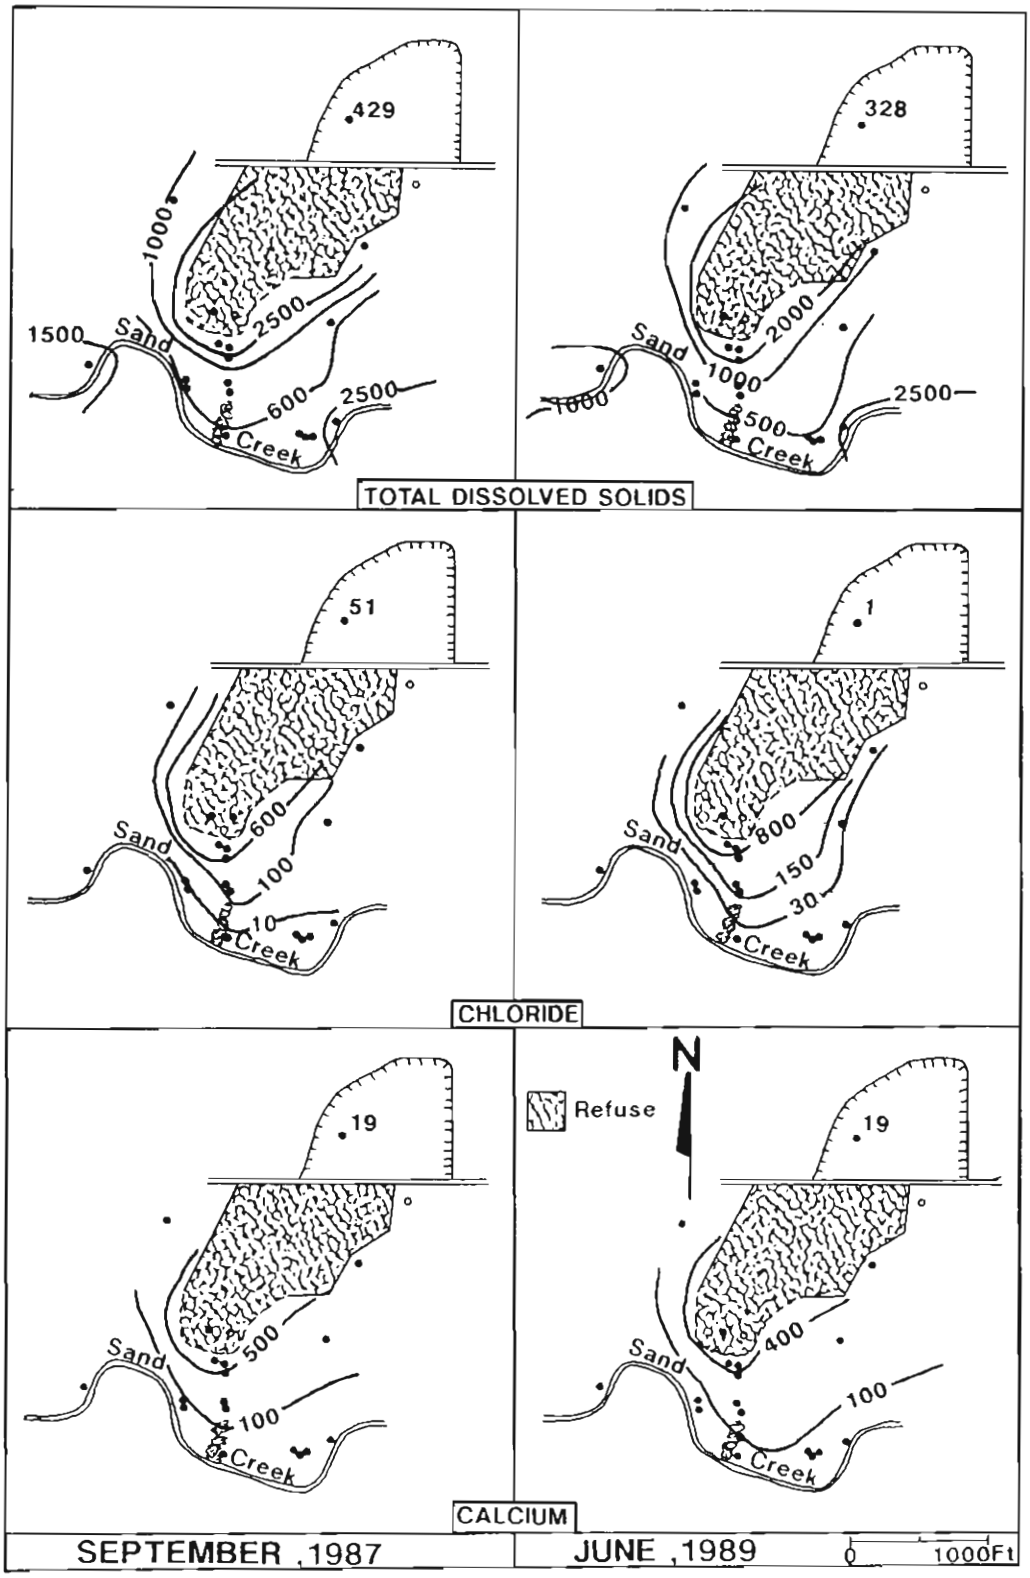
A comparison of isoconcentration maps for selected parameters within the groundwater adjacent to the Williston landfill indicates that a plume of degraded groundwater extends downgradient from the buried refuse for approximately 500 feet (figures 9 to 11). This plume is well defined in the TDS map and is evident in a comparison of the major ion concentrations, especially the chloride ion (figure 9).

Figure 9. Isoconcentration maps for TDS, chloride, and calcium at the Williston landfill.

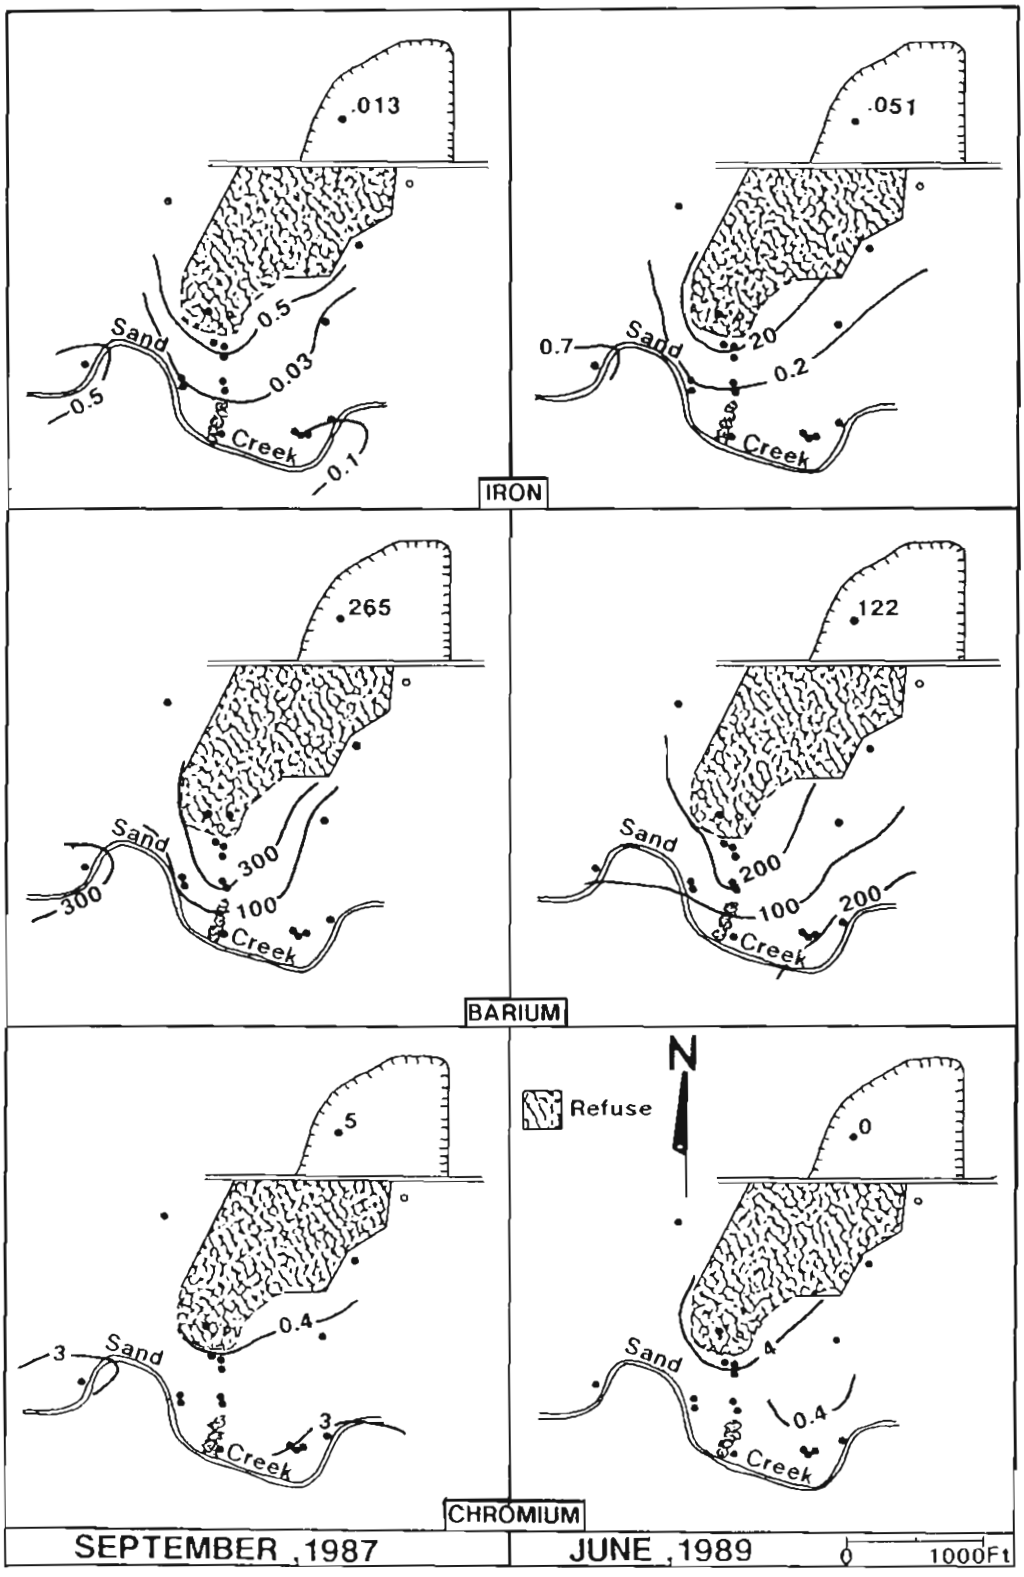
Trace metal concentrations within the degraded plume of groundwater are generally at or near the same levels as background concentrations and do not exhibit the same distinct pattern as seen with the major ions (figures 9 and 10). Two exceptions to this appear to be barium and zinc. A groundwater plume, enriched in these two metals, eminates from the southern end of the landfill (figures 10 and 11).

Figure 10. Isoconcentration maps for iron, barium, and chromium at the Williston landfill.

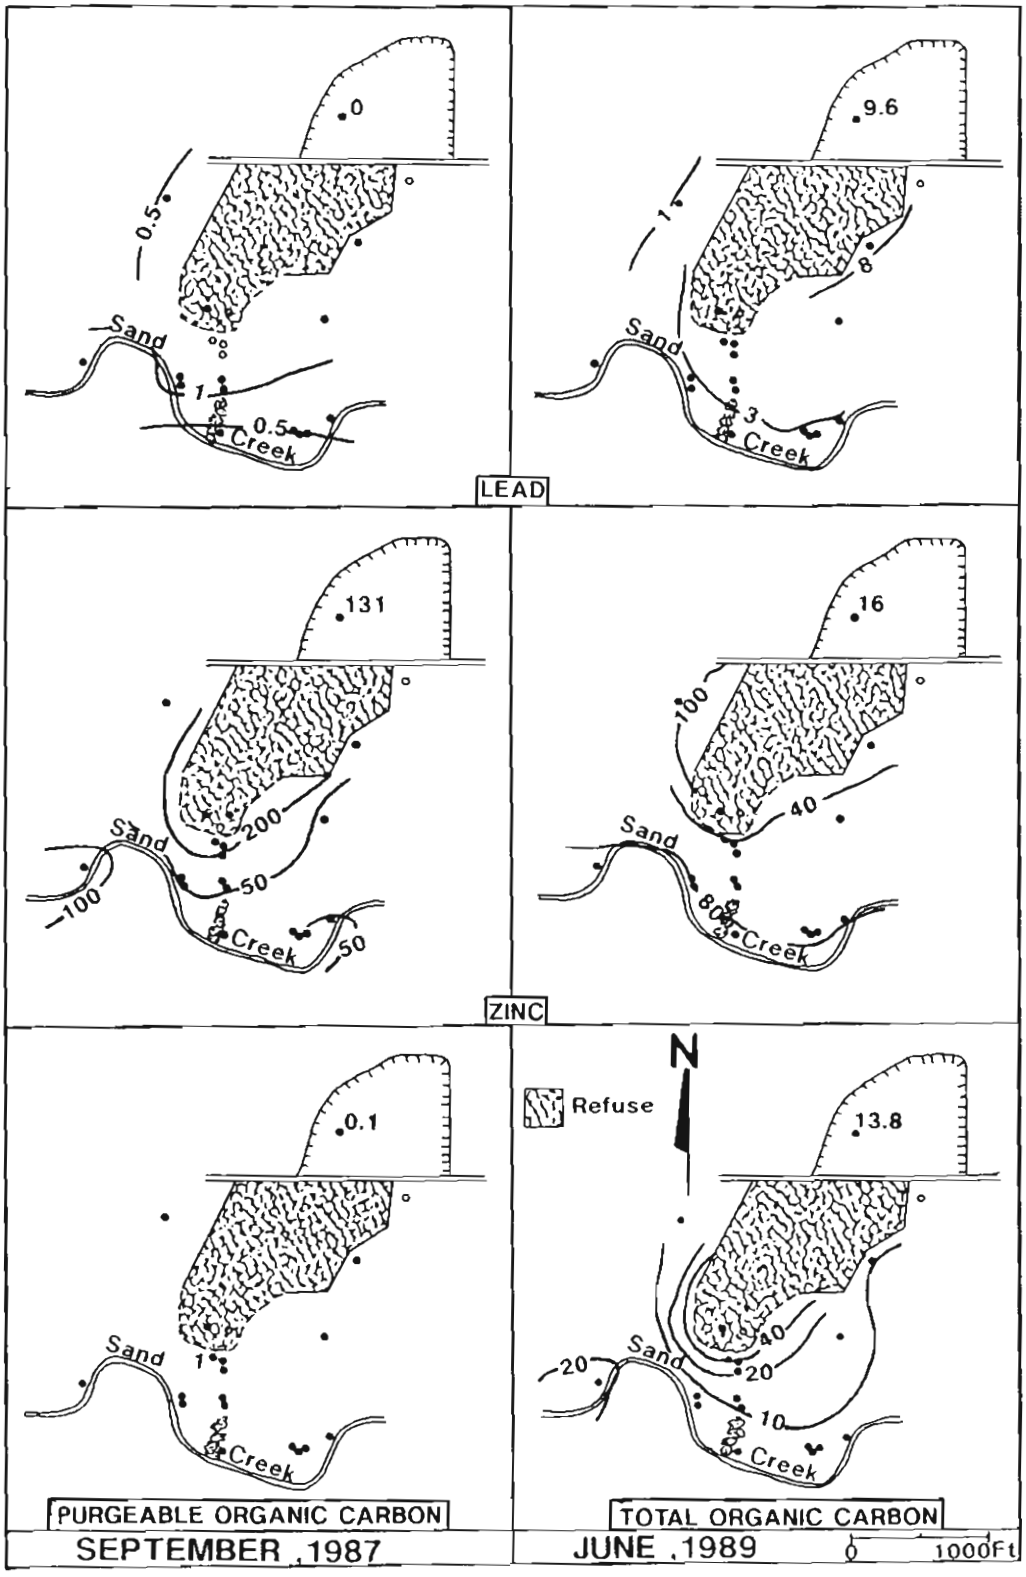
Figure 11. Isoconcentration maps for lead, zinc, and organic carbon at the Williston landfill.

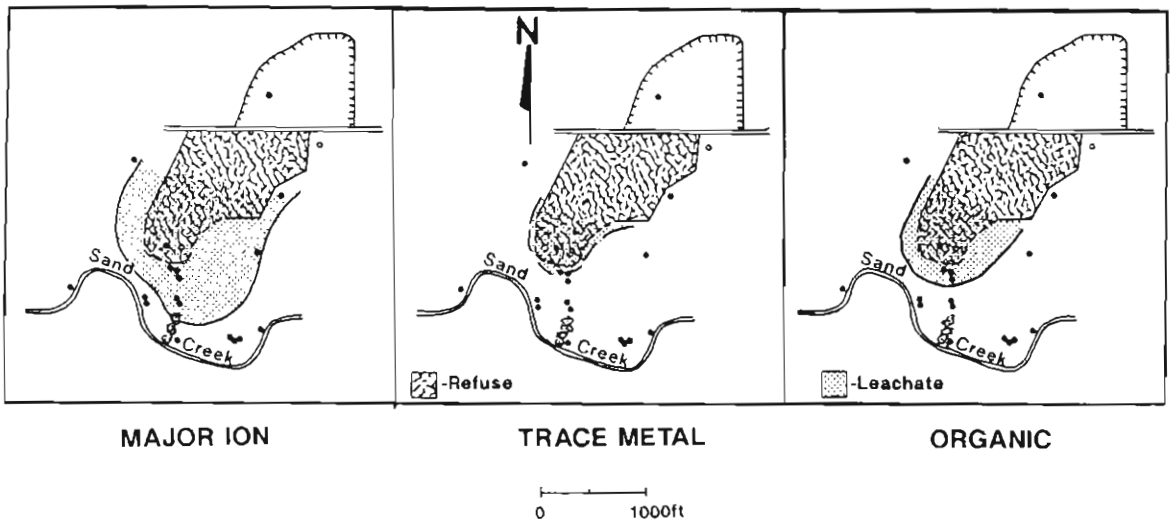
3. The Williston landfill is degrading groundwater at least 350 feet downgradient from the site boundary (figure 12). This leachate plume is characterized by high concentrations of some major ions (Ca, Cl, Fe), slight to moderate increases of one or two trace metals (Ba and Zn), and high concentrations of organic carbon.

4. Perched water migrating out of the Williston landfill is degraded to a higher degree than is the groundwater. The zone of contaminated or degraded perched water appears to extend for at least 350 feet south and 850 feet southeast of the landfill boundary.

Figure 12. Extent of leachate migration at the Williston landfill.

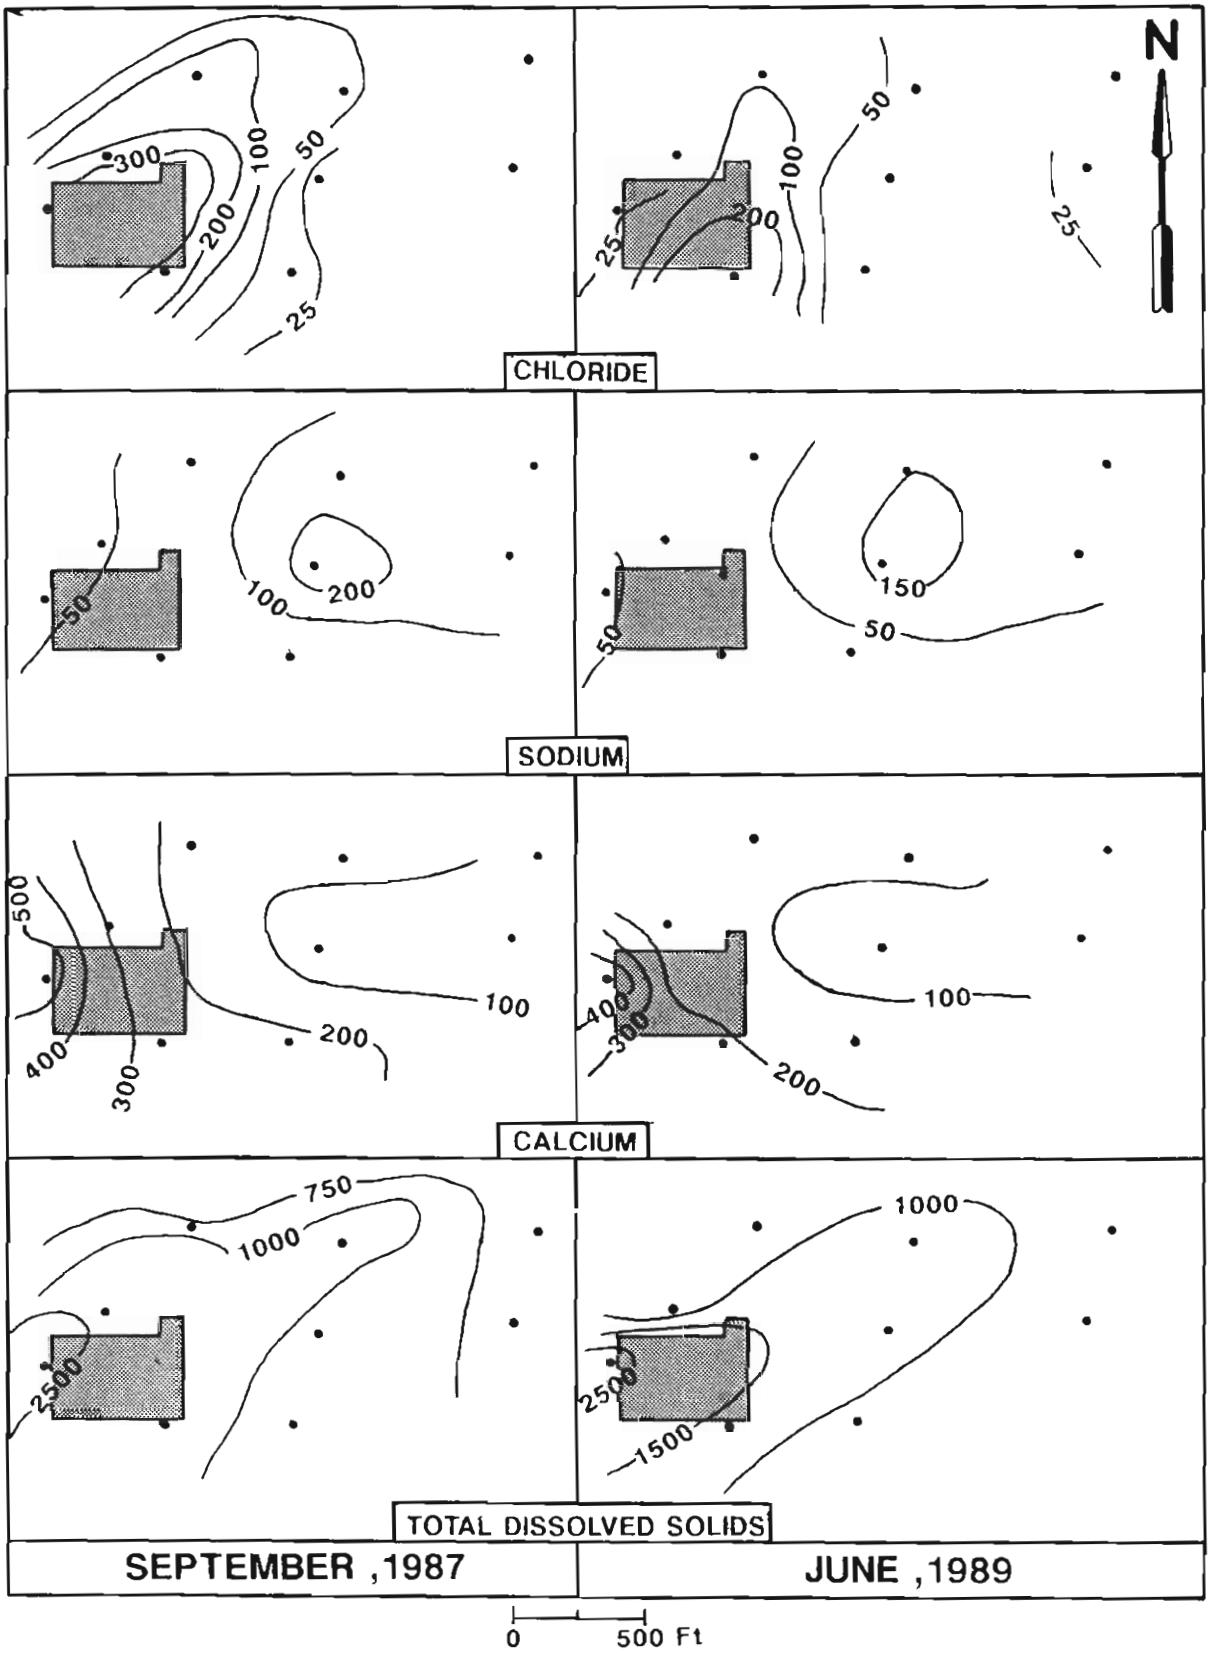
Concentrations of selected major ions and trace metals in the groundwater at the Wishek landfill appear to be within the normal range for these parameters in shallow groundwater within this area. The isoconcentration maps of these parameters did not reveal a consistent leachate plume, and only a few maps indicated the landfill as the probable source of ion increase (figures 27 to 29). Total dissolved solids and chloride are two parameters that indicate a possible landfill source (figure 27). The level of the chloride ion in natural (nondegraded) shallow groundwater in this area is generally 15 to 30 mg/l. Groundwater beneath the landfill contained up to 300 mg/l of chloride, or 10 times the normal concentrations. Refuse is commonly a source for the chloride ion. However, groundwater within the Pierre Formation generally contains higher than normal levels of the chloride ion. Therefore, in this case the high chloride levels may be natural, a result of buried garbage, or a combination of the two.

Figure 27. Isoconcentration maps for chloride, sodium, calcium, and TDS at the Wishek landfill.

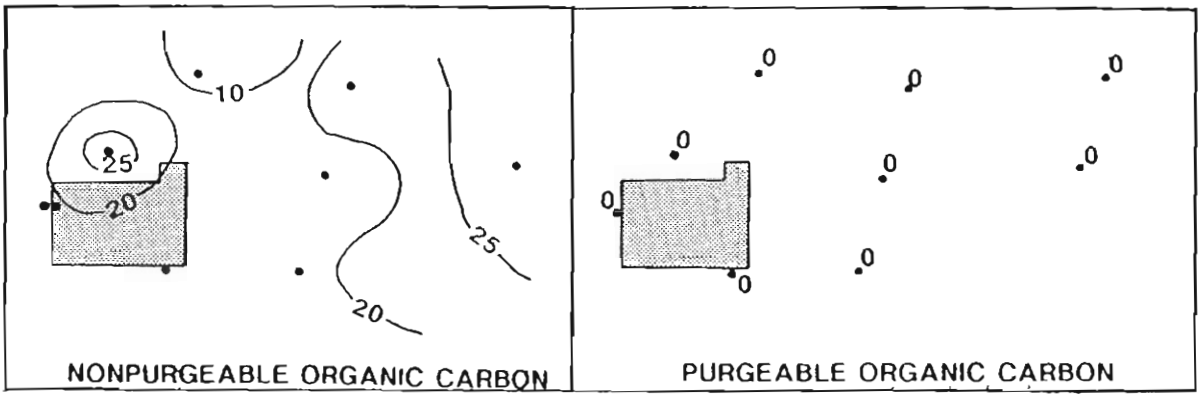
The highest concentrations of organic carbon were found in groundwater at wells 10 and 11. The elevated levels at well 11 may be traceable to buried refuse (figure 29). However, the source at well 10 may be related to the adjacent railroad, possibly the creosote from the railroad ties. No pesticides were detected in the four wells sampled at this landfill. Volatile organic compounds were also below detection limits in the seven samples from monitoring wells which were analyzed (table 9).

Figure 29. Isoconcentration map for organic carbon at the Wishek landfill.

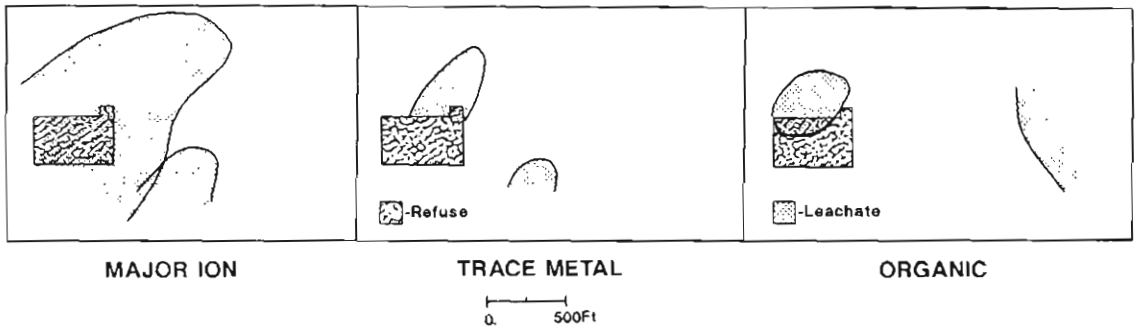
4. The groundwater information gathered to date at the Wishek landfill indicates that refuse is impacting groundwater quality beneath the site. At this time the impact appears to be small and is difficult to quantify due to the natural variability

Figure 30. Leachate in groundwater at the Wishek landfill.

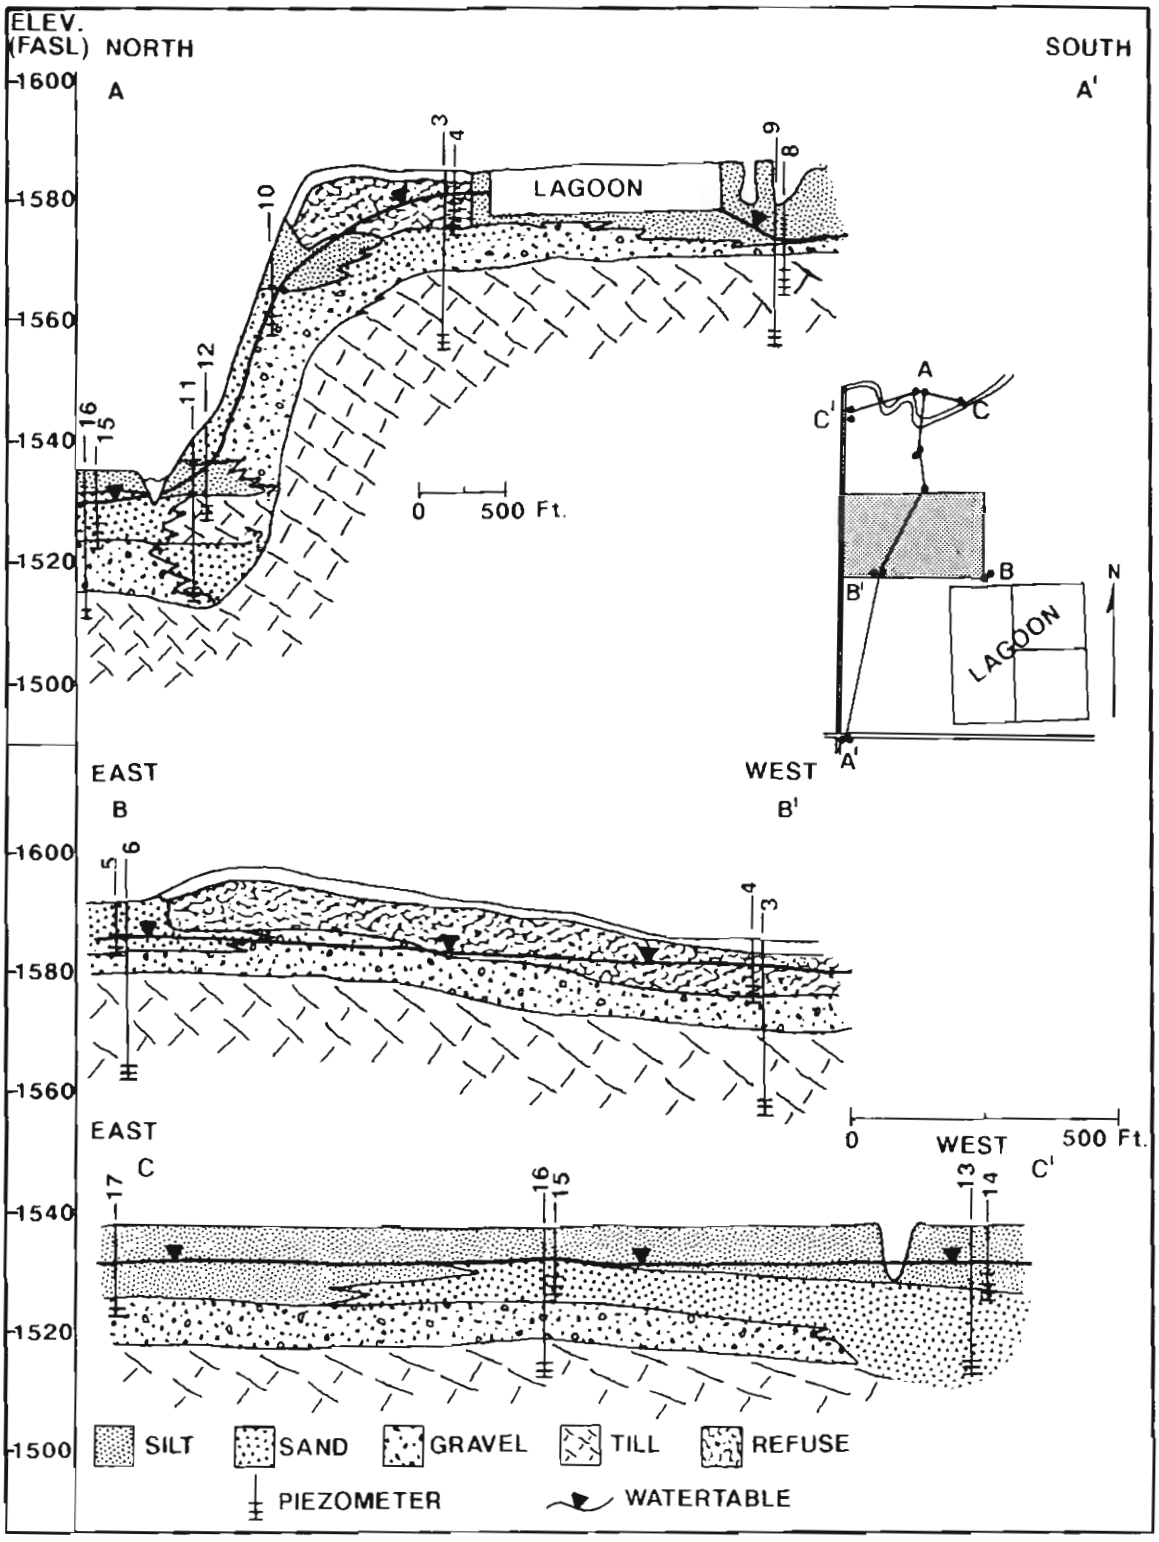
Figure 34. Geologic cross-sections of the Harvey landfill.

The wastewater impoundments are having a large impact upon the local groundwater system. A profile of the groundwater table shows the configuration of a groundwater mound in the vicinity of the lagoon (figure 34). The water table varies from a depth of 5 feet beneath the surface along the southern landfill boundary to a depth of 10 to 15 feet along the northern edge of the landfill. Approximately 1/3 to 1/2 of the refuse is buried beneath the groundwater table. This is largely a result of the rise in the water table attributable to the wastewater ponds. A number of springs are located along the hillside beneath the landfill. In addition, a small creek flows through the eastern portion of the site (figure 32).

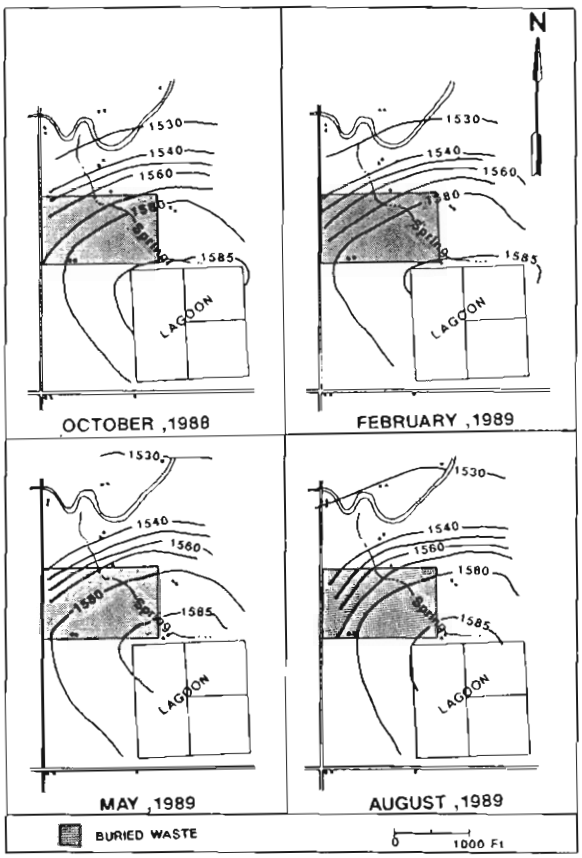
Figure 35. Water table maps for the Harvey landfill.

The groundwater flow direction is generally to the north-northwest (figure 35). The gradient of the water table is approximately 2.8 x 10^{-2} (figure 35). As anticipated, a comparison of the nested monitoring well water levels indicated that the landfill is situated on a groundwater divide (Appendix C). The upland area is a recharge zone and the valley sides and floor are discharge zones.

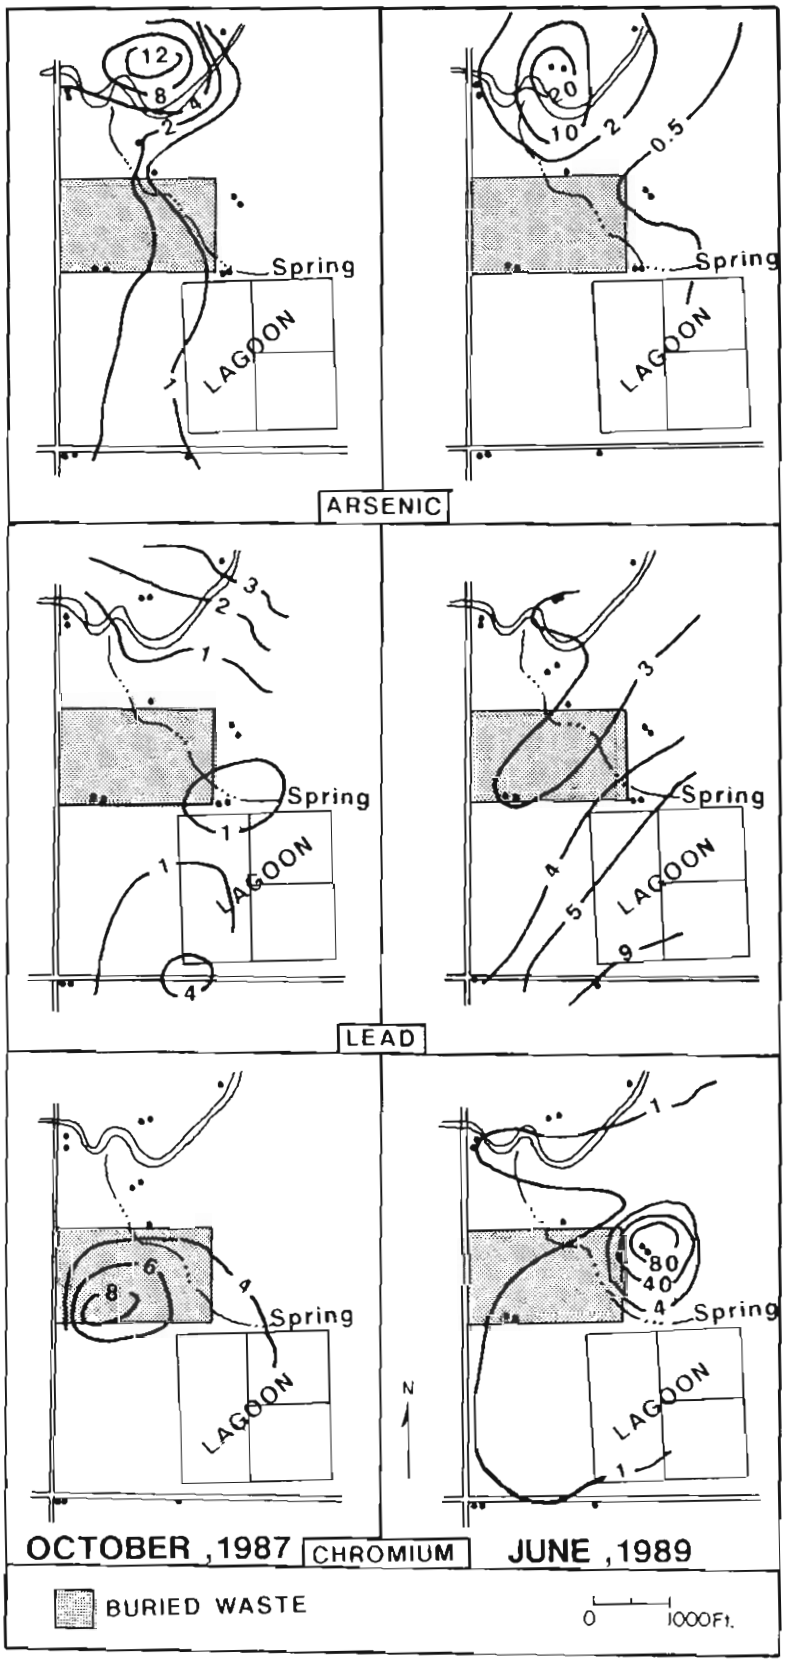
Figure 40. Isoconcentration maps for arsenic, lead, and chromium at the Harvey landfill.

A very high value of 83 ug/l of chromium was reported in the June 1989 sample from monitoring well 2 (0 ug/l in 1987) (figure 40). This well is located in an area outside of the buried refuse boundary. However, isolated pockets of buried refuse occur beyond the boundary and a large volume of scrap metal was present near this well. The source of chromium may be from either surface of subsurface refuse. Another potential source could be a Cretaceous shale boulder within the outwash. These shales tend to have abnormally high concentrations of some trace metals (although chromium is generally not one of them). The high arsenic levels in monitoring well 15 may also be attributable to a Cretaceous shale source.

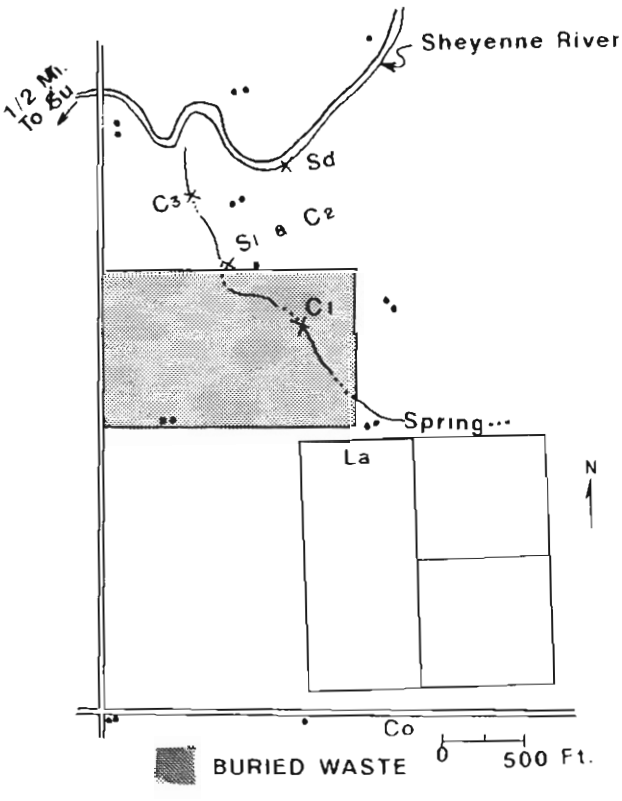
Figure 42. The location of surface water samples at the Harvey landfill.

In addition to the groundwater monitoring, water samples were taken from the Sheyenne River, from surface water within the landfill, from springs below the landfill, and from the wastewater impoundments. This data is summarized in table 12 and the location of the samples is shown in figure 42.

Three parameters (F, Pb, and TOC) were found to be high in the wastewater within the impoundments (table 12). The high fluoride ion concentration is a result of fluoridation of the city water supply and the lead may be coming from residential lead pipes or lead solder. The sample labeled "Co" was taken in stagnant water (cattail slough) in the road ditch south of the impoundments (figure 42). This area is likely being impacted by wastewater seeping out of the impoundments. The chemical concentrations of the surface water at this site are also increased as a result of evaporation. Samples C_1, C_2, and C_3 were obtained from the small creek flowing through the landfill (figure 42). Ion concentrations are generally high and do not appreciably decrease from C_1 to C_3 (table 12). The C_3 sample was taken at the farthest point from the landfill from which a bucket sample could be obtained. Beyond this point, the surface water spread out over a large area and it was not possible to obtain a large (one gallon) clean sample. However, the surface water could be

6. Surface water, which has been degraded by either or both the landfill and the wastewater impoundments, is reaching the Sheyenne River. The impact appears, at this time, to be only slightly due to the leachate chemistry and the low ratio of leachate volume to the Sheyenne River.

If, in the future, the landfill is found to be impacting the water quality of the Sheyenne River and the underlying aquifer to an unacceptable degree, the City of Harvey should consider relocating the wastewater impoundments, thereby lowering the water table in the landfill.

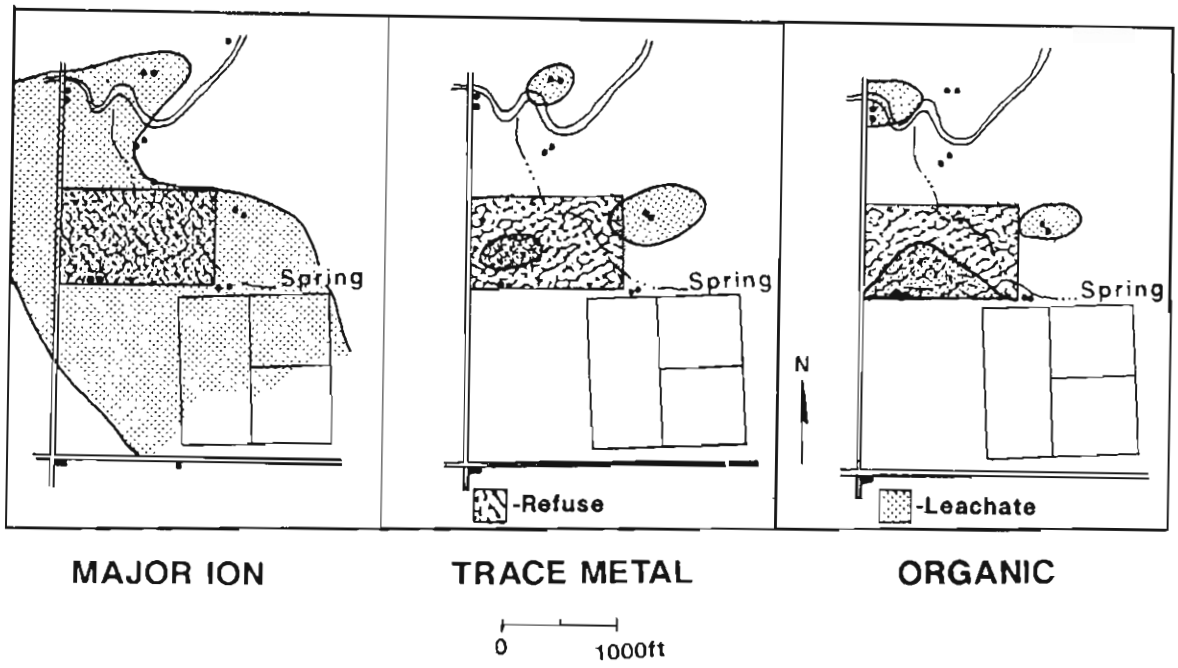
Figure 43. Leachate in groundwater at the Harvey landfill.

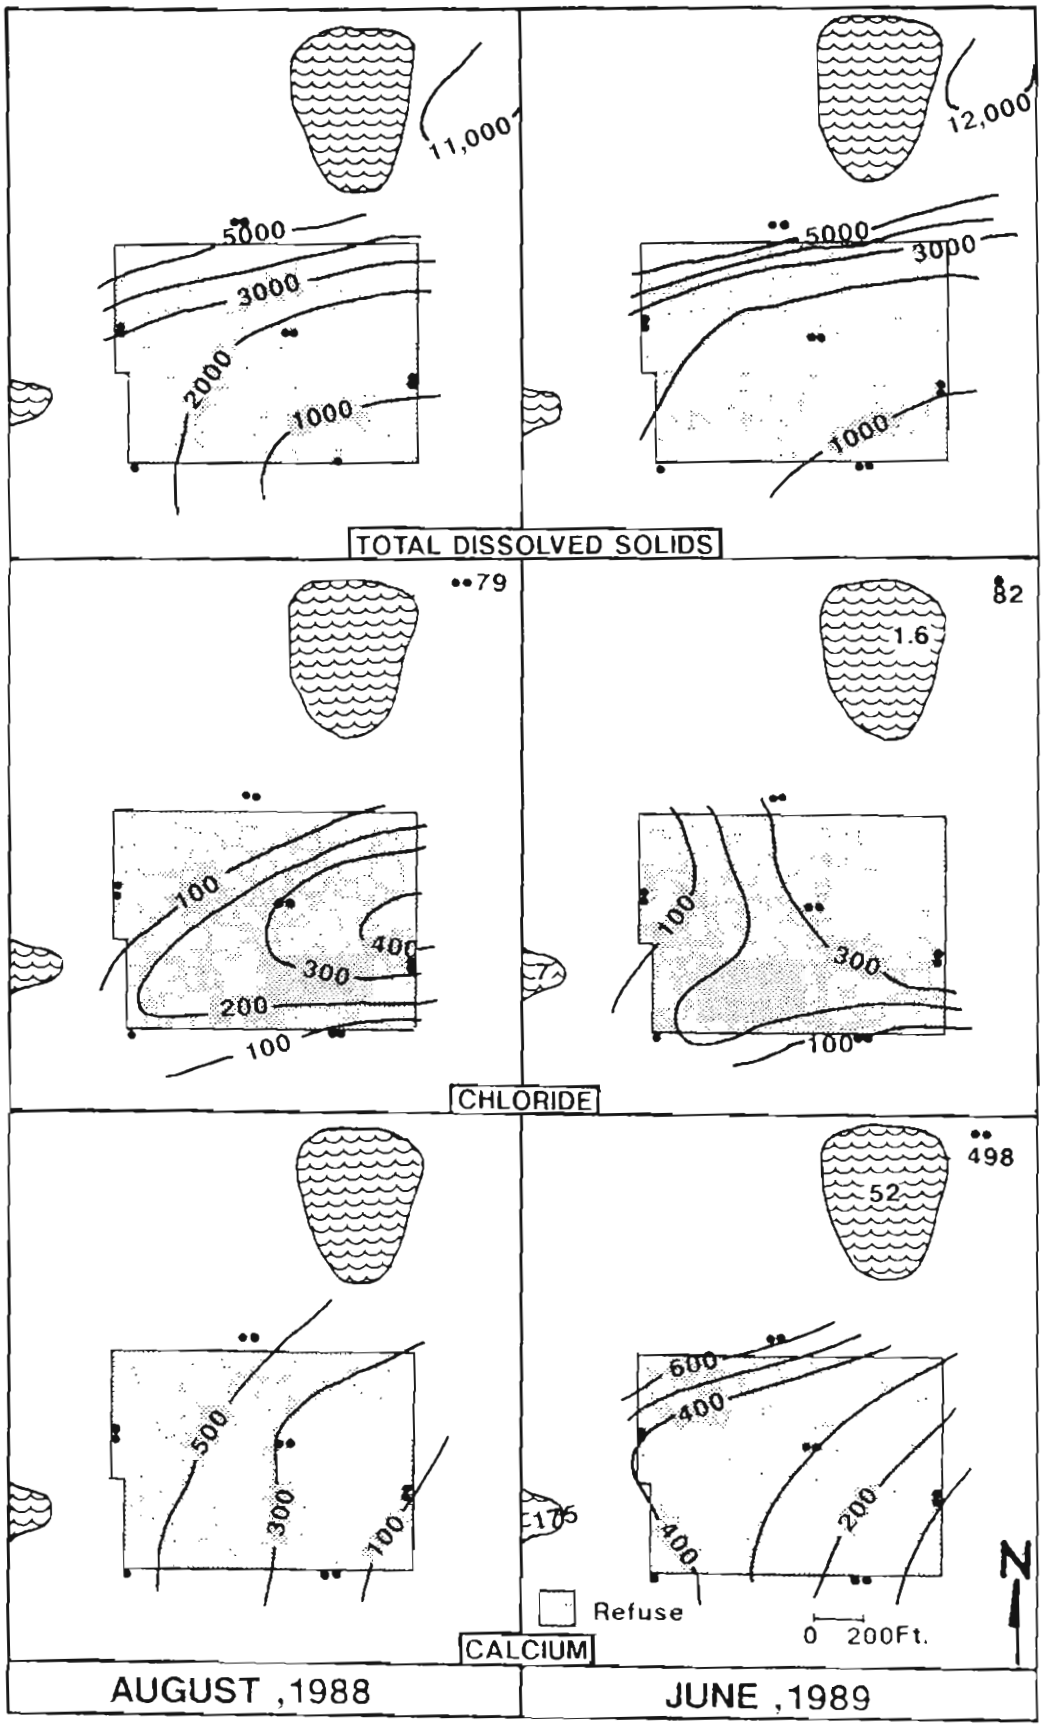
Figure 50. Isoconcentration maps for TDS, chloride, and calcium at the Devils Lake landfill.

High concentrations of several major ions and trace metals were found in the groundwater adjacent to the Devils Lake landfill. A comparison of the isoconcentration maps for the selected parameters reveals no consistent shape or pattern to the leachate plume (figures 50 to 52). This inconsistency is believed to be a result of the heterogeneity of the buried waste and the irregular flow patterns in the fractured till. Monitoring

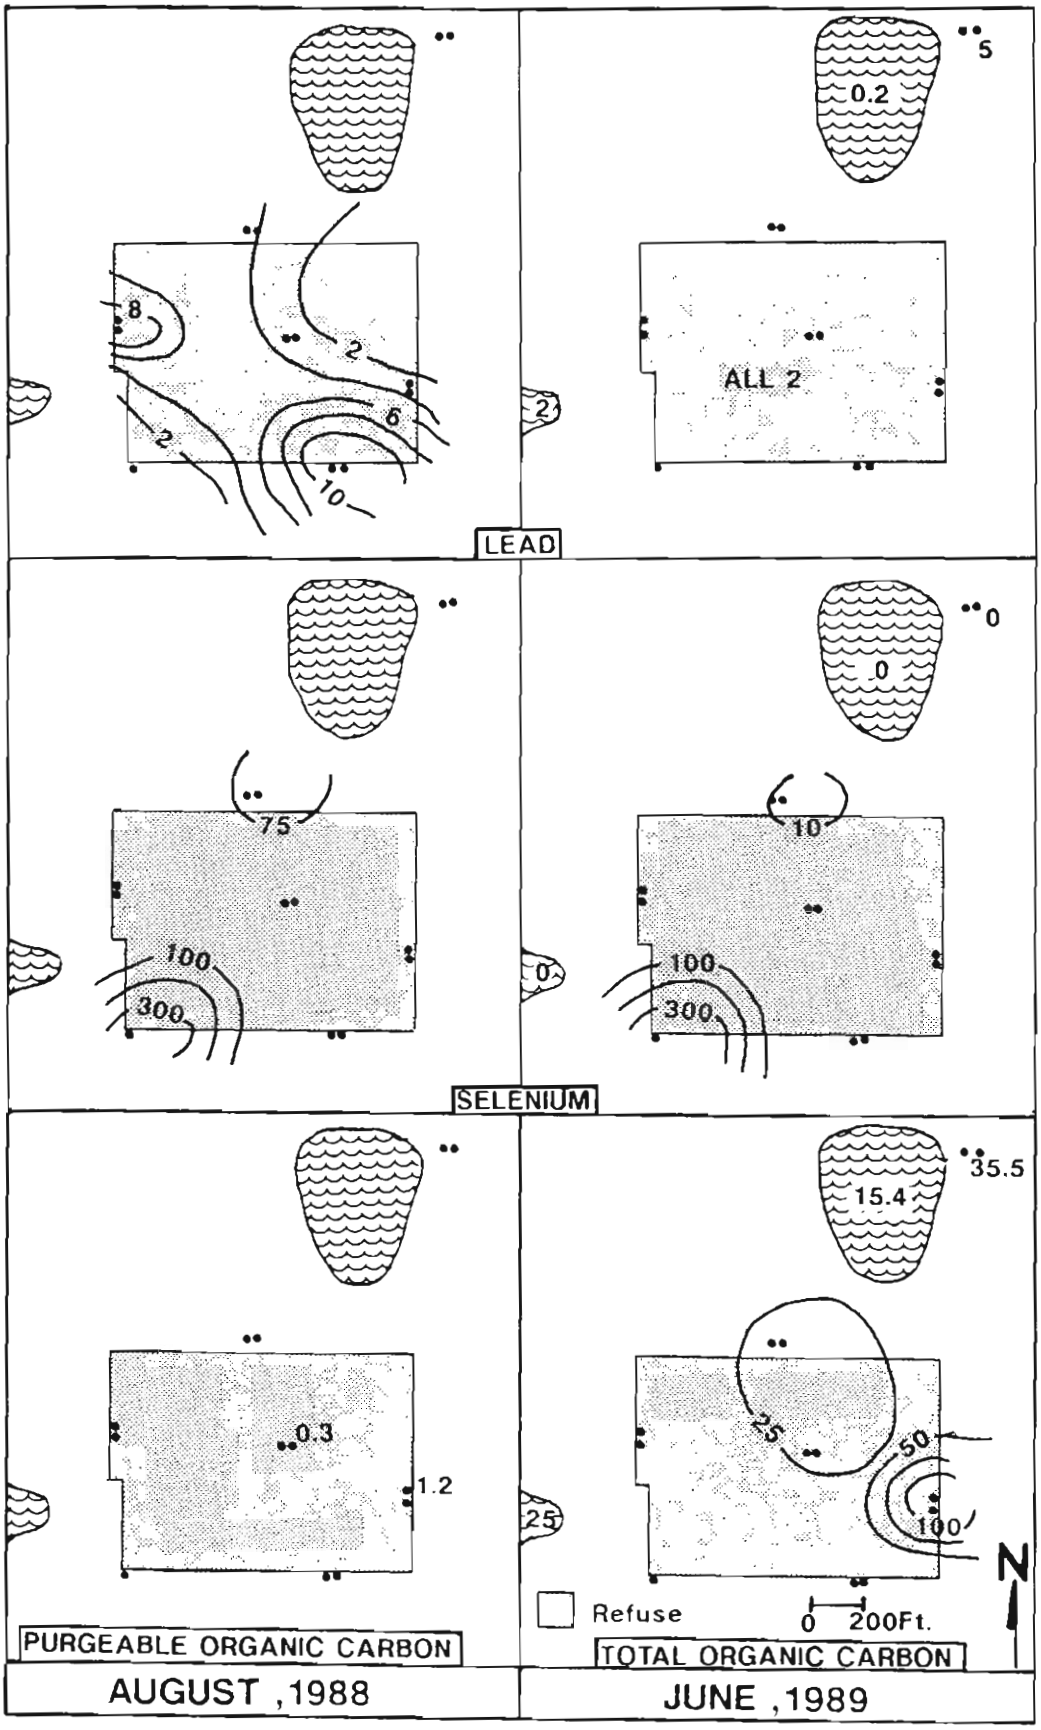
Figure 52. Isoconcentration maps for lead, selenium, and organic carbon at the Devils Lake landfill.

High levels of organic carbon were found in monitoring wells 1 (46 mg/l TOC) and 5 (113 mg/l TOC) (figure 52). The top of the screen in monitoring well 5 is approximately 2 to 3 feet below the base of the buried refuse. The water samples from this well had a deep green coloration and a very strong odor. The high concentrations of organic carbon in the east, central and northern portion of the landfill generally correspond to the high concentration levels of the major ion and trace metals. At present, there is no explanation for the high organic carbon levels in groundwater at wells 12 and 13 (appendix F).

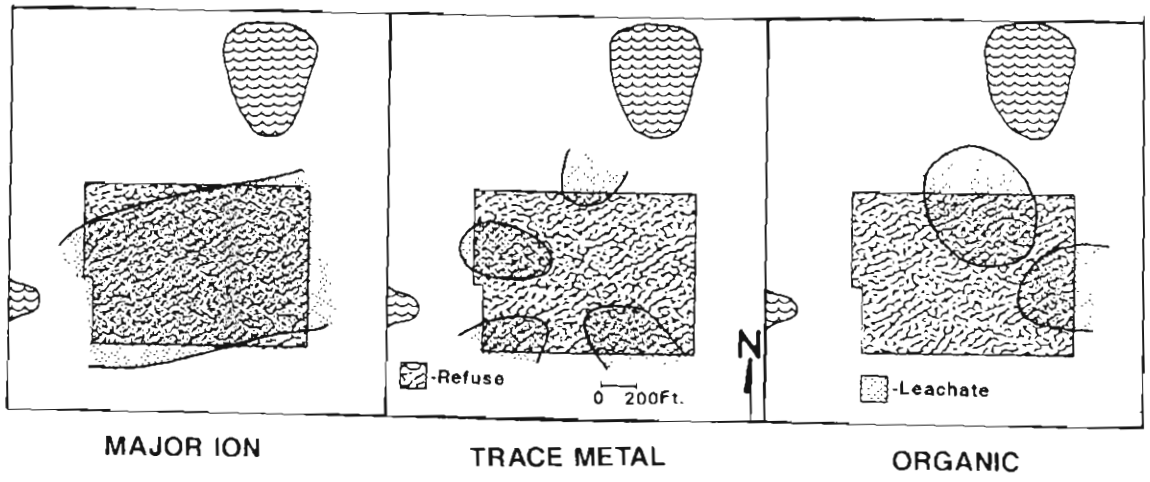
Figure 53. Leachate migration at the Devils Lake landfill.

4. No well-defined plume boundary is discernible from the isoconcentration maps. This is believed to be a result of the placement of the monitoring wells, the heterogeneity of the waste, and flow through a fractured media (figure 53).

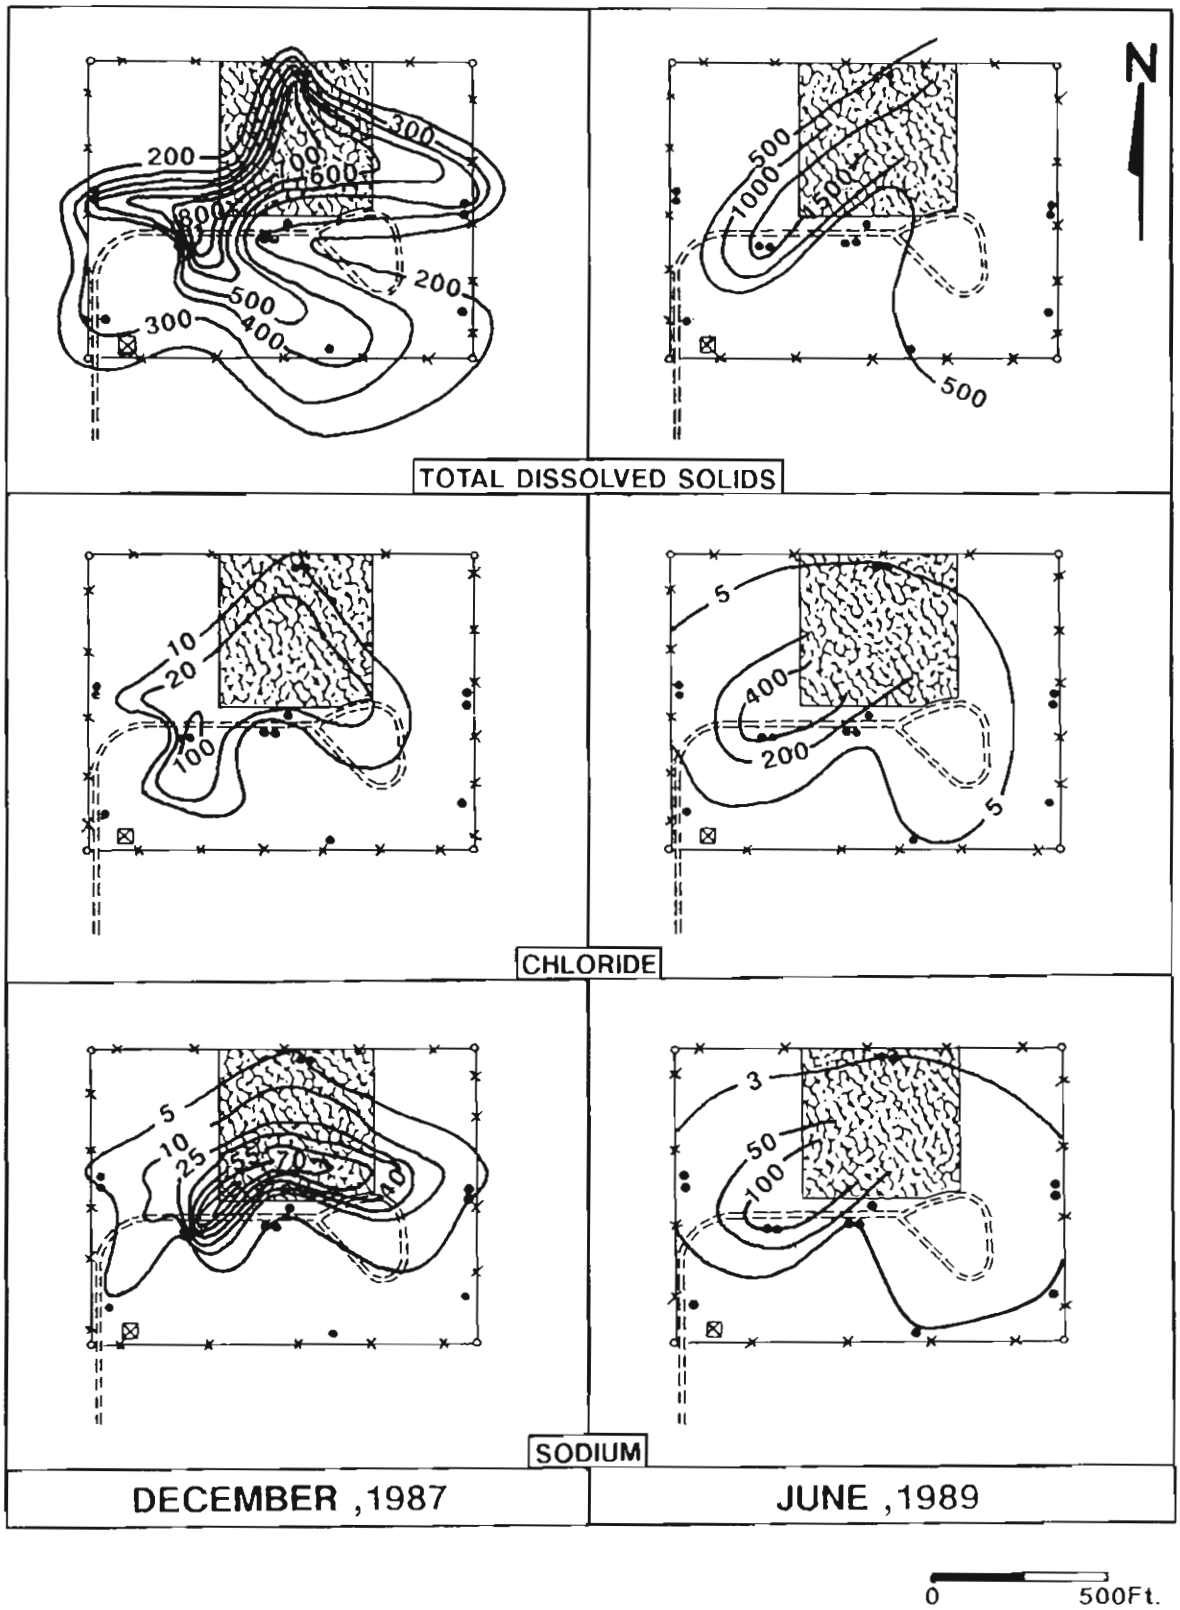
Figure 59. Isoconcentration maps for TDS, chloride, and sodium at the Hillsboro landfill (1987 map from Maletzke, 1988).

trations of the chloride ion were found in groundwater southwest of the landfill (well 11) (figure 59) (appendix D). The chloride levels detected are 10 to 100 times higher than background concentrations in this area. The plume of increased chloride ion concentrations appears to be confined to an area approximately 200 to 300 feet in diameter.

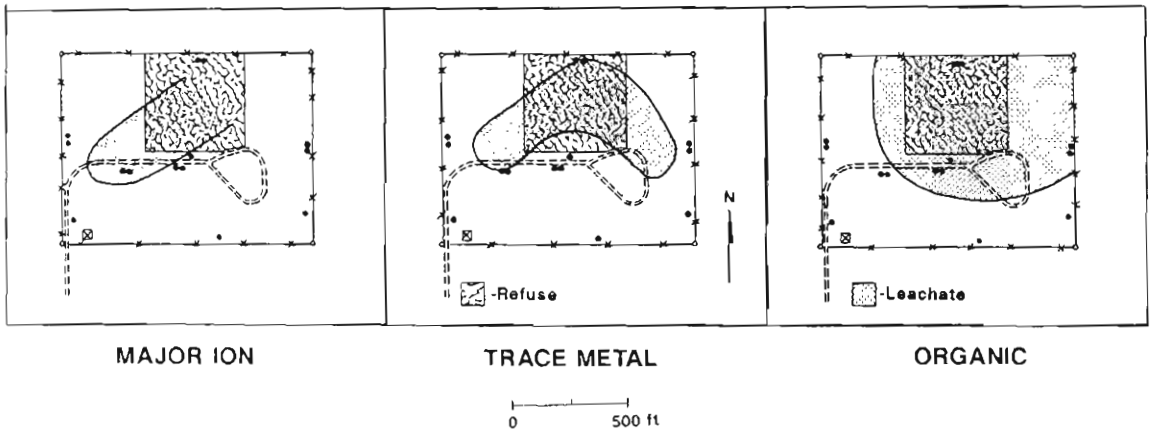
Figure 62. Leachate migration at the Hillsboro landfill.
