NDIC Brine Pond Study

Phase II: Site Assessments

June 25, 2018

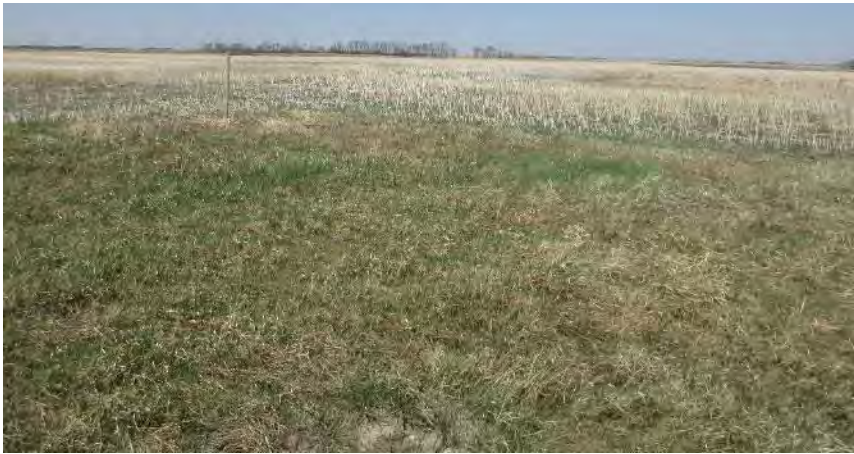
Photograph facing north off of an oilfield lease road showing no visual impacts in agricultural field.

B1-1 was inspected on May 15th, 2018, and is located approximately 500 feet north of an oilfield lease road. The site could not be accessed at the time of the site visit. The site is currently used as agricultural land, and is surrounded by agricultural fields. Visual impacts were not observed from a distance at the time of the site visit. A wetland was observed to the south of the site. The site topography is generally flat, and a drainage direction could not be assessed due to access limitations.

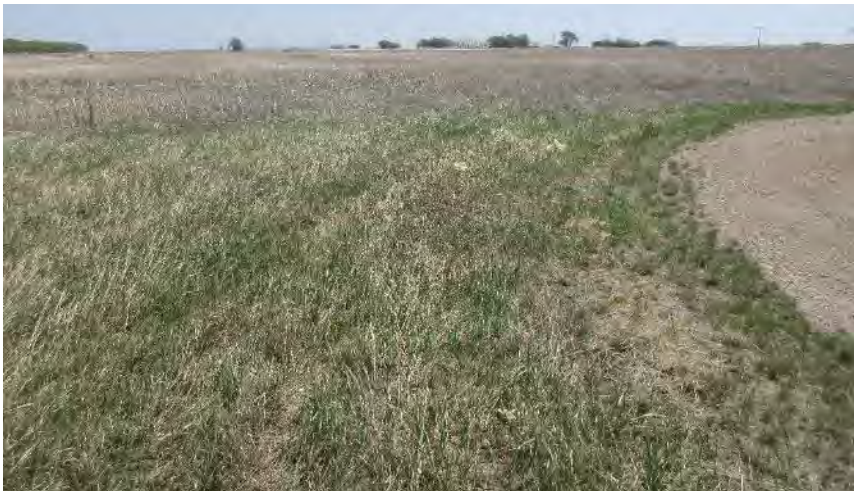
Photograph facing northeast off of an oilfield lease road showing no visual impacts in agricultural field.

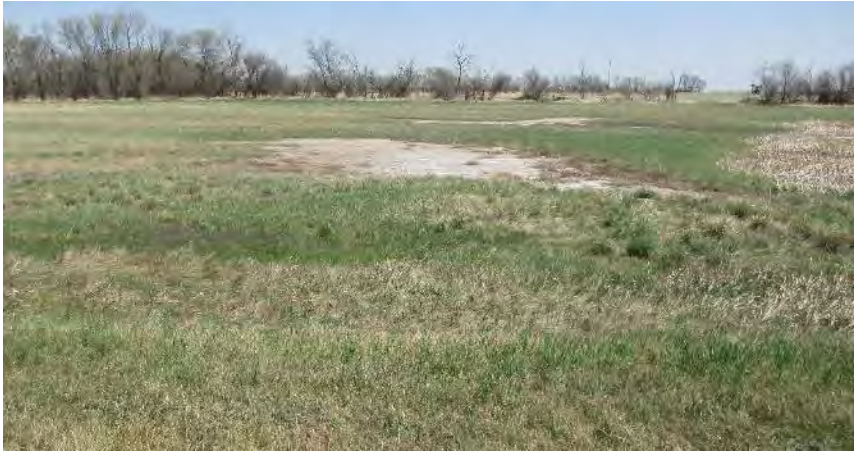
Photograph facing east off of an oilfield lease road showing visual impacts. Two areas were observed with barren ground, a lack of vegetation, and salt crusts.

B1-4 was inspected on May 15th, 2018, and is located approximately 50 feet east of an oilfield lease road. The site is currently native grassland, and is surrounded by grasslands. An oil & gas facility consisting of one pump jack was observed to the northwest of the site. Visual impacts were observed, including two areas of barren ground with little to no vegetation and salt crusting. The areas measured approximately 50 feet by 40 feet and approximately 40 feet by 40 feet. A wetland was observed to the south of the site. The site topography is generally flat and slopes to the southwest. Aboveground powerlines were observed to the west of the site.

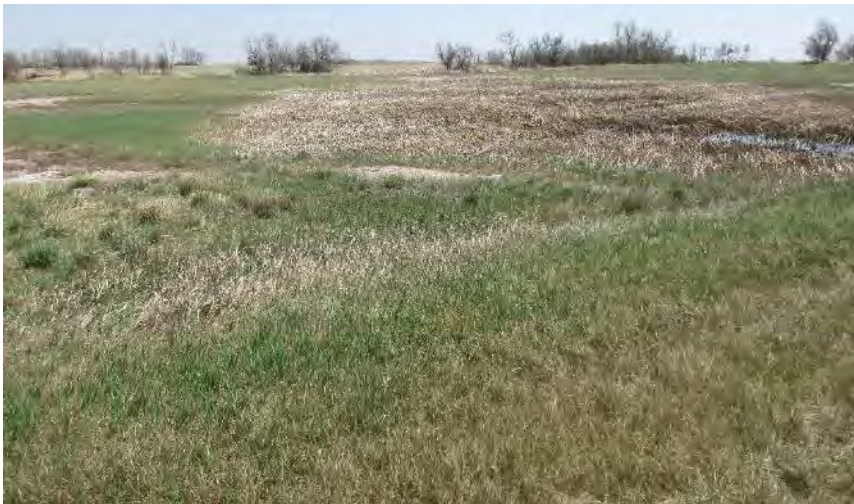
Photograph facing southeast off of an oilfield lease road showing one of the two visually impacted areas and a wetland to the south.

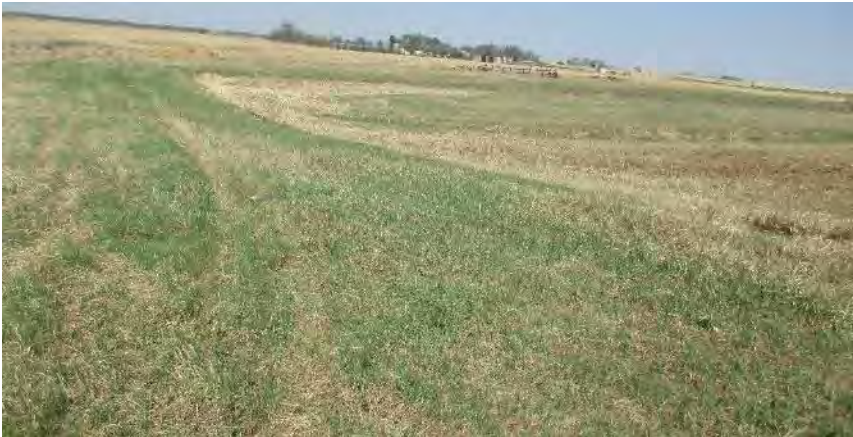
Photograph facing northwest off of 30th Ave NW showing a residential area approximately 1,000 feet northwest of the site.

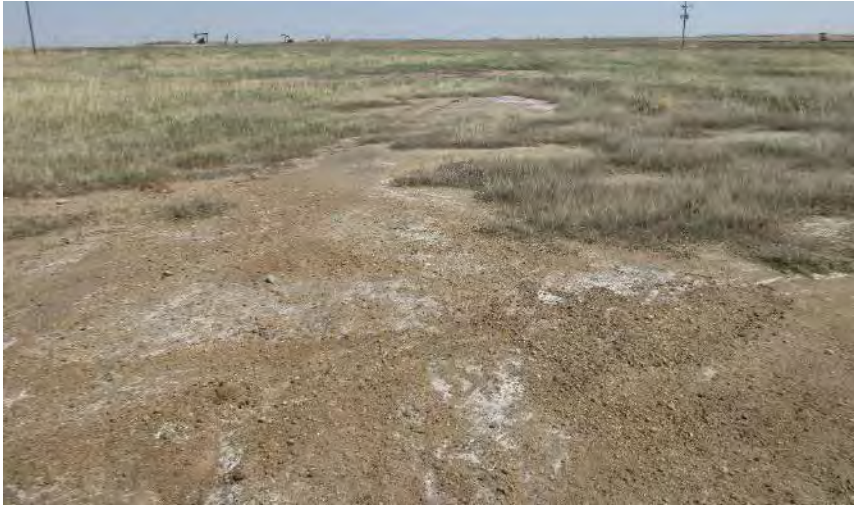
Photograph facing east off of an oilfield lease road showing a visually impacted area. Extensive dead zones with salt crusts were visible in an area approximately 80 feet by 30 feet. Aboveground powerlines were observed to the east.

B1-7 was inspected on May 15th, 2018, and is located approximately 150 feet south of 104th St NW and 50 feet east of an oilfield lease road. The site is currently native grassland. Native grasslands lie to the east and south, and agricultural fields lie to the north. An oil & gas facility consisting of 11 aboveground storage tanks, one pump jack, and three heater-treaters was observed to the west of the site. Visual impacts were observed, including an area of barren ground with stressed vegetation and salt crusting; the area of visual impacts measured approximately 80 feet by 30 feet. The site topography is generally flat and slopes to the southeast. Aboveground powerlines were observed to the east of the site, and underground oil & gas pipelines were observed to the north, just south of 104th St NW.

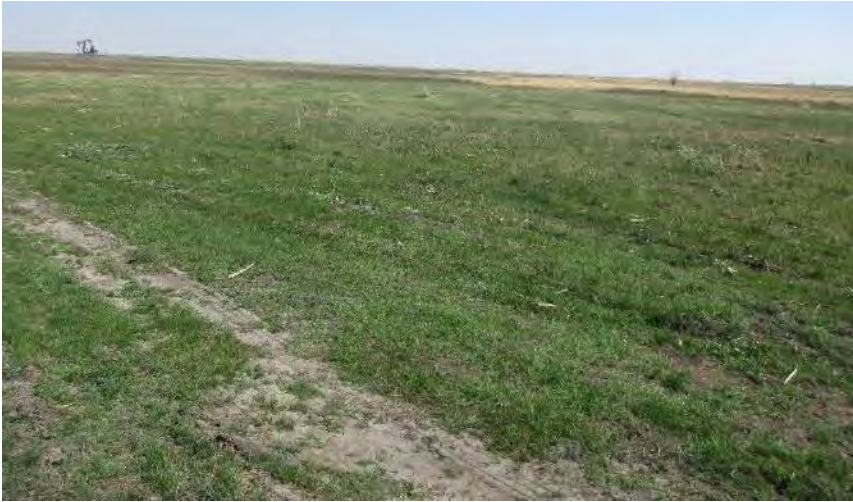
Photograph facing southeast off of an oilfield lease road showing no visual impacts. A pump jack is located approximately 1,000 feet east of site.

B1-10 was inspected on May 15th, 2018, and is located approximately 200 feet south of an oilfield lease road. The site is currently native grassland, and is surrounded by grasslands to the west, south, and east. Agricultural fields lie to the north. No visual impacts were observed at the time of the site visit. A wetland was observed to the south. The site topography is generally flat, and slopes to the north.

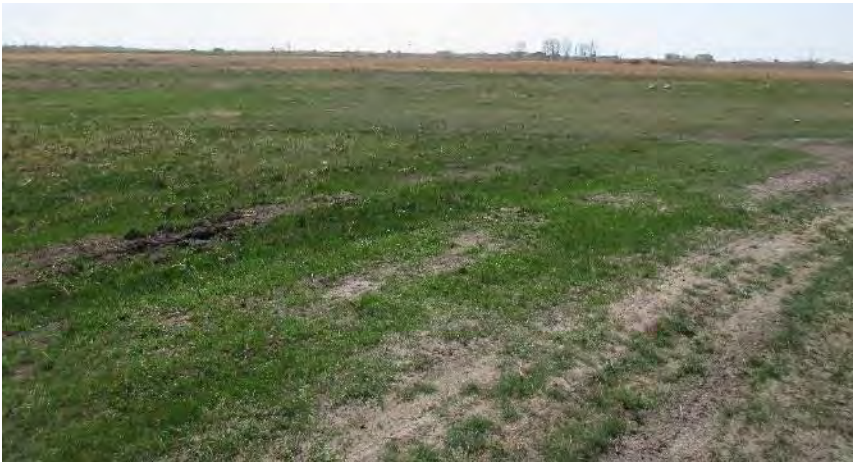
Photograph facing southwest off of oilfield lease road showing no visual impacts. A wetland is located approximately 100 feet south of the site.

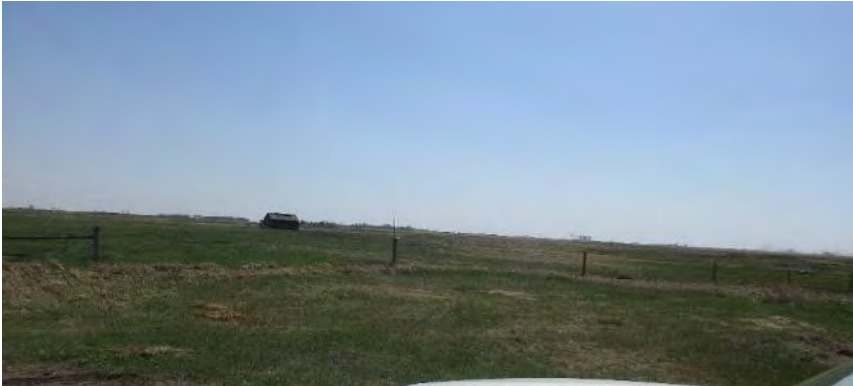
Photograph facing southwest off of 31st Ave NW. Site is in fenced off pasture land approximately 1,500 feet further southwest.

B1-13 was inspected on May 15th, 2018, and is located approximately 1,500 feet south of 31st Ave NW. The site could not be accessed at the time of the site visit. The site is currently native grassland, and is surrounded by grasslands. Visual impacts were not observed from a distance at the time of the site visit. The site topography appears to drain to the north.

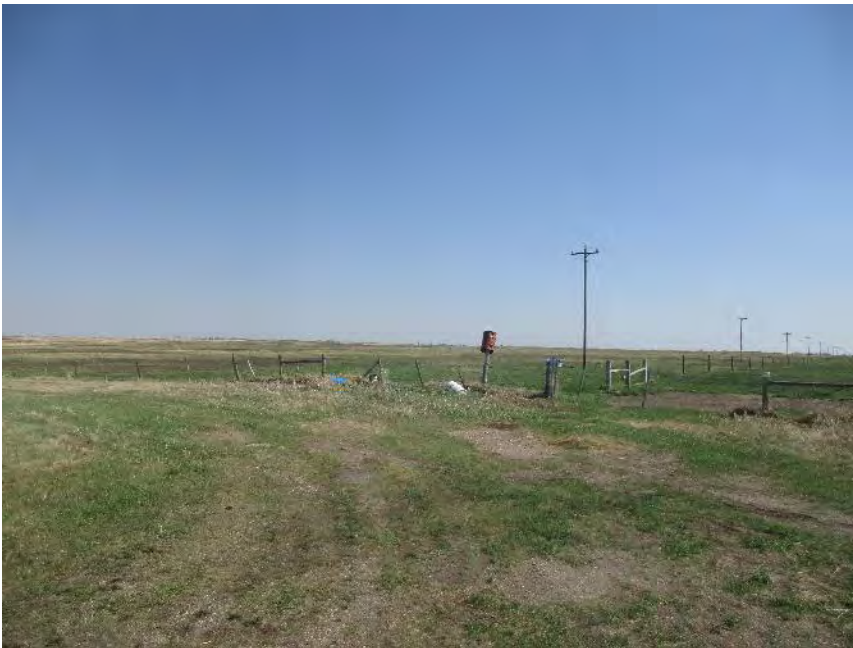
Photograph facing southwest off of 31st Ave. NW. The site is in fenced-off pasture land. Aboveground powerlines are located approximately 500 feet east of the site.

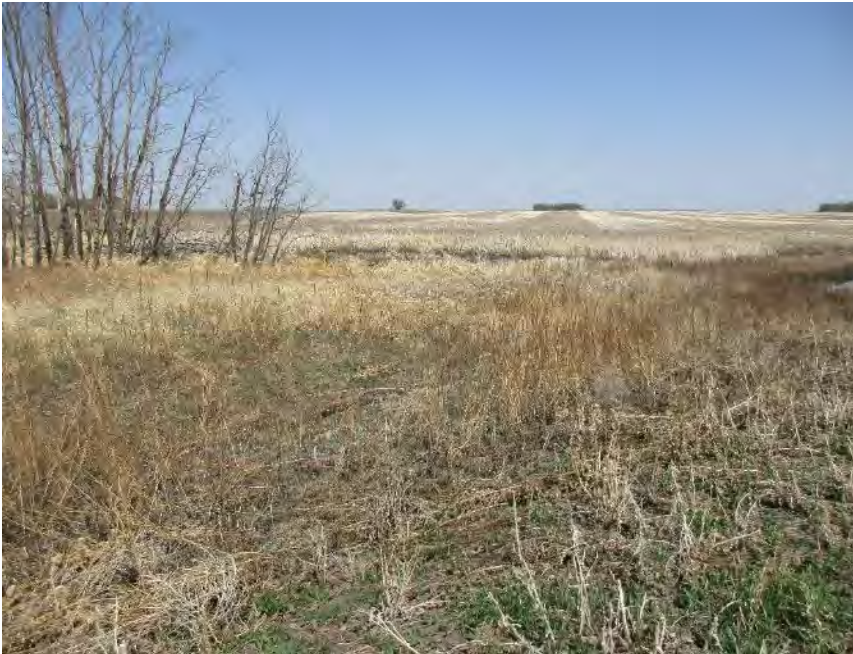
Photograph facing northwest of the wetland located to the southwest of the site. No visual impacts could be observed at the time of the visit due to access limitations.

B2-2 was inspected on May 16th, 2018, and is located approximately 500 feet northeast of 29th Ave NW. The site could not be accessed at the time of the site visit. The site is currently used for agricultural purposes, and is surrounded by agricultural fields. No visual impacts could be observed from a distance at the time of the site visit. A wetland was observed to the southwest of the site. The site topography is generally flat and slopes to the southwest.

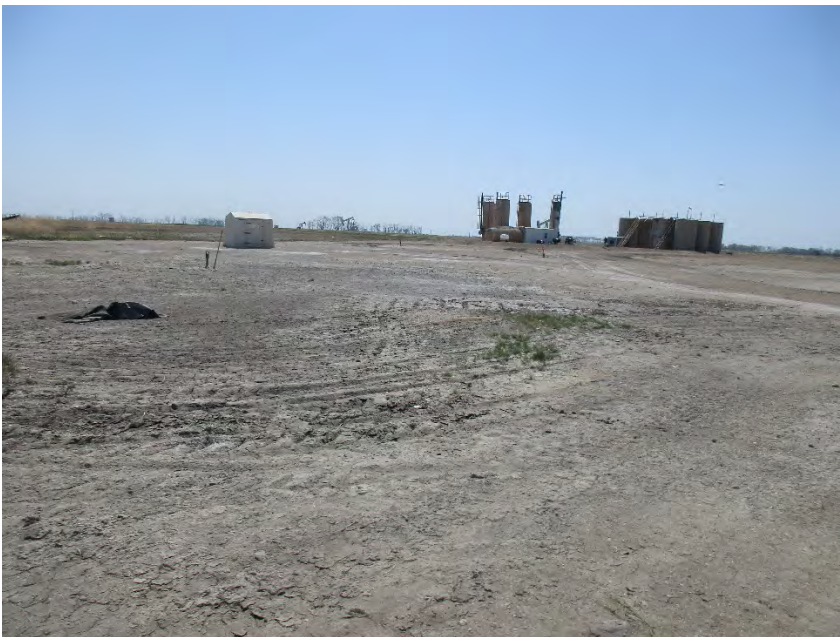
Photograph facing west from the east side of the site, showing site conditions.

B3-1 was inspected on May 16th, 2018, and is located at the center of an active oil & gas facility. The site is currently used as an oil & gas facility. The facility consists of 16 aboveground storage tanks, four heater-treaters, four shacks, and one horizontal separator. Visual impacts were observed, including an area of barren soils with little to no vegetation and salt residues; the area of visual impacts measured approximately 50 feet by 50 feet. The site topography is generally flat and slopes to the northeast. An aboveground powerline was observed on the oil pad facility, running east-west.

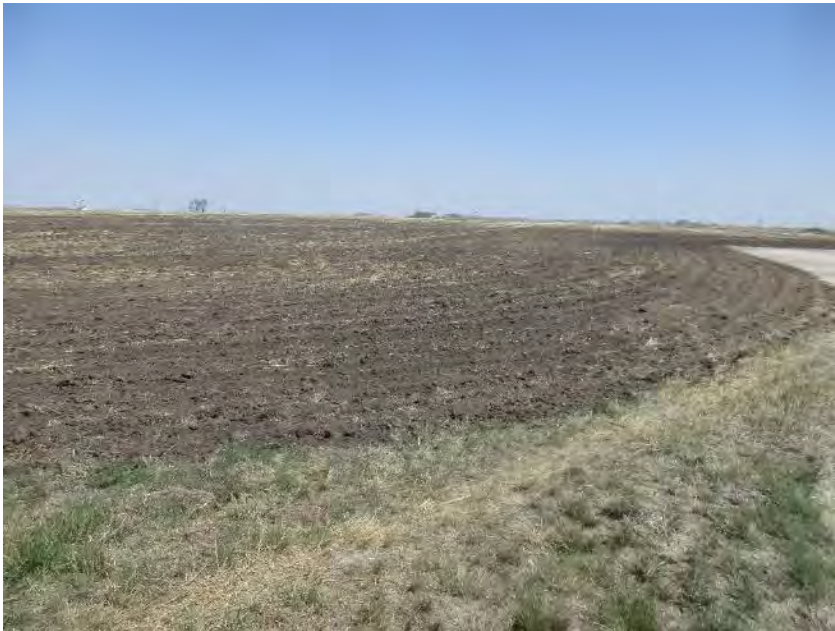
B3-3 (May 2018)

Photograph facing east off of 19th Ave NW. No visual impacts were observed at the time of the May 16, 2018 site visit.

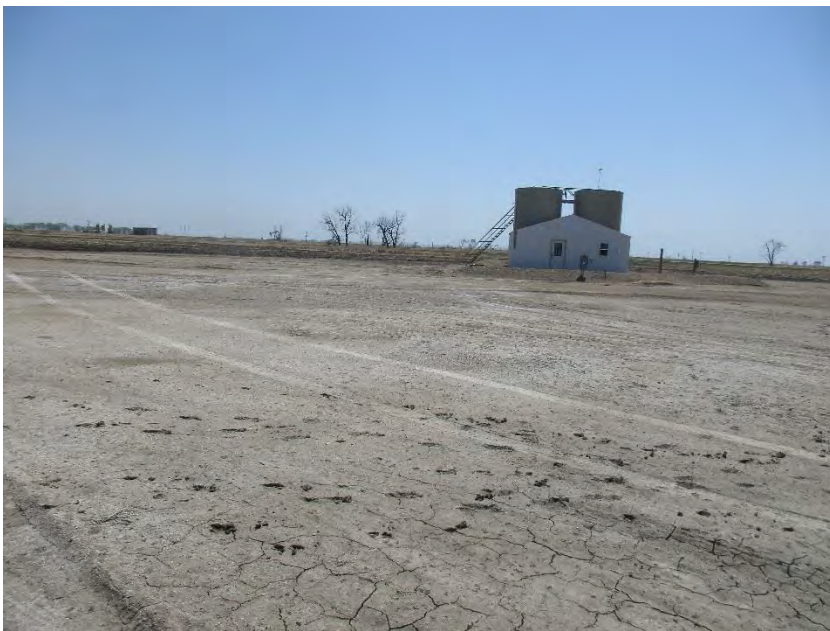
Photograph facing southwest looking onto the oil & gas facility. Soils shown in the foreground were part of the oil & gas pad, and not part of the site.

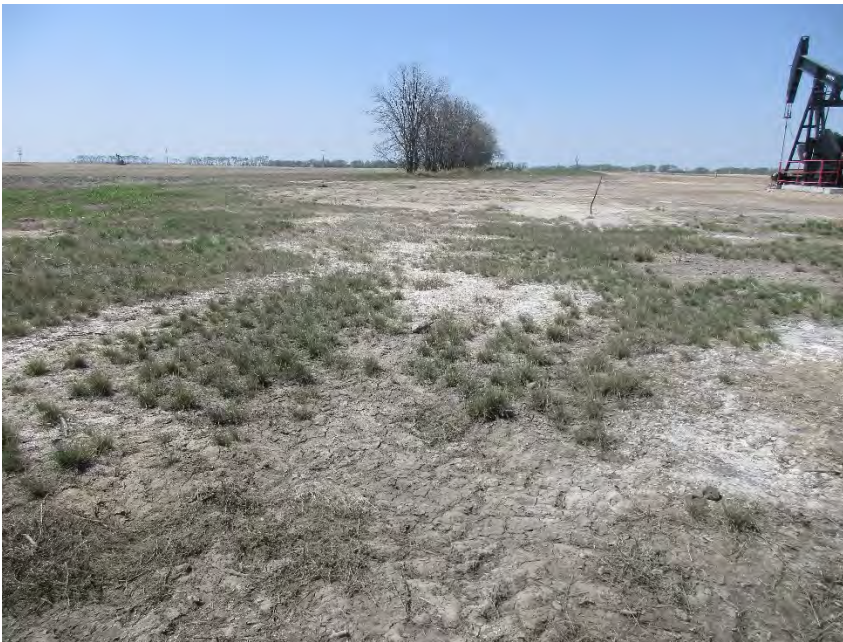
Photograph facing west from the eastern portion of the site. The oil & gas facility can be seen in the background of the photograph.

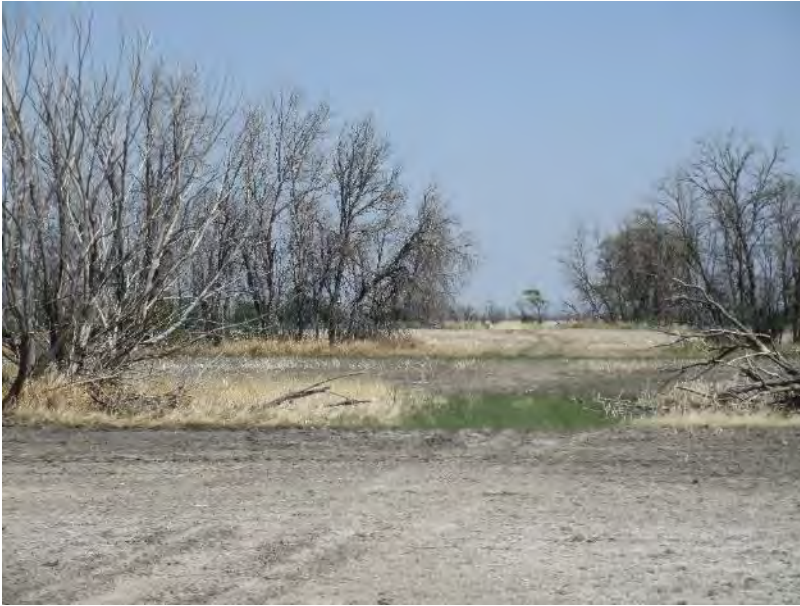
B4-2

Photograph facing east off of US Highway 83. The site is located approximately 1,500 feet farther east, on private property. No visual impacts could be observed due to access limitations.

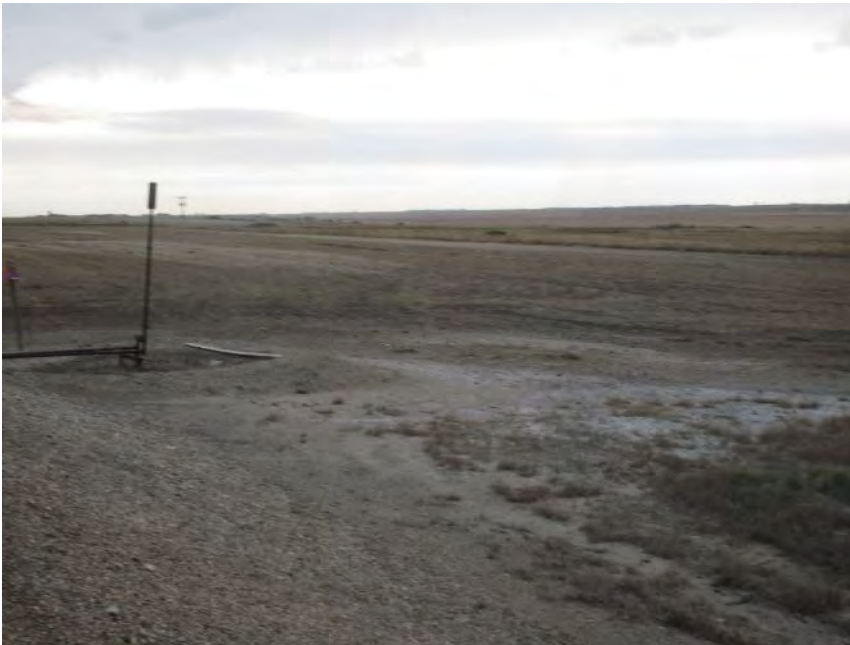
Photograph showing a closer view of the area of stressed vegetation and salt residues.

B4-5 was inspected on May 17th, 2018, and is located approximately 600 feet south of 108th St NW and just east of an oilfield lease road. The site is currently used for agricultural purposes. Agricultural land lies to the north and grasslands lie to the east and south. An oil & gas facility was observed to the west, consisting of five aboveground storage tanks, one heater treater, one flare pit, and one shack. Visual impacts were observed, including an area of stressed vegetation and salt residues; the area of visual impacts measured approximately 50 feet by 50 feet. The site topography is generally flat and slopes to the east/southeast.

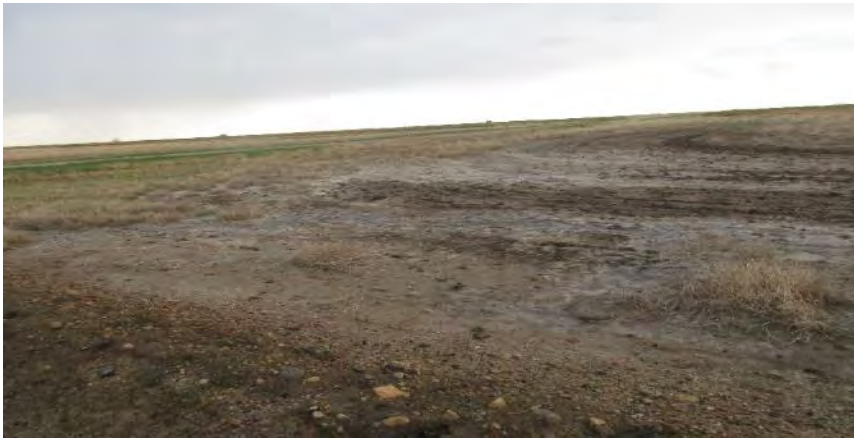
Photograph facing northwest off of an oil & gas facility showing the visually impacted area. Visual impacts follow the edge of the oil & gas facility.

B4-6 was inspected on May 17th, 2018, and is located approximately 250 feet south of 108th St NW and just east of an oilfield lease road. The site is currently used for agricultural purposes, and is surrounded by agricultural fields. An oil & gas facility was observed to the west, consisting of one shack. Visual impacts were observed along the eastern edge of the oil & gas facility, including an area of stressed vegetation and salt residues; the area of visual impacts measured approximately 200 feet by 20 feet. The site topography is generally flat and slopes to the southeast.

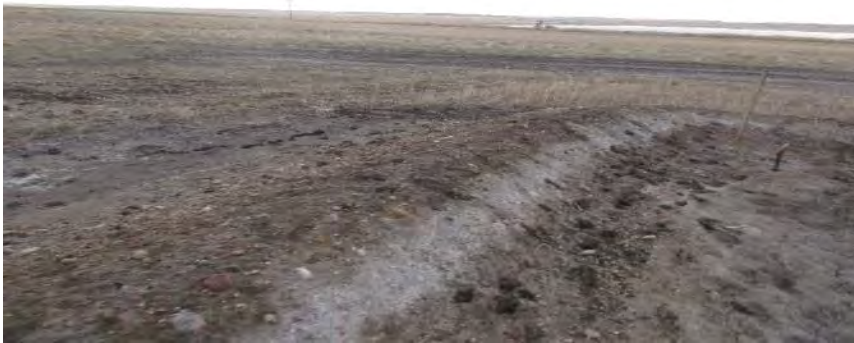
Photograph facing northeast off of the oil & gas facility showing the visually impacted area between the facility and an agricultural field. The Souris River can be seen in the background.

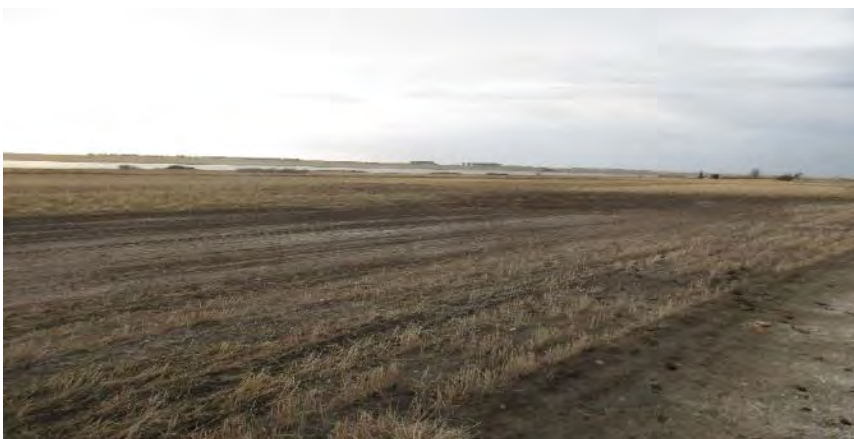
Photograph facing southeast off of the oil & gas facility showing the visually impacted area between the facility and an agricultural field. The Souris River can be seen in the background.

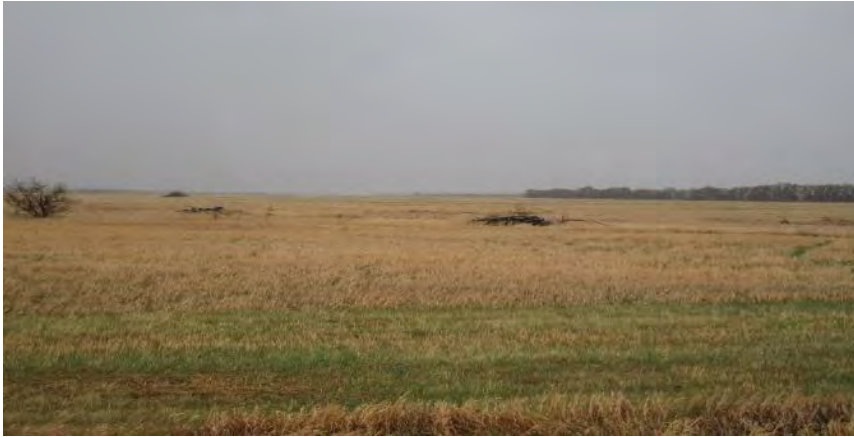
Photograph facing south off of 109th St NW showing the site. No visual impacts were observed at the time of the site visit.

B5-1 was inspected on May 17th, 2018, and is located approximately 400 feet south of 109th St NW. The site could not be accessed at the time of the site visit. The site is currently native grassland, and is surrounded by grasslands. Two small wetlands were observed at the site. Visual impacts were not observed from a distance at the time of the site visit. The site topography is generally flat and slopes to the northeast. An underground natural gas pipeline was observed to the north, running south of 109th St NW.

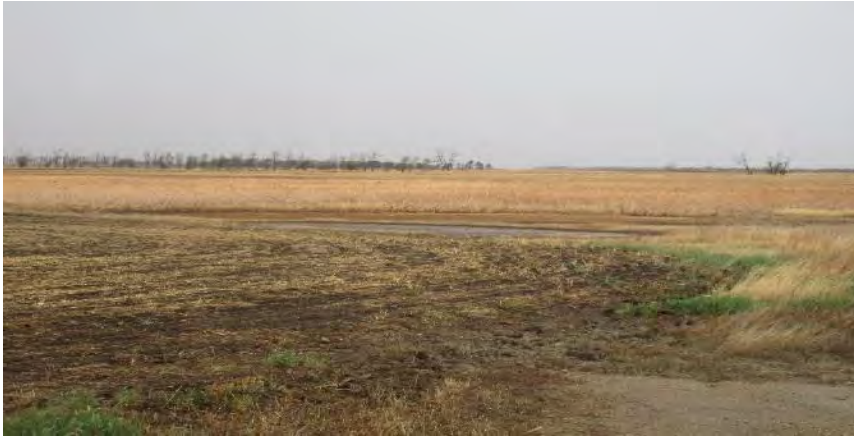
B5-2

Photograph facing southwest off of an oil & gas facility showing the visually impacted area lacking vegetation.

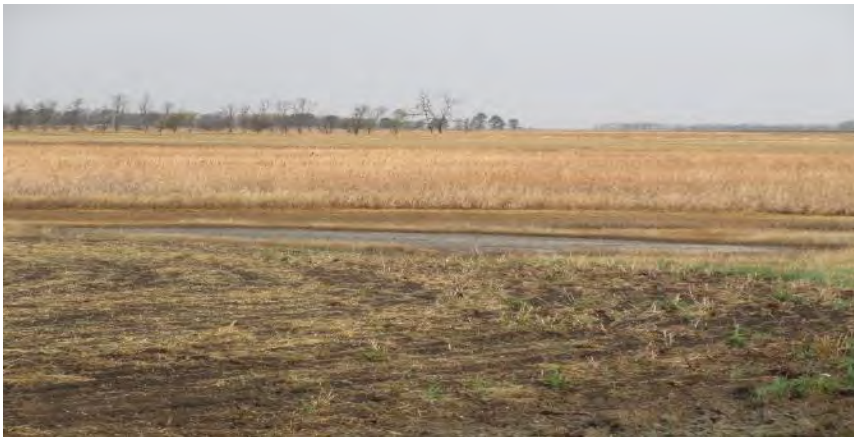
Photograph facing southwest off of an oil & gas facility showing the visually impacted area lacking vegetation. The visually impacted area is north of a wetland visible in the background.

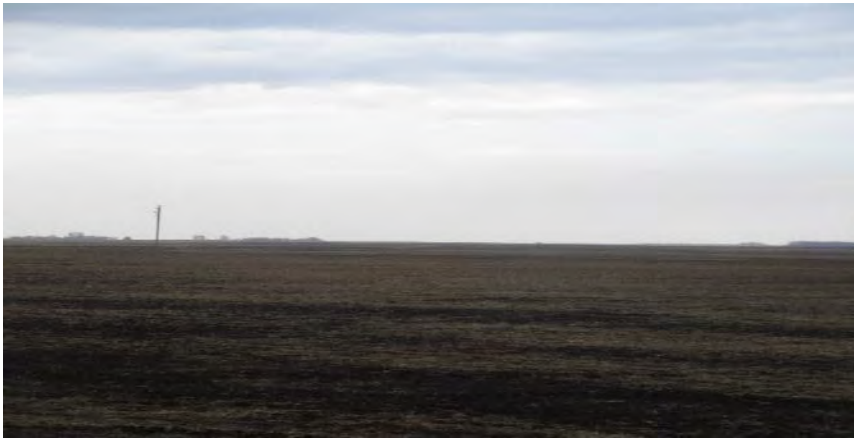
B6-1

Photograph facing northwest off of an oilfield lease road showing the site. No visual impacts could be observed due to access limitations.

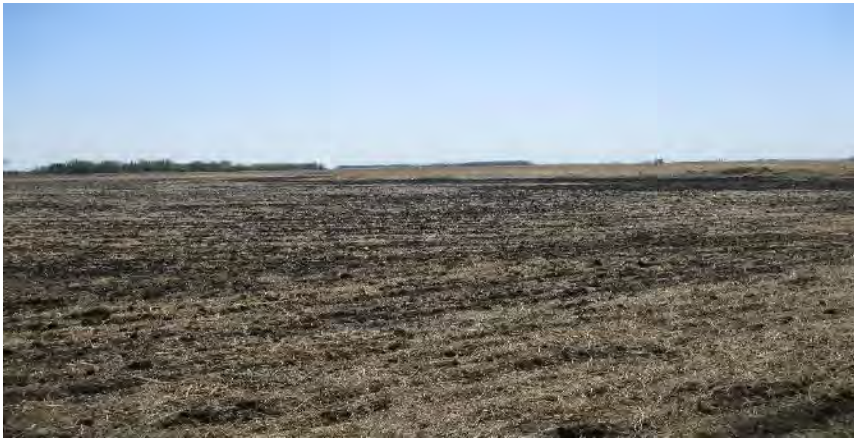
B6-4 (May 2018)

Photograph facing south off of an oilfield lease road showing the site. No visual impacts were observed at the time of the May 17, 2018 site visit.

B6-4 was inspected on May 17th, 2018 and is located approximately 1,800 feet west of 5th Ave NW and 200 feet south of an oilfield lease road. The site is currently used for agricultural purposes and is surrounded by agricultural fields. An oil & gas facility was observed to the northwest, consisting of one aboveground storage tank, one heater-treater, and one pump jack. A wetland was observed to the south, and a residential property was observed approximately 1,500 feet to the east. Visual impacts were not observed at the time of the site visit. The site topography is generally flat and slopes to the south. An aboveground powerline was observed to the north.

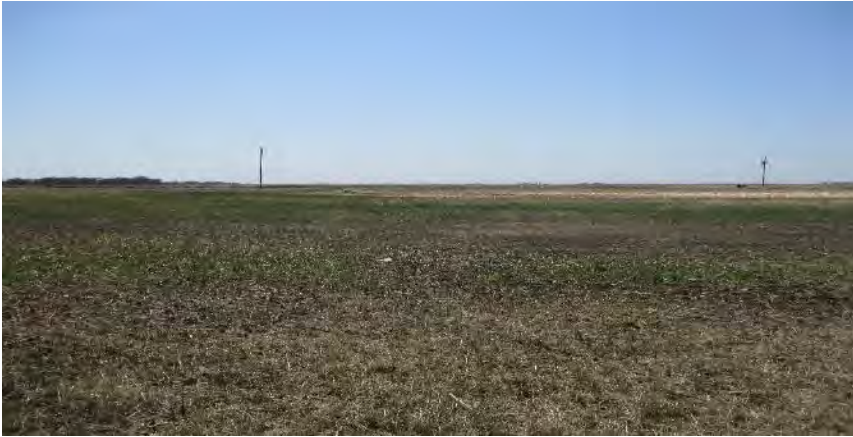
B6-5

Photograph facing south off of an oilfield lease road showing the site. A wetland and aboveground powerlines can be seen in the background.

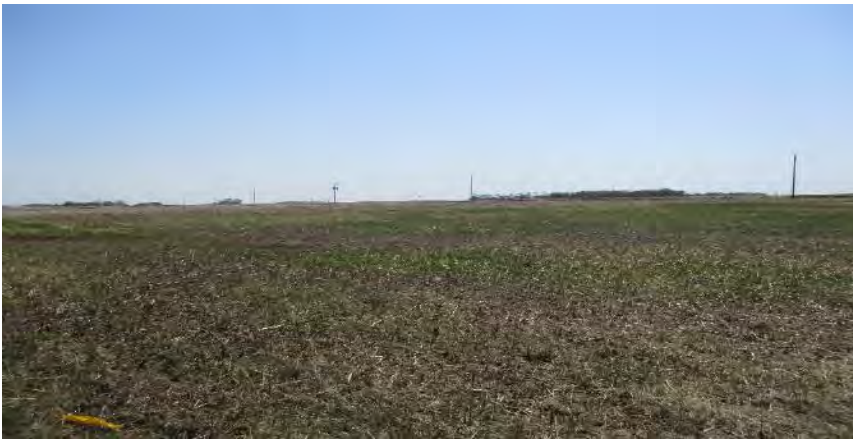
Photograph facing south off of an oilfield lease road showing the site. A small area of slightly stressed vegetation was observed at the time of the site visit.

B6-5 was inspected on May 17th, 2018 and is located approximately 300 feet north of 103rd St NW and 100 feet south of an oilfield lease road. The site is currently used for agricultural purposes, and is surrounded by agricultural fields. Oil & gas facilities were observed to the west and north, consisting of two aboveground storage tanks, one heater-treater, and one pump jack. A barn and grain silo were observed to the southwest. A wetland was observed to the south. Minimal visual impacts were observed, including an area of slightly stressed vegetation; the area of visual impacts measured measuring approximately 25 feet by 25 feet. The site topography is generally flat and slopes to the south towards the aforementioned wetland. An aboveground powerline was observed to the south of the site.

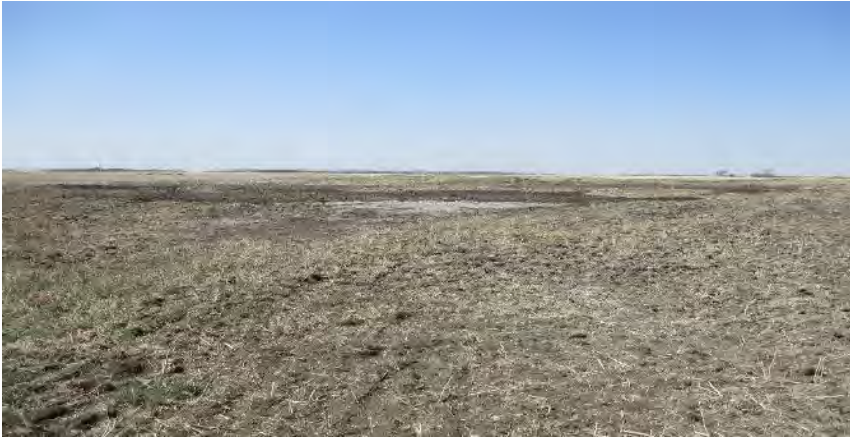
Photograph facing southwest off of 103rd St NW showing the visually impacted area lacking vegetation with salt crusting.

B6-6 was inspected on May 17th, 2018, and is located approximately 100 feet south of 103rd St. NW. The site is currently used for agricultural purposes, and is surrounded by agricultural fields. A wetland was observed to the west. Visual impacts were observed, including an area of barren soils, stressed vegetation, and salt residues; the area of visual impacts measured approximately 120 feet by 120 feet. The site topography is generally flat and slopes slightly to the north.

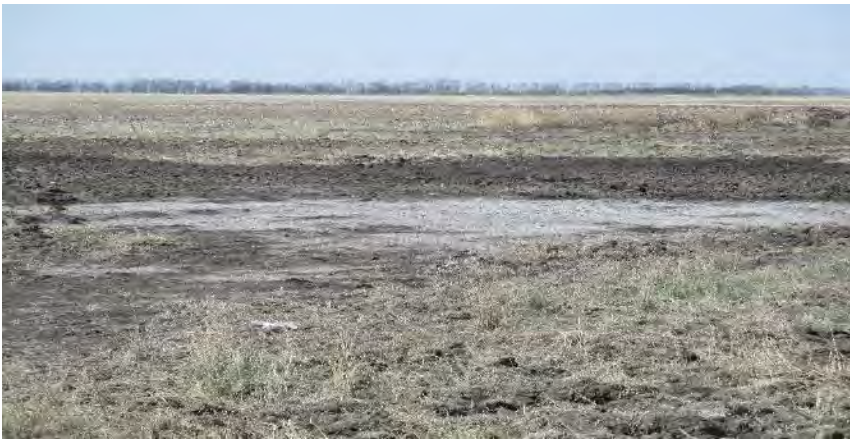
Photograph facing southwest showing a closer view of the visually impacted area.

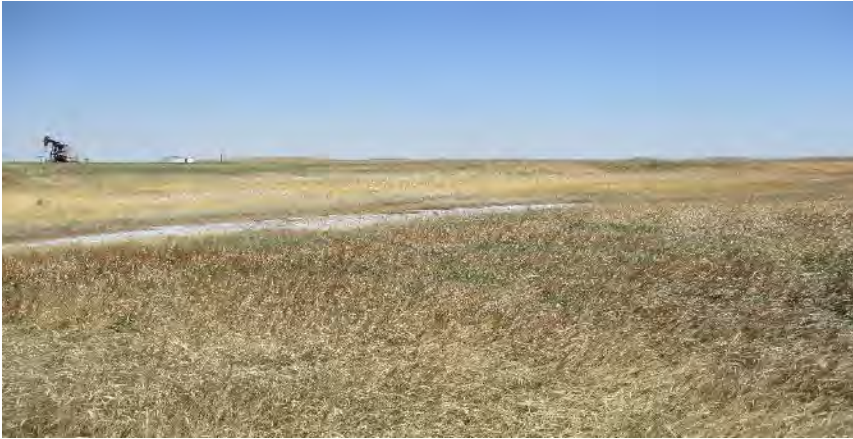
Photograph facing northeast off of an oilfield lease road showing the visually impacted area.

B7-3 was inspected on May 16th, 2018 and is located approximately 75 feet north of an oilfield lease road. The site is currently native grassland. Oil & gas facilities lie to the north, east, and south of the site. The facility to the north consists of three aboveground storage tanks and one pump jack. The facility to the east consists of two aboveground storage tanks. The facility to the south consists of five aboveground storage tanks and one heater treater. Wetlands were observed to the west, east, and south of the site. Visual impacts were observed, including a barren area with salt crusting; the area of visual impacts measured approximately 50 feet by 20 feet. The site is located in a low area, between the aforementioned wetlands. Aboveground powerlines were observed to the south of the site.

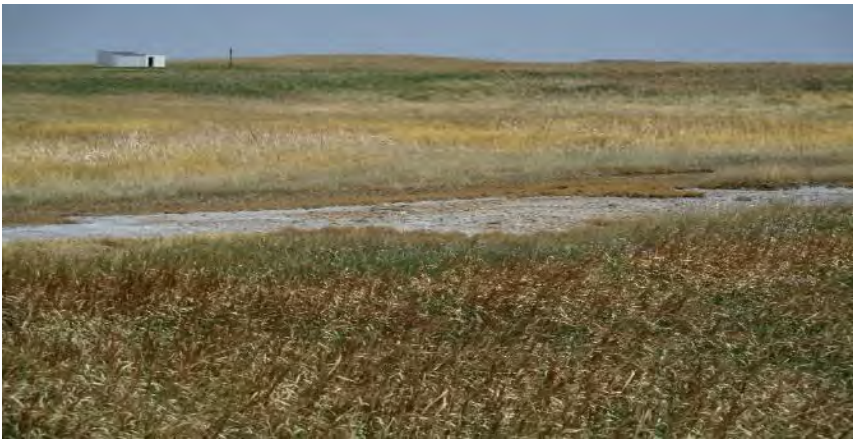
Photograph showing a closer view of the visually impacted area. A lack of vegetative growth and salt crusting can be seen. A wetland can be seen in the background.

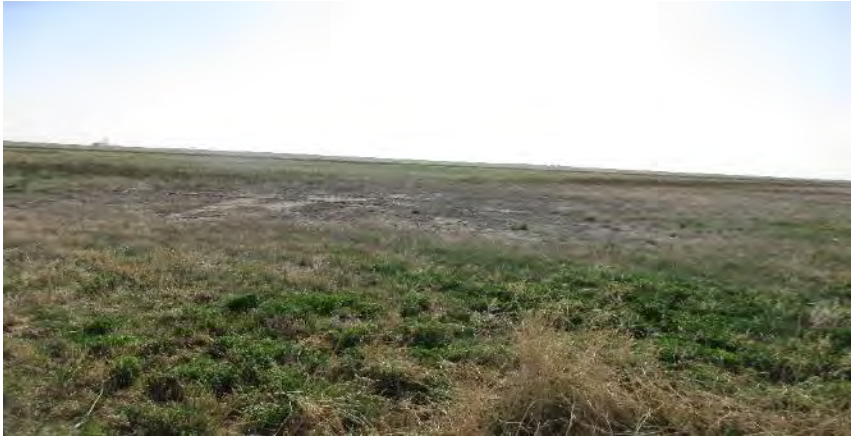
Photograph facing east off of an oilfield lease road showing the visually impacted area lacking vegetation. A wetland can be seen in the background.

B11-2 was inspected on May 16th, 2018 and is located approximately 800 feet south of 97th St NW and 50 feet east of an oilfield lease road. The site is currently native grassland, and is surrounded by agricultural fields. An oil & gas facility was observed to the west, consisting of one pump jack. A wetland was observed to the south of the site. Visual impacts were observed, including an area of barren soil, stressed vegetation, and salt crusting; the area of visual impacts measured approximately 70 feet by 50 feet. The site topography is generally flat and slopes to the southeast. An aboveground powerline was observed west of the site.

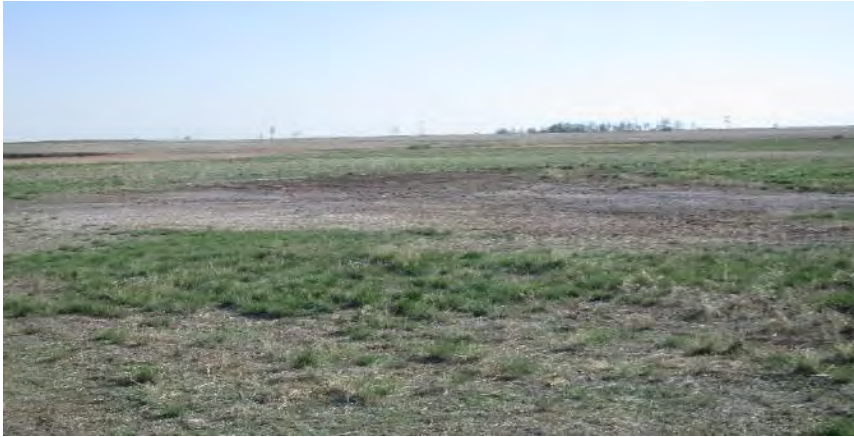
Photograph facing northeast off of an oilfield lease road showing the visually impacted area and the lack of vegetative growth. The impacted area is directly east of the oilfield lease road.

B11-3 was inspected on May 16th, 2018 and is located approximately 150 feet north of 96th St NW and just east of an oilfield lease road. The site is currently used for agricultural purposes and is surrounded by agricultural fields. An oil & gas facility lies immediately to the west, consisting of one pump jack. A wetland was observed to the northeast of the site. Visual impacts were observed, including an area of barren soil and salt crusting; the area of visual impacts measured approximately 350 feet by 100 feet. The site topography is generally flat and slopes to the southwest. An aboveground powerline was observed west of the site running east-west, and an underground oil & gas pipeline was observed west of the site running north-south.

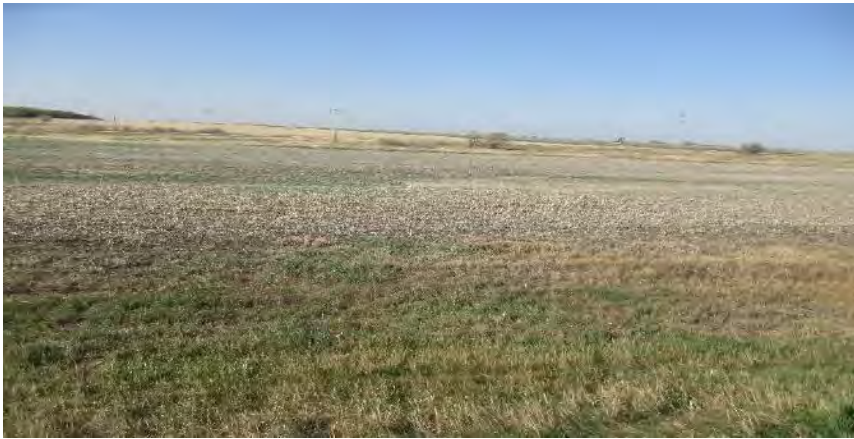
Photograph facing southwest off of an oilfield lease road showing the visually impacted area lacking vegetative growth.

B11-4 was inspected on May 16th, 2018, and is located approximately 250 feet north of 96th St NW and 50 feet south of an oilfield lease road. The site is currently used for agricultural purposes, and is surrounded by agricultural fields. An oil & gas facility lies to the east, consisting of eight aboveground storage tanks, one heater-treater, and one pump jack. A wetland was observed to the north of the site, and an intermittent stream was observed 200 feet south of the site. Visual impacts were observed, including an area of barren soil with stressed vegetation; the area of visual impacts measured approximately 40 feet by 15 feet. The site topography is generally flat and slopes to the west/southwest. An aboveground powerline was observed west of the site.

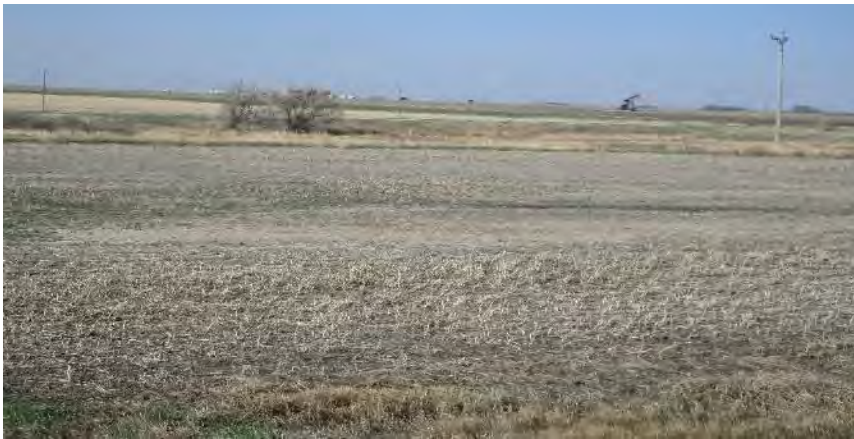
Photograph facing southwest showing a closer view of the visually impacted area located on agricultural land. Aboveground powerlines and an intermittent stream can be seen in the background.

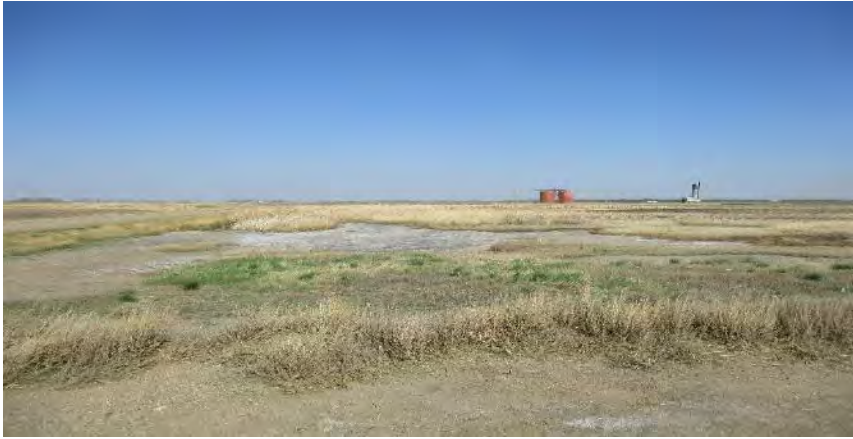
Photograph facing east off of an oil & gas facility showing the visually impacted area lacking vegetation and exhibiting salt crusting.

B13-1 was inspected on May 14th, 2018 and is located approximately 200 feet west of 23rd Ave NW and just south of an oilfield lease road. The site is currently for agricultural purposes and in part as an oil & gas facility. Oil & gas facilities were observed to the northwest and southeast of the site, including four aboveground storage tanks and two pump jacks. Agricultural fields surround the site otherwise. Visual impacts were observed, including a barren area devoid of vegetation and exhibiting salt crusting. The impacted area measured approximately 120 feet by 100 feet. A wetland was also observed adjacent to the east of the impacted area. The site topography is generally flat and drains to the northeast.

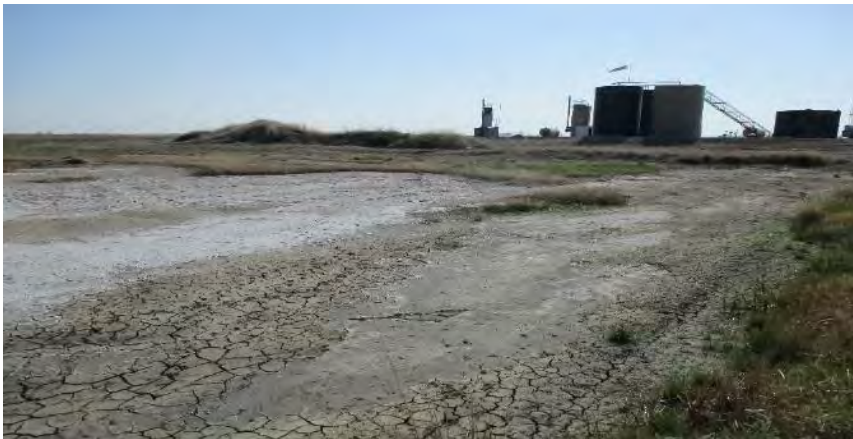
Photograph facing west/southwest off of an oilfield lease road showing the visually impacted area.

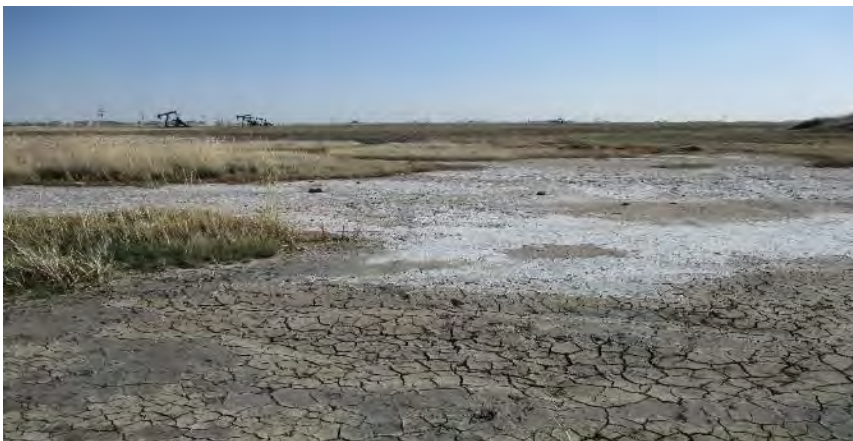
Photograph facing south off of an oilfield lease road showing visually impacted area. Soil cracking and salt crusting can be seen. A wetland is located adjacent to the site as can be seen in the background.

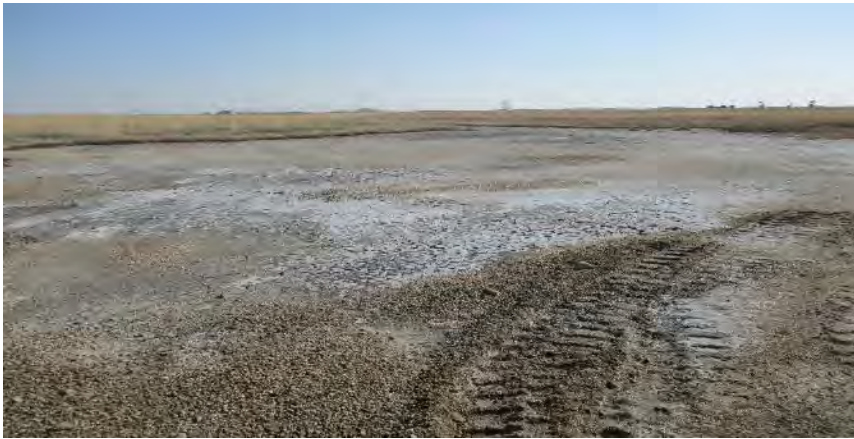
Photograph facing southwest off of an oil & gas facility showing the visually impacted area. Soil cracking and salt crusting were observed.

B13-2 was inspected on May 14th, 2018 and is located approximately 500 feet west of 23rd Ave NW and just east of an oilfield lease road. The site is currently used as an oil & gas facility, consisting of six aboveground storage tanks, one heater treater, and one horizontal vessel. Wetlands surround the site to the west, east, and south. Native grassland lies to the north. Extensive visual impacts were observed, including numerous barren areas devoid of vegetation and exhibiting salt crusting. Three major impacted areas were observed, which were located south and northwest of the oil & gas facility. The areas measured approximately 50 feet by 50 feet, 50 feet by 30 feet, and 50 feet by 50 feet. The site topography is generally flat and drains to the east.

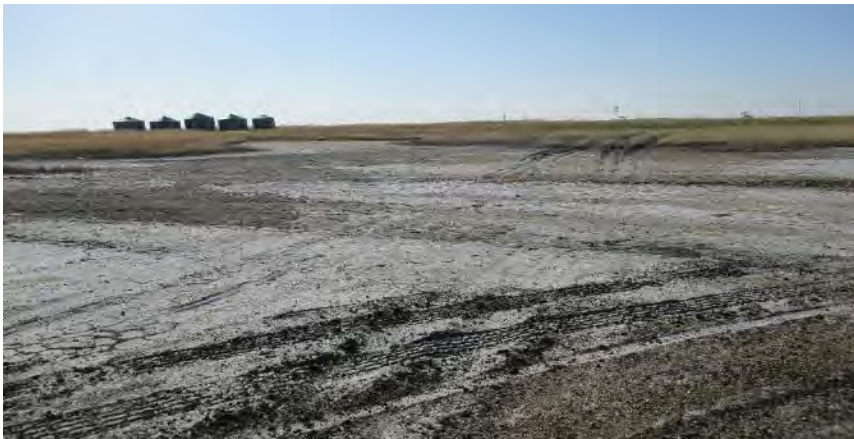
Photograph facing northwest off of an oil & gas facility showing the visually impacted area. Salt crusting and a lack of vegetative growth can be seen.

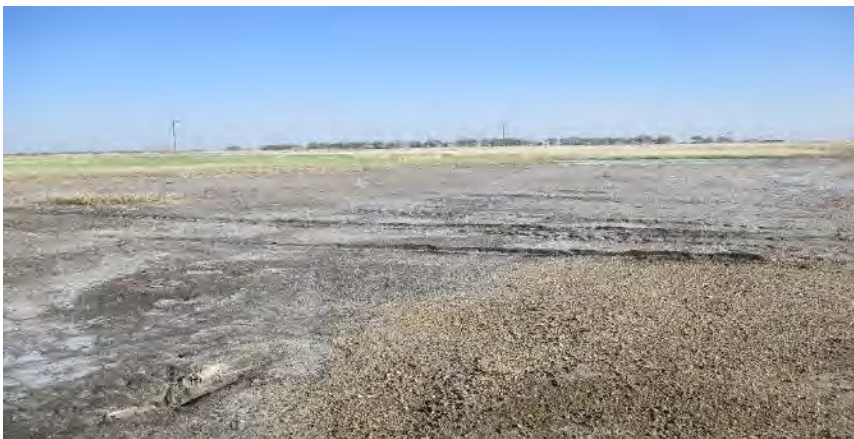
Photograph facing northeast off of an oil & gas facility showing the visually impacted area.

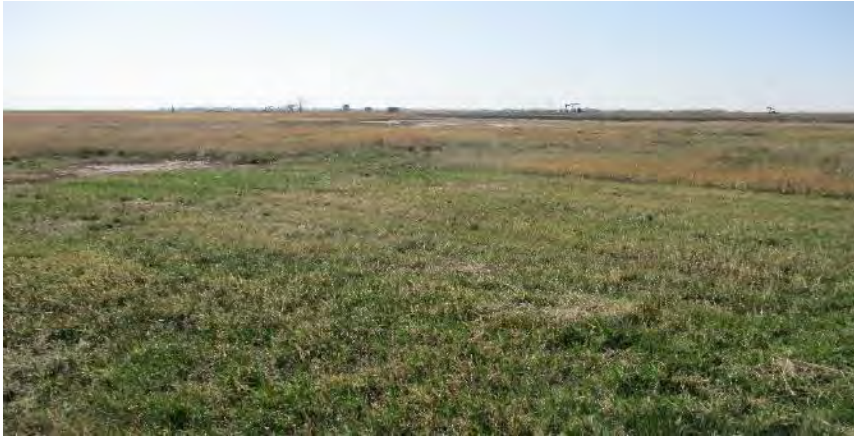
Photograph facing northeast off of an oil & gas facility showing the visually impacted area. A lack of vegetative growth can be seen.

B13-3 was inspected on May 14th, 2018 and is located approximately 500 feet north of 97th St NW and 200 feet northwest of an oilfield lease road. The site is currently grassland and also used in part for agricultural purposes. Agricultural fields lie to the north, and grasslands lie to the east and south. A wetland lies to the west. An oil & gas facility consisting of one pump jack lies to the southeast of the site. Visual impacts were observed, including a barren area devoid of vegetation and salt crusting; the area of visual impacts measured approximately 100 feet by 50 feet. Additional salt crusting was observed on the oil & gas pad to the southeast, where the pump jack is located. The site topography is generally flat and drains to the north.

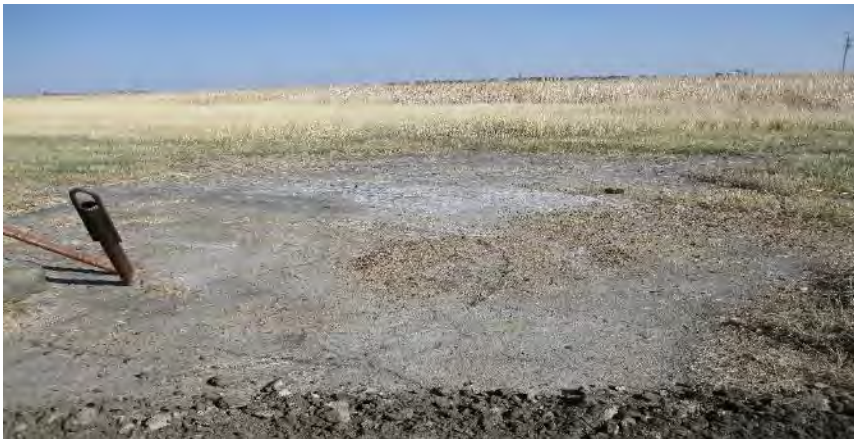
Photograph facing west off of an oil & gas facility showing additional salt crusting on an oil & gas well pad, where a pump jack was located.
