NDIC Brine Pond Study

Phase II: Site Assessments

June 25, 2018

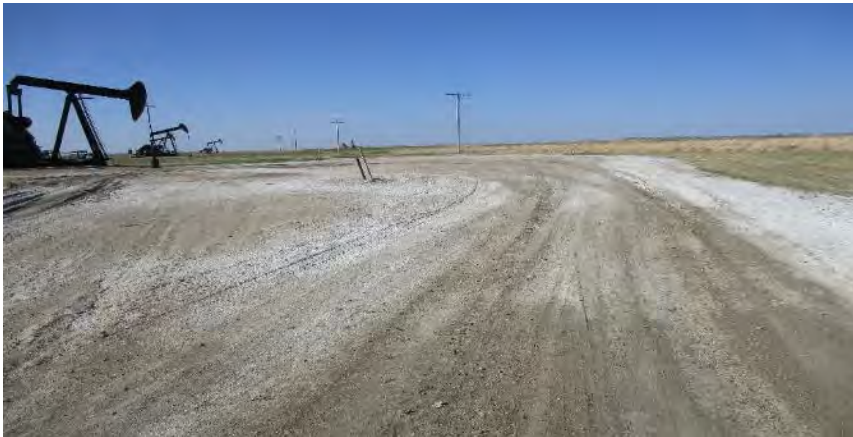
Photograph facing north off of an oil & gas well pad showing visually impacted area with salt crusting.

B13-4 was inspected on May 14th, 2018 and is located approximately 100 feet north of 97th St NW and 50 feet west of 23rd Ave NW, just south of an oilfield lease road. The site is currently used as an oil & gas facility, consisting of one pump jack. Grassland lies to the south of the site, and wetlands lie to the east and west. Another oil & gas facility consisting of one pump jack lies further north of the site. Visual impacts were observed, including salt crusting on the oil & gas pad where the pump jack is located. The impacted area measured approximately 100 feet by 50 feet. The site topography is generally flat and drains to the east. Aboveground powerlines were also observed to the south and east, running along 97th St NW and 23rd Ave NW, respectively.

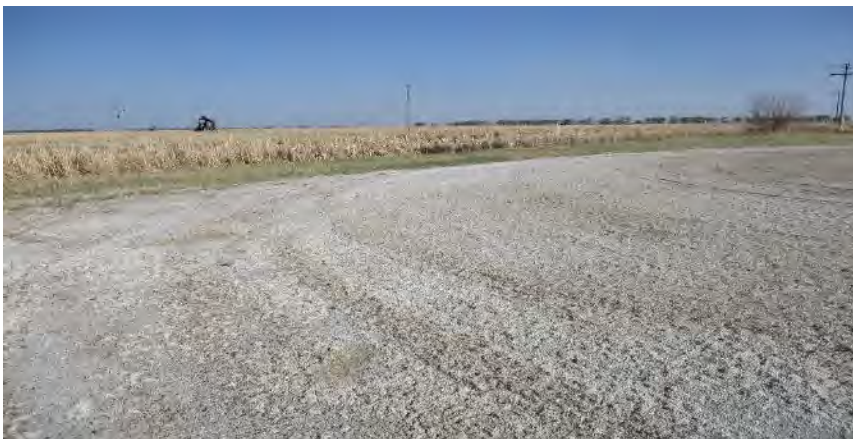
Photograph facing southeast off of an oil & gas well pad showing the visually impacted area with salt crusting. A wetland and aboveground powerlines can be seen in the background.

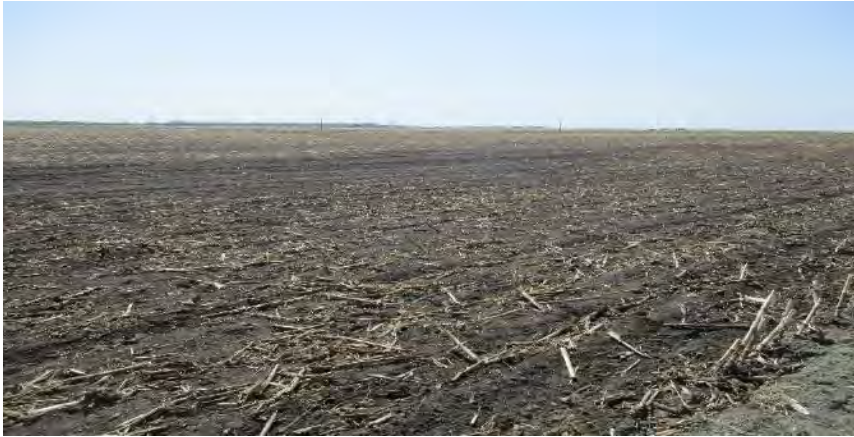
Photograph facing southeast off of an oilfield lease road showing the visually impacted area. Slightly stressed vegetation can be seen.

B14-1 was inspected on May 16th, 2018 and is located approximately 500 feet north of 101st St NW and 100 feet east of an oilfield lease road. The site is currently used for agricultural purposes and is surrounded by agricultural fields. An oil & gas facility was observed to the west, consisting of two aboveground storage tanks, one heater treater, and one pump jack. Visual impacts were observed, including an area of slightly stressed vegetation; the area of visual impacts measured approximately 100 feet by 20 feet. The site topography is generally flat and slopes to the east. A burning smell from an unknown source was encountered during the site visit.

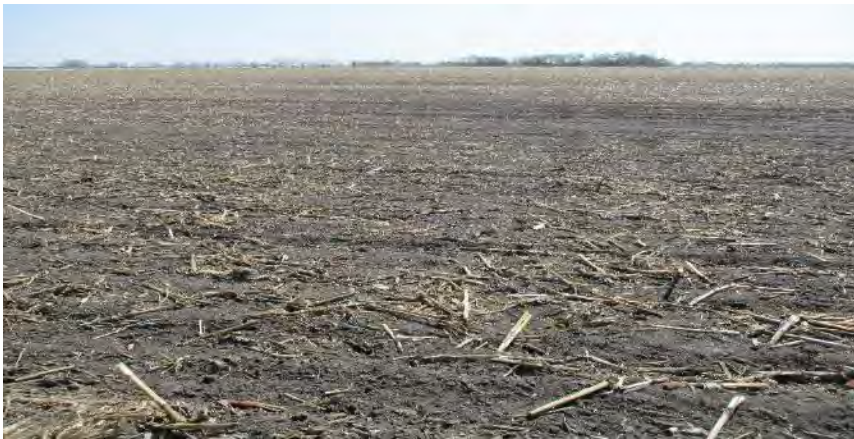
Photograph facing east off of an oilfield lease road showing the northern portion of the visually impacted area.

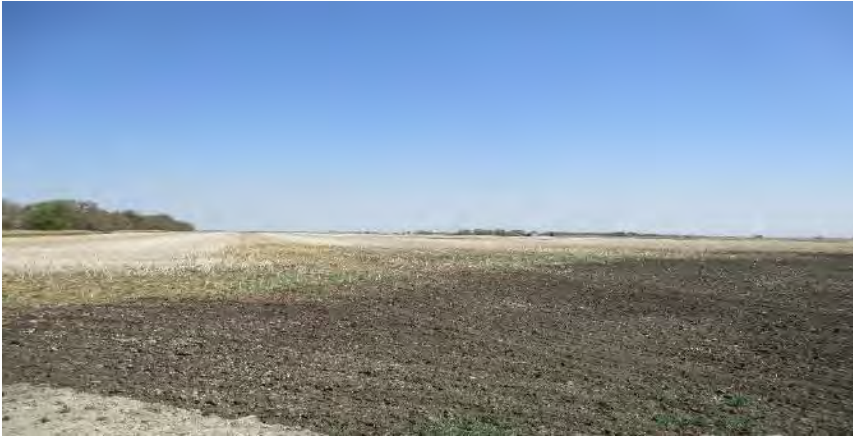
Photograph facing north/northeast off of an oilfield lease road showing the recently reclaimed site. No visual impacts were observed during the time of the site inspection due to recent site reclamation.

B14-2 was inspected on May 16th, 2018, and is located approximately 500 feet northeast of an oilfield lease road. The site appears to be recently reclaimed, and is currently used for agricultural purposes. The site is surrounded by agricultural fields. No visual impacts were observed during the site visit, as the area appears to be recently reclaimed. The site topography is generally flat and slopes to the southwest.

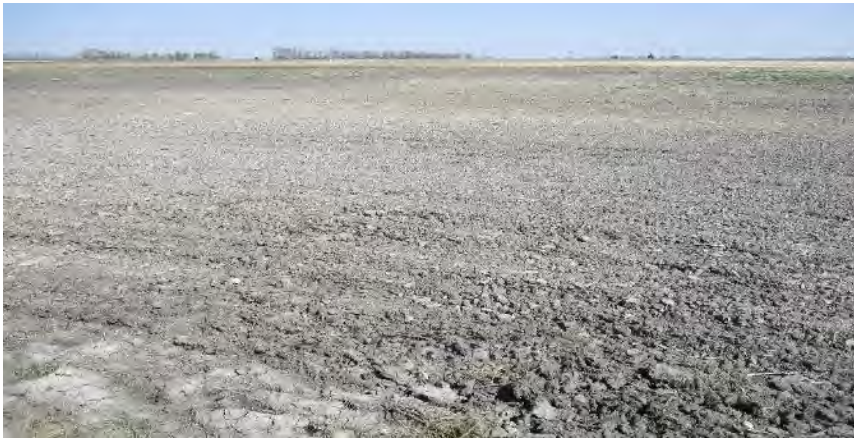
Photograph facing north off of an oil & gas facility showing the extents of the visually impacted area with stressed vegetative growth.

B14-3 was inspected on May 16th, 2018 and is located approximately 600 feet east of 15th Ave SE and 100 feet north of an oilfield lease road. The site is currently used for agricultural purposes and is surrounded by agricultural fields. An oil & gas facility was observed to the south, consisting of five aboveground storage tanks, one heater treater, and one pump jack. A wetland with standing water was observed south of the oil & gas facility. Visual impacts were observed, including stressed vegetation; the area of visual impacts measured approximately 120 feet by 30 feet. A small depressed area with stressed vegetation was also observed to the northwest, which measured approximately 50 feet by 50 feet. The site topography is generally flat and slopes to the south/southwest.

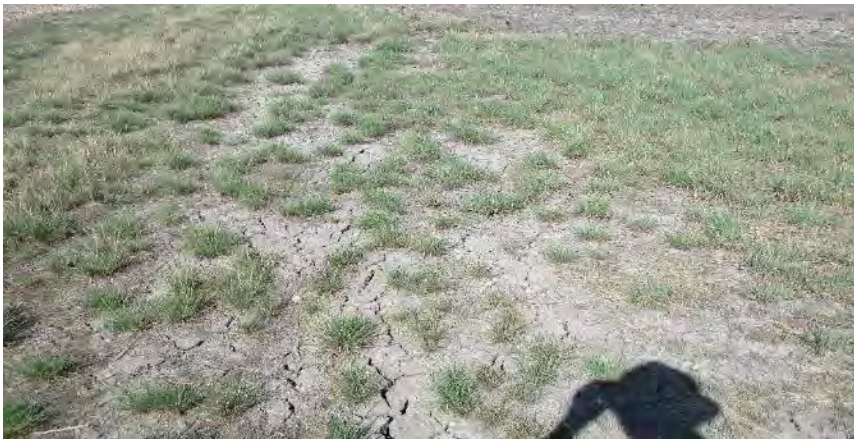
Photograph showing a closer view of stressed vegetation and soil cracking present at the site.

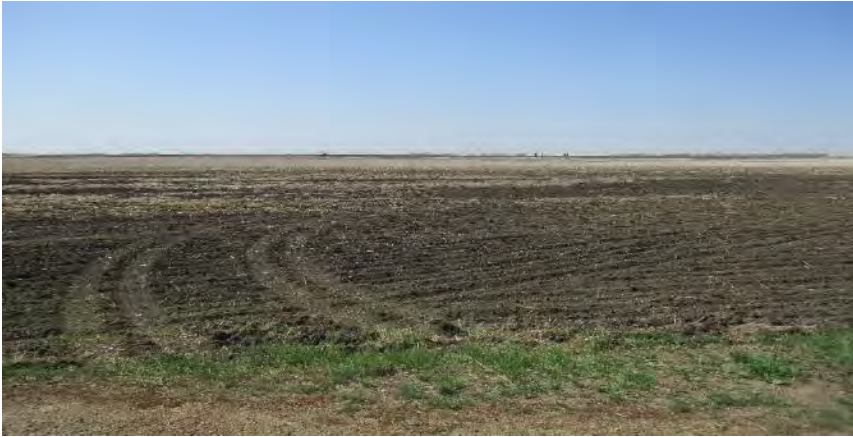
Photograph facing south off of an oilfield lease road showing a slightly impacted area.

B14-4 was inspected on May 16th, 2018 and is located approximately 2,000 feet east of 15th Ave SE and 50 feet south of an oilfield lease road. The site is currently used for agricultural purposes and is surrounded by agricultural fields. An oil & gas facility was observed to the north, consisting of three aboveground storage tanks and one horizontal vessel. Visual impacts were observed, including slightly stressed vegetation; the area of visual impacts measured approximately 20 feet by 15 feet. The site topography is generally flat and slopes to the north/northeast.

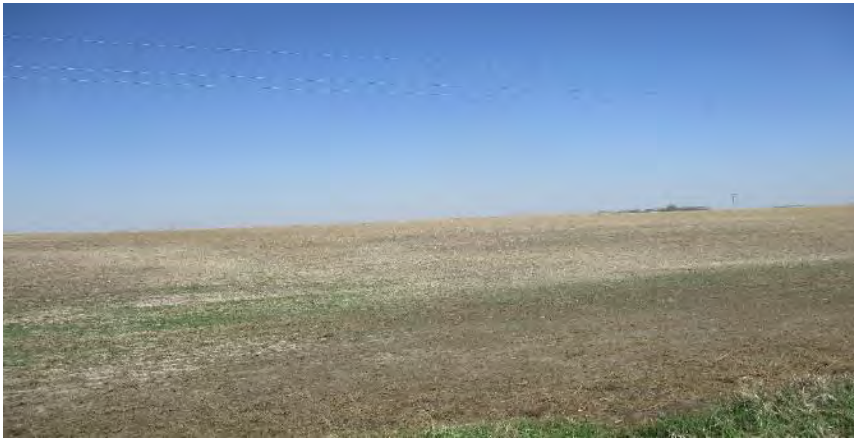
Photograph facing west off of 15th Ave SE showing the visually impacted area with stressed vegetation.

B14-5 was inspected on May 16th, 2018, and is located approximately 50 feet west of 15th Ave SE. The site is currently used for agricultural purposes and is surrounded by agricultural fields. A wetland was observed to the east of the site, past 15th Ave SE. Visual impacts were observed, including lighter colored soils and stressed vegetation; the area of visual impacts measured approximately 50 feet by 25 feet. The site topography is generally flat and slopes to the north/northeast. Aboveground powerlines were observed to the east of the site, along 15th Ave SE.

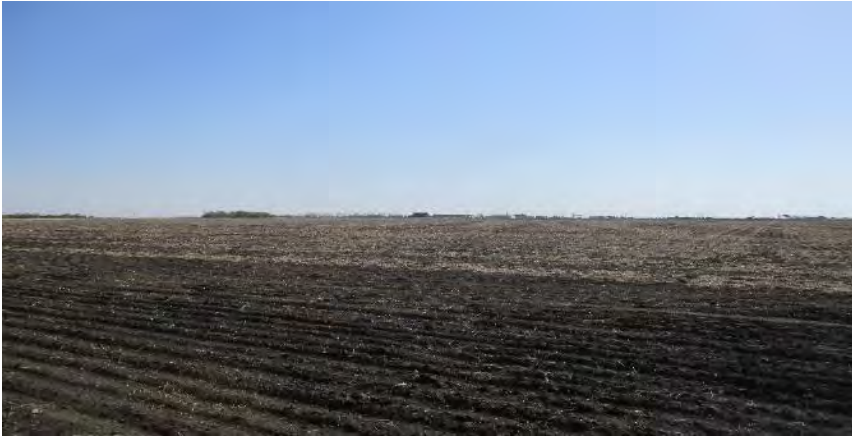
B14-6 (May 2018)

Photograph facing east off of an oil & gas facility showing the site. No visual impacts were observed at the time of the May 16, 2018 site inspection as the site had been recently disturbed for agricultural purposes.

B14-6 was inspected on May 16th, 2018 and is located approximately 500 feet north of 99th St NW and 50 feet east of oilfield lease road. The site is an agricultural field that was recently plowed and is surrounded by agricultural fields. An oil & gas facility was observed to the east, consisting of two aboveground storage tanks, a heater treater, and a pump jack. No visual impacts were observed at the time of site visit as the field had been recently disturbed. The site topography is generally flat and slopes to the northeast. Aboveground powerlines were observed to the east of the oil & gas facility.

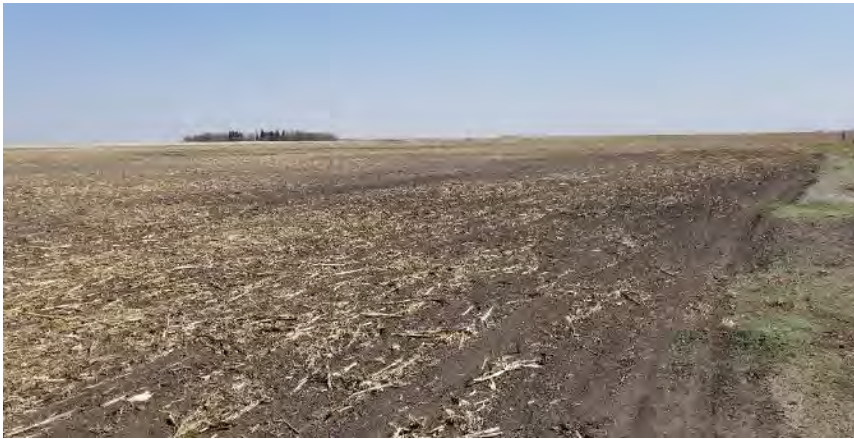
Photograph facing southeast off of an oilfield lease road showing the visually impacted area slightly lacking vegetative growth.

B14-7 was inspected on May 15th, 2018, and is located approximately 500 feet west of 12th Ave NW and 100 feet east of an oilfield lease road. The site is currently used for agricultural purposes, and is surrounded by agricultural fields. An oil & gas facility was observed to the west, consisting of three aboveground storage tanks and one pump jack. Visual impacts were observed, including an area with slightly stressed vegetation; the area of visual impacts measured approximately 300 feet by 50 feet. The site topography is generally flat and slopes to the west.

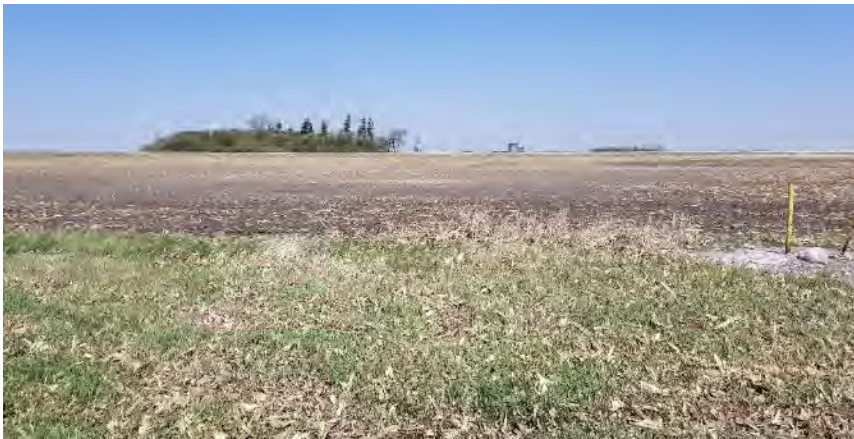
Photograph facing east off of an oilfield lease road showing the visually impacted area slightly lacking vegetative growth.

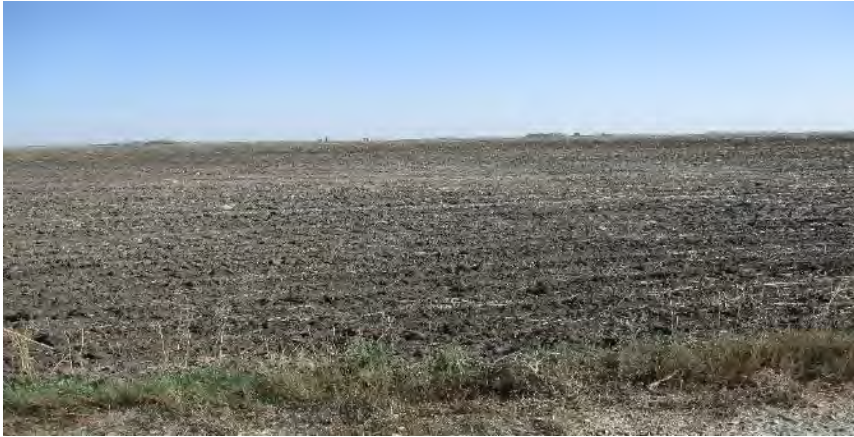
Photograph facing north off of an oilfield lease road showing the visually impacted area with some barren soils and slightly stressed vegetation.

B14-8 was inspected on May 16th, 2018 and is located approximately 600 feet north of 98th St NW and just north of an oilfield lease road. The site is currently used for agricultural purposes and is surrounded by agricultural fields. An oil & gas facility was observed to the north, consisting of two aboveground storage tanks, one heater treater, and one pump jack. Visual impacts were observed, including an area of slightly barren ground with slightly stressed vegetation; the area of visual impacts measured approximately 50 feet by 20 feet. The site topography is generally flat and slopes to the southwest. Aboveground power lines and an underground oil & gas pipeline were observed to the north of the site, along 98th St NW.

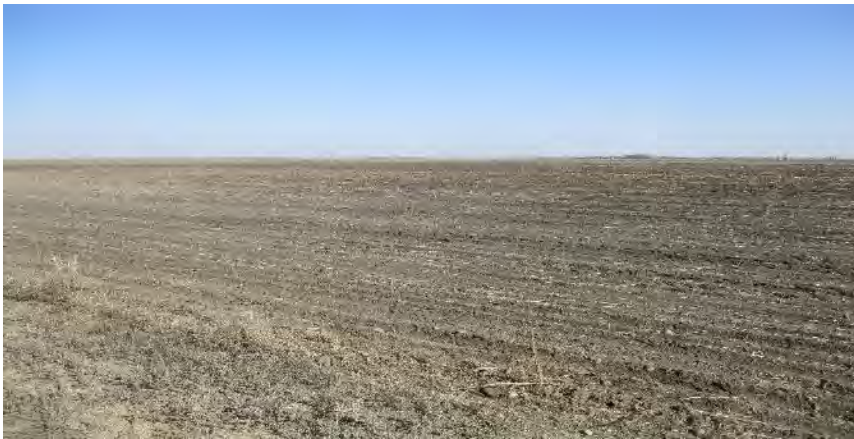
Photograph facing north west off of an oilfield lease road showing the visually impacted area.

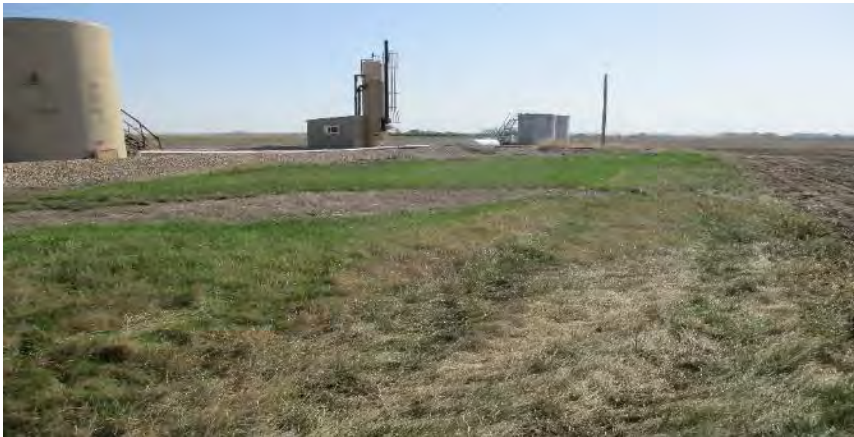
Photograph facing west off of an oil & gas facility showing the visually impacted area with little vegetative growth.

B14-9 was inspected on May 16th, 2018 and is located approximately 700 feet south of 99th St NW and just south of an oilfield lease road. The site is an agricultural field that was recently plowed and is surrounded by agricultural fields. An oil & gas facility was observed to the north, consisting of three aboveground storage tanks, one heater treater, and one pump jack. Visual impacts were observed, including an area of slightly barren ground with stressed vegetation; the area of visual impacts measured approximately 25 feet by 10 feet. The impacts appeared to be migrating from the oil & gas pad from the north. Stressed vegetation was also observed in the plowed agricultural field but appeared to be a result of the ground disturbance. The site topography is generally flat and slopes to the south/southeast. Aboveground powerlines were observed to the north of the site, on the oil & gas pad, running to the south across the site.

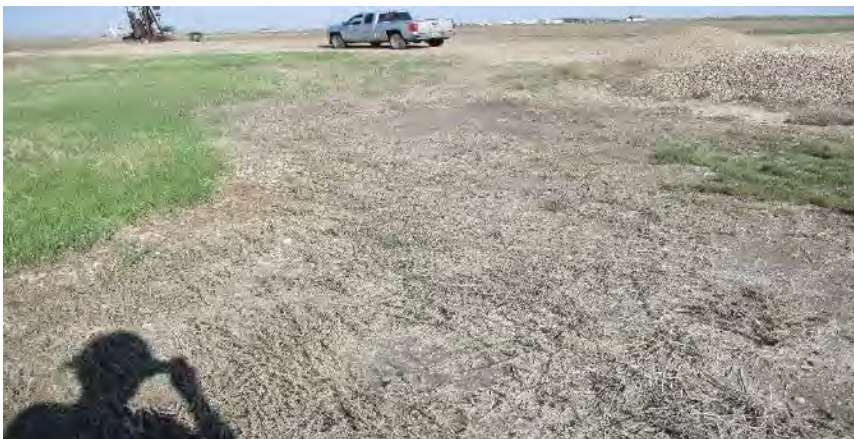
Photograph facing northwest showing the visually impacted area with stressed vegetation. The impacts appeared to be migrating from the oil & gas facility that lies to the north.

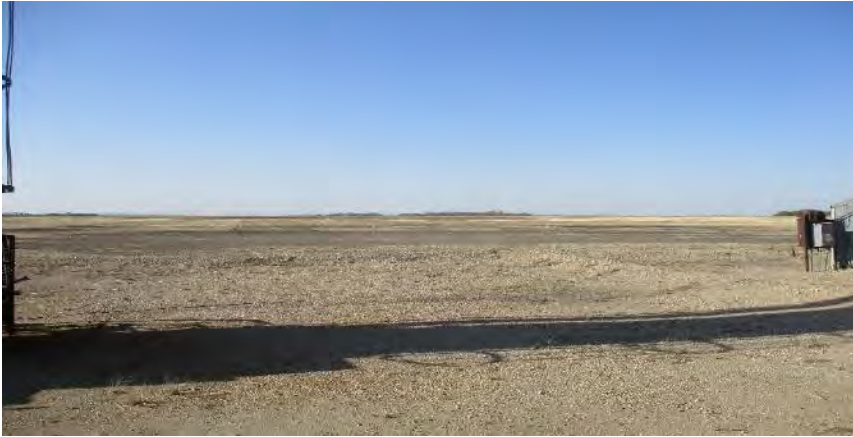
Photograph facing north off of an oil & gas facility showing the visually impacted area 100 feet north of the facility.

B14-10 was inspected on May 16th, 2018 and is located approximately 1,000 feet south of 98th St NW and 100 feet south of an oilfield lease road. The site is currently used for agricultural purposes and is surrounded by agricultural fields. An oil & gas facility was observed to the north, consisting of two aboveground storage tanks, one heater treater, and one pump jack. A small puddle of standing water measuring 20 feet by 20 feet was observed southwest of the site. Visual impacts were observed, including an area of barren ground with stressed vegetation; the area of visual impacts measured approximately 200 feet by 30 feet. The site topography is generally flat and slopes to the south/southwest. Aboveground powerlines were observed to the north of the site along the eastern edge of the oil & gas pad, and along 98th St NW.

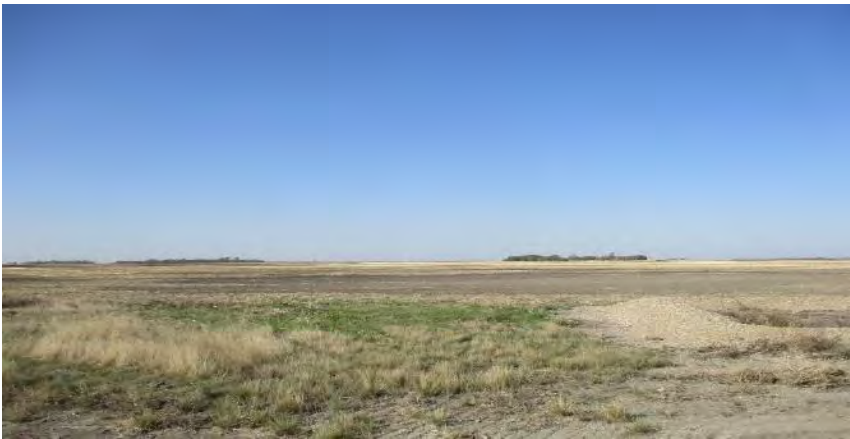
Photograph facing north off of an oil & gas facility showing the visually impacted area located in a field used in agricultural production.

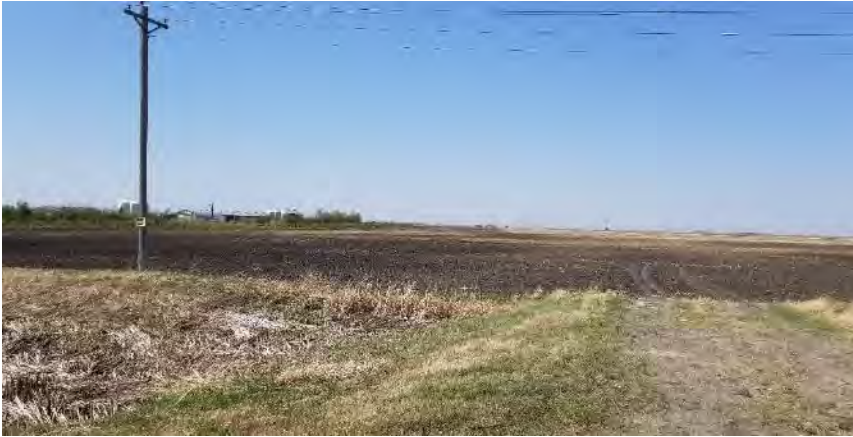
B14-11 (May 2018)

Photograph facing north off of 97th St. NW. The site is located approximately 100 feet north of 97th St. NW in a field used in agricultural production. No visual impacts were observed at the time of the May 15, 2018 site visit.

B14-11 was inspected on May 15th, 2018, and is located approximately 100 feet north of 97th St. NW. The site is currently an agricultural field that was recently plowed and is surrounded by agricultural fields. Visual impacts were not observed at the time of the site visit. The site topography is generally flat and slopes to the south. Aboveground powerlines were observed to the south, along 97th St NW.

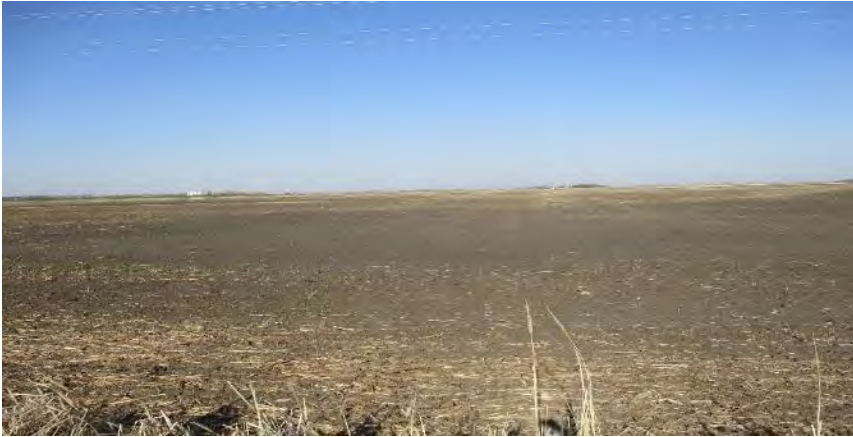
Photograph facing west off of 12th Ave NW showing the site. No visual impacts could be observed due to access limitations.

B14-12 was inspected on May 16th, 2018, and is located approximately 600 feet west of 12th Ave. NW. The site could not be accessed at the time of the site visit. The site is currently used for agricultural purposes and is surrounded by agricultural fields. Visual impacts could not be observed at the time of the site visit due to access limitations. Two separate depressions were observed towards the center of the site, one measuring approximately 100 feet by 50 feet and the other approximately 50 feet by 25 feet. The site topography is generally flat and slopes to the two aforementioned depressions. Aboveground powerlines were observed to the east of the site.

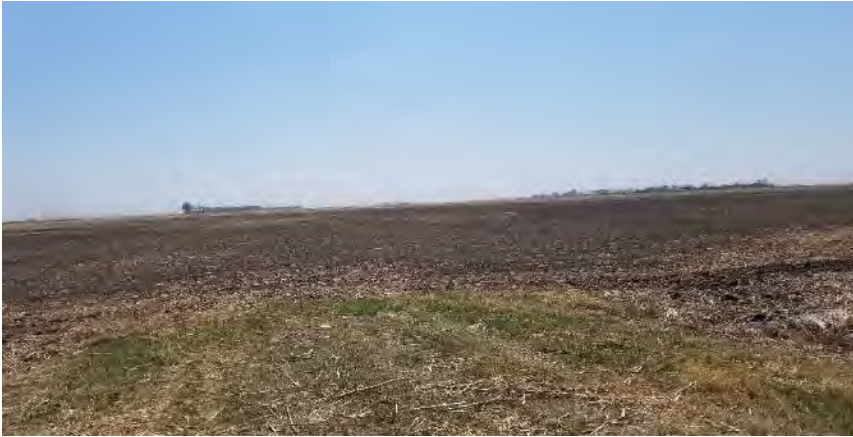
Photograph facing south off of North Dakota Highway 5 showing the site. No visual impacts could be observed from the roadway.

B14-13 was inspected on May 15th, 2018, and is located approximately 500 feet south of North Dakota Highway 5. The site could not be accessed at the time of the site visit. The site appears to be a wetland surrounded by agricultural fields. Visual impacts could not be observed from a distance at the time of site visit. The site topography is generally flat and slopes to the north towards the wetland.

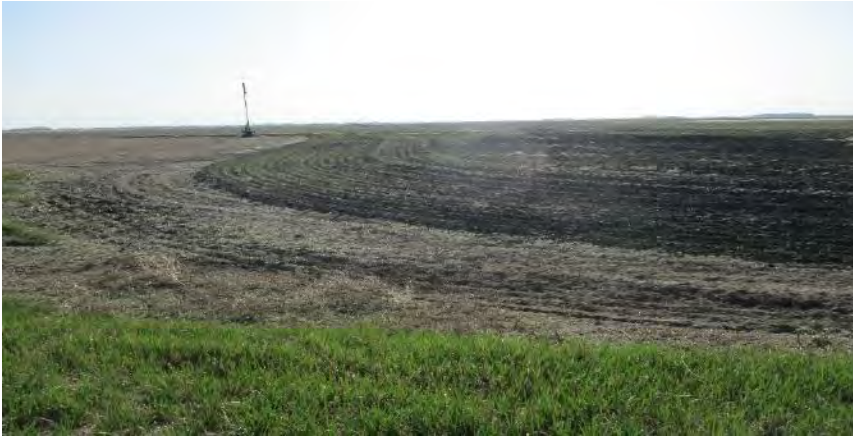
B14-14 (May 2018)

Photograph facing east off of 12th Ave NW showing the site. No visual impacts were noted during the May 16, 2018 site inspection. A flare can be seen in the background.

B14-14 was inspected on May 16th, 2018, and is located approximately 100 feet east of 12th Ave. NW and 100 feet south of an oilfield lease road. The site is an agricultural field that was recently plowed, and is surrounded by agricultural fields. An oil & gas facility was observed to the west, consisting of two aboveground storage tanks and one heater treater. A flare was observed to the east. Visual impacts were not observed at the time of the site visit. The site topography is generally flat, with a slight rise towards the south of the site. The site drains outwards from this rise. Aboveground power lines were observed to the west of the site, along 12th Ave NW.

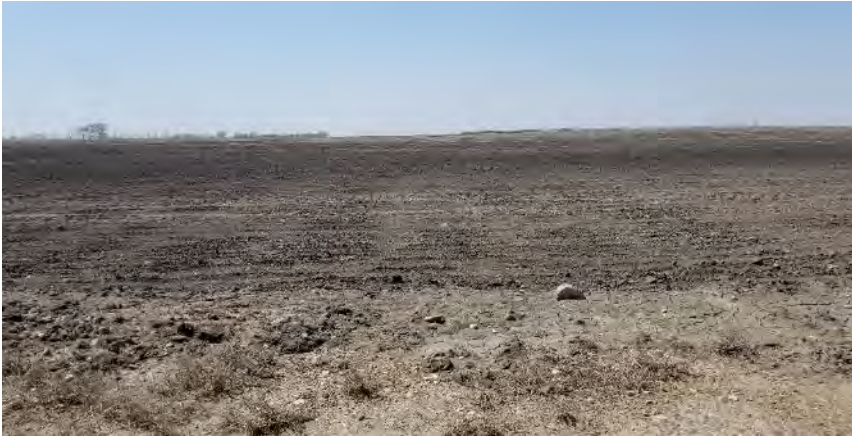
Photograph facing north off of an oil & gas facility showing the visually impacted area directly adjacent to the facility. The agricultural field to the north of the site can be seen in the background.

B14-15 was inspected on May 15th, 2018, and is located at the end of an oilfield lease road. The site is currently used in part for agricultural purposes, and in part as an oil & gas facility measuring approximately 500 feet by 100 feet. The facility consists of two pump jacks and one shack. Agricultural fields surround the site. Visual impacts were observed, including salt crusting and barren soils along the north and west edges of the oil & gas pad. The area of visual impacts measured approximately 200 feet by 100 feet in total. The site topography is generally flat and slopes to the north.

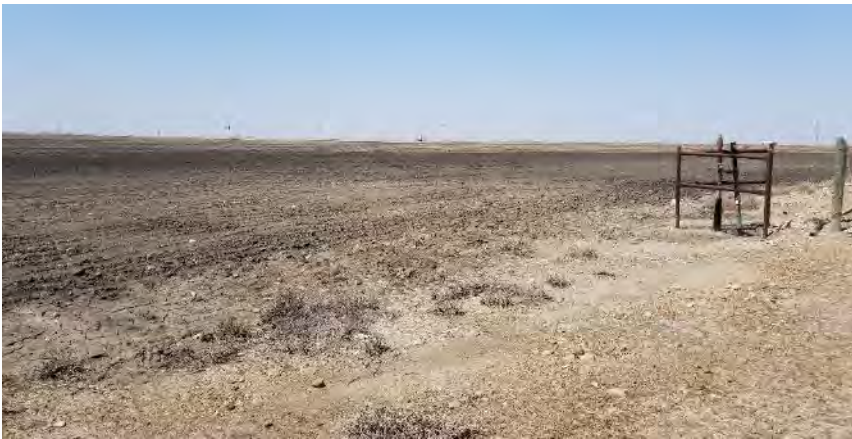
Photograph facing northeast off of the oil & gas facility showing the visually impacted area adjacent to the facility. The agricultural field surrounding the site can be seen in the background.

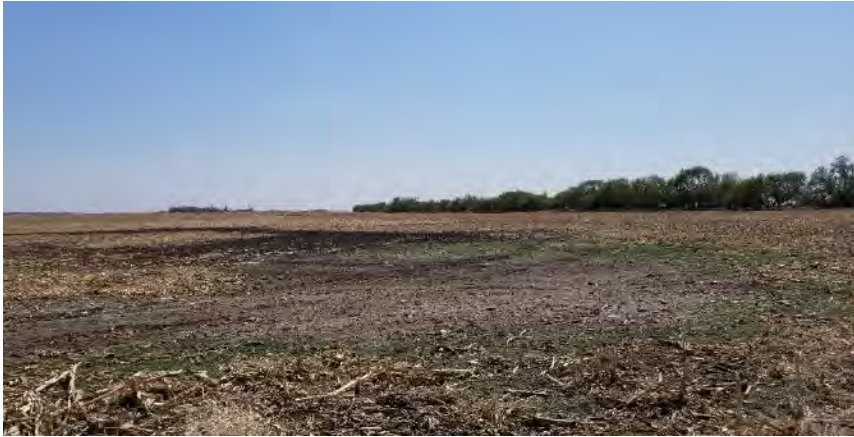
Photograph facing south west off of 98th St. NW showing the visually impacted area with stressed vegetation.

B14-16 was inspected on May 15th, 2018, and is located approximately 25 feet south of 98th St. NW. The site is currently used for agricultural purposes, and is surrounded by agricultural fields. Visual impacts were observed, including small areas of barren soil and stressed vegetation. Three separate areas were observed, and measured approximately 10 feet by 10 feet, 30 feet by 10 feet, and 10 feet by 10 feet, respectively. The site topography is generally flat and slopes to the north.

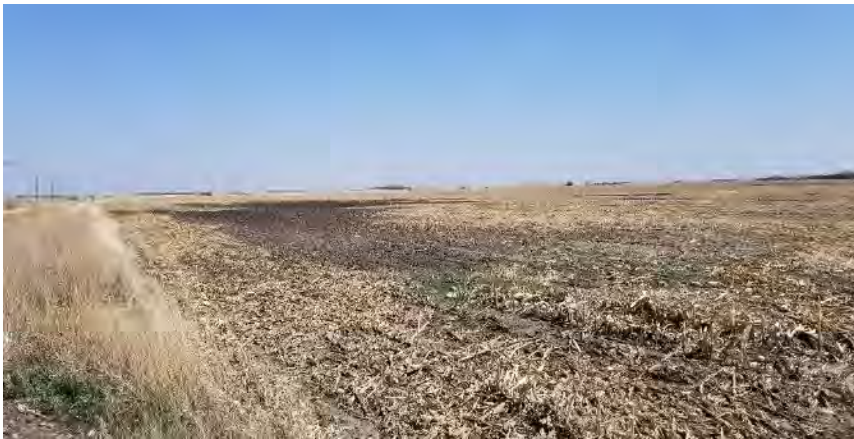
Photograph facing south east off of 98th St. NW showing the visually impacted area with stressed vegetation.

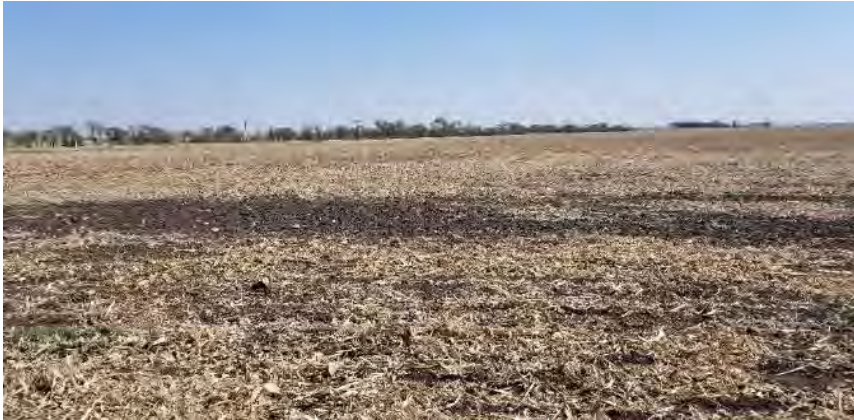
Photograph facing east off of an oil & gas facility showing the visually impacted area with slightly stressed vegetation.

B14-17 was inspected on May 15th, 2018, and is located approximately 150 feet south of an oilfield lease road. The site is currently used for agricultural purposes, and is surrounded by agricultural fields. An oil & gas facility was also observed to the west, consisting of one pump jack. Minimal visual impacts were observed, including slightly stressed vegetation; the area of visual impacts measured approximately 40 feet by 20 feet. The site topography is generally flat, slightly undulating, and slopes to the southeast.

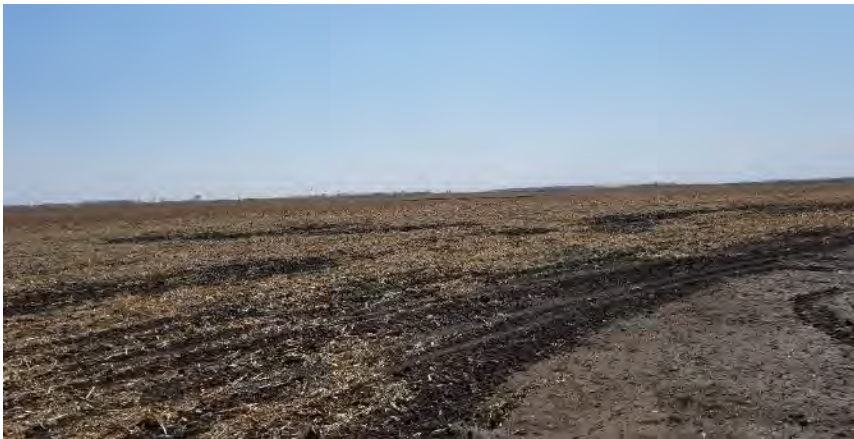
Photograph facing southeast off of an oil & gas facility showing the visually impacted area with slightly stressed vegetation. The site is located in an agricultural field.

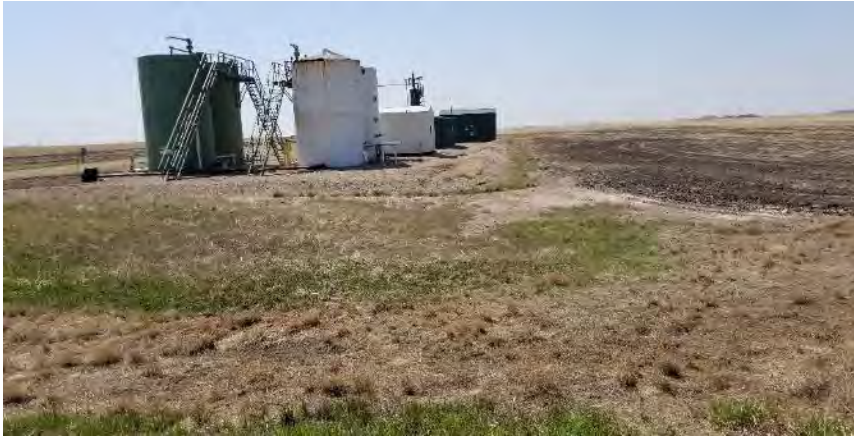
Photograph facing east off of 11th Ave NW showing a lack of vegetative growth and salt residues. The impacted area is approximately 20 feet by 20 feet in size. An oil & gas facility can be seen in the background.

B14-18 was inspected on May 15th, 2018, and is located approximately 50 feet west of 11th Ave NW and 100 feet north of an oilfield lease road. The site is currently used for agricultural purposes, and is surrounded by agricultural fields. An oil & gas facility was observed to the south, consisting of six aboveground storage tank, one heater treater and several shacks. Visual impacts were observed, including a barren area with salt crusting; the area of visual impacts measured approximately 20 feet by 20 feet. The site topography is generally flat and slopes to the northeast. An aboveground powerline was also observed to the east, east of 11th St NW.

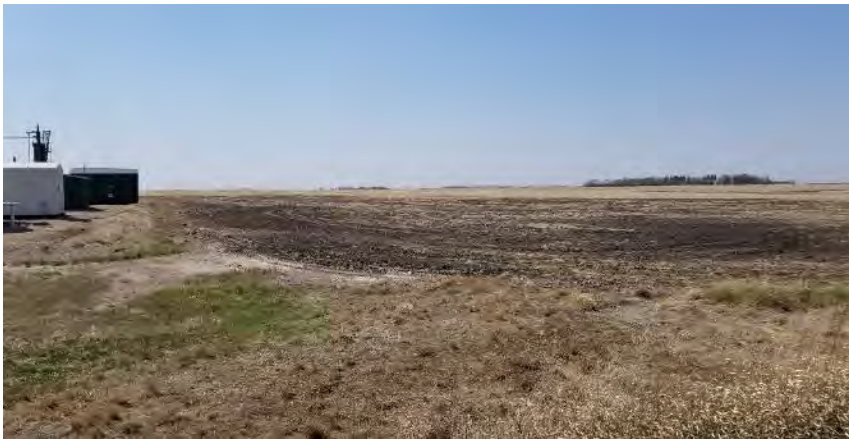
Photograph facing east off of 11th Ave NW showing the visually impacted area.

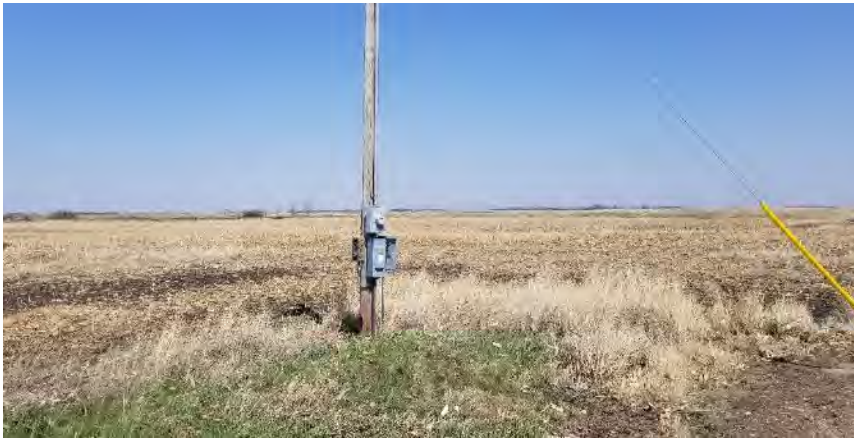
Photograph facing northeast off of an oil & gas facility showing slightly stressed vegetation in the agricultural field. An aboveground powerline at the site can be seen.

B14-19 was inspected on May 15th, 2018, and is located at the terminating point of an oilfield lease road. The site is currently used partly for agricultural purposes and partly as an oil & gas facility. The facility consisted of a single shack. Minimal visual impacts were observed, including minor stressed vegetation along the northeast edge of the pad and some soil cracking on the oil & gas pad. The area of visual impacts measured approximately 30 feet by 10 feet. The site topography is generally flat and slopes to the southeast. An aboveground powerline was also observed to the north of the site.

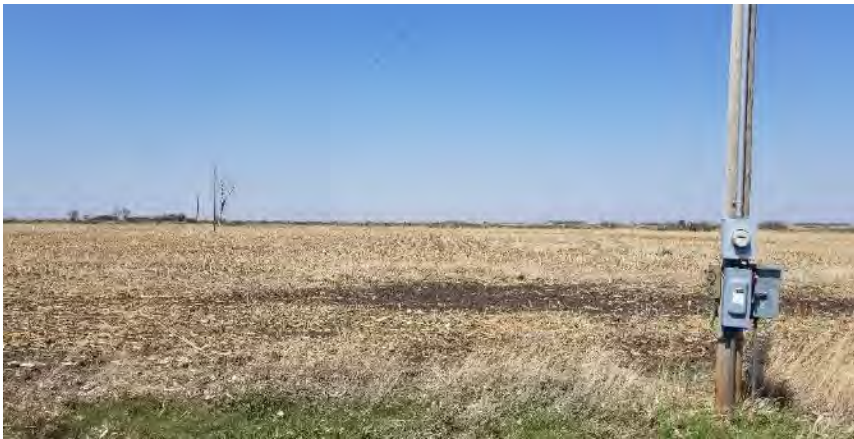
Photograph facing north off of an oil & gas facility showing the slightly impacted area. An aboveground powerline at the site can be seen.

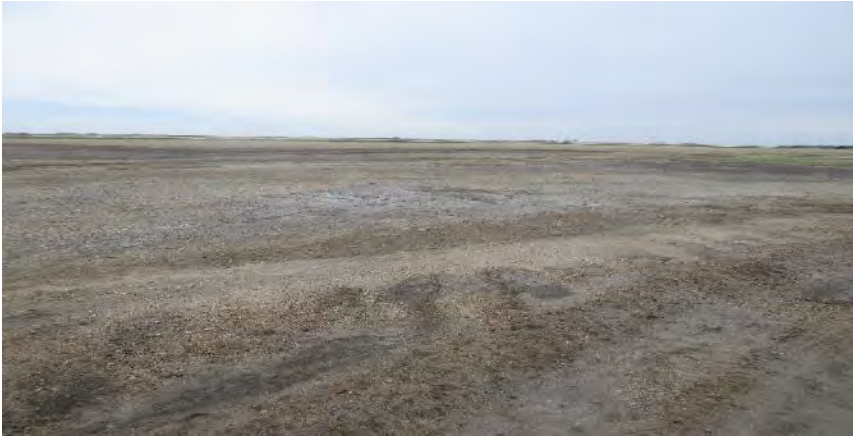
Photograph facing southeast off of an oil & gas facility showing the visually impacted area. Barren soil lacking vegetative growth, salt crusting, and cracking soil can be seen. The site is directly east of the oil & gas facility.

B20-1 was inspected on May 10th, 2018, and is located approximately 400 feet south of 95th St NW and just east of an oilfield lease road. The site is currently used for agricultural purposes. Agricultural fields lie to the north, south, and east. Immediately adjacent to the west of the site is an oil & gas facility consisting of three aboveground storage tanks and two shacks. A wetland was also observed to the south of the site. Visual impacts including barren ground lacking vegetation and salt crusting were observed at two locations. The first area measured approximately 200 feet by 100 feet, and the second area measured approximately 400 feet by 50 feet. The first impacted area was along the outskirts of the oil & gas facility pad and appeared to extend to the northeast into the second impacted area. It appears the impacts may have migrated from a previous spill at the oil & gas facility. The site topography is generally flat and slopes slightly to the northeast. Aboveground powerlines were observed to the west of the site.

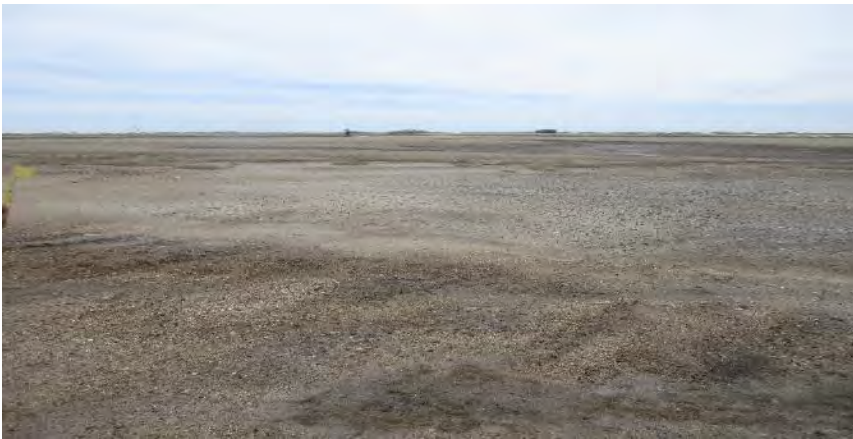
Photograph facing east off of an oil & gas facility showing the visually impacted area. Barren soil lacking vegetative growth, salt crusting, and cracking soil can be seen. The visual impacts appear to be migrating from the oil & gas facility located to the west.

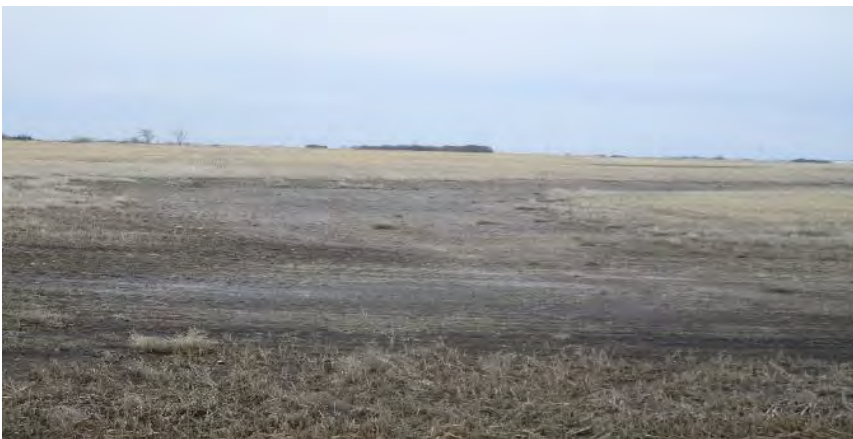
Photograph facing south off of 95th St NW showing the impacts that may have migrated from the oil & gas facility located to the west.

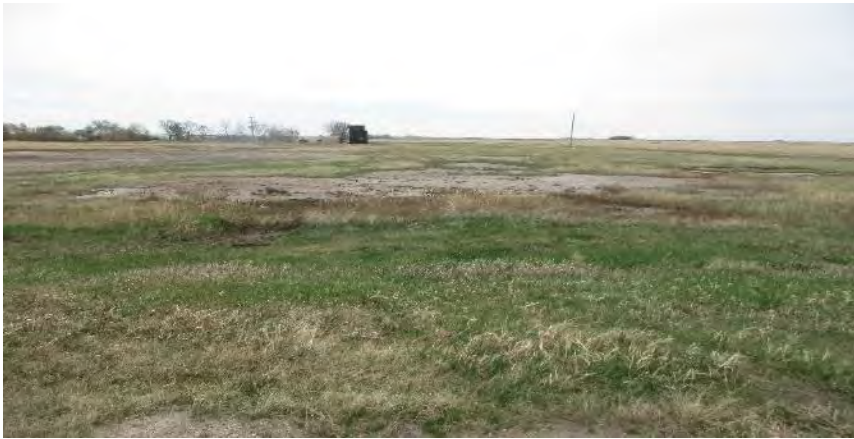
Photograph facing west off of an oilfield lease road showing the visually impacted area. Barren soil lacking vegetative growth and stressed vegetation can be seen.

B20-2 was inspected on May 10th, 2018, and is located approximately 100 feet east of 35th Ave NW and 50 feet north of an oilfield lease road. The site is currently native grassland. Agricultural fields lie to the north and south. Grassland lie to the east and west. An oil & gas facility consisting of two aboveground storage tanks was also observed to the east/northeast. A wetland was observed to the north/northeast of the site. Visual impacts were observed, including barren ground lacking vegetation and salt crusting; the area of visual impacts measured approximately 100 feet by 100 feet. Within this area, hydrocarbon impacts were observed in an area approximately 10 feet by 10 feet. The site topography is generally flat and slopes slightly to the northwest. An Enbridge underground petroleum product pipeline was observed to the north of the site, and aboveground powerlines were observed to the west of the site.

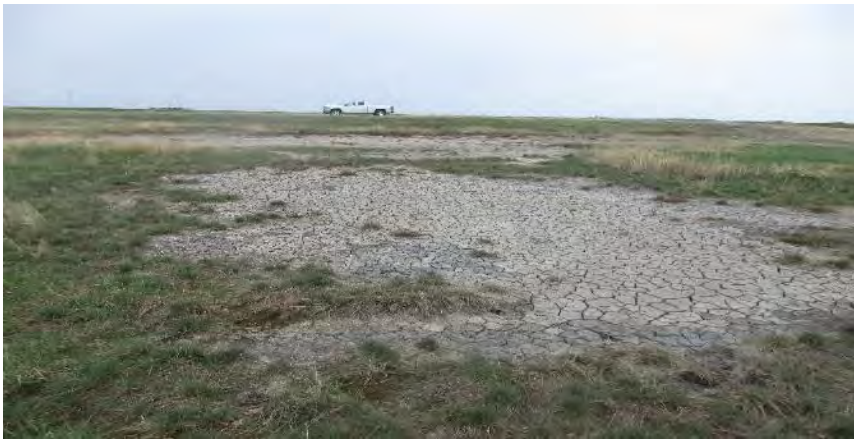
Photograph facing showing the visually impacted area. Barren soil lacking vegetation and soil cracking can be seen.

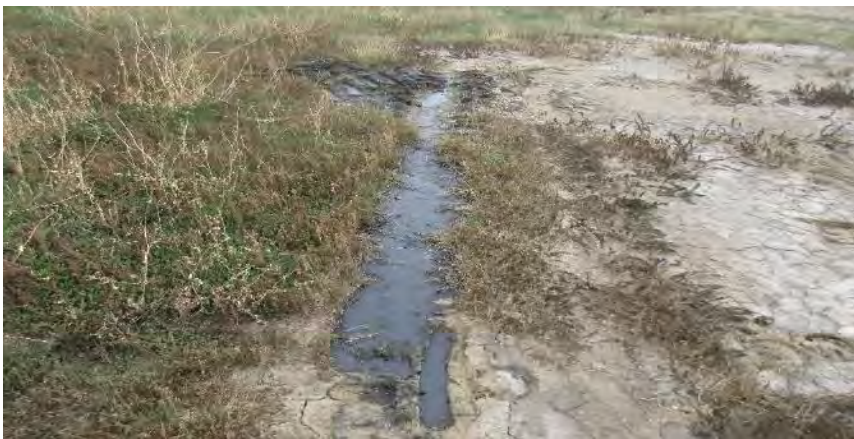
Photograph facing north showing the visually impacted area. Hydrocarbon impacts can be observed in a small 10 foot by 10 foot section on the northwestern portion of the site.

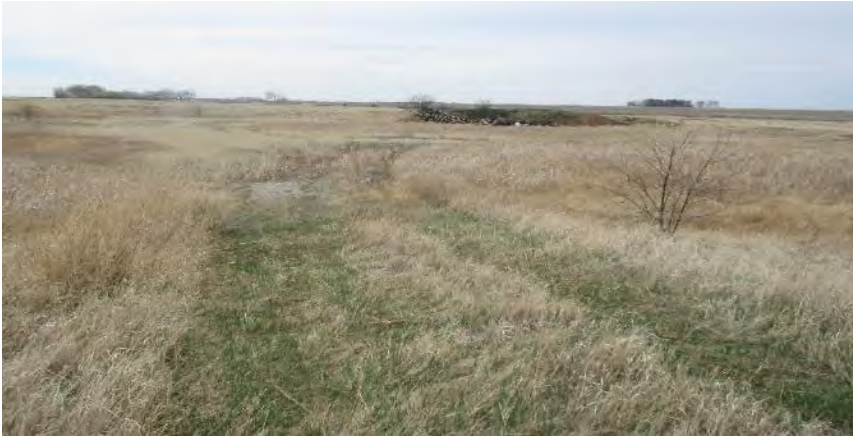
Photograph facing southeast off of an oilfield lease road showing the visually impacted area. Small areas of barren soil lacking vegetation can be observed. The site is located within a perimeter berm.

B20-3 was inspected on May 10th, 2018, and is located approximately 200 feet north of 96th St NW. The site is currently used as a storage yard for derelict equipment and parts. Agricultural fields lie to the north and south. A farmhouse lies to the north east, and storage of derelict parts lies to the west. A stream was also observed to the south of the site. Numerous small areas of barren soils lacking vegetation were observed, each measuring approximately 10 feet by 10 feet. The site topography is generally flat and a berm surrounds the site, measuring approximately 200 feet by 200 feet.

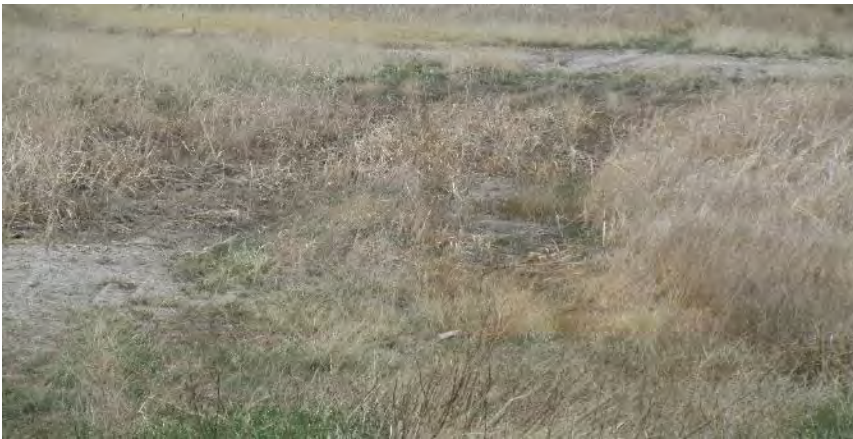
Photograph facing southeast off of an oilfield lease road showing a closer view of the visually impacted area lacking vegetative growth.

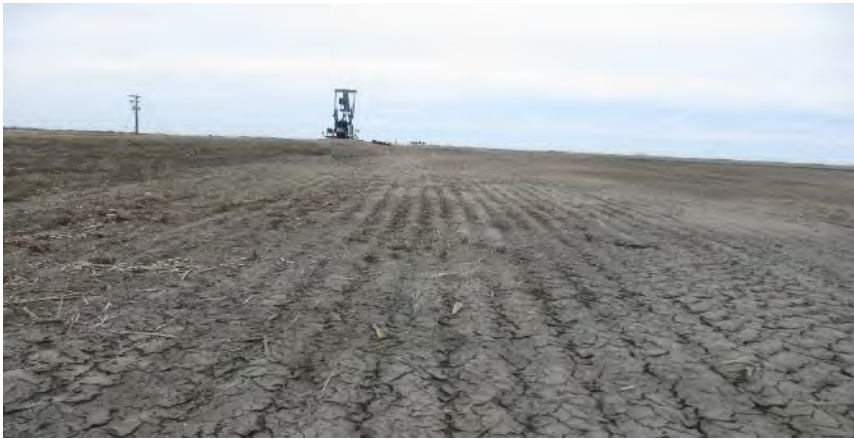
Photograph facing north showing the visually impacted area. Barren ground with little vegetative growth and cracking soil can be seen. A pump jack located north of the site can be seen in the background.

B20-4 was inspected on May 10th, 2018, and is located approximately 250 feet north of 95th St NW and east of an oilfield lease road. The site is currently used for agricultural purposes, and is surrounded by agricultural fields. An oil & gas facility was observed to the north, and consisted of a single pump jack. A wetland was observed to the northeast of the site. Visual impacts were observed, including barren ground lacking vegetation and salt crusting; the area of visual impacts measured approximately 150 feet by 100 feet. The site topography is generally flat and drains to the northwest. An aboveground powerlines was also observed to the northwest.

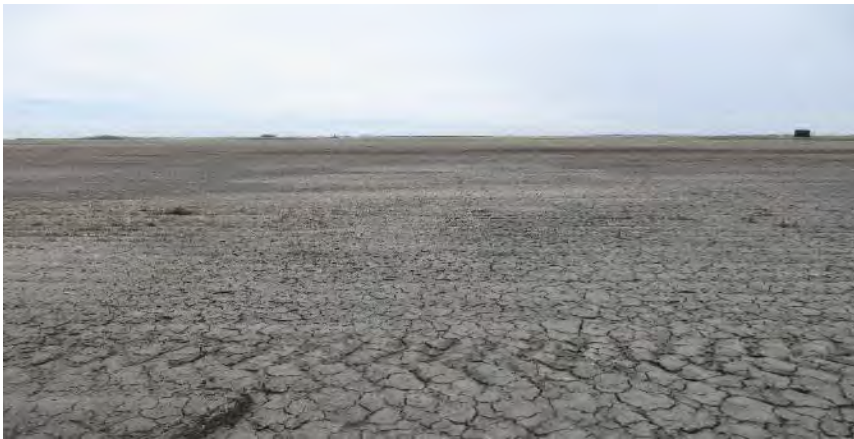
Photograph facing east showing the visually impacted area. Barren ground with little vegetative growth and cracking soil can be seen. The visually impacted area measured approximately 150 feet by 100 feet.

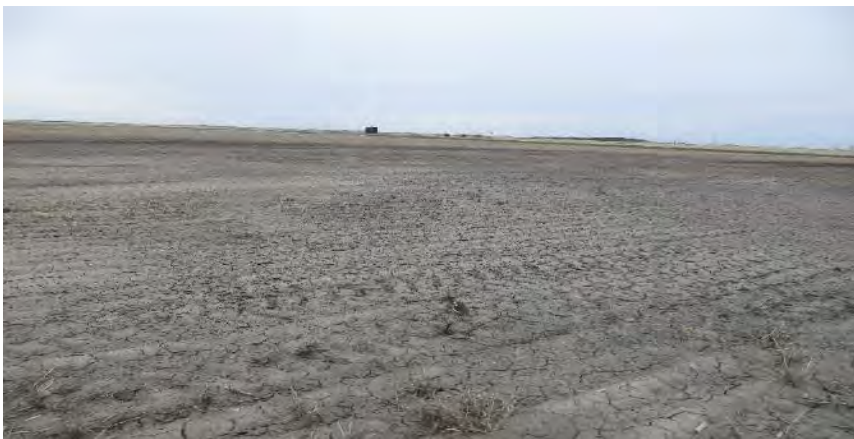
Photograph facing southeast showing the visually impacted area. Barren ground with little vegetative growth and cracking soil can be seen. The site is located in a field used in agricultural production.
