NDIC Brine Pond Study

Phase II: Site Assessments

June 25, 2018

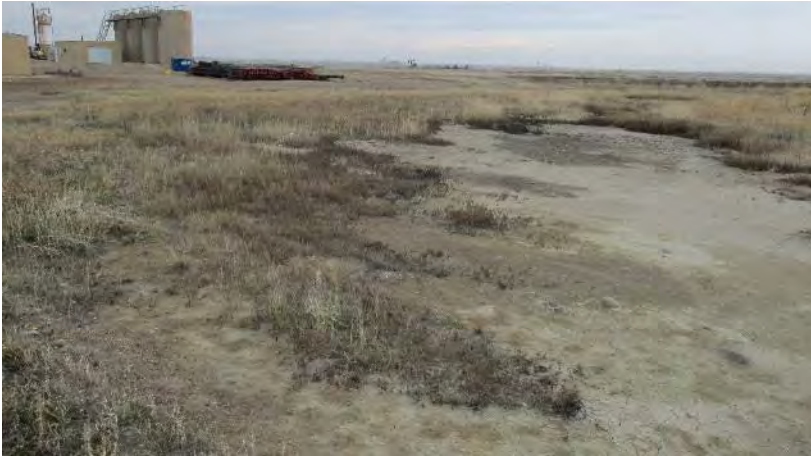
Photograph facing west/northwest off of oilfield lease road showing visually impacted area with barren soils and no vegetation. The impacted area is approximately 400 feet east of 25th Ave NW. Oil & gas facilities are located west of site.

B21-1 was inspected on May 2nd, 2018, and is located approximately 400 feet east of 25th Ave NW and 30 feet west of an oilfield lease road. The site is currently native grassland. Agricultural fields lie to the north, east, and south. An oil & gas facility was observed to the west, consisting of seven aboveground storage tanks, shacks, pumps, and pipeline risers. Visual impacts were observed, including barren soils lacking vegetative growth; the area of visual impacts measured approximately 50 feet by 30 feet. A wetland was observed east of the site. The site topography is predominantly flat and slopes slightly to the north/northeast. Aboveground powerlines were observed to the south, east, and northeast of the site.

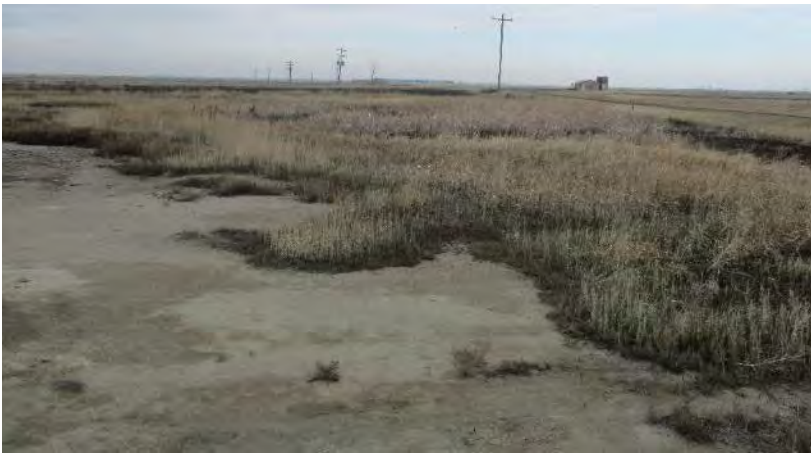
Photograph facing north off of oilfield lease road showing visually impacted area and wetland located approximately 15 feet to the northeast of site. Aboveground powerlines running north-south and a shack to the northeast are visible.

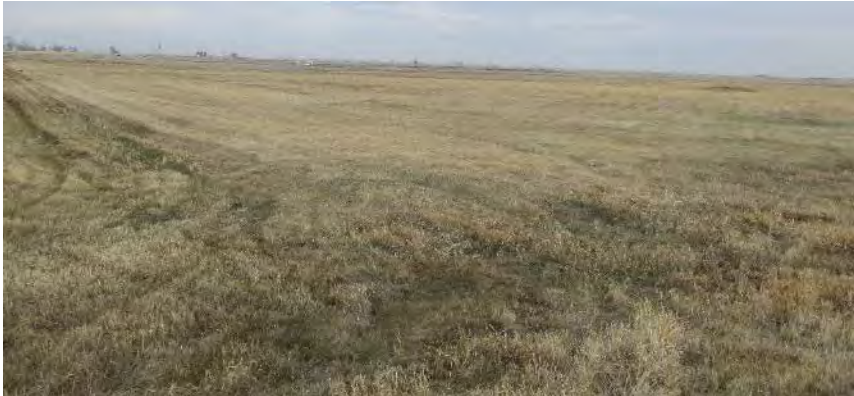
Photograph facing north/northwest off of 93rd St NW. The site is located on private grassland, approximately 500 feet north of road, but could not be accessed.

B21-2 was inspected on May 2nd, 2018, and is located approximately 500 feet north of 93rd St NW on private land. The site is currently native grassland with residential buildings approximately 1,000 feet to the northeast. No visual impacts could be observed at the time of the site visit due to access limitations. A wetland was observed approximately 1,000 feet northeast of the site. Agricultural fields are located to the west and south, with native grasslands to the north and east. The site topography is predominantly flat, and a drainage direction could not be assessed due to access limitations. Aboveground powerlines are located to the south of 93rd St. NW.

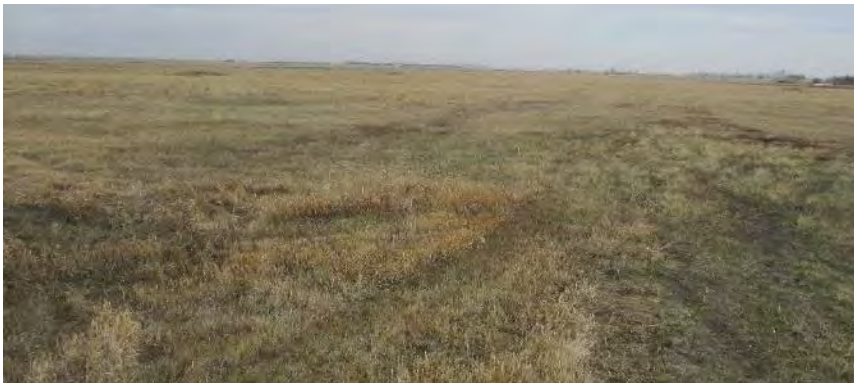
Photograph facing northwest off of 93rd St NW. Wetlands and residential buildings were observed approximately 1,000 feet to the northeast.

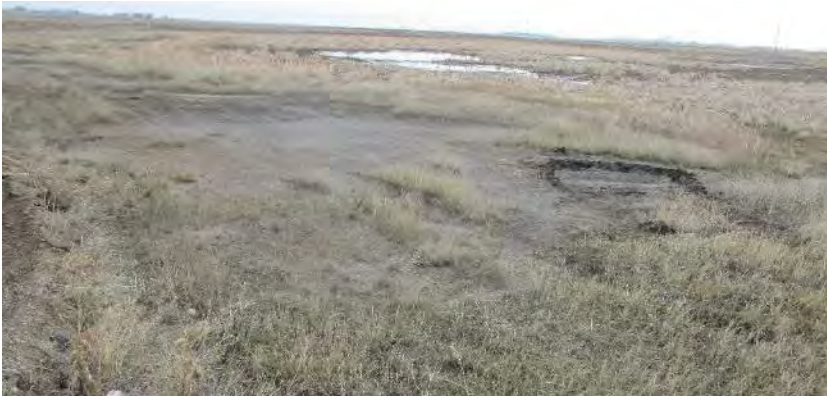
Photograph facing north/northeast off of an oilfield lease road showing visual impacts at the site. 25th Ave NW is approximately 400 feet east of the site. Aboveground powerlines were observed to the east.

B21-3 was inspected on May 2nd, 2018, and is located approximately 400 feet west of 25th Ave NW and just north of an oilfield lease road. The site is currently native grassland. Agricultural fields lie to the north, east, and south. An oil & gas facility consisting of a wellhead, two chemical injection tanks, and other miscellaneous equipment was observed to the west. Visual impacts were observed, including stressed vegetation, barren ground, soil cracks, and tan soils; the area of visual impacts measured approximately 75 feet by 20 feet. A wetland is located approximately 50 feet northeast of the site. The site topography is predominantly flat and drains to the east/northeast.

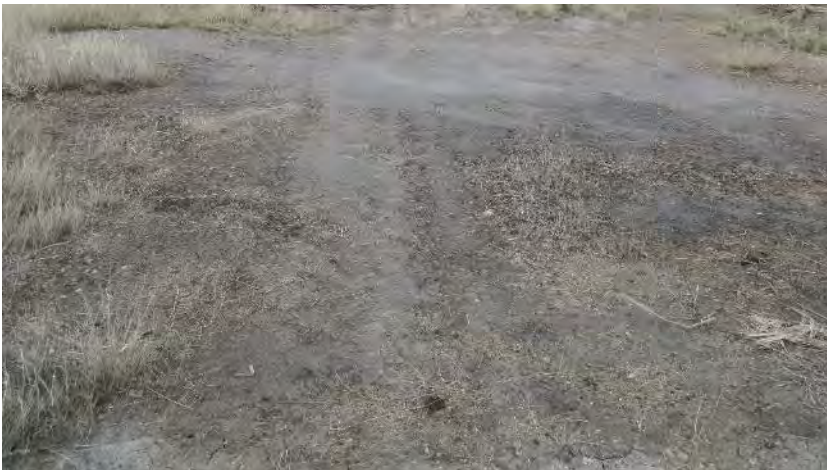
Photograph facing south off of the oilfield lease road showing visual impacts, including soil cracks, stressed vegetation, and tan soils.

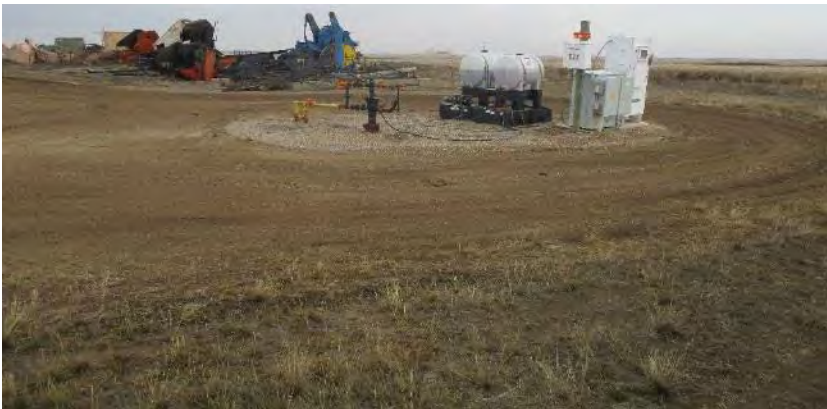
Photograph facing west showing oilfield equipment approximately 25 feet from site.

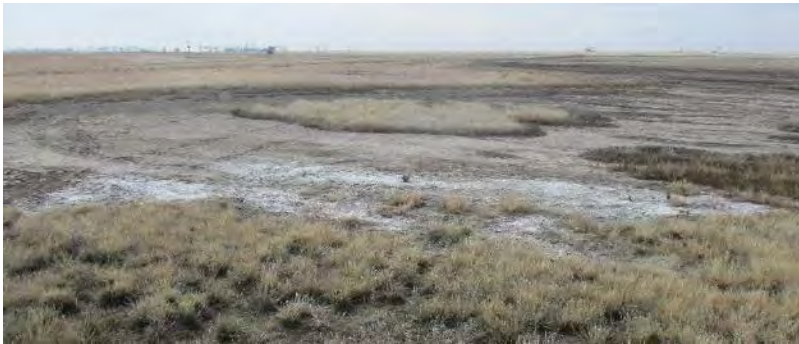
Photograph facing south/southeast off of an oilfield lease road showing visually impacted area, including barren soil and salt crusts. 93rd St NW is approximately 1,000 feet north of site.

B21-4 was inspected on May 2nd, 2018, and is located approximately 1,000 feet south of 93rd St NW and 25 feet south of an oilfield lease road. The site is currently native grassland with wetlands to the north and east. Agricultural fields are located to the south. Oil & gas facilities were observed to the north, consisting of seven aboveground storage tanks, a pump jack, a shack, and other miscellaneous oilfield equipment. Visual impacts were observed, including barren ground, salt crusts, and stressed vegetation; the area of visual impacts measured approximately 100 feet by 50 feet. The site topography is predominantly flat and drains to the south.

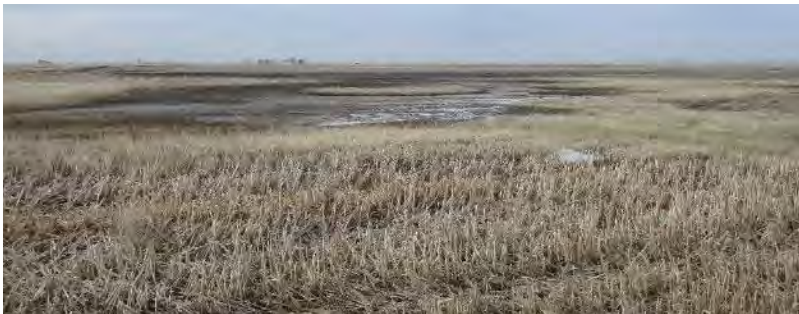
Photograph facing south off of an oilfield lease road showing visually impacted area. A wetland is located along the oilfield lease road.

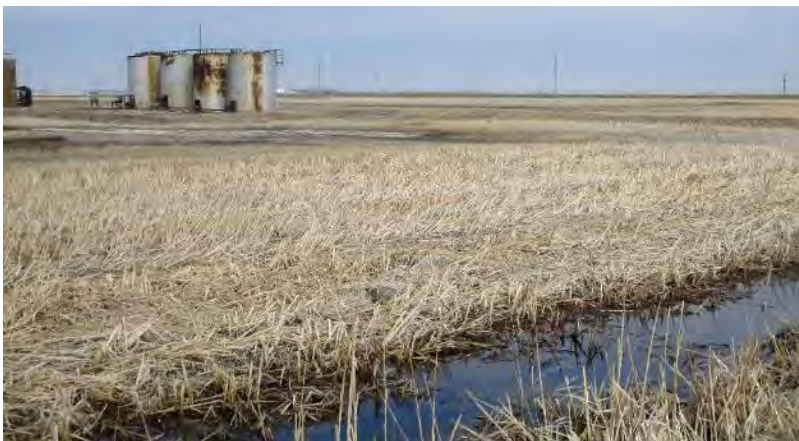
Photograph facing northwest off of an oilfield lease road showing wetland area adjacent to the west of site and standing water along road. Oilfield facilities and aboveground storage tanks are located northwest of site.

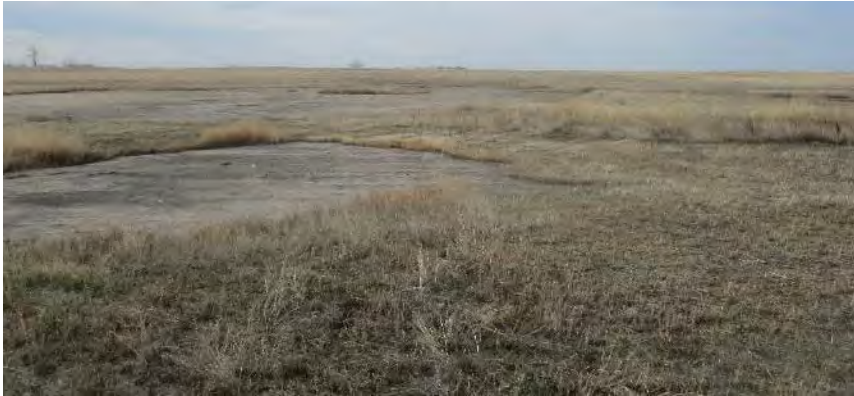
Photograph facing south off of an oilfield lease road showing visually impacted area. The site is on native grassland, with a wetland to the west and agricultural fields to the east.

B21-5 was inspected on May 2nd, 2018, and is located approximately 50 feet south of an oilfield lease road. The site is currently native grassland with wetlands approximately 100 feet to the east. Agricultural fields lie to the west and south. An oil & gas facility was observed to the north, consisting of four aboveground storage tanks, a pump jack, and a shack. Visual impacts were observed, including barren ground and stressed vegetation; the area of visual impacts measured approximately 400 feet by 200 feet. The site topography slopes inward to a depression at the center of the site.

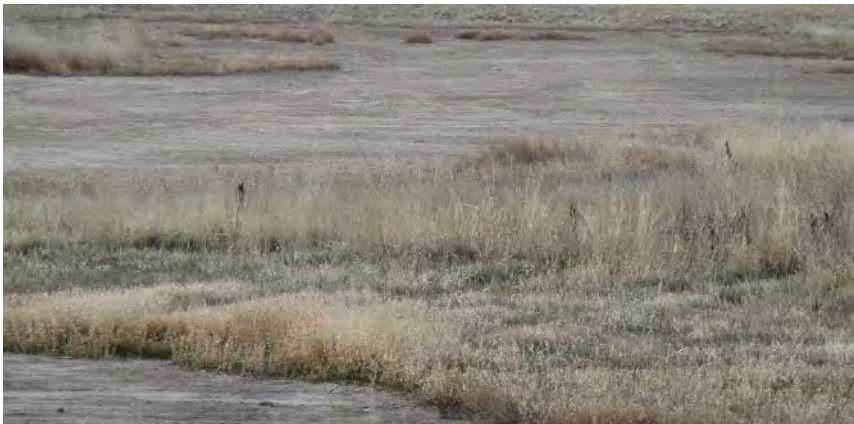
Photograph facing south off of oilfield lease road showing close up of visual impact area. Salt crusts and extensive dead zones are visible.

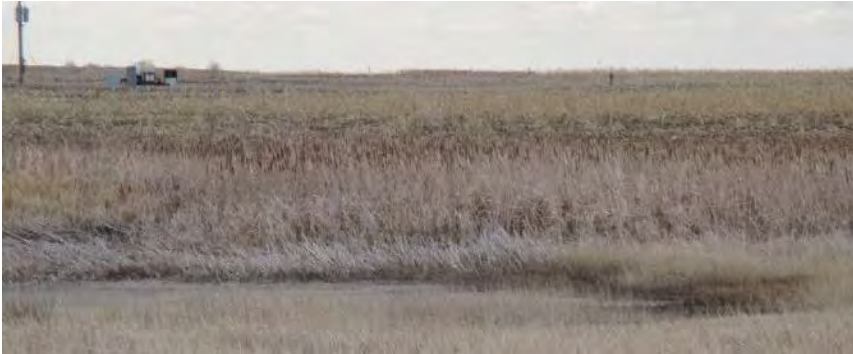
Photograph facing south off of an oilfield lease road showing visually impacted area. Site is on native grassland adjacent to a wetland to the south.

B21-6 was inspected on May 2nd, 2018, and is located approximately 200 feet west of 25th Ave NW and 100 feet south of an oilfield lease road. The site is currently native grassland with wetlands to the east and south. Agricultural fields are located to the north and south. Oil & gas facilities were observed to the north, consisting of four aboveground storage tanks, a pump jack, two horizontal separators, a shack, and other miscellaneous oilfield equipment. Visual impacts were observed, including barren ground and stressed vegetation; the area of visual impacts measured approximately 20 feet by 20 feet. The site topography slopes inward toward a depression at the center of the site. Aboveground powerlines and underground oil & gas lines were observed to the north, in the vicinity of the oil & gas facilities.

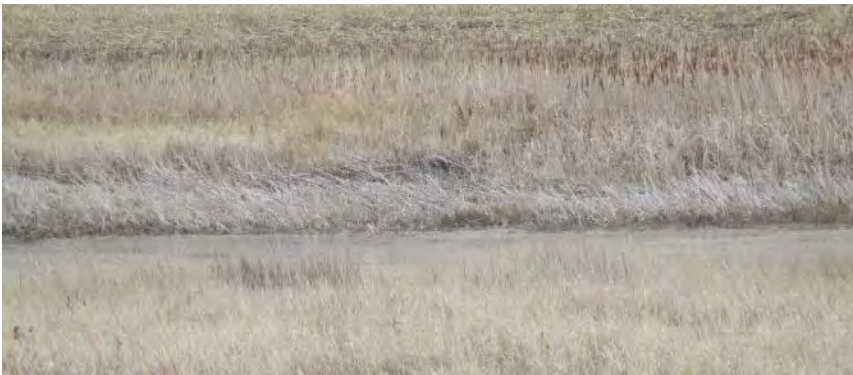
Photograph facing south off of an oilfield lease road showing close up of visually impacted area. Extensive dead zones were observed.

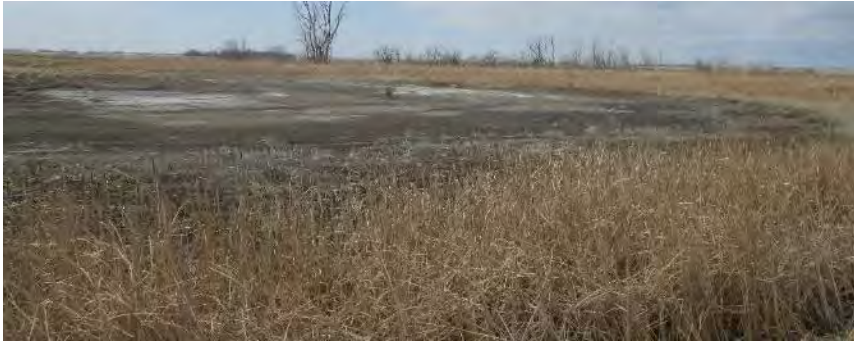
Photograph facing south off of an oilfield lease road showing visually impacted area. The site is on the border between agricultural fields and wetlands.

B21-7 was inspected on May 2nd, 2018, and is located approximately 4,000 feet south of 93rd St NW and 100 feet south of an oilfield lease road. The site is currently used for agricultural purposes, and is surrounded by agricultural fields. A wetland was also observed to the west. An oil & gas facility was observed to the east, consisting of five aboveground storage tanks and a storage shack. Visual impacts were observed, including an extensive dead zone, salt crusts, and stressed vegetation; the area of visual impacts measured approximately 50 feet by 50 feet. The site topography is generally flat and slopes to the northwest. Aboveground powerlines were observed to the north of the site.

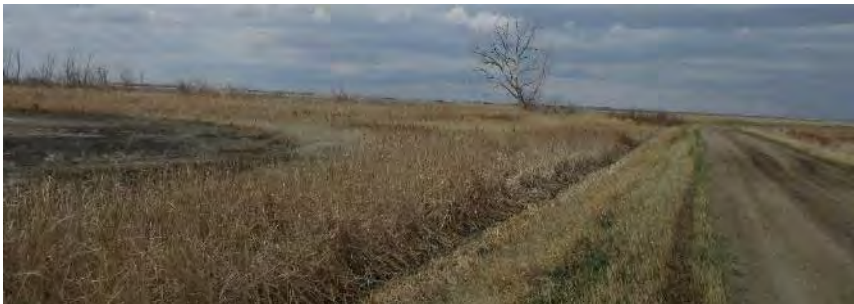
Photograph facing southwest off of an oilfield lease road showing impacted area and wetland along the road.

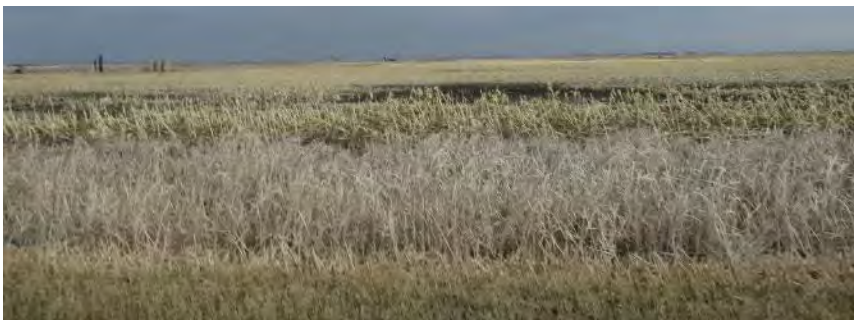
Photograph facing north off of an oilfield lease road showing agricultural fields and wetland along the road.

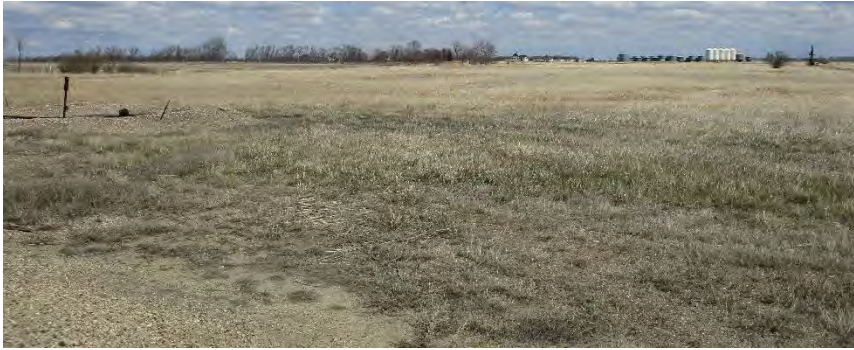
Photograph facing northeast off of an oilfield lease road showing no visual impact at the site. The site is on native grassland.

B21-8 was inspected on May 2nd, 2018, and is located approximately 200 feet east of an oilfield lease road. The site is currently native grassland and shows no visible impacts. An oil & gas facility is located to the northwest, consisting of four aboveground storage tanks and pipeline risers. The site topography is generally flat, slightly undulating, and drains to the north. An aboveground powerline was observed to the north.

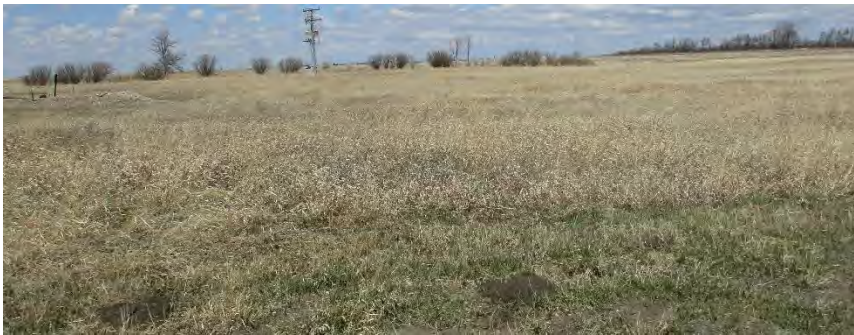
Photograph facing north/northeast off of an oilfield lease road showing no visual impact at the site.

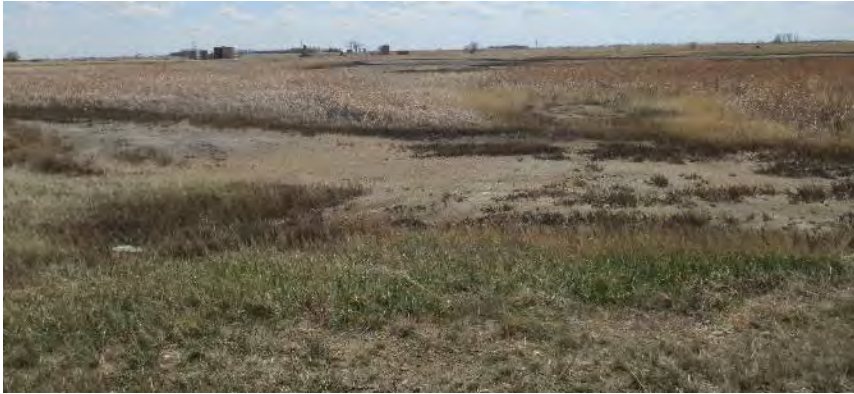
Photograph facing southwest off of an oilfield lease road showing two large visually impacted areas. The site is located on native grassland.

B21-9 was inspected on May 2nd, 2018, and is located approximately 200 feet north of 92nd St NW. The site is currently native grassland and is surrounded by grasslands. Oil & gas facilities were observed further to the southeast and northwest. Visual impacts were observed, including two areas of extensively barren soils with little to no vegetation. The western area is approximately 200 feet by 200 feet and the eastern area is approximately 400 feet by 300 feet. The site topography is generally flat and generally slopes to the north. The west side of the site slopes to a slight depression towards the center of the site.

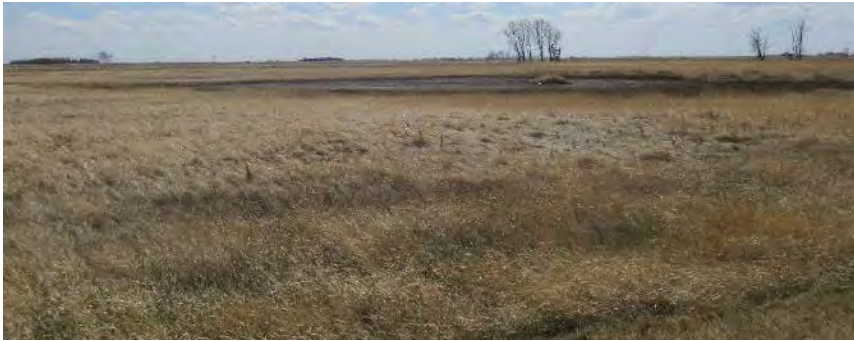
Photograph facing south-southwest off of an oilfield lease road showing one visually impacted area of approximately 200 feet by 200 feet.

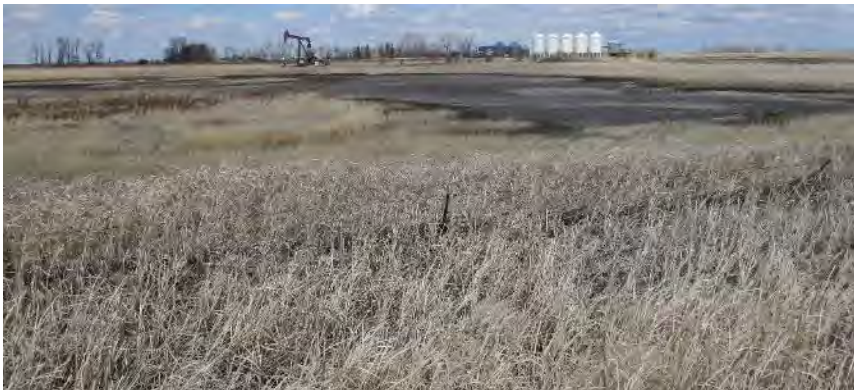
Photograph facing north-northeast off of 92nd St NW showing another visually impacted area of approximately 400 feet by 300 feet.

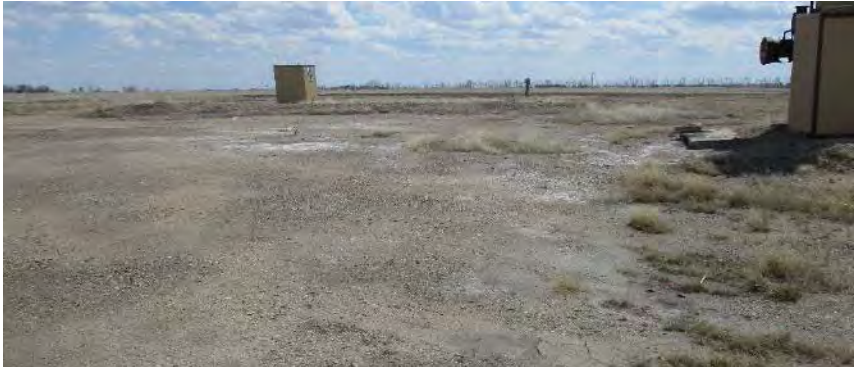
Photograph facing southeast off of an oilfield lease road showing visually impacted area measuring approximately 400 feet by 100 feet. The site is on native grassland.

B21-10 was inspected on May 2nd, 2018, and is located approximately 400 feet south of 93rd St NW and 30 feet east of an oilfield lease road. The site is currently native grassland. Agricultural fields are located to the west and south. An oil & gas facility was observed to the west, consisting of three aboveground storage tanks and a shack. Wetlands are located to the east and west of the site. Visual impacts were observed, including extensive dead zones, soil cracks, and salt crusts; the area of visual impacts measured approximately 400 feet by 100 feet. The site topography is generally flat and drains to the north-northwest.

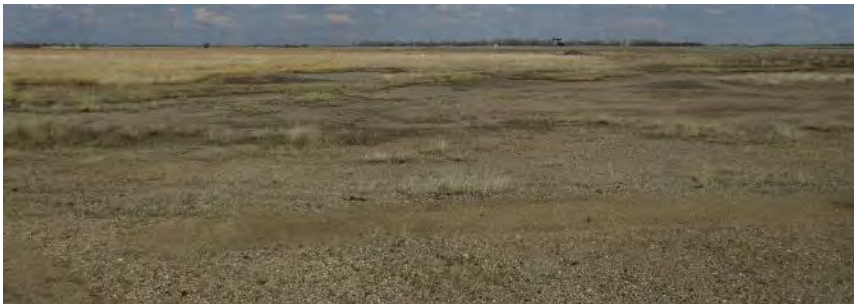
Photograph facing northeast off of an oilfield lease road showing visually impacted area.

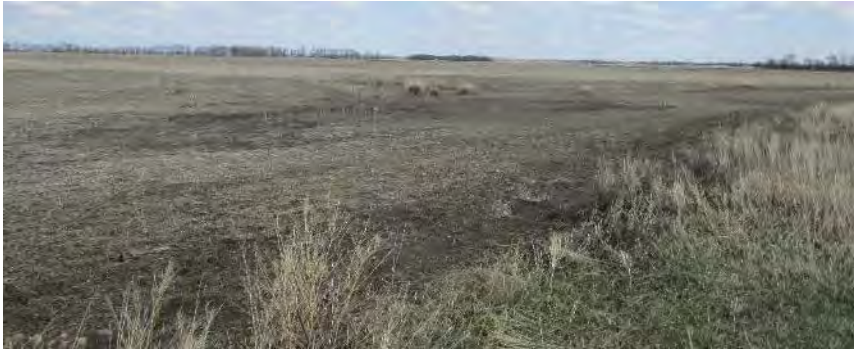
Photograph facing southeast off of an oilfield lease road, showing a visually impacted area of stressed vegetation measuring approximately 150 feet by 20 feet. The site is located on agricultural production land.

B21-11 was inspected on May 2nd, 2018, and is located approximately 1,500 feet south of 93rd St NW and 100 feet east of an oilfield lease road. The site is currently used agricultural purposes, and is surrounded by agricultural fields. An oil & gas facility was observed to the southwest of the site, consisting of one pump jack. Wetlands are located to the south and northwest of the site. Visual impacts were observed, including stressed vegetation and some barren spots; the area of visual impacts measured approximately 150 feet by 20 feet. The site topography is generally flat and drains to the north-northwest.

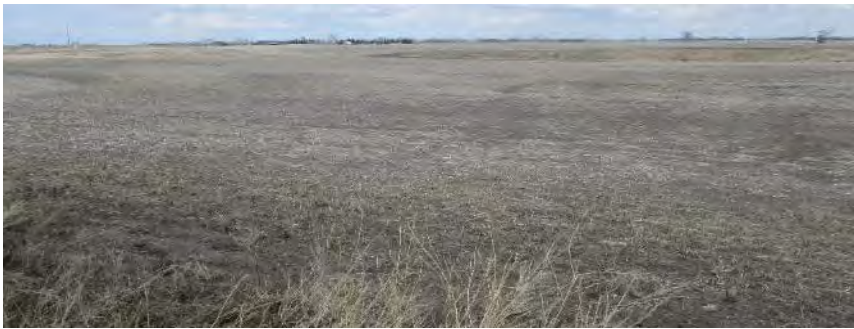
Photograph facing northeast off of oilfield lease road showing visually impacted area.

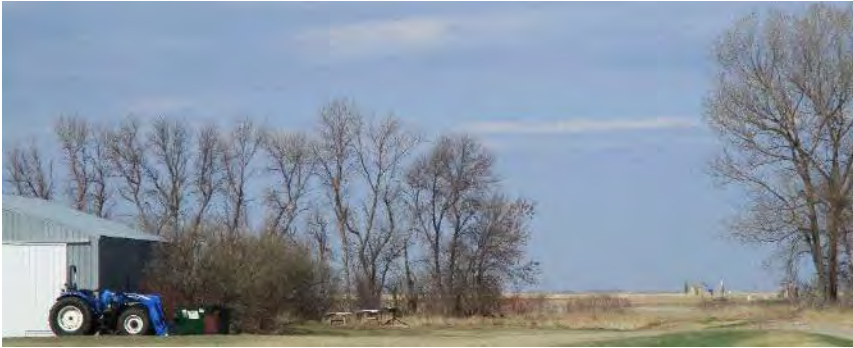
Photograph facing west off of oilfield lease road and private drive way. The site is on private land approximately 300 feet off of road, and could not be accessed at the time of site visit.

B21-12 was inspected on May 2nd, 2018, and is located approximately 500 feet west of 24th Ave NW and 300 feet west of an oilfield lease road and. The site could not be accessed at the time of the site visit. The site is currently used for agricultural purposes. Visible impact could not be observed due to access limitations. An oil & gas facility was observed to the northeast, consisting of one pump jack. A residential home is located approximately 300 feet southeast of site. The site topography is generally flat and slightly undulating.

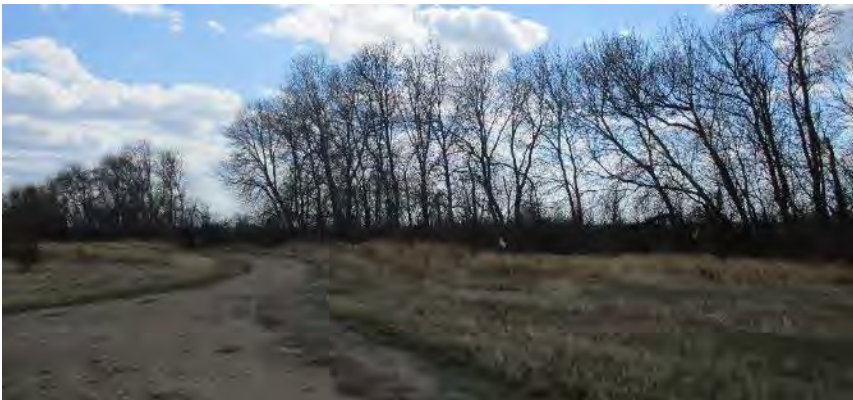
Photograph facing southwest off of oilfield lease road. The site is on native grassland near a pump jack.

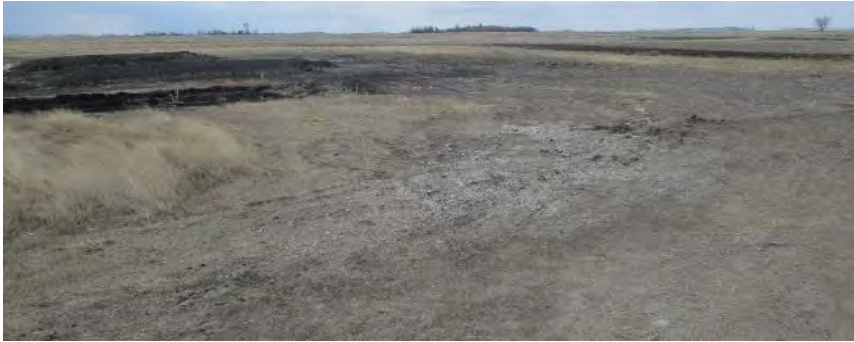
Photograph facing southwest off of an access road. Site is approximately 50 feet west of 25th Ave NW. The site is on native grassland that appeared to be recently drilled for wells. Salt crusts and soil cracks are visible in extensive dead zones.

B21-13 was inspected on May 2nd, 2018, and is located approximately 50 feet west of 25th Ave NW. The site appeared to have undergone recent drilling activity, as drill pits full of water were observed at the site. Three recently drilled wells and five drill pits were observed. Grasslands lie to the north, east, and south, and agricultural fields lie to the west. A wetland approximately 50 feet by 20 feet is located in the northern section of the site. Another wetland lies to the southeast of the site. An oil & gas facility was observed to the northwest, consisting of one pump jack. Visual impacts were observed, including extensive dead zones, salt crusts, and soil cracks. The visual impacts were observed throughout the site in a number of areas, each measuring approximately 30 feet by 15 feet. The site is approximately 500 feet by 500 feet in area. The site appears to be a low spot in the surrounding area, and slopes inwards.

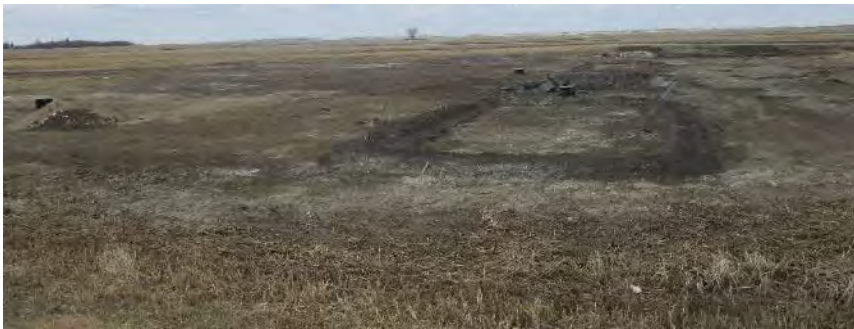
Photograph facing west off of 25th Ave NW showing visually impacted area. Recent drilling activity was evident. Drill pits were observed on-site.

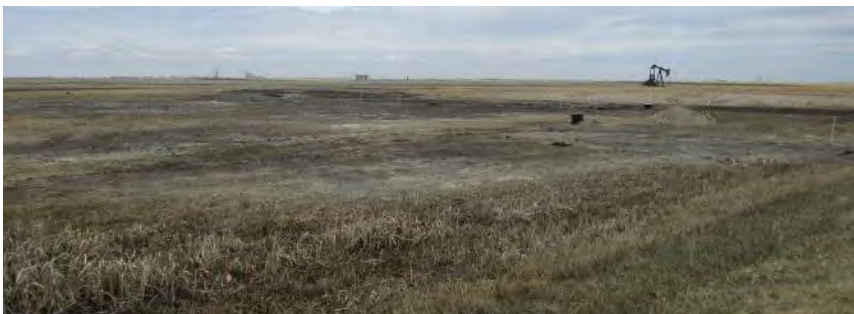
Photograph facing northwest off of 25th Ave NW showing visually impacted area of salt crusts and barren soil.

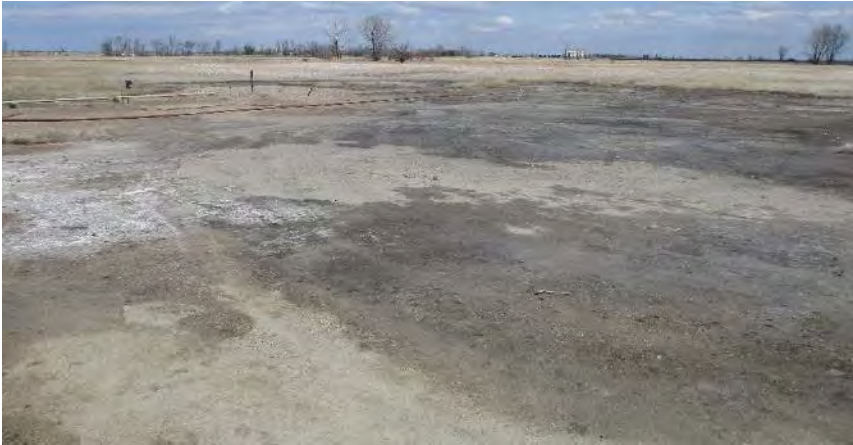
Photograph facing northeast off of an oilfield lease road, showing visually impacted area. The site is approximately 100 feet east of an oil & gas facility. Extensive dead zones and salt crusts were observed.

B21-14 was inspected on May 2nd, 2018, and is located approximately 500 feet south of 92nd St NW and 100 feet east of an oilfield lease road. The site is currently native grassland, with agricultural fields to the north and grasslands to the west, south, and east. An oil & gas facility was also observed to the west, consisting of six aboveground storage tanks and other oilfield equipment. Wetlands were observed to the north, east, and south of the site. Visual impacts were observed, including extensive dead zones, salt crusts, and soil cracks; the area of visual impacts measured approximately 100 feet by 50 feet. The site topography is generally flat, and slopes towards a depression at the center of the site. Aboveground pipelines were observed on-site, and an aboveground powerline was observed to the west/southwest.

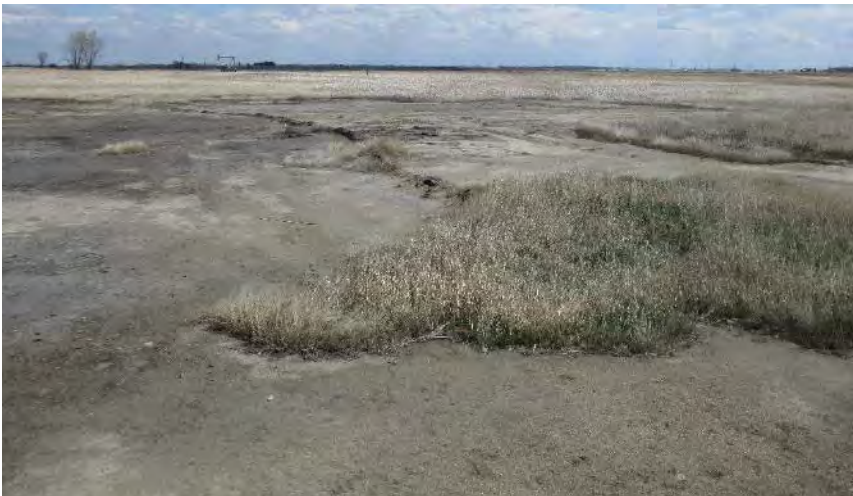
Photograph facing east off of an oilfield lease road showing large patches of barren ground and stressed vegetation.

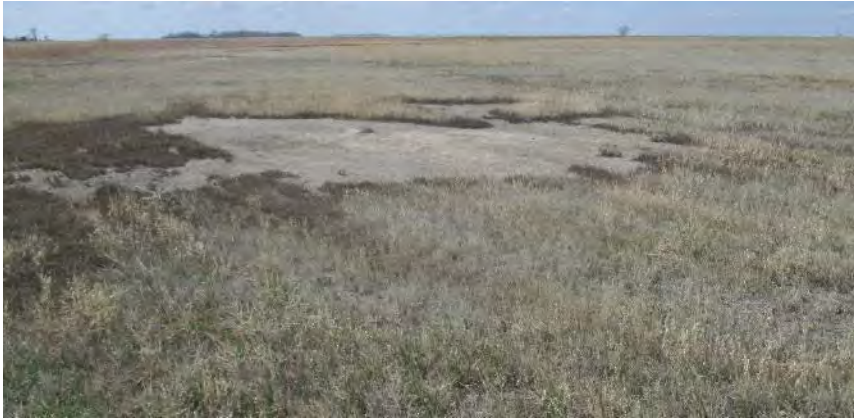
B21-15

Photograph facing north off of an oilfield lease road, showing visually impacted area measuring approximately 100 feet by 100 feet.

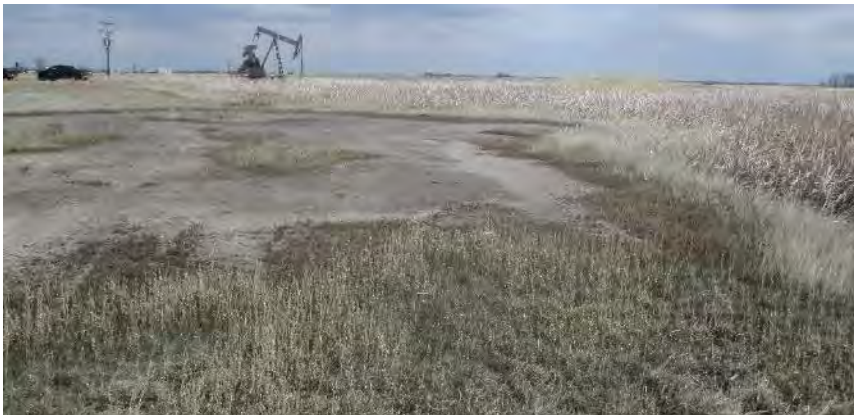
Photograph facing east-northeast off of an oilfield lease road, showing an extensive dead zone. Site is approximately 150 feet west of a pump jack. The site is on native grassland adjacent to wetlands to the south and east.

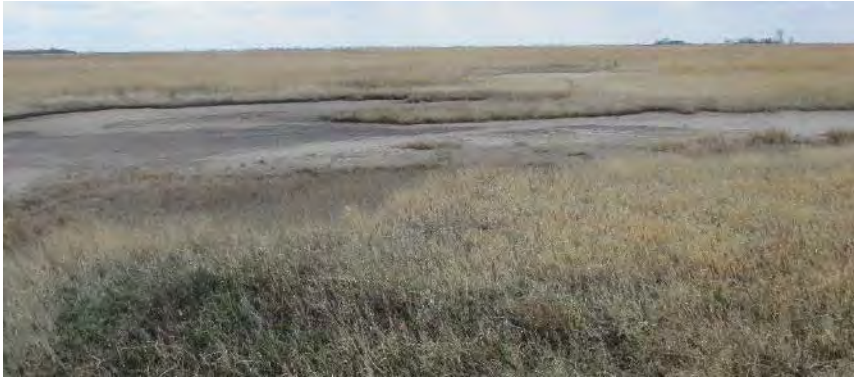
B21-16

Photograph facing south off of oilfield lease road showing two visually impacted areas. One area runs parallel to the road the other, smaller, area is located approximately 100 feet further south. The site is on native grassland.

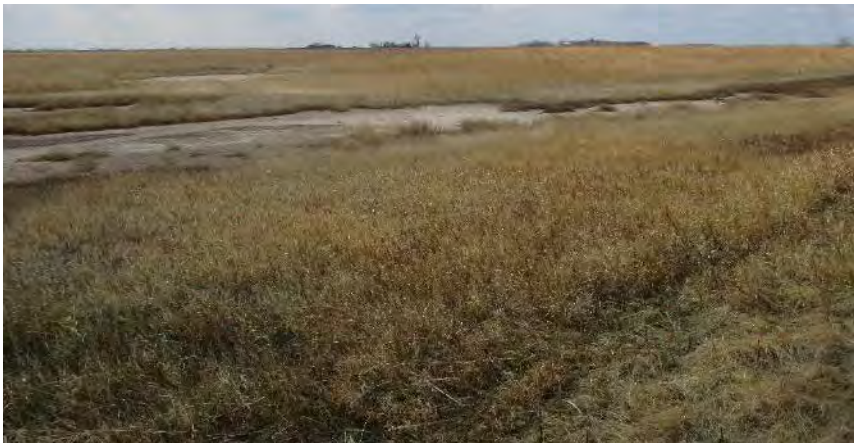
Photograph facing southwest off of oilfield lease road showing site along road, with extensive dead zones and stressed vegetation.

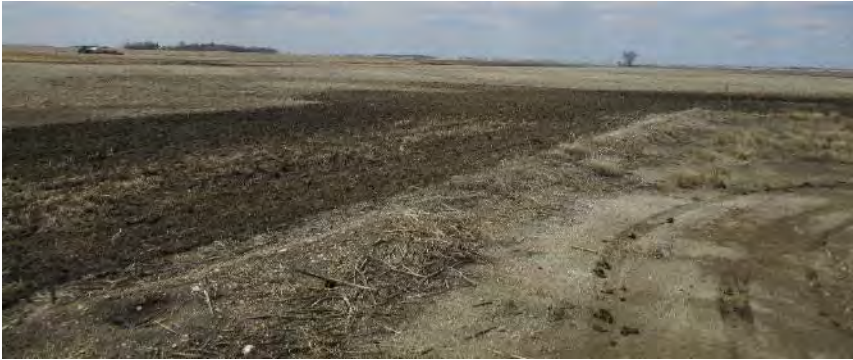
B21-17 (May 2018)

Photograph facing southwest off of an oilfield lease road showing no visual impact during the May 2, 2018 site visit due to recent agricultural work.

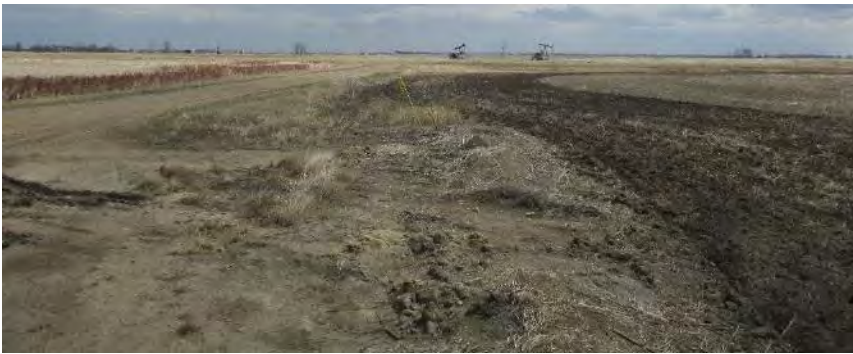
Photograph facing southeast off of an oilfield lease road showing no visual impact during the May 2, 2018 site visit due to recent agricultural work.

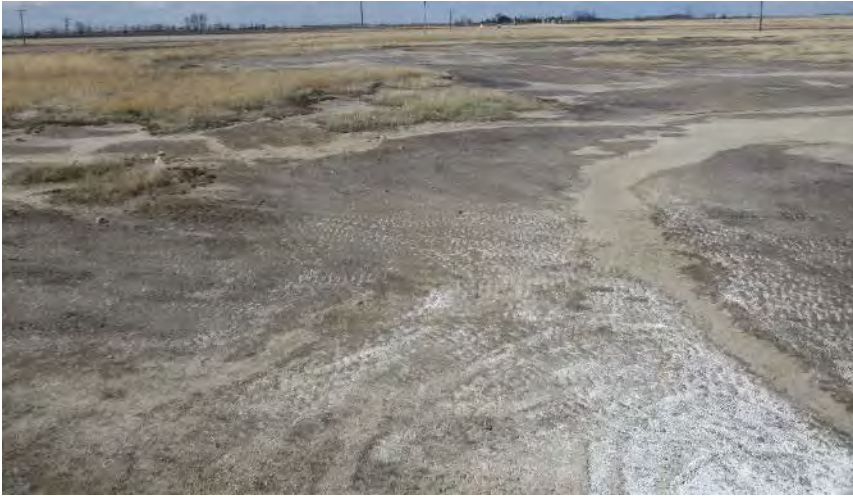
B21-18

Photograph facing north off of an oilfield lease road showing a visually impacted area. Extensive dead zones, salt crusts, and soil cracks were observed. The site is on native grassland adjacent to agricultural land.

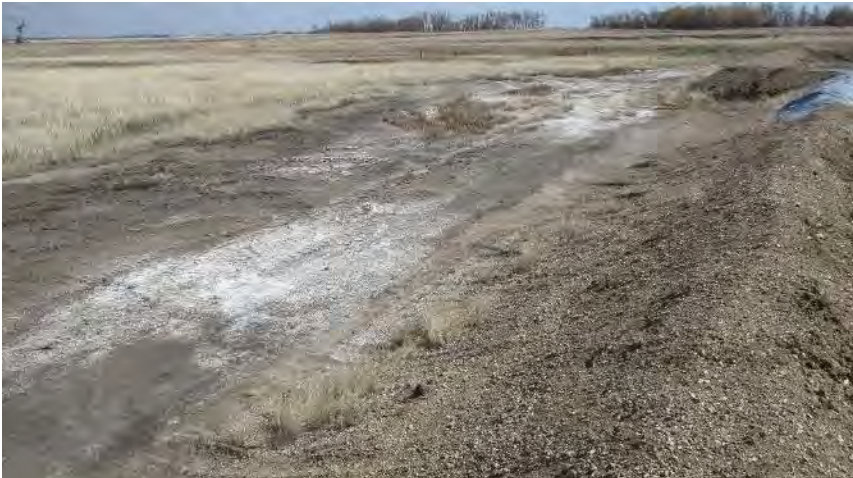
Photograph facing southeast off of oilfield lease road. Large section of salt crusting is visible along berm.

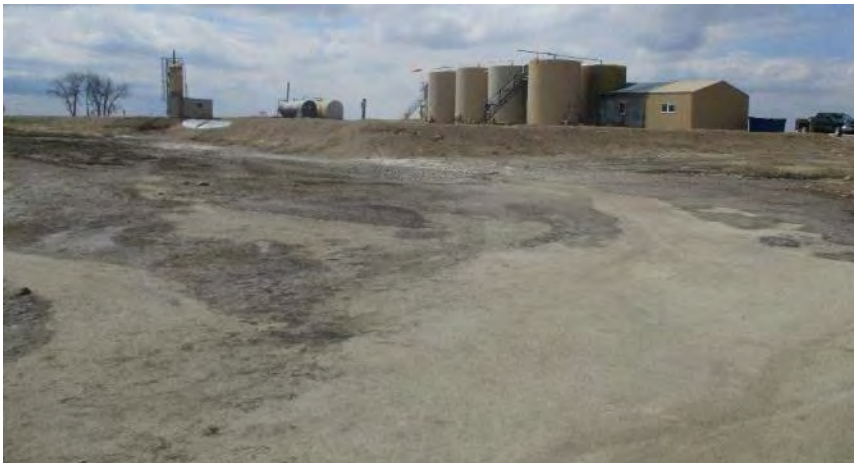
Photograph facing southwest off of an oilfield lease road. Large sections of barren ground, soil cracks, erosion, and salt crust along berm were observed.

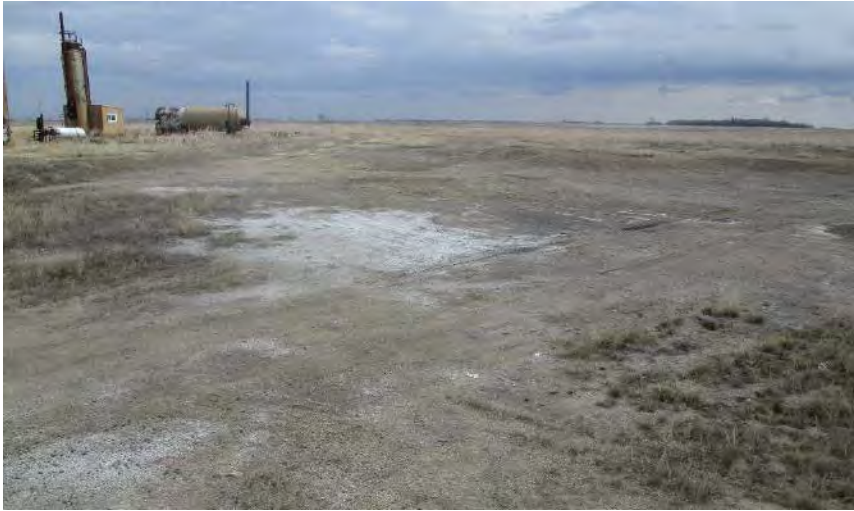
B21-20

Photograph facing northeast off of an oilfield lease road showing a visually impacted area. Extensive dead zones, salt crusts, and soil cracks were observed. The site is adjacent to an oilfield pad surrounded by agricultural land.

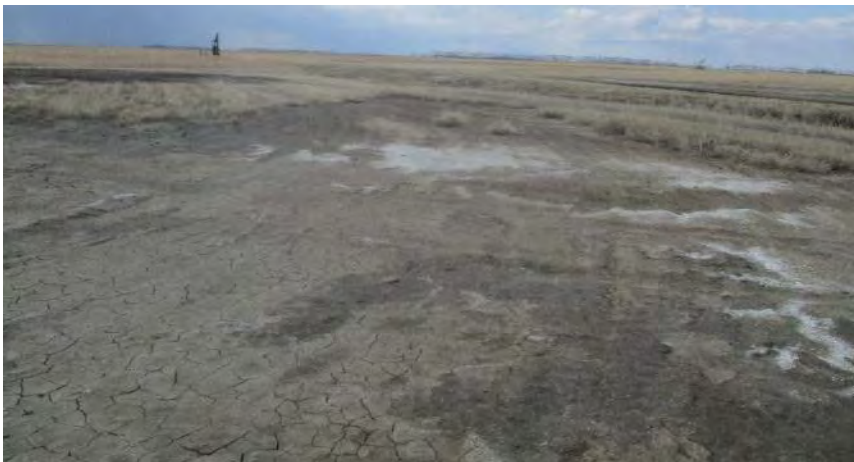
Photograph facing south off of an oilfield lease road showing soil cracks, salt crusts, and dead zones.

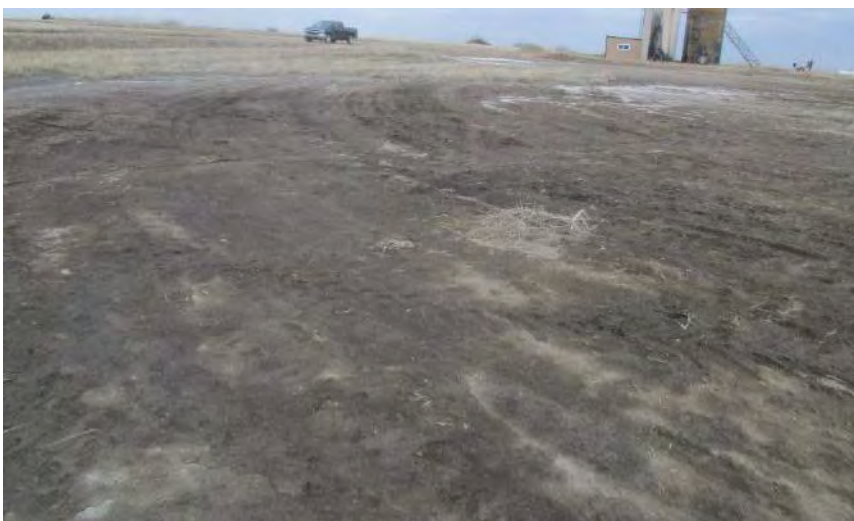
Photograph facing north off of an oilfield lease road showing patches of stressed vegetation and salt crusts.

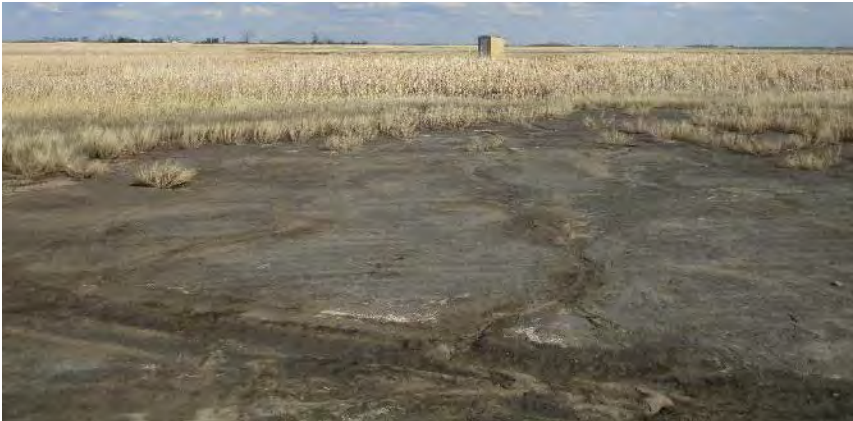
Photograph facing southeast off of oilfield lease road showing dead zone and erosion next to wetlands. A shack is located further southeast.

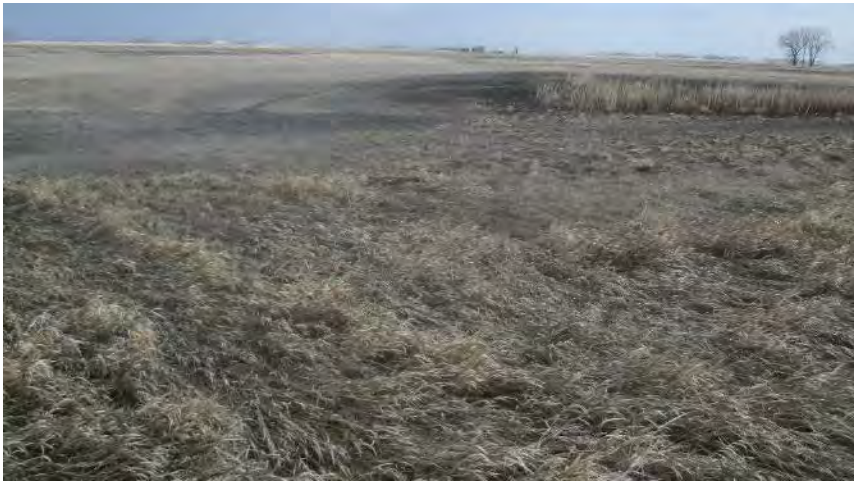
B21-22

Photograph facing northeast from 91st St NW. Site could not be accessed due to it being located on private agricultural land. No evidence of visual impacts in the agricultural field was apparent.

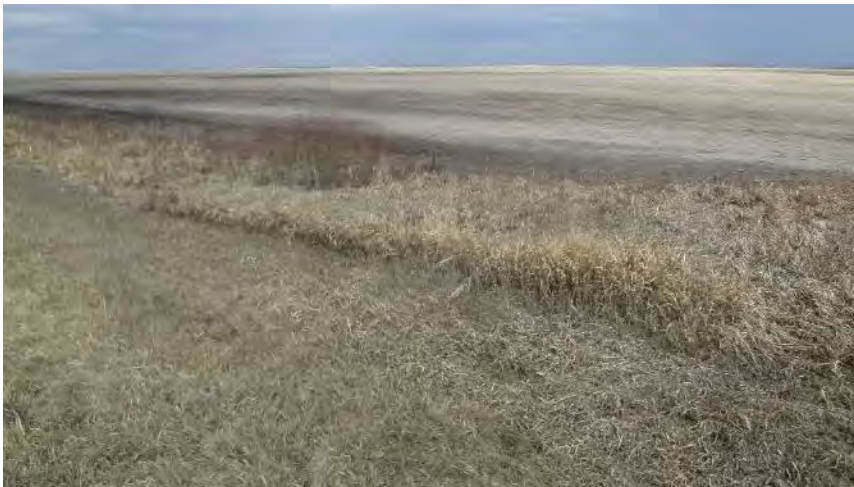
Photograph facing northwest from 91st St NW. Site could not be accessed due to it being located on private agricultural land.

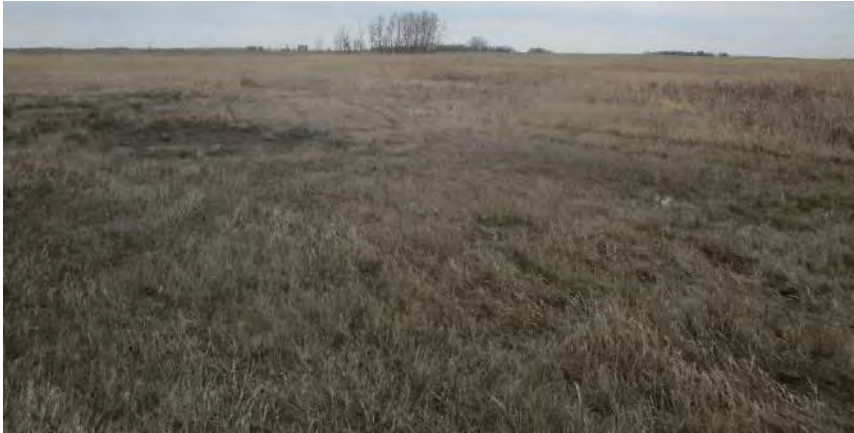
B21-23

Photograph facing south from an oilfield lease road. Site could not be accessed due to it being located on private land. No evidence of visual impacts at the site was apparent.

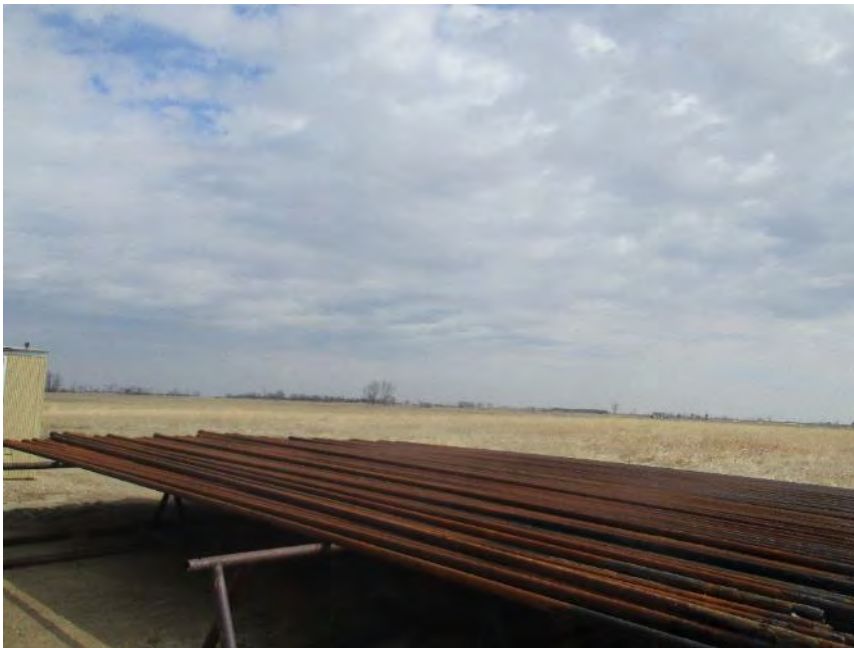
Photograph facing southwest from an oilfield lease road, with a shack and pipe rack on location. Site could not be accessed due to it being located on private land. No evidence of visual impacts at the site was apparent.

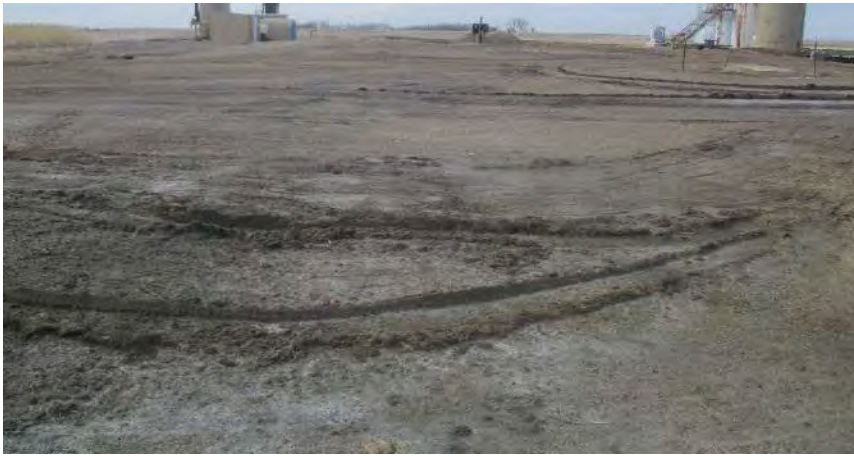
B21-25

Photograph facing south on an oilfield lease road showing salt crusts and barren soils. The site is partly used as an oil & gas facility.

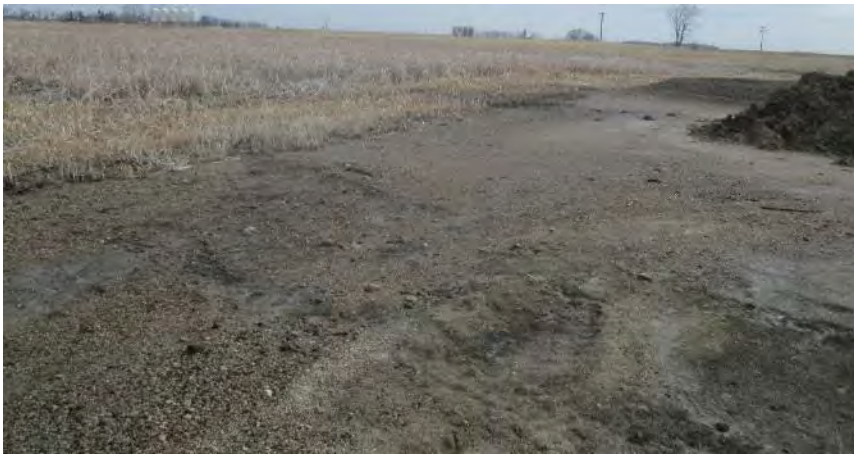
Photograph facing northeast from oilfield production pad showing dead zone and stressed vegetation.
