NDIC Brine Pond Study

Phase II: Site Assessments

June 25, 2018

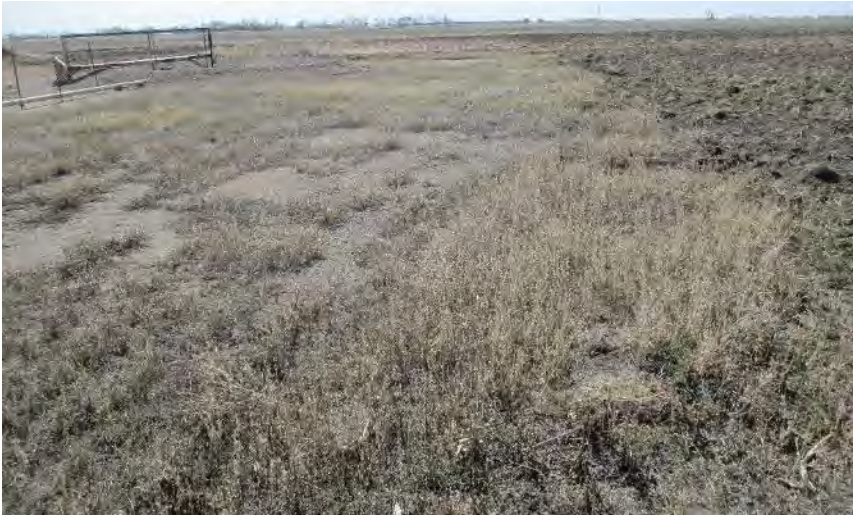
B22-1

Photograph facing south off of an oilfield lease road showing the visually impacted area. Stressed vegetation and some lighter soils were observed at the site.

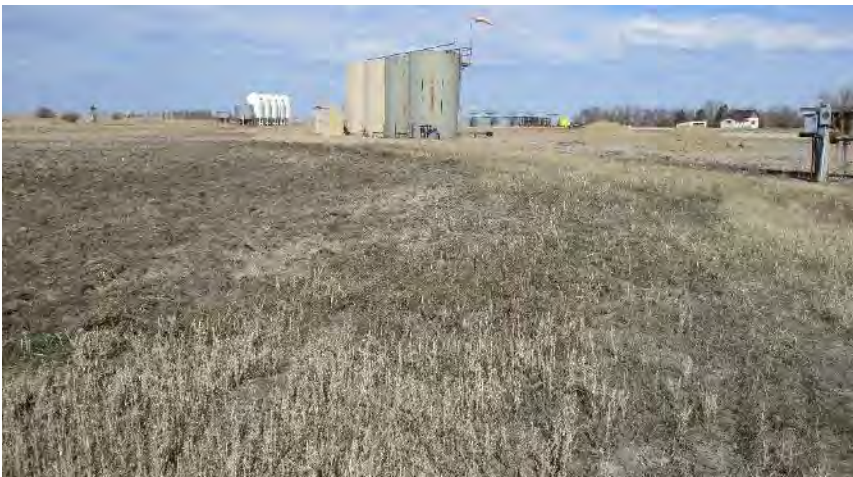
Photograph facing northwest off of an oilfield lease road showing the visually impacted area. Four aboveground storage tanks that are part of an oil & gas facility are visible. Residential and farming buildings are visible further in the background.

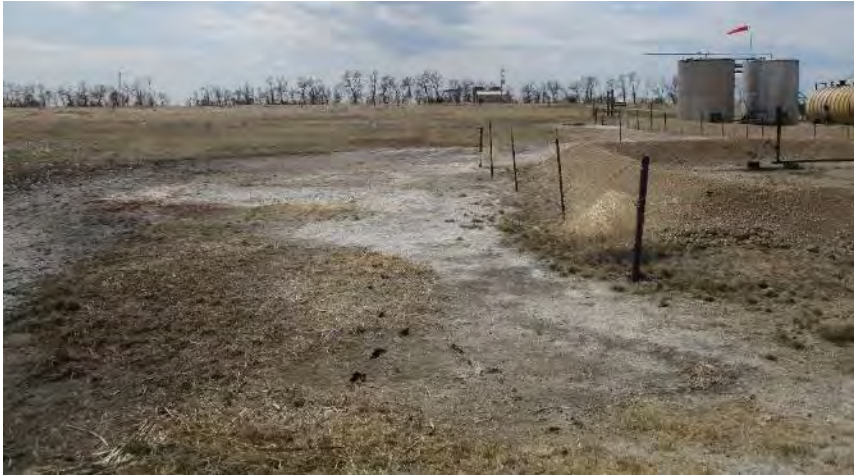
B22-2

Photograph facing south off of an oilfield lease road showing the visually impacted area. Dead zones, barren soils and salt crusts were observed in an approximately 20 feet by 20 feet area. The site is adjacent to oilfield production pad. Two aboveground storage tanks were observed.

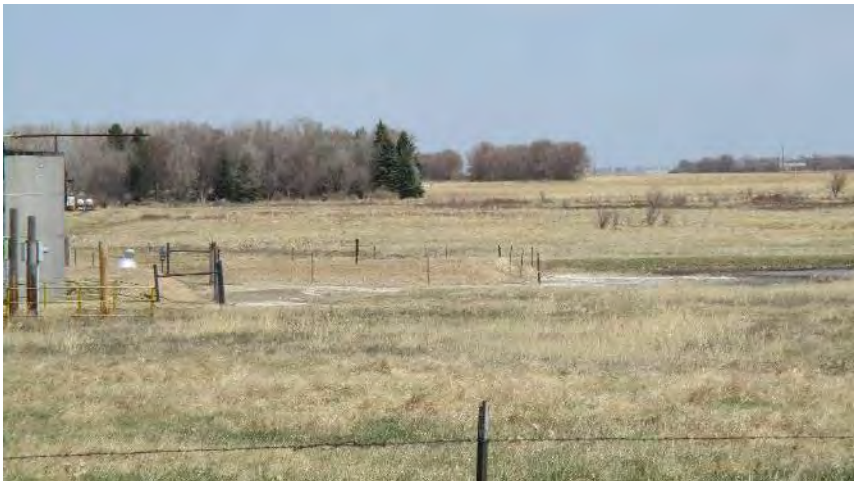
Photograph facing north off of 92nd St NW. A wetland is located adjacent to site. A large pond approximately 300 feet by 300 feet is located northeast of site.

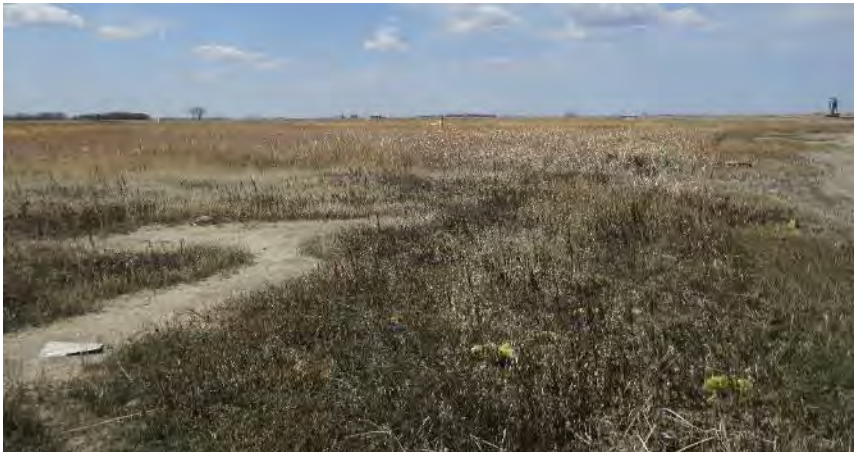
Photograph facing southwest off of an oilfield lease road showing the site. Wetlands can be seen in the background.

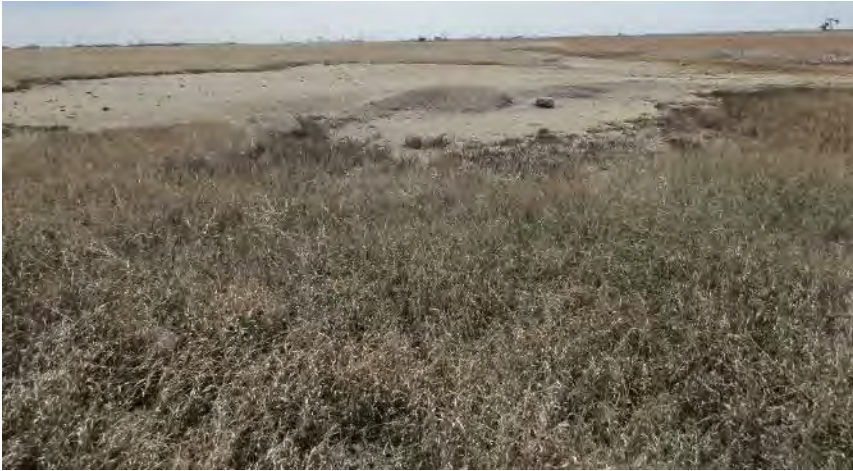
B22-5

Photograph facing south off of an oilfield lease road showing the site. Extensive dead zones and salt crusting were observed.

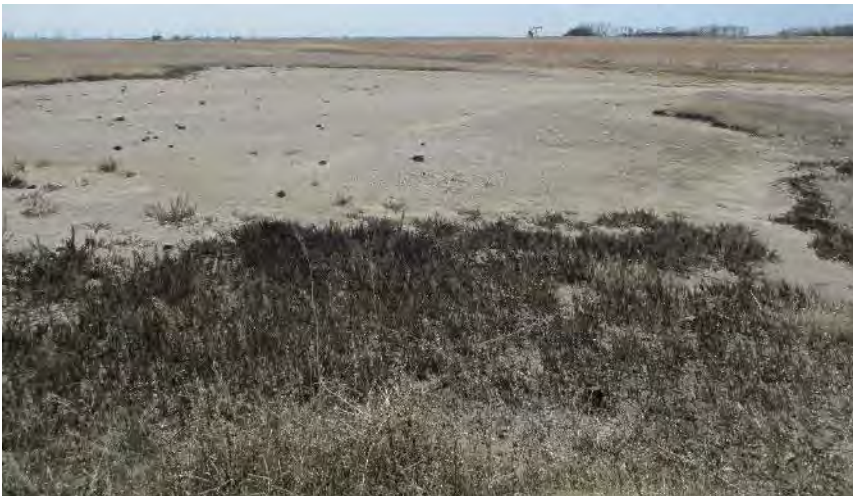
Photograph showing closer view of the visually impacted area.

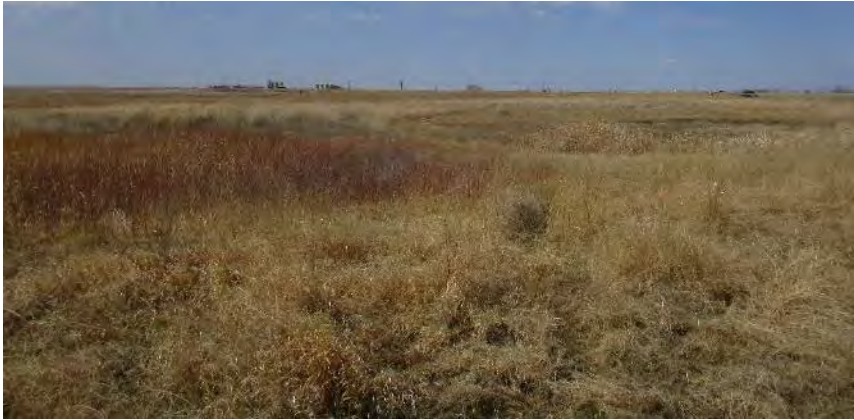
B22-6

Photograph facing north west off of an oilfield lease road showing the site. One of the ponds observed at the site can be seen in the background.

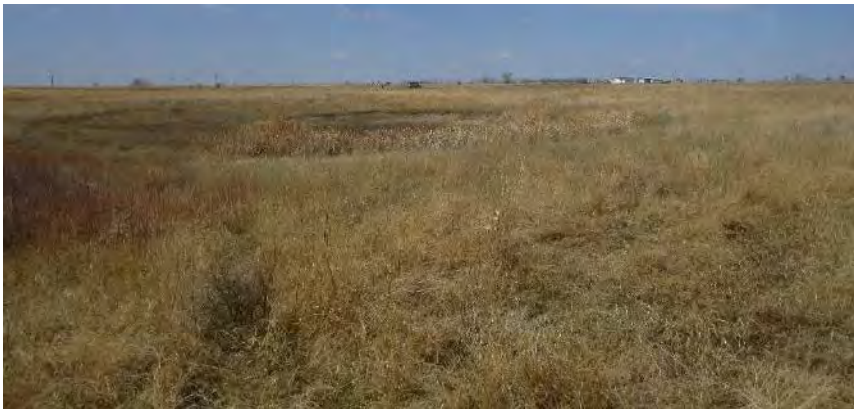
Photograph facing north/northwest off of an oilfield lease road showing the site. Residential properties are located approximately 2,000 feet further northwest from the site.

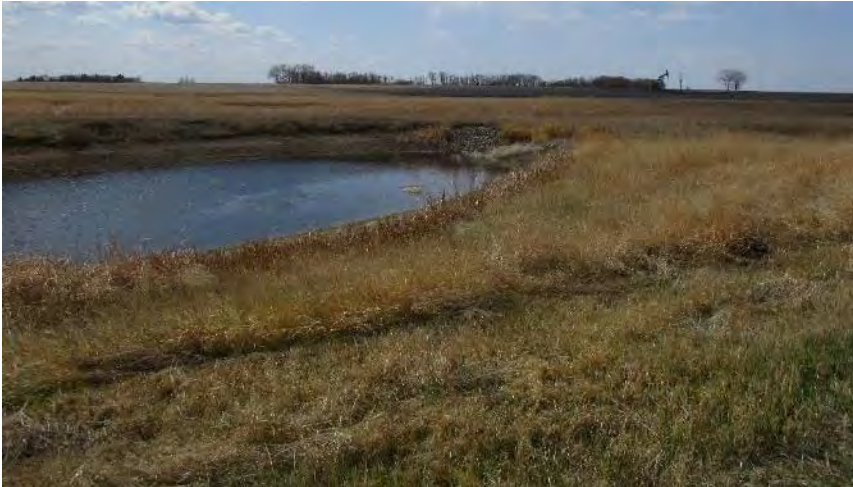
B22-7

Photograph facing west off of an oilfield lease road showing the site with the large pond observed.

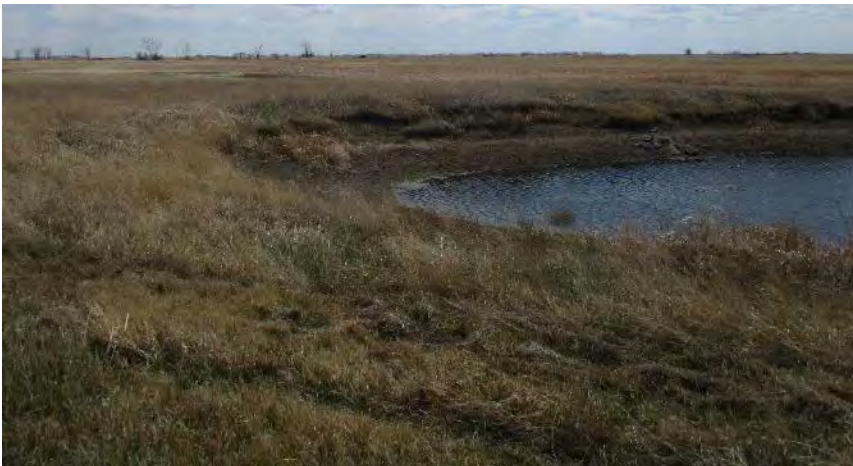
Photograph facing southeast off of an oilfield lease road showing the pond.

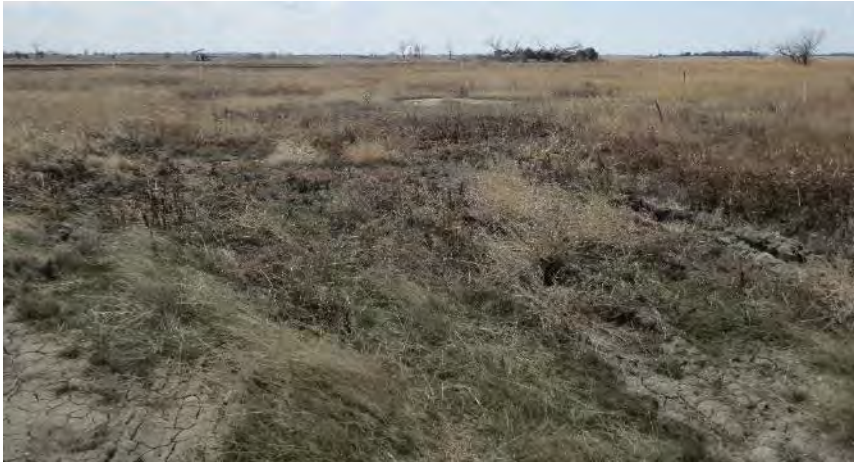
B22-8

Photograph facing south off of an oilfield lease road showing the site. Dead zones and stressed vegetation were observed.

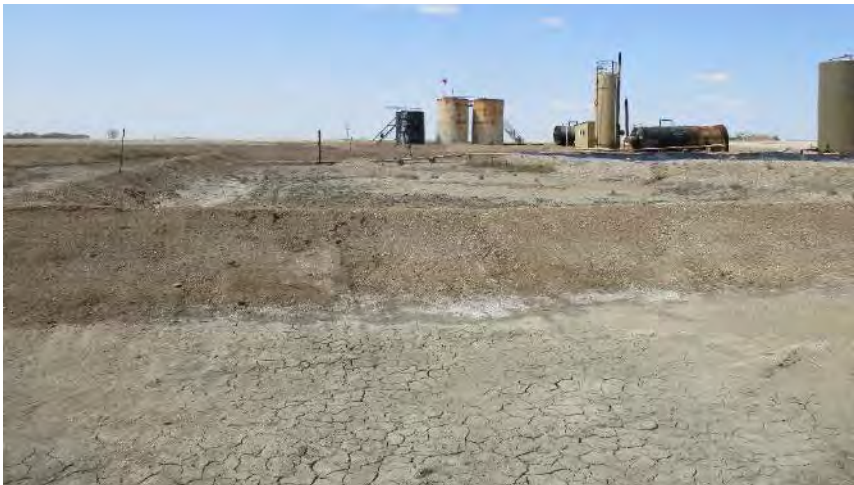
Photograph facing west off of an oil & gas pad showing soil cracks, salt residues, and barren zones.

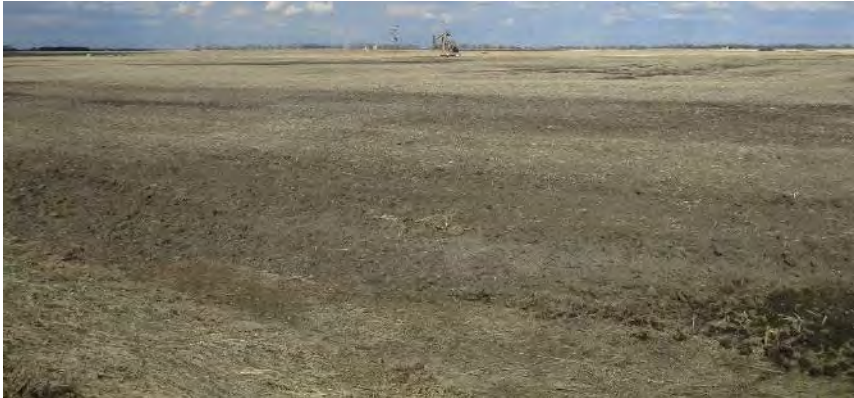
B22-9

Photograph facing northeast off of 24th Ave NW showing an area of barren soils with no vegetation.

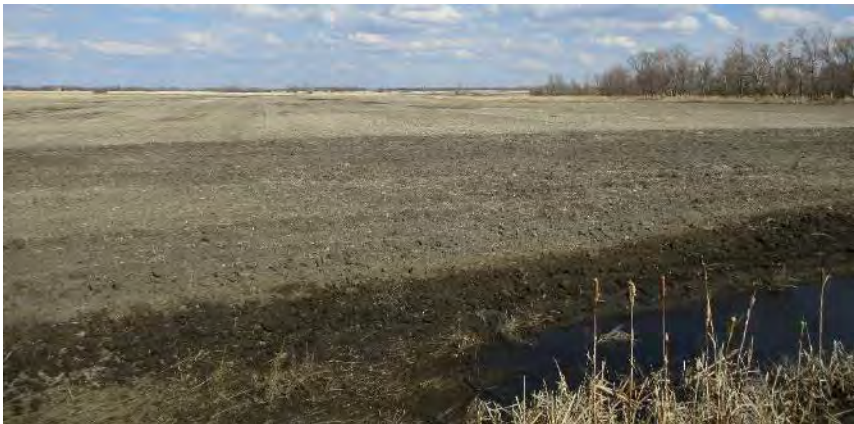
Photograph facing south off of 24th Ave NW showing the visually impacted area. Standing water was observed in a ditch along 24th Ave NW, as can be seen in the bottom right-hand corner of the photograph.

B22-9 was inspected on May 2nd, 2018, and is located approximately 300 feet east of 24th Ave NW and 500 feet south of an oilfield lease road. The site is currently used for agricultural purposes, and is surrounded by agricultural fields. A pump jack and a wetland were apparent further to the north. Visual impacts were observed, including an area of little to no vegetation and patchy ground; the area of visual impacts measured approximately 150 feet by 50 feet. The site topography is generally flat, and drains to the area where the visual impacts were observed, which appeared to be a low spot compared to the rest of the site.

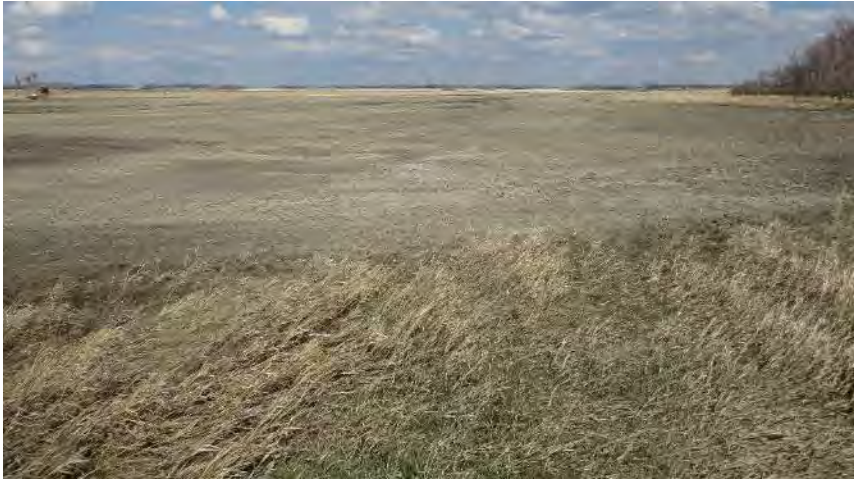
Photograph facing east off of 24th Ave NW showing the site. Barren areas with no vegetation and some white residues were observed from a distance.

B22-10 was inspected on May 2nd, 2018, and is located approximately 300 feet east of 24th Ave NW. The site could not be accessed at the time of the site visit. The site is currently used for agricultural purposes. Visual impacts were observed from a distance, including barren patches with no vegetation and white surficial staining. Measurements of the impacted area could not be obtained due to access limitations. A wetland was observed to the west of the site, and agricultural fields surround the site. The site is generally flat and drains to the southwest.

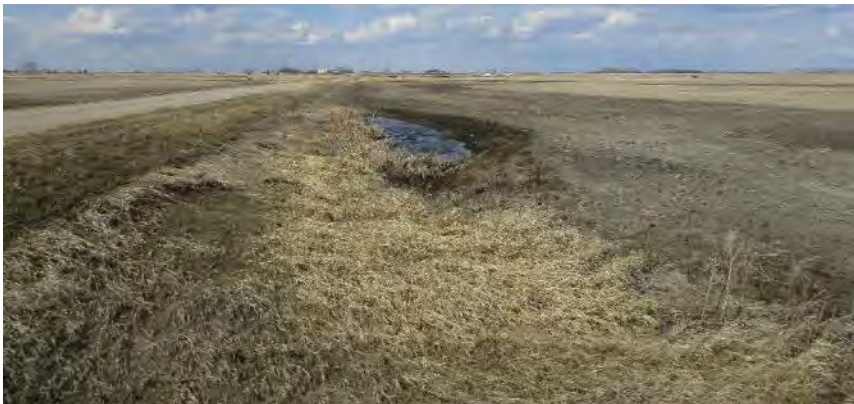
Photograph facing north off of 24th Ave NW showing standing water in a ditch along the road.

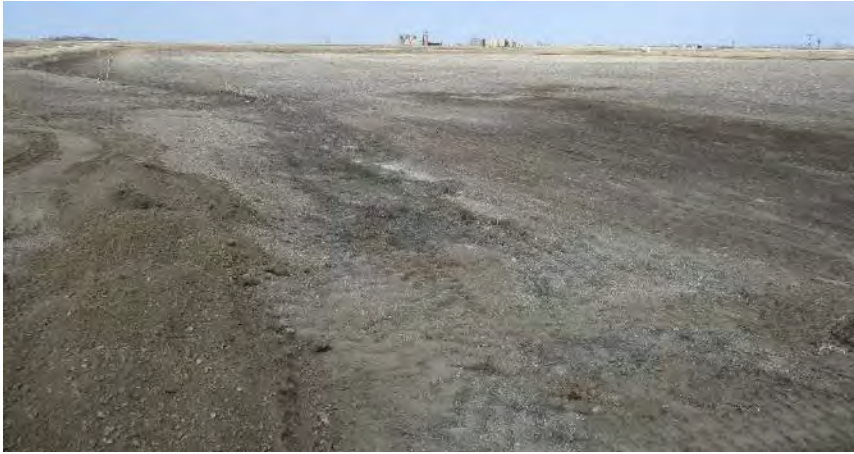
Photograph facing west off of an oilfield lease road showing stressed vegetation, dead zones, and salt crusts at the site.

B22-11 was inspected on May 3rd, 2018, and is located approximately 500 feet east of 24th Ave NW and 10 feet north of the terminating point of an oilfield lease road. The site is currently used for agricultural and oil & gas purposes. A pump jack was apparent to the south, on the lease road. Agricultural fields surround the site otherwise. Visual impacts were observed, including stressed vegetation, a lack of vegetation, and apparent salt crusting; the area of visual impacts measured approximately 50 feet by 20 feet. The site topography is generally flat and drains to the east/southeast. An underground power line was observed to the southeast.

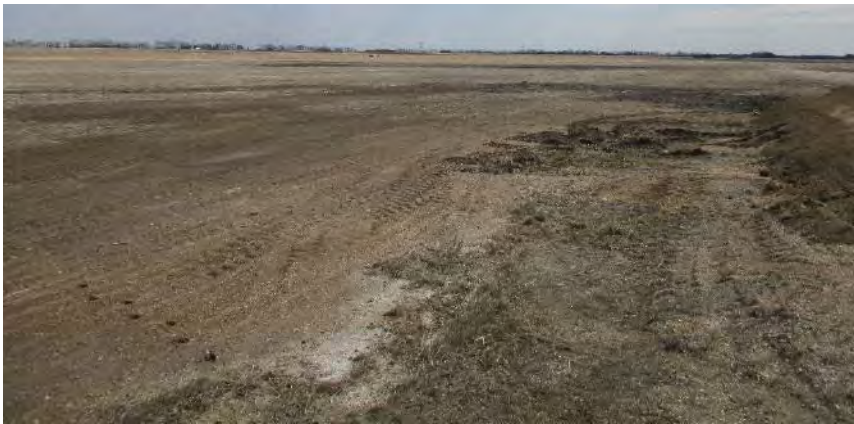
Photograph facing east off of an oilfield lease road showing stressed vegetation, dead zones, and salt crusts.

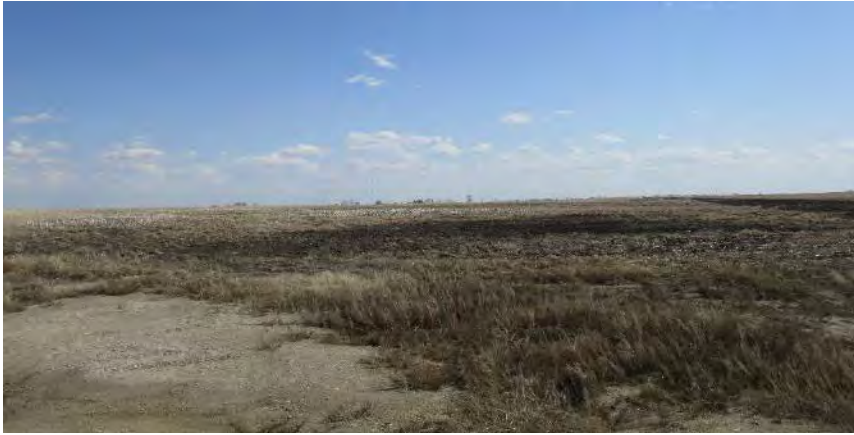
Photograph facing south off of an oilfield lease road showing the site. The site could not be accessed at the time of the site visit.

B22-12 was inspected on May 3rd, 2018, and is located approximately 500 feet west of 23rd Ave NW and 500 feet southeast of an oilfield lease road. The site could not be accessed at the time of the site visit. The site is currently used for agricultural purposes, and is surrounded by agricultural fields. No visual impacts could be observed at the time of the site visit due to access limitations. The site topography is generally flat and slightly undulating, with a slight rise in topography at the location of the site.

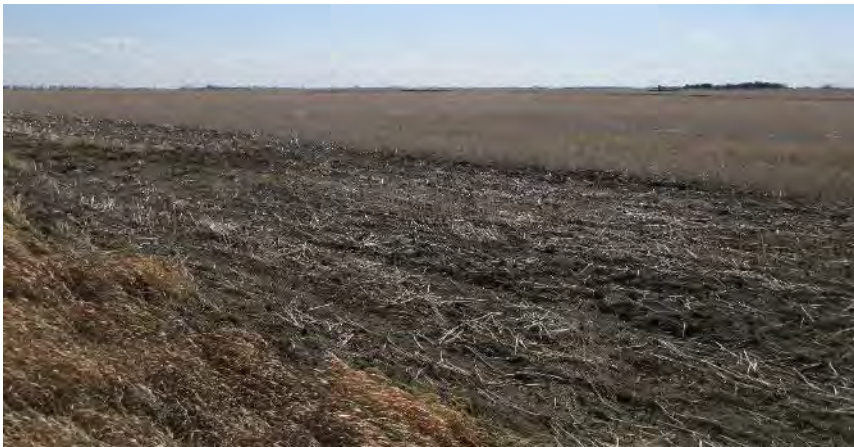
Photograph facing southeast off of an oilfield lease road showing the site.

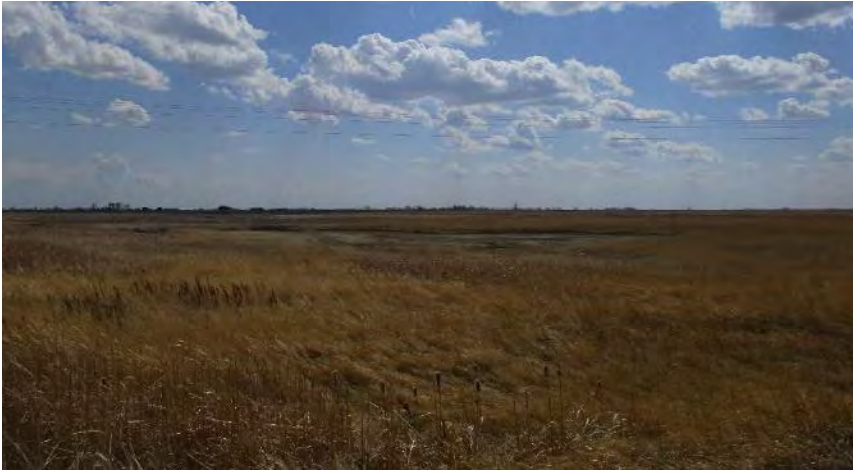
Photograph facing south off of 91st St NW showing barren soils and stressed vegetation at the site.

B22-13 was inspected on May 3rd, 2018, and is located approximately 500 feet south of 91st St NW. The site is located in a wetland area, and was observed to show visual evidence of stressed vegetation and barren grounds. The largest of these visually impacted areas was approximately 100 feet by 100 feet, with a smaller area approximately 20 feet by 20 feet also evident. Wetlands and natural grassland surround the site. The site topography is undulating, with several depressions on the site, and generally drains to the north. Aboveground powerlines were observed to the north along 91st St NW.

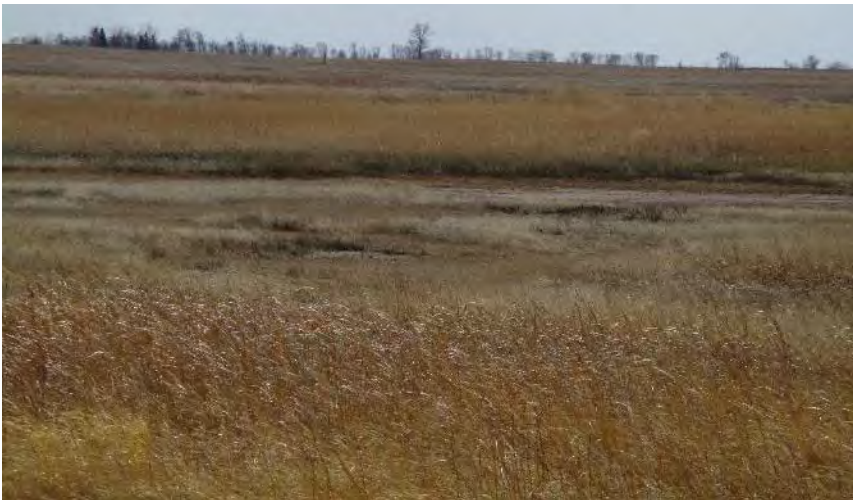
Photograph facing south off of 91st St NW showing a closer view of the impacted area.

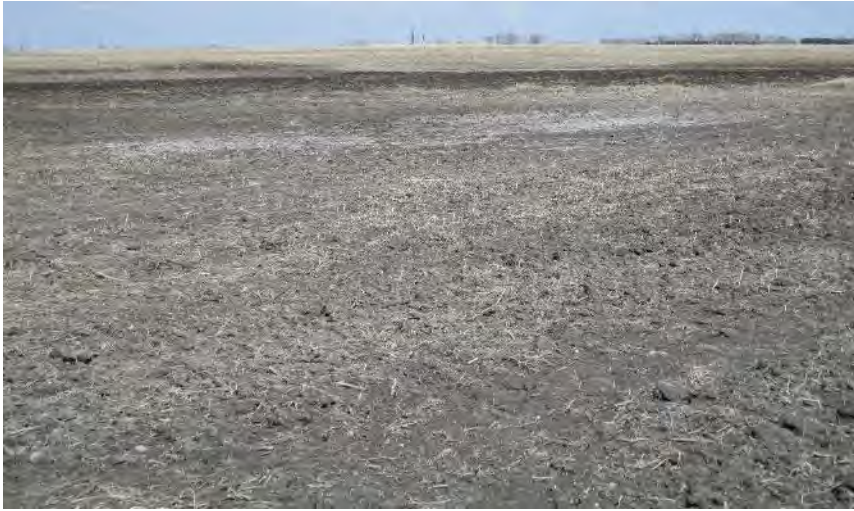
Photograph facing north off of 91st St NW showing stressed vegetation, tan to grey soils, and potential salt crusting at the site.

B22-14 was inspected on May 3rd, 2018, and is located approximately 100 feet north of 91st St NW. The site is currently used for agricultural purposes, and is surrounded by agricultural fields. Visual impacts were observed, including stressed vegetation, gray soils, and minor salt crusting; the area of visual impacts measured approximately 600 feet by 100 feet. Wetlands were also observed along the 91st St NW roadside ditch to the south of the site. The site topography is generally flat and drains towards the south.

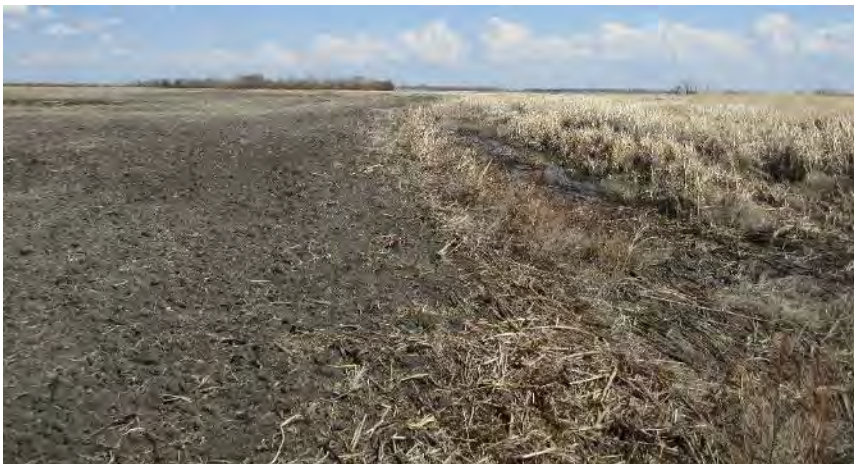
Photograph facing east off of 91st St NW showing the impacted area and adjacent wetland. The wetland runs along road and was observed with standing water.

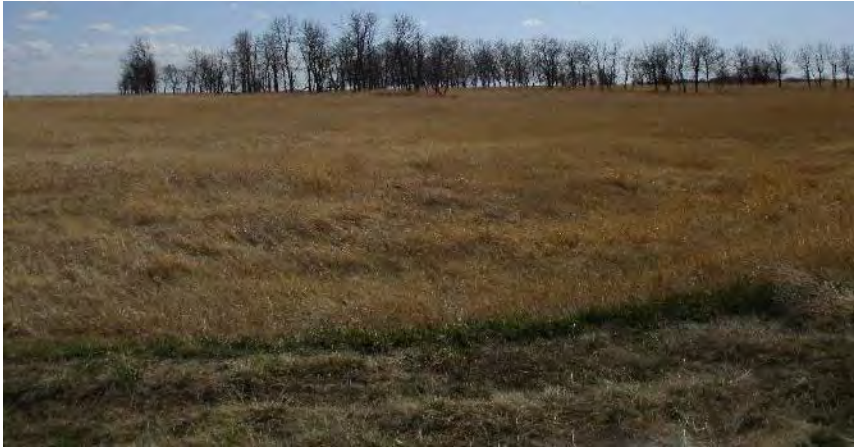
Photograph facing north off of an oilfield lease road showing the site. No visual impacts were observed at the time of the site visit.

B22-15 was inspected on May 3rd, 2018, and is located approximately 200 feet north of an oilfield lease road. The site is currently native grassland, and is surrounded by native grassland. No visible impacts were observed at the time of the site visit. A pond was observed approximately 100 feet west of the site roughly 100 feet by 200 feet in size. The site topography is generally flat and drains slightly to the west.

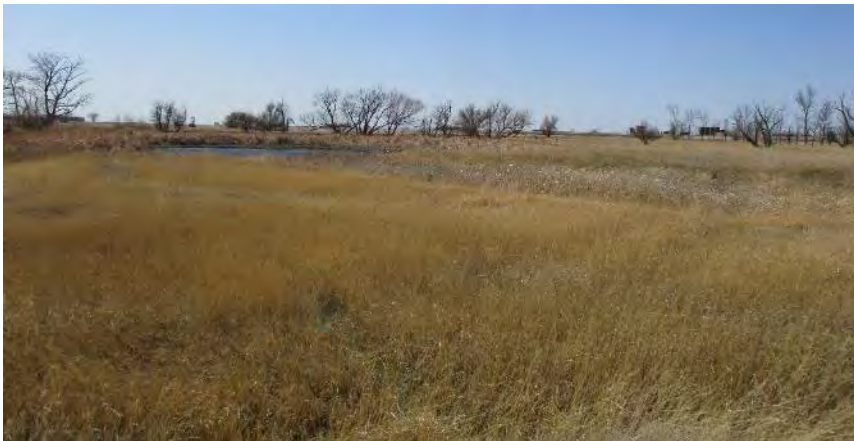
Photograph facing northwest off of an oilfield lease road, showing the site. A pond is visible in the background.

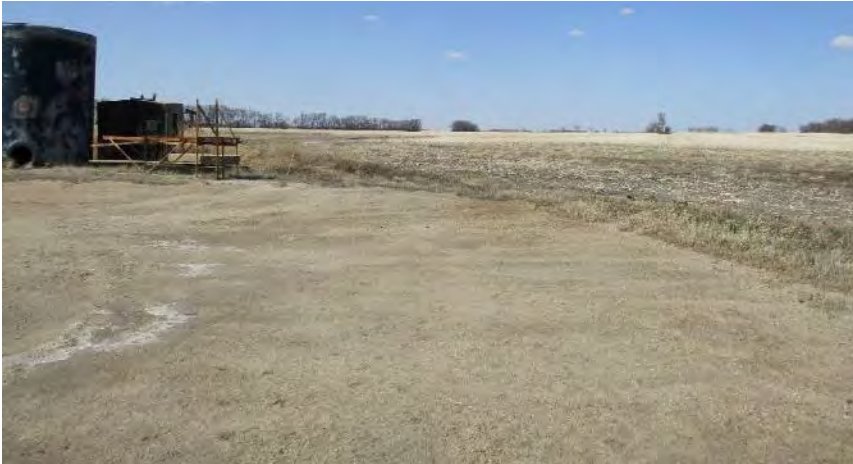
Photograph facing north off of oilfield pad and staging area showing salt crusting, soil cracking, and dead zones. Stressed vegetation was observed in the agricultural field.

B22-16 was inspected on May 3rd, 2018, and is located approximately 1,000 feet north of 91st St NW. The site is currently used as part of an oil & gas equipment staging area. Oilfield equipment were observed at the site, including 10 aboveground storage tanks, injection units, a separator, a pump jack, and other miscellaneous oilfield equipment. Visual impacts were observed, including salt residues, cracking of grayish colored soils, and extensive barren soils lacking vegetation; the area of visual impacts measured approximately 200 feet by 100 feet. Agricultural fields surround the site. The site topography is generally flat and drains predominantly to the south.

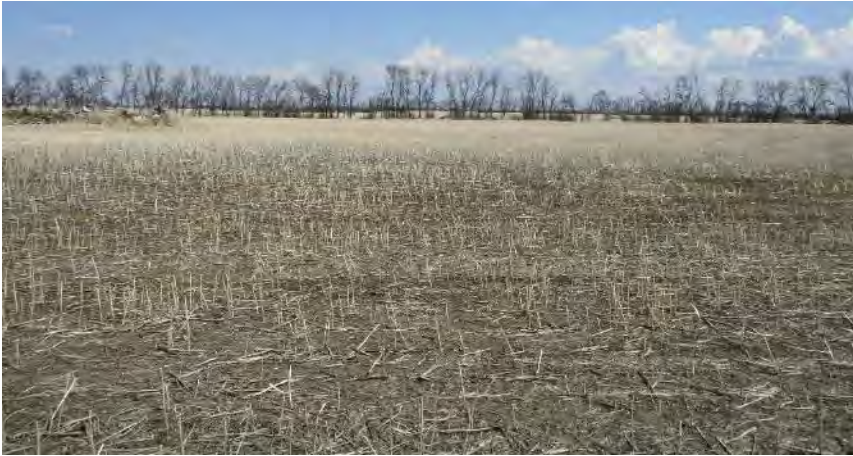
Photograph facing east off of an oilfield pad showing slightly stressed vegetation in an agricultural field.

B22-17 was inspected on May 3rd, 2018, and is located approximately 750 feet east of 23rd Ave NW and 50 feet northeast of an oil & gas facility, which houses a shack used by Scout EP. The site is located on agricultural land and showed slightly stressed vegetation, but impact observed was minimal. The area of slightly stressed vegetation measured approximately 10 feet by 10 feet. The site is surrounded by agricultural lands. The site is generally flat, with a slight depression towards the center of the site.

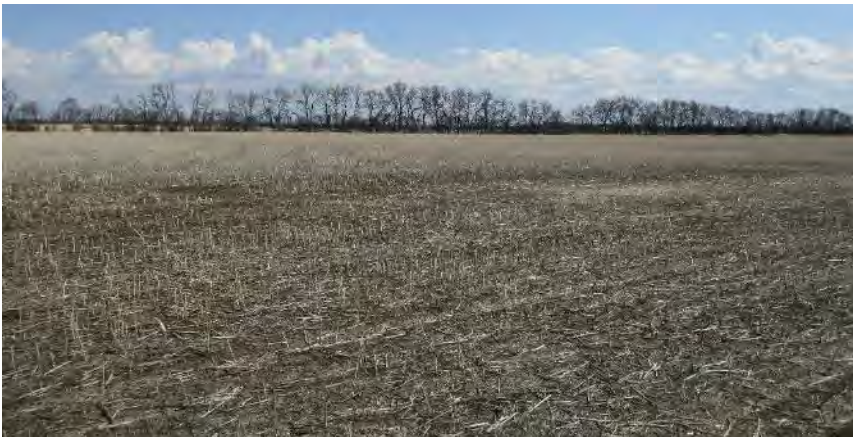
Photograph facing southeast off of an oilfield pad showing slightly stressed vegetation.

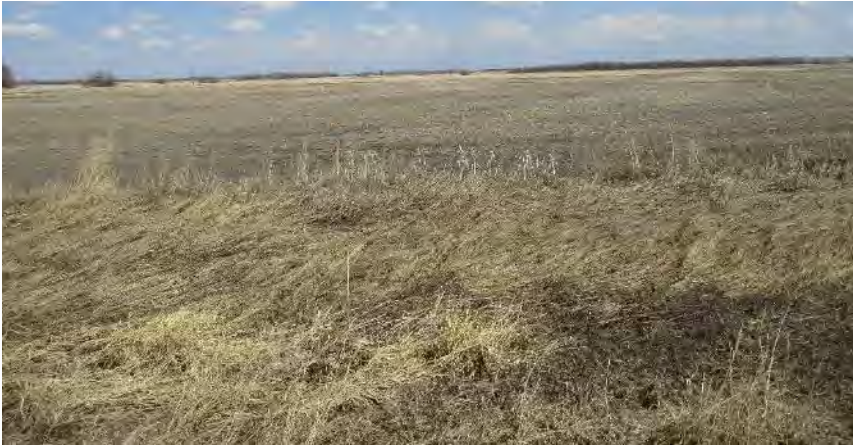
Photograph facing east off of 23rd Ave NW showing the site further to the east. The site could not be accessed at the time of the site visit.

B22-18 was inspected on May 3rd, 2018, and is located approximately 200 feet east of 23rd Ave NW and 400 feet south of 91st St NW. The site could not be accessed at the time of the site visit. The site is currently used for agricultural purposes. Wetlands lie to the east and north, with agricultural land to the west and south. No visual impacts could be observed at the time of site visit due to access limitations. The site topography is relatively flat, and a drainage direction could not be observed at the time of site visit.

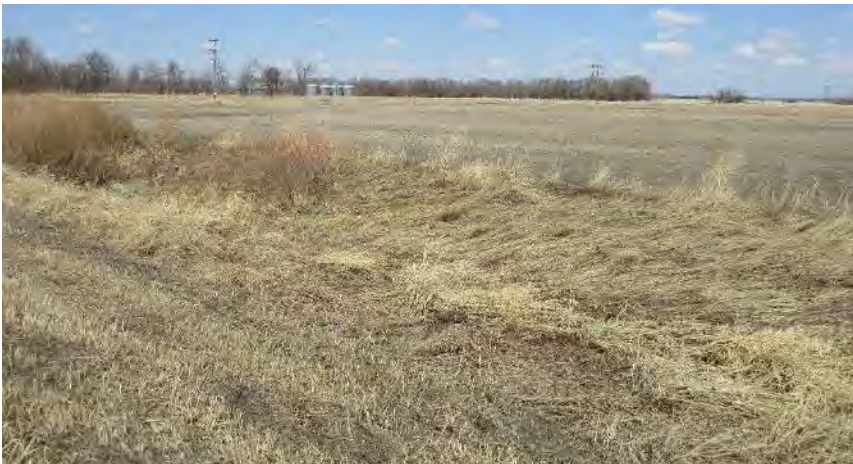
Photograph facing north east off of 23rd Ave NW. Grain silos were observed northeast of site and aboveground powerlines run along 91st St NW.

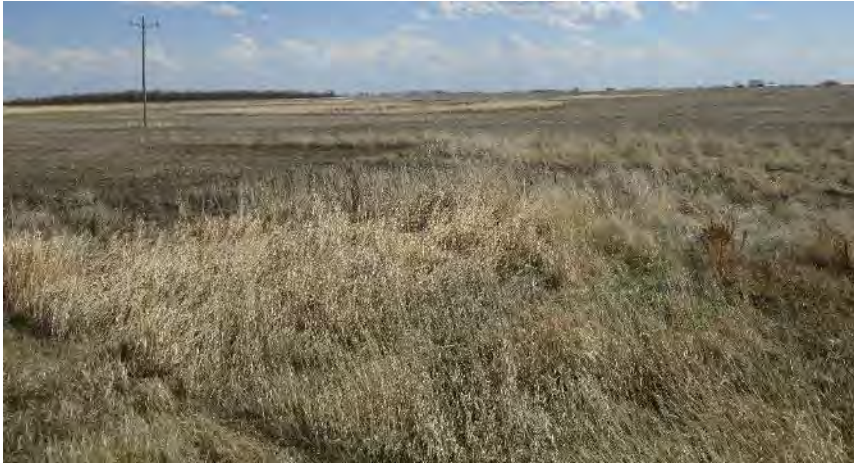
Photograph facing southeast off of 91st St NW showing the site further southeast. The site could not be accessed at the time of the site visit. No visual impacts could be observed from a distance. Aboveground powerlines run along 91st St NW.

B22-19 was inspected on May 3rd, 2018, and is located approximately 500 feet south of 91st St NW. The site could not be accessed at the time of the site visit. The site appears to have been reclaimed, and is currently used for agricultural purposes. Visual impacts were not observed from a distance at the time of the site visit. Agricultural lands lie to the south, east, and west. A wetland was observed to the west. The site topography is generally flat and appears to drain to the south and southwest.

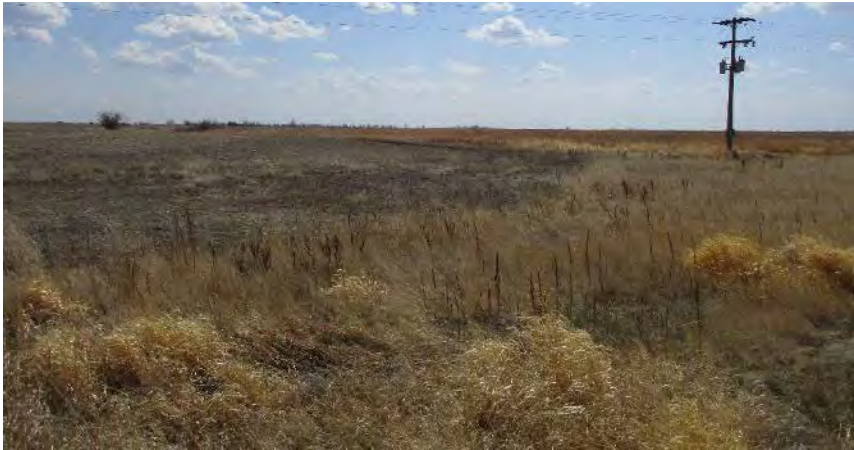
Photograph facing southwest off of 91st St. NW showing the site. A wetland is located to the west of the site.

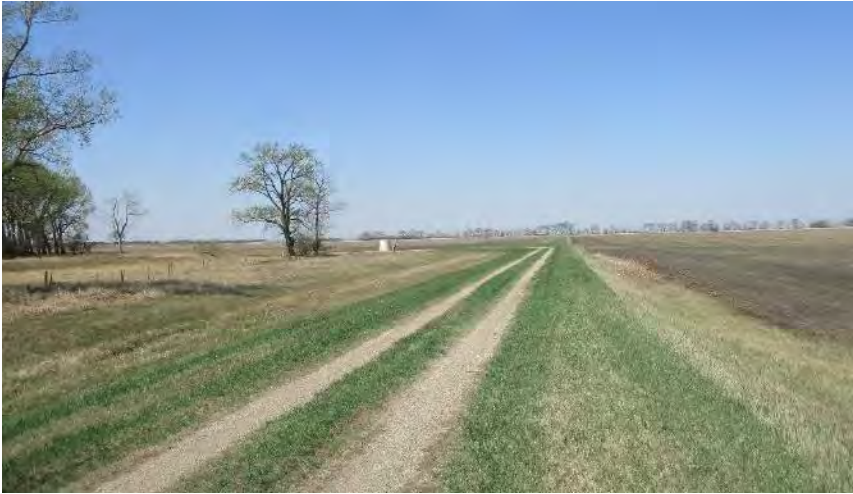
Photograph facing west off of 12th Ave NW showing the site. The site could not be accessed at the time of the site visit. No visual impacts were observed from a distance.

B23-1 was inspected on May 15th, 2018, and is located 500 feet west of 12th Ave NW and 50 feet south of an oilfield lease road. The site could not be accessed at the time of the site visit. The site is currently used for agricultural purposes. Agricultural fields lie to the north, west, and south. An oil & gas facility was observed to the east, and consisted of a single shack. Grasslands lie further to the east, before 12th Ave NW. Visual impacts could not be observed from a distance at the time of the site visit. The site topography is predominantly flat, but drainage direction could not be determined due to access limitations.

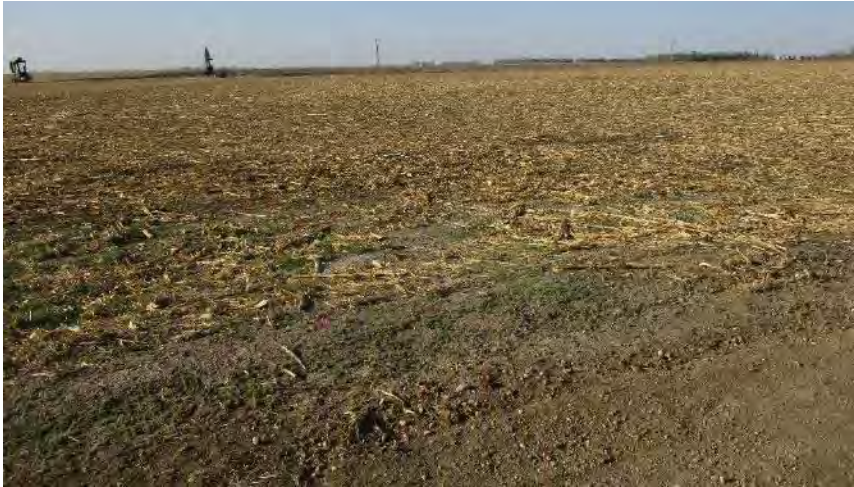
Photograph facing south off of an oilfield lease road showing the site. No visual impacts were observed.

B24-1 was inspected on May 15th, 2018, and is located approximately 100 feet west of an oilfield lease road. The site is currently used for agricultural purposes, and is surrounded by agricultural fields. An oil & gas facility was observed to the northeast, consisting of a heater treater, shack and a storage tank. Visual impacts were not observed at the time of the site visit. A slight depression was observed at the site in the middle of the agricultural field. The site topography is generally flat and drains towards the depression.

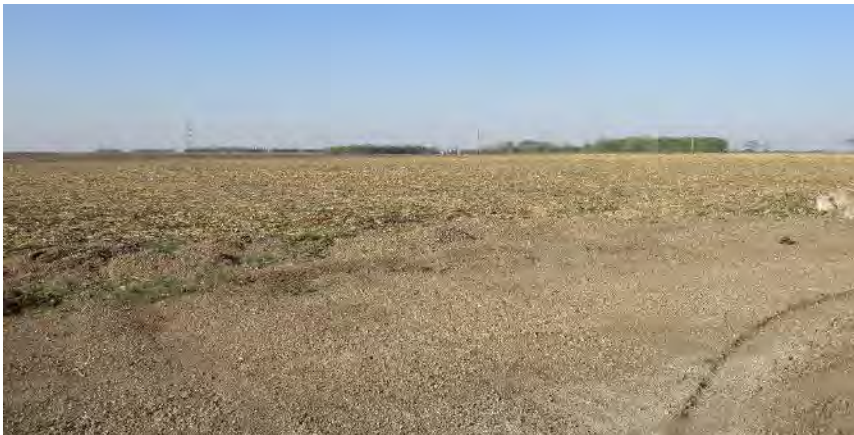
Photograph facing southwest off of an oilfield lease road. Aboveground powerlines are visible in the background, approximately 500 feet south of site.

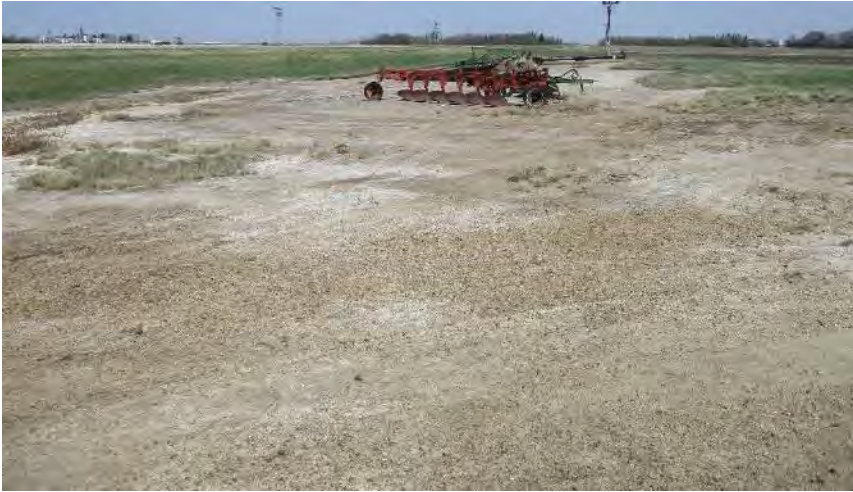
Photograph facing north off of an oilfield lease road showing the visually impacted area. Extensive dead zones, cracks, and salt crusts are visible. Aboveground powerlines were observed at the site running along 10th Ave NW

B24-2 was inspected on May 15th, 2018, and is located approximately 50 feet east of 10th Ave NW and 50 feet north of an oil & gas facility. The site is currently a combination of natural grassland, agricultural field, and an oil & gas facility. The oil & gas facility consisted of a heater treater, storage tank, and shack. Agricultural fields lie to the north, east, and west. Visual impacts were observed, including an area of barren soil with little to no vegetation and salt crusting; the area of visual impacts measured approximately 100 feet by 100 feet. The site topography is generally flat and drains south and west. Aboveground powerlines were observed over the site, along the east side of 10th Ave NW. Farming equipment were also observed on the site.

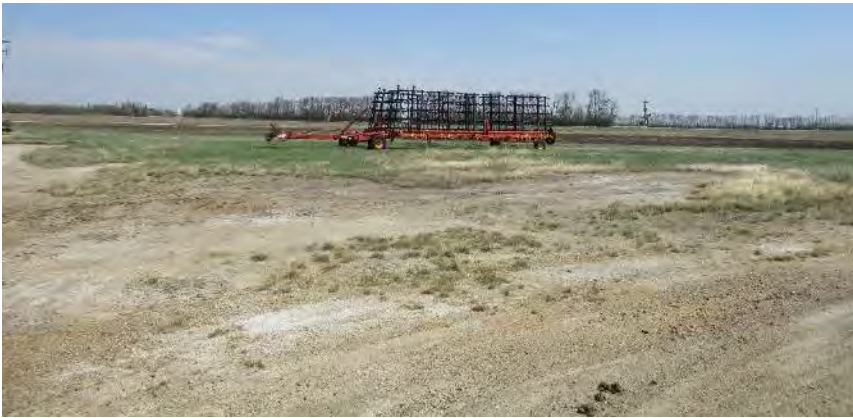
Photograph facing northeast off of an oilfield lease pad showing the visually impacted area. Farming equipment is parked on-site.

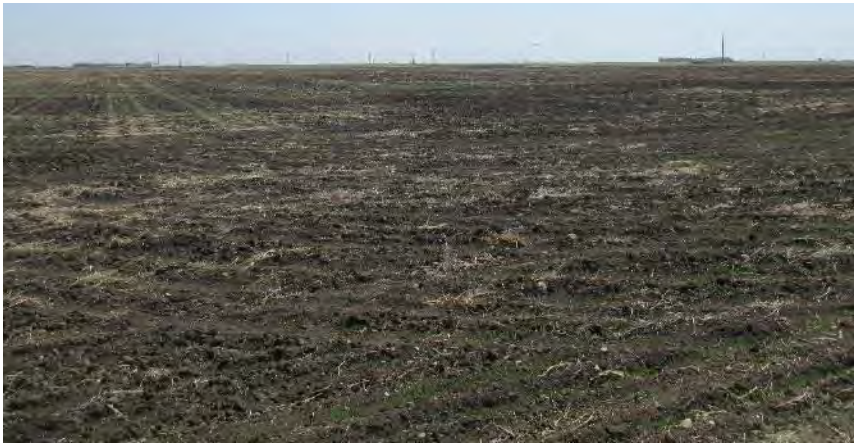
B24-3 (May 2018)

Photograph facing southeast off of an oilfield lease road showing a plowed agricultural field. During the May 15, 2018 inspection, slight impacts were noted, such as lighter colored soils and some stressed vegetation.

B24-3 was inspected on May 15th, 2018 and is located approximately 500 feet north of 94th St NW and 100 feet southeast of an oilfield lease road. The site is currently used as an agricultural field and was recently plowed. The site is also surrounded by agricultural fields. An oil & gas facility was observed to the west, consisting of a single shack. Slight visual impacts were observed, including some slightly stressed vegetation; the area of visual impacts measured approximately 25 feet by 25 feet. The site topography is generally flat and drains to the east. Aboveground powerlines were observed to the south of the site, along 94th St NW.

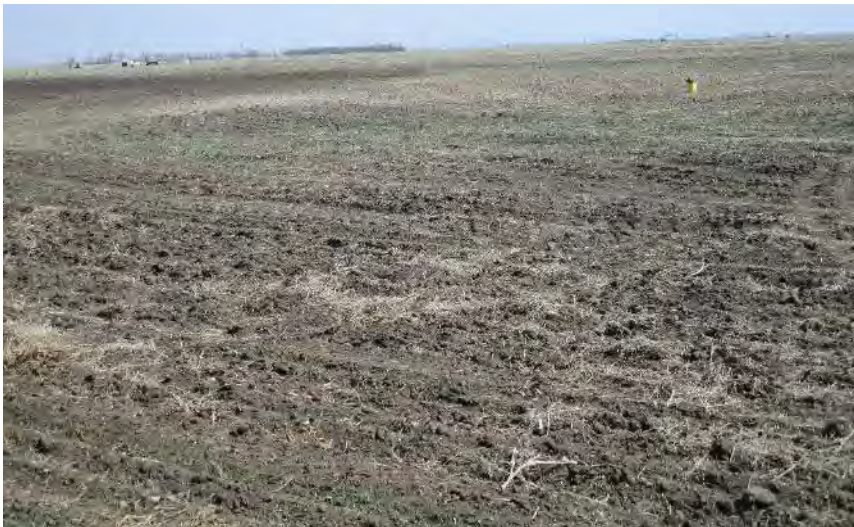
Photograph facing east off of an oilfield lease road showing the visually impacted area. Lighter soils and stressed vegetation are visible towards the left side of the photograph. Impacts appear to be minimal.

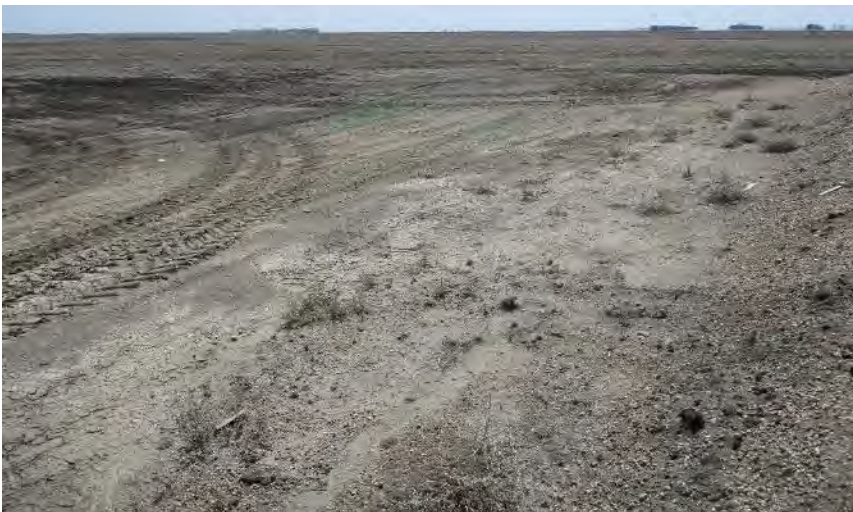
Photograph facing southeast north off of an oilfield lease road showing the visually impacted area.

B24-4 was inspected on May 15th, 2018, and is located approximately 1,000 feet east of 9th Ave NW and 100 feet east of an oilfield lease road. The site is currently used for agricultural purposes, and is surrounded by agricultural fields. Oilfield pad observed immediately to the west appears to be a storage area, consisting of four aboveground storage tanks, a dumpster, a tanker, and three shacks. Visual impacts were observed, including lighter colored soils, stressed vegetation, and salt residues; the area of visual impacts measured approximately 80 feet by 20 feet. The site topography is generally flat and drains to the northwest. Aboveground powerlines were observed to the east of the site, along 9th Ave NW.

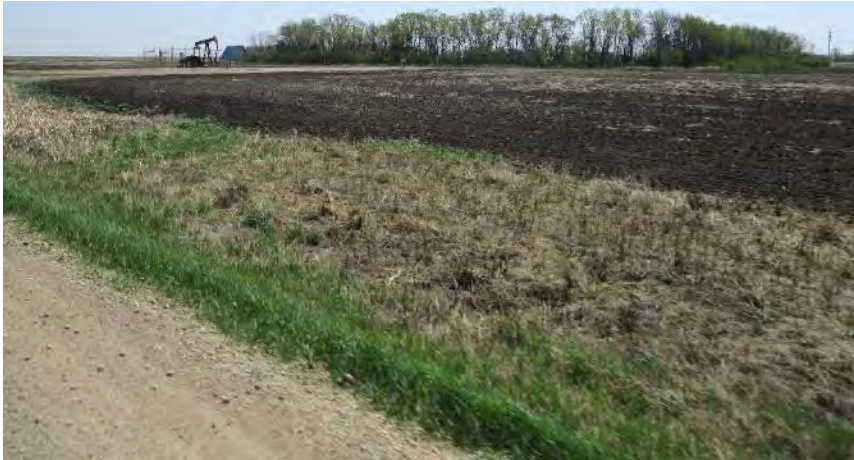
B24-5 (May 2018)

Photograph facing southeast off of an oilfield lease road showing the site. No visual impacts were observed at the time of the May 15, 2018 site visit. A pump jack is visible in the background.

B24-5 was inspected on May 15th, 2018 and is located approximately 500 feet north of 92nd St NW and 100 feet south of an oilfield lease road. The site is currently used for agricultural purposes, and is surrounded by agricultural fields. A pump jack is located to the east of the site and oil & gas facilities, consisting of 14 above ground storage tanks, heater treater, separator, and various shacks. No visual impacts were observed during the site visit. The site topography is generally flat and drains to the west.

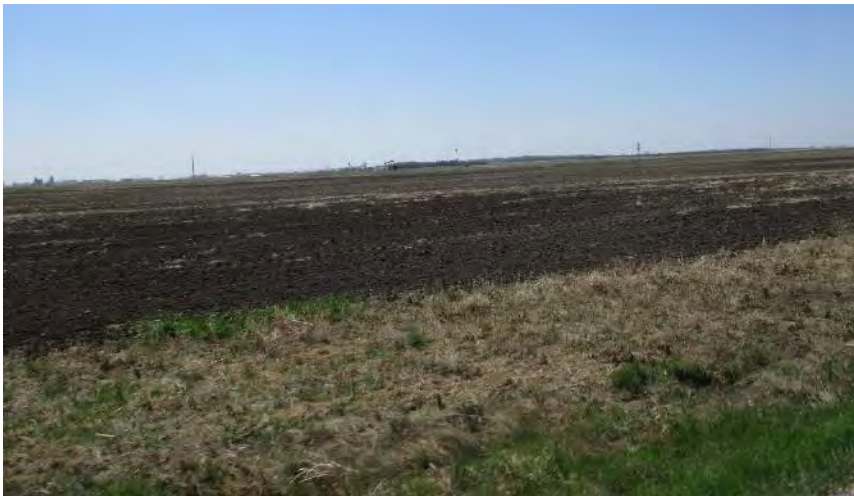
Photograph facing southwest off of an oilfield lease road showing the site. The site is located on agricultural lands.

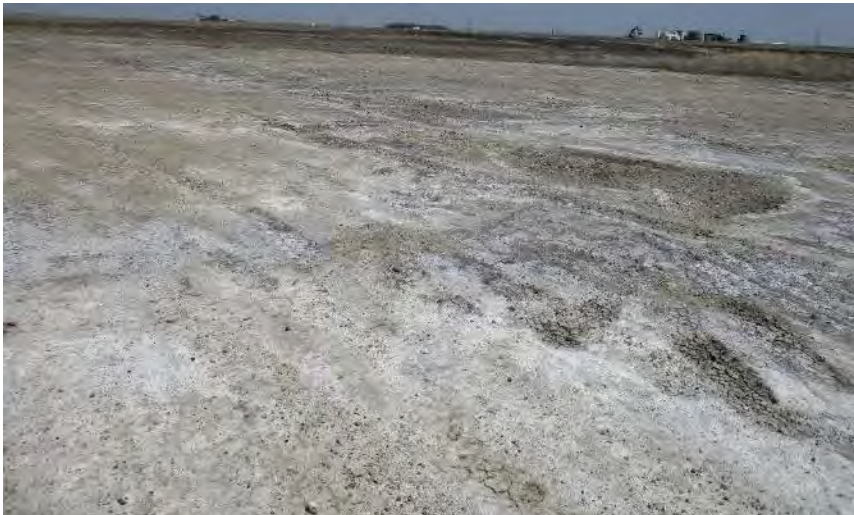
Photograph facing northeast off of an oilfield lease road showing the visually impacted area. Aboveground powerlines were observed along 92nd St. NW.

B24-6 was inspected on May 15th, 2018, and is located approximately 400 feet north of 92nd St NW. The site is currently used as an oil & gas facility, and is surrounded by agricultural fields. The oil & gas facility consisted of aboveground storage tanks, separator, heater treater, and a shack. Visual impacts were observed, including barren land with little to no vegetation and salt crusting; the area of visual impacts measured approximately 500 feet by 20 feet. The impacted area was directly adjacent to the east of the oil & gas pad. The site topography is generally flat and drains to the west/southwest.
