NDIC Brine Pond Study

Phase II: Site Assessments

June 25, 2018

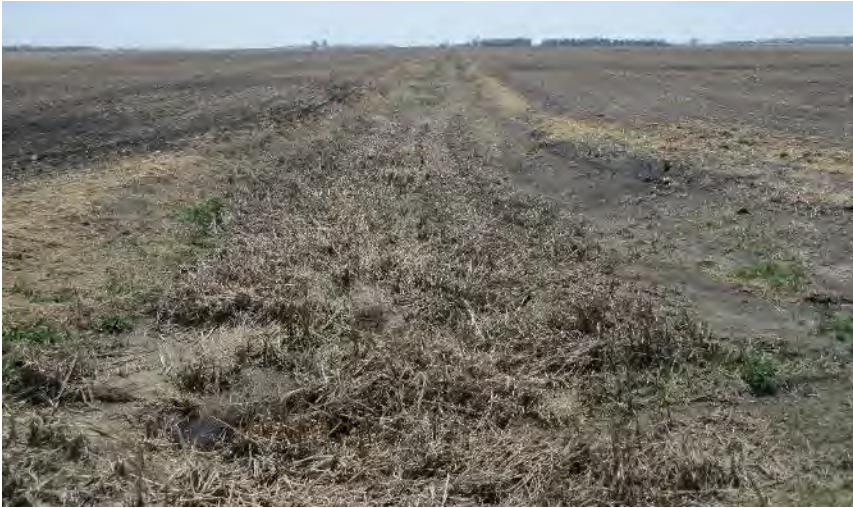
Photograph facing south off of 92nd St NW. The site is located 2,000 feet further south, and could not be accessed at the time of the site visit.

B24-7 was inspected on May 15th, 2018, and is located approximately 2,000 feet south of 92nd St NW. The site could not be accessed at the time of the site visit. The site appeared to be used for agricultural purposes, and is surrounded by agricultural fields. Visual impacts could not be observed at the time of site visit due to access limitations. The site topography could not be observed at the time of site visit due to access limitations.

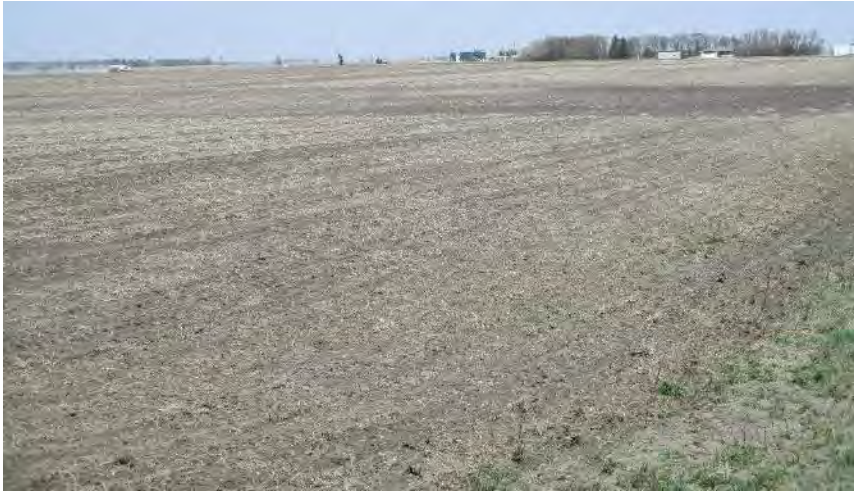
Photograph facing north west off of 9th Ave NW showing the visually impacted area. Stressed vegetation and lighter colored soils are visible.

B24-8 was inspected on May 15th, 2018, and is located approximately 30 feet west of 9th Ave NW. The site is currently used for agricultural purposes, and is surrounded by agricultural fields. Visual impacts were observed, including lighter colored soils with stressed vegetation; the area of visual impacts measured approximately 50 feet by 30 feet. The site topography is generally flat, and drains to a slight depression in the middle of the site. A barn was observed to the south of the site, and aboveground powerlines were observed east of the site.

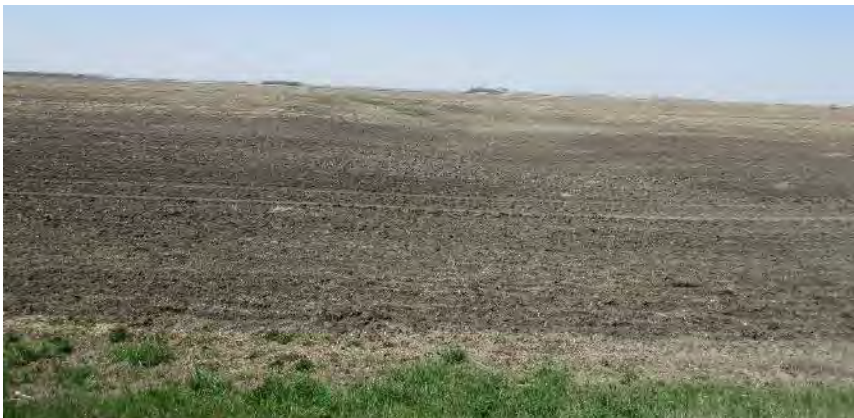
Photograph facing west off of 9th Ave NW showing the visually impacted area in a trough like depression. Aboveground powerlines are located on the east side of 9th Ave NW and a barn is located approximately 300 feet to the south.

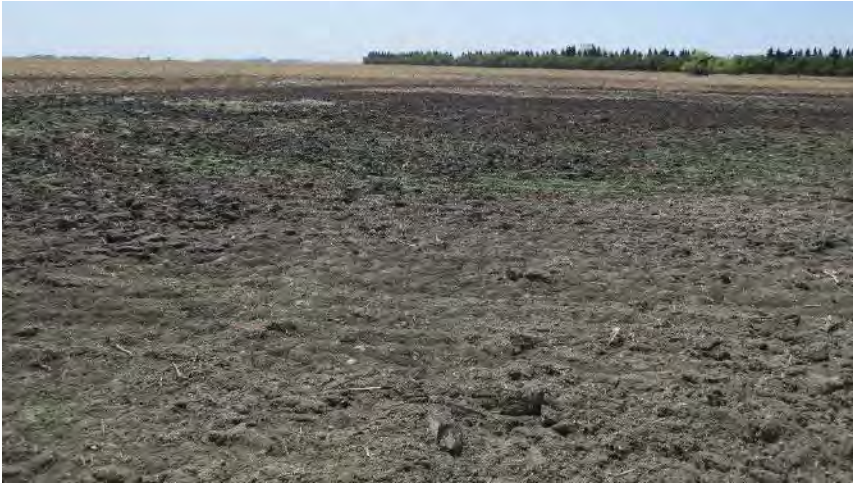
Photograph facing south off of an oilfield lease road showing the visually impacted area. Stressed vegetation and lighter colored soils were observed.

B24-9 was inspected on May 15th, 2018, and is located approximately 1,000 feet east of County Road 27B and 200 feet south of an oilfield lease road. The site is currently used for agricultural purposes. Agricultural fields lie to the west, east, and south. An oil & gas facility was observed to the north, consisting of two aboveground storage tanks, one pump jack, and a heater treater. A wetland was observed towards the center of the site. Visual impacts were observed, including stressed vegetation and salt residue. Salt residues were observed in an area measuring approximately 100 feet by 50 feet just to the south of the oil & gas facility. Stressed vegetation was observed south of the wetland, measuring approximately 150 feet by 30 feet. The site topography is generally flat and drains towards the wetland. Aboveground powerlines were observed north of the site, on the oil & gas facility.

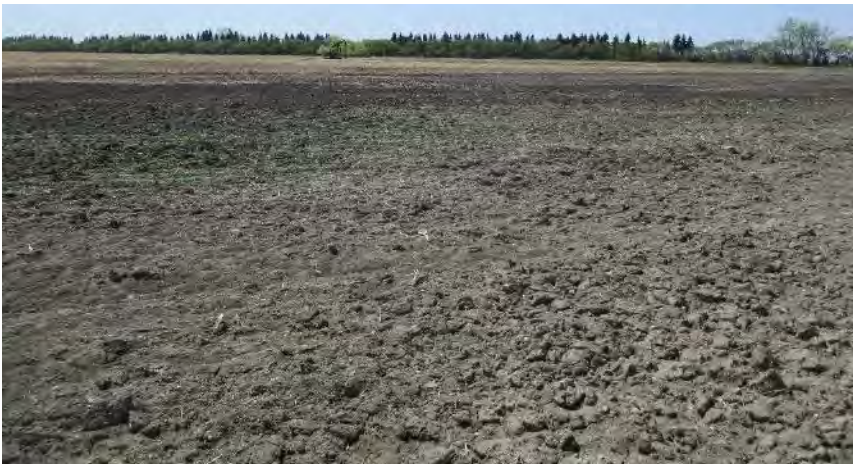
Photograph facing south west off of an oilfield lease road showing the visually impacted area. A wetland is visible in the background.

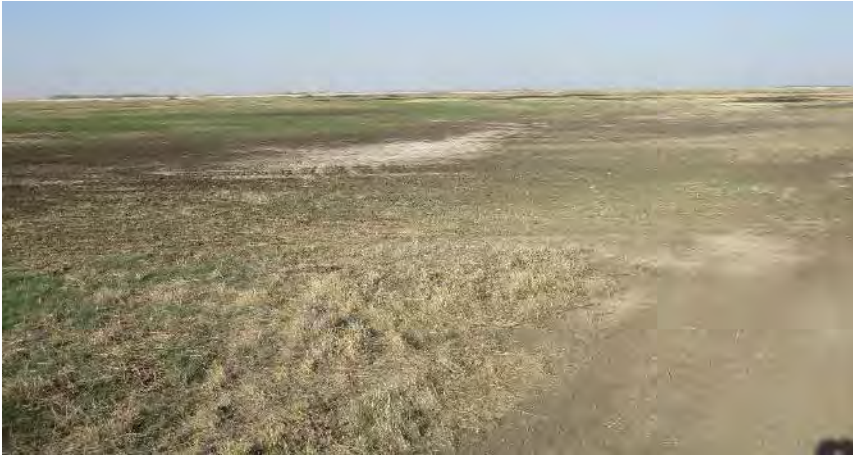
Photograph facing west/southwest off of 5th Ave NW looking towards the site, which lies approximately 500 feet further west. The site appeared to have been reclaimed, but lighter soils, potential dead zones, and slumping in field were visible from road.

B25-1 was inspected on May 15th, 2018, and is located approximately 500 feet west of 5th Ave NW. The site could not be accessed at the time of the site visit. The site appears to be a potential former oilfield pad in the process of reclamation. Agricultural land lies to the north, south, and east. A wetland was observed to the west. Visual impacts were observed from a distance, including lighter soils with little to no vegetation. These impacted areas included three separate areas estimated to measure approximately 30 feet by 20 feet, 20 feet by 20 feet, and 10 feet by 10 feet. The site topography is generally flat, slightly undulating, and drains to the east. Aboveground powerlines were observed to the east of the site.

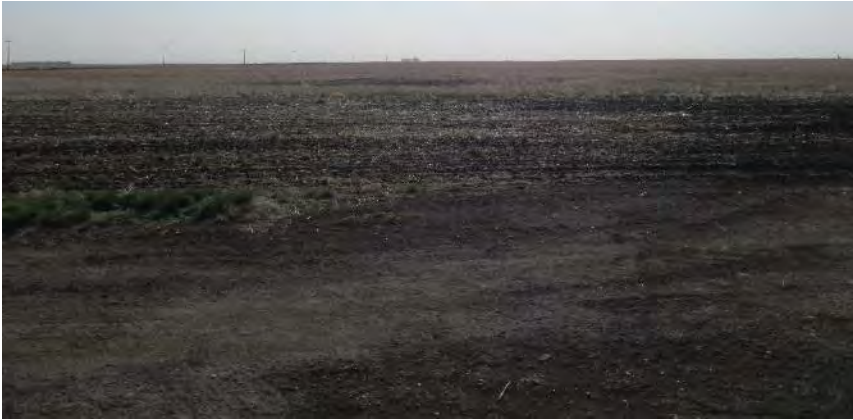
Photograph facing east off of an oilfield lease road showing the visually impacted area.

B25-2 was inspected on May 15th, 2018, and is located approximately 500 feet south of 93rd St NW and 200 feet east of an oilfield lease road. The site is currently used for agricultural purposes, and is surrounded by agricultural fields. An oil & gas facility was located to the southwest of the site, consisting of one aboveground storage tank, one pump jack, and miscellaneous oilfield equipment. Visual impacts were observed, including barren soils and stressed vegetation; the area of visual impacts measured approximately 20 feet by 20 feet. Additional barren soil was visible next to oilfield production pad. The site topography is generally flat and slopes to the east. Aboveground powerlines were observed to the north of the site.

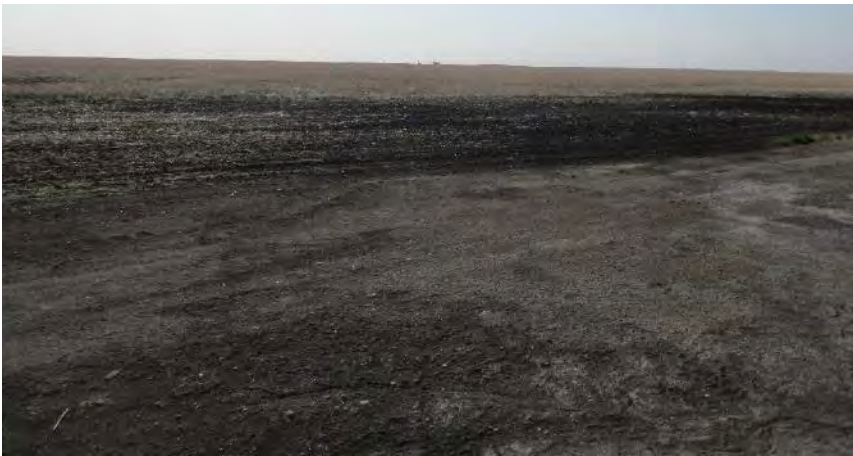
Photograph facing southeast off of an oilfield lease road showing visually impacted area. Dead zones are visible along oilfield production pad.

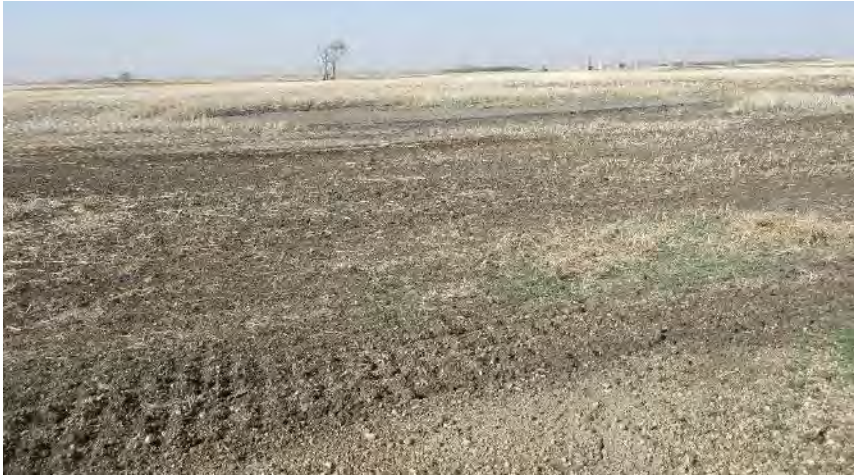
Photograph facing south off of an oilfield lease road showing the visually impacted area. Dead zones and barren areas were observed.

B25-3 was inspected on May 15th, 2018, and is located approximately 10 feet south of an oil & gas facility located on an oilfield lease road. The site is currently used for agricultural purposes, and is surrounded by agricultural fields. The oil & gas facility is located to the north of the site, consisting of two aboveground storage tanks and one pump jack. Visual impacts were observed just south of the oil & gas facility, including barren soils with little to no vegetation and slight salt crusting; the area of visual impacts measured approximately 30 feet by 10 feet. The site topography is generally flat and slopes to the north.

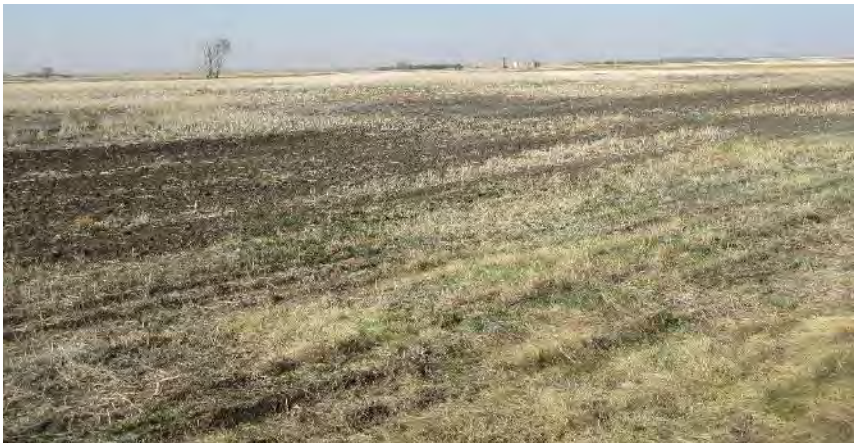
Photograph facing southwest off of an oilfield lease road showing the visually impacted area in agricultural land. Dead zones and barren soils were observed.

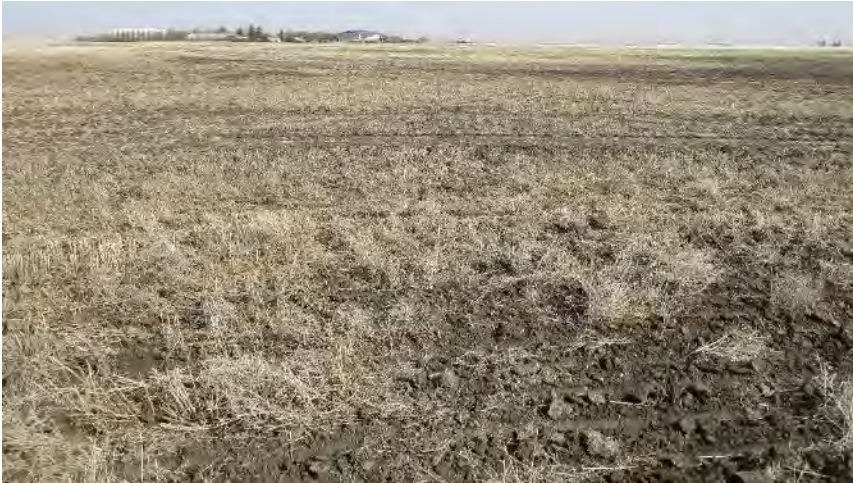
Photograph facing north off of an oilfield lease road showing minimal impacts. Slightly stressed vegetation was observed in an agricultural field.

B25-4 was inspected on May 15th, 2018, and is located approximately 30 feet north of an oilfield lease road. The site is currently used for agricultural purposes, and is surrounded by agricultural fields. An oil & gas facility was observed to the south, consisting of four aboveground storage tanks, one pump jack, and a heater treater. Visual impacts were observed, including slightly stressed vegetation; the area of visual impacts measured approximately 50 feet by 25 feet. A residential building was observed approximately 1,500 feet to the northwest. The site topography is generally flat and drains to a slight depression towards the center of the site.

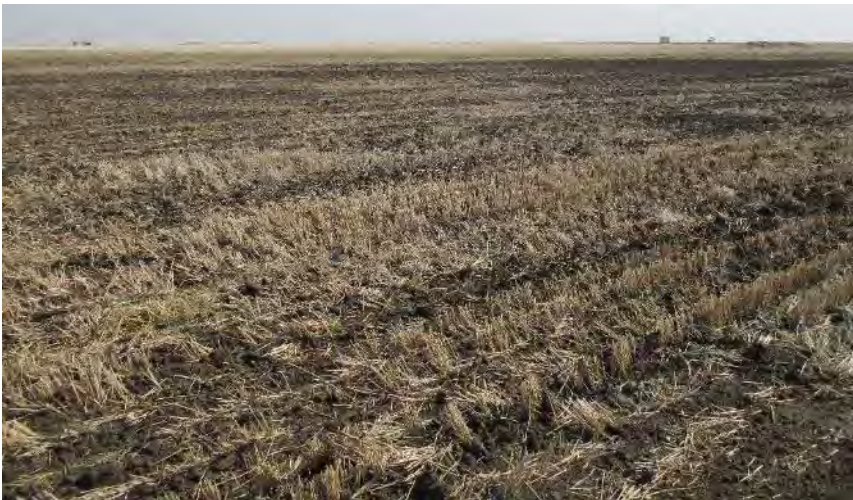
Photograph facing northeast off of an oilfield lease road showing the visually impacted area.

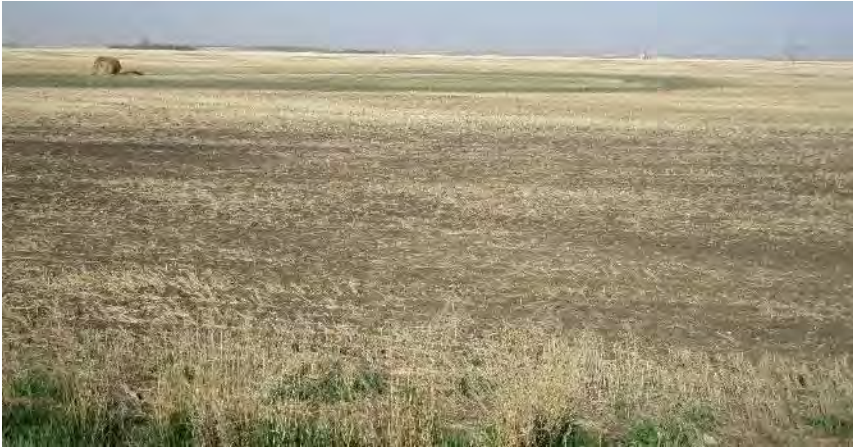
Photograph facing west off of 4th Ave NW showing the visually impacted area. Slightly stressed vegetation and barren areas were observed.

B25-5 was inspected on May 15th, 2018, and is located approximately 150 feet west of 4th Ave NW. The site is currently used for agricultural purposes, and is surrounded by agricultural fields. Visual impacts were observed, including slightly barren soils and stressed vegetation; the area of visual impacts measured approximately 200 feet by 200 feet. The site topography is generally flat and drains to a slight depression towards the center of the site, where the impacts were observed.

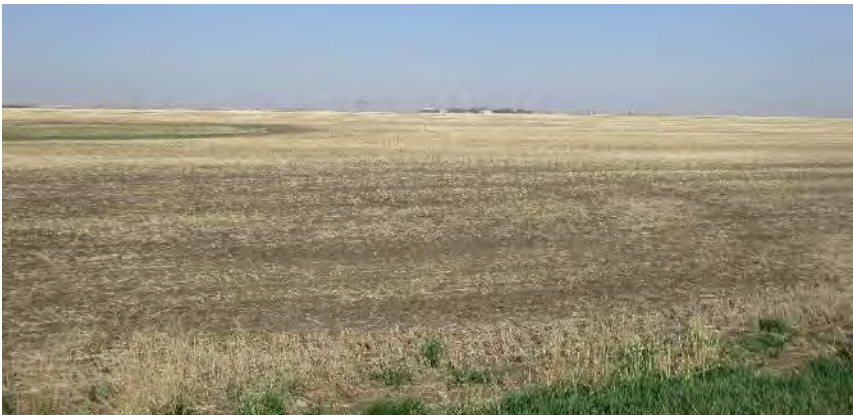
Photograph facing northwest off of 4th Ave NW showing visually impacted area and a residential area located approximately 3,000 feet to the northwest. Wetlands are located approximately 1,000 feet to the southwest and 2,000 feet to the west of site.

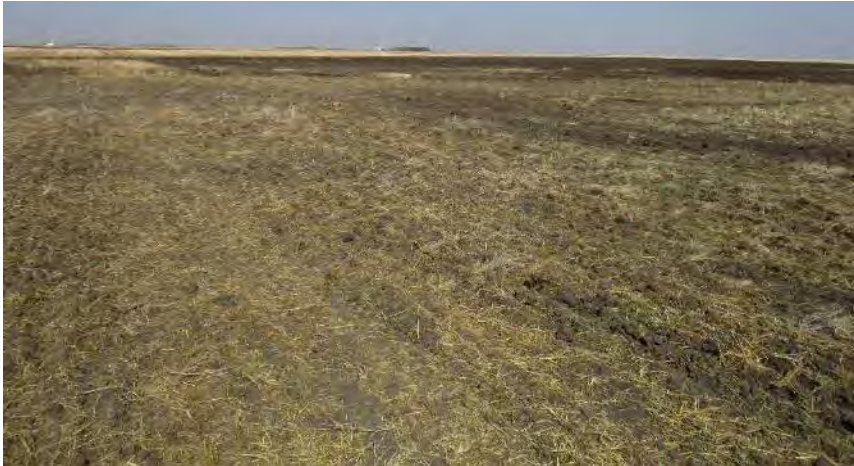
Photograph facing northwest off of an oilfield lease road showing the visually impacted area. Extensive dead zones and stressed vegetation were observed in an agricultural field.

B25-6 was inspected on May 15th, 2018, and is located approximately 700 feet east of 4th Ave NW. The site is currently used for agricultural purposes, and is surrounded by agricultural fields. A wetland was observed to the north. Visual impacts were observed, including barren soils and stressed vegetation; the area of visual impacts measured approximately 500 feet by 200 feet. The site topography is generally flat and drains to a depression towards the center of the site, where the impacts were observed.

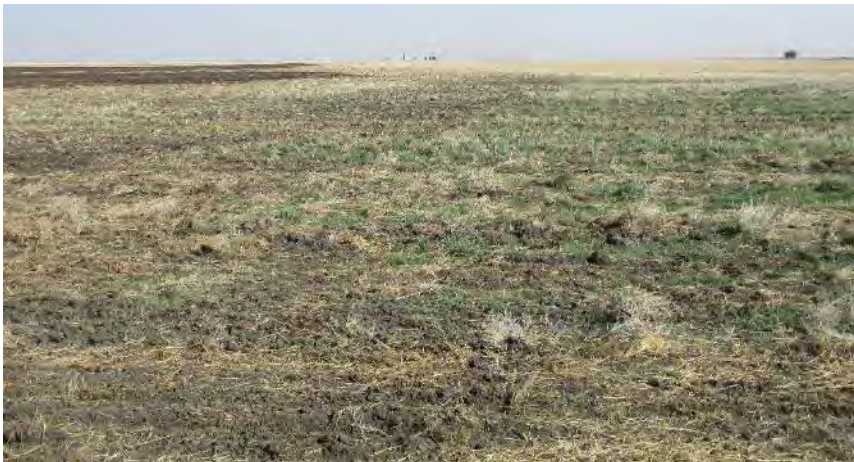
Photograph facing north off of an oilfield lease road showing the visually impacted area. A wetland is located approximately 500 feet to the north of the site.

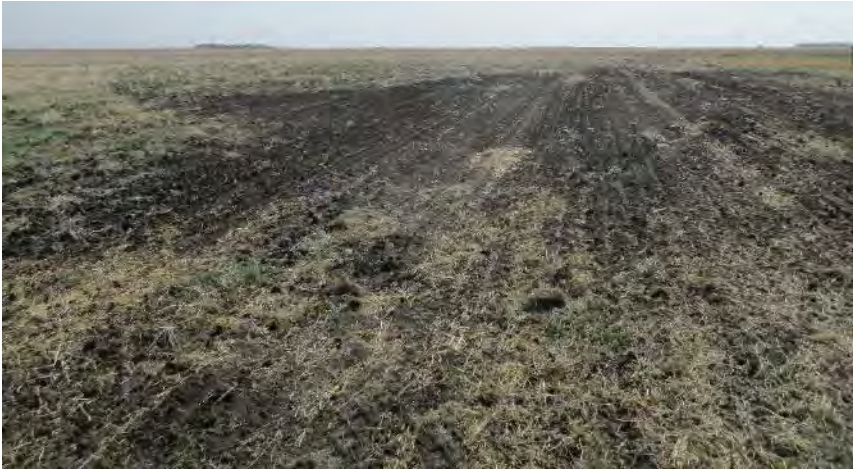
Photograph facing east off of an oilfield lease road showing the visually impacted area. Stressed vegetation and dead zones were observed.

B25-7 was inspected on May 15th, 2018, and is located approximately 20 feet north of an oilfield lease road. The site is currently used for agricultural purposes, and is surrounded by agricultural fields. An oil & gas facility was observed to the south of the site, consisting of one pump jack. Visual impacts were observed, including an area of barren soils measuring approximately 20 feet by 10 feet, and an area of stressed vegetation measuring approximately 50 feet by 20 feet. The site topography is generally flat and slopes to the north. An underground powerline appears to service the pump jack, to the south.

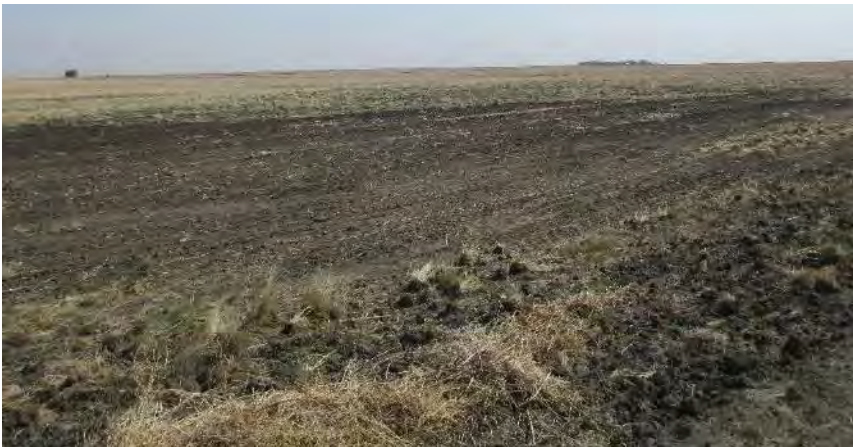
Photograph facing northeast off of an oilfield lease road showing the visually impacted area in an agricultural field. The site is adjacent to a pump jack, which is located approximately 20 feet south of site.

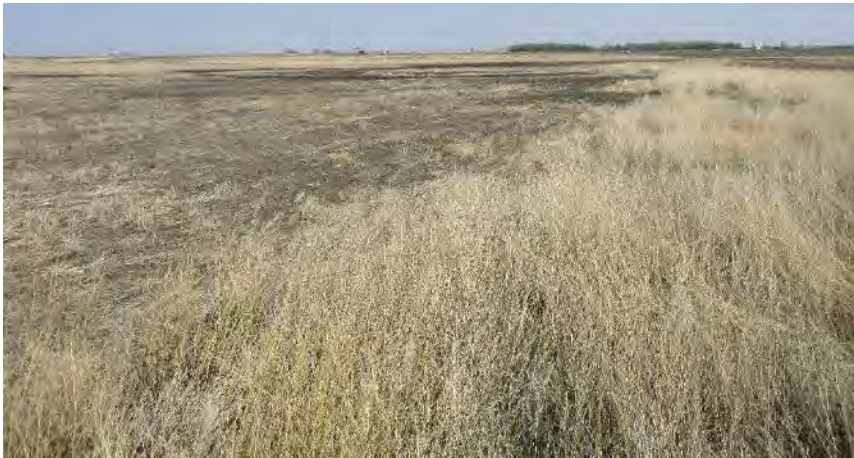
Photograph facing southeast off of an oilfield lease road showing the visually impacted area. Stressed vegetation with barren spots were observed. The site is adjacent to an oilfield pad.

B41-1 was inspected on May 14th, 2018, and is located approximately 200 feet east of an oilfield lease road. The site is currently used for agricultural purposes. Agricultural fields lie to the north and south. A wetland lies to the east, and an oil & gas facility lies to the west. The oil & gas facility consisted of five aboveground storage tanks, a heater treater, and one pump jack. Visual impacts were observed, including a barren area with stressed vegetation; the area of visual impacts measured approximately 500 feet by 50 feet. The site topography is generally flat and drains to the east. Odors of hydrocarbon and hydrogen sulfide were also observed during the site visit.

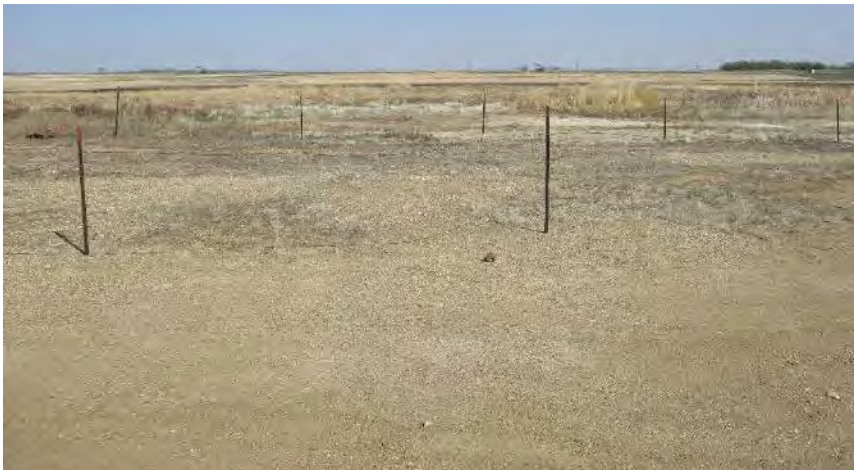
Photograph facing east off of an oilfield lease road showing the visually impacted area. Salt crusts and lighter colored soils were observed.

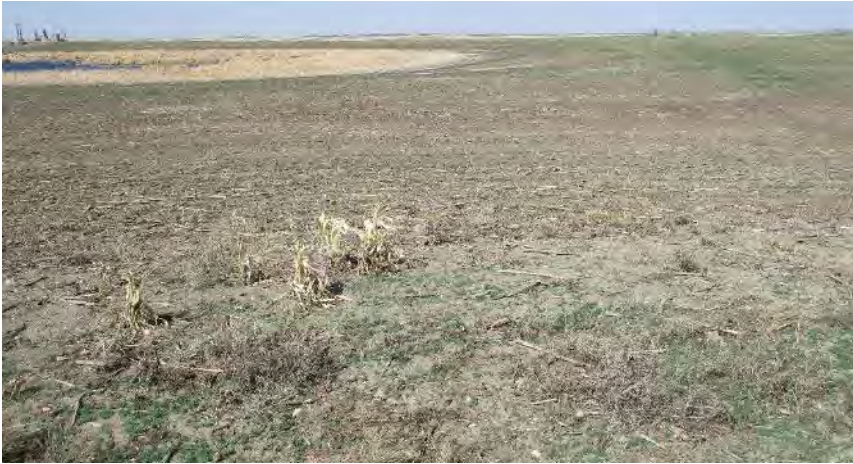
Photograph facing northeast off of an oilfield lease road showing the visually impacted area. Lighter soils and salt crusts were observed around the southeast edge of the wetland.

B41-2 was inspected on May 14th, 2018, and is located approximately 100 feet north of an oilfield lease road. The site is currently used for agricultural purposes. Agricultural fields lie to the east and west. A wetland and pond lie to the north, and an oil & gas facility lies to the south. The oil & gas facility consisted of one wellhead with chemical injection equipment. Visual impacts were observed, including stressed vegetation and salt crusting; the area of visual impacts measured approximately 25 feet by 10 feet. Barren soils were also observed along the southeast edge of the wetland, measuring approximately 50 feet by 5 feet. The site topography is generally flat and drains to the north.

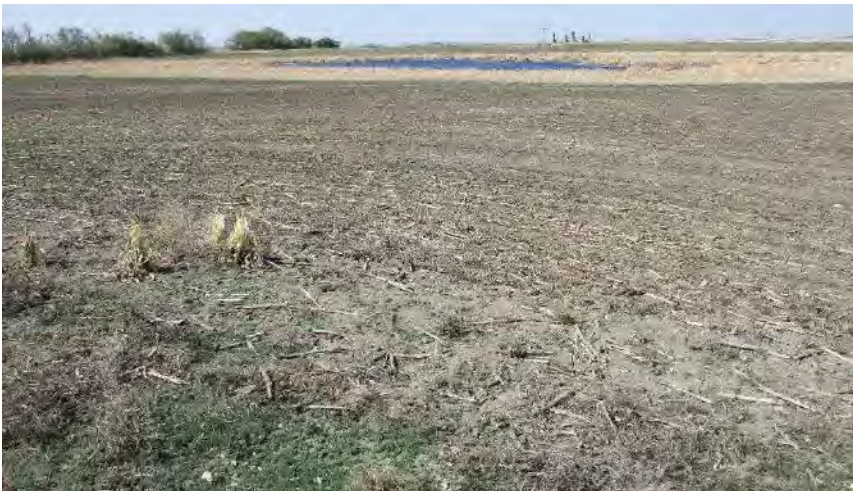
Photograph facing north off of an oilfield lease road showing the visually impacted area and wetland located approximately 50 feet to the north of site. Stressed vegetation is visible within the agricultural field.

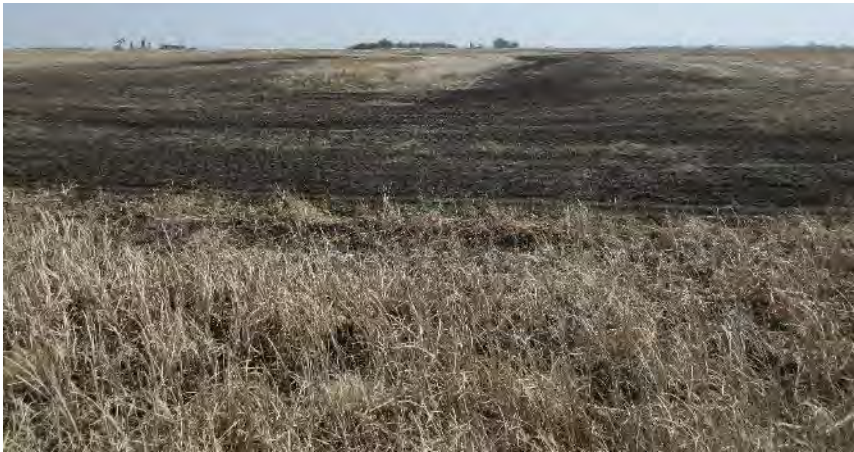
Photograph facing south off of 79th St. NW showing a large wetland measuring approximately 1,000 feet by 500 feet located towards the center of the site. The site could not be accessed at the time of the site visit.

B41-3 was inspected on May 14th, 2018, and is located approximately 1,000 feet south of 79th St NW. The site could not be accessed at the time of site visit. The site is currently used for agricultural purposes, and is surrounded by agricultural fields. A wetland was observed towards the center of the site. Visual impacts were observed from a distance at the time of site visit from a distance. Impacts included stressed vegetation and salt crusts along the shore of the pond. Measurements of the impacts could not be taken due to access limitations. The wetland at the center of the site presents a low point such that the rest of the site drains inwards to it.

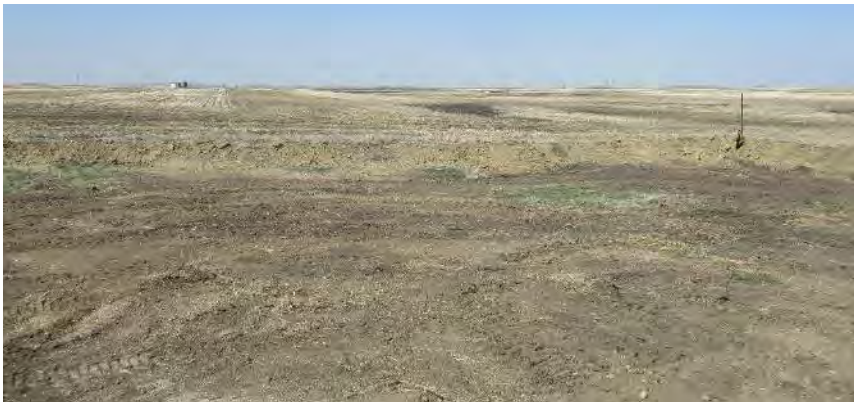
Photograph facing north off of oilfield lease road showing agricultural field. Site is located approximately 1,000 feet further north. Potentially stressed vegetation is visible on edge of wetland.

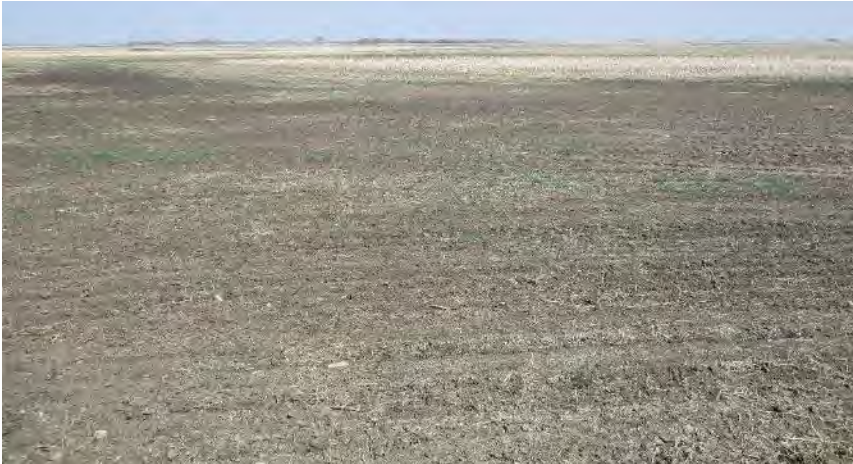
Photograph facing east/northeast off of an oilfield lease road showing the visually impacted area. Stressed vegetation was observed in an approximately 15 feet by 15 feet area.

B42-1 was inspected on May 14th, 2018, and is located approximately 800 feet east of 22nd Ave NW and 200 feet east of an oilfield lease road. The site is currently used for agricultural purposes, and is surrounded by agricultural fields. An oil & gas facility was also observed to the west, consisting of a single pump jack. A wetland was observed towards the east of the site. Minimal visual impacts were observed, including stressed vegetation; the area of visual impacts measured approximately 15 feet by 15 feet. The site topography is generally flat and drains east to the wetland. An aboveground powerline was also observed west of the site, along 22nd Ave NW.

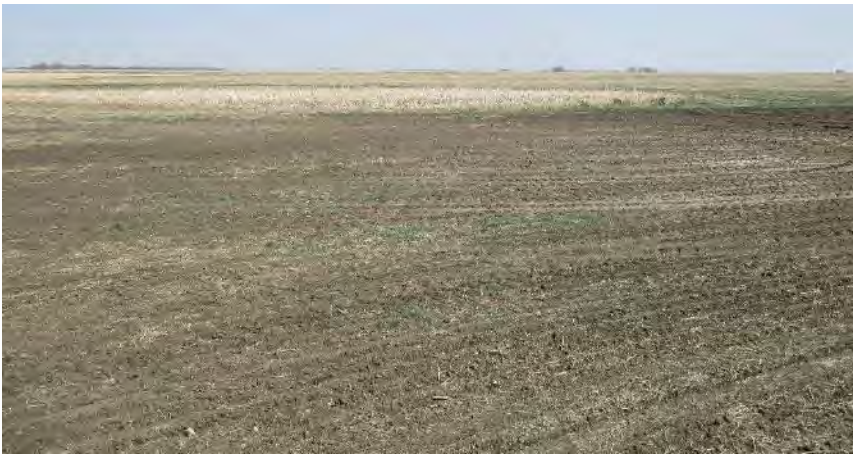
Photograph facing east off of an oilfield lease road showing the visually impacted area and a wetland located northeast of site.

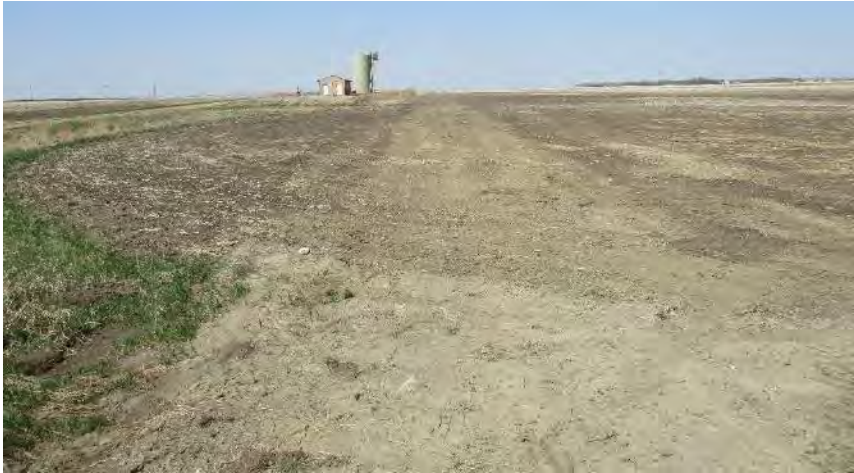
Photograph facing north off of 79th St NW showing the visually impacted area. Stressed vegetation was observed in an agricultural field. Two aboveground storage tanks are located west of the site.

B42-2 was inspected on May 14th, 2018, and is located approximately 500 feet north of 79th St NW and 300 feet east of an oilfield lease road. The site is currently used for agricultural purposes. Agricultural fields lie to the north, east, and south. An oil & gas facility was observed to the west, consisting of two aboveground storage tanks and a shack. A wetland was observed towards the northeast of the site. Minimal visual impacts were observed, including stressed vegetation in an area of subsidence; the area of visual impacts measured approximately 20 feet by 20 feet. The site topography is generally flat and drains southeast. To the west of the site, an Enbridge underground pipeline running north-south along the lease road to the aboveground storage tanks was also observed.

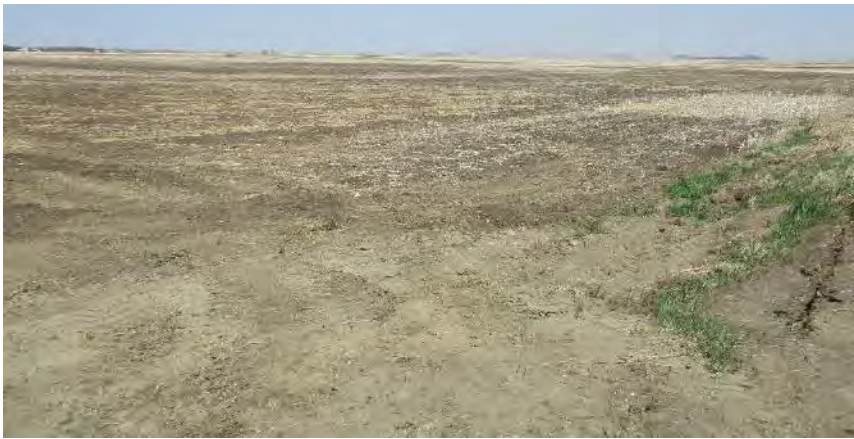
Photograph facing southeast off of an oilfield lease road showing the visually impacted area in an agricultural field.

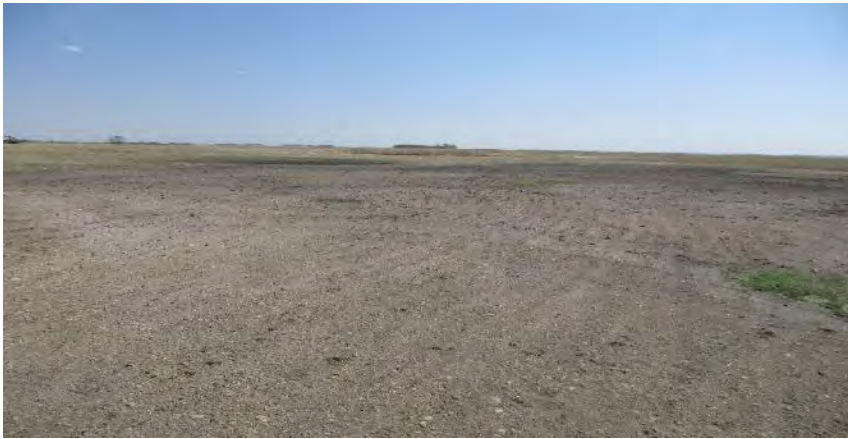
Photograph facing south showing the visually impacted area measuring approximately 300 feet by 125 feet and consisting of barren ground with little to no vegetative growth. A wetland can be seen in the background.

R1-1 was inspected on May 14th, 2018 and is located approximately 400 feet north of 107th St NW and just south of an oilfield lease road. The site is currently used for agricultural purposes and is surrounded by agricultural fields. A pump jack was also observed to the north at the terminating point of the lease road. Visual impacts were observed, including a barren area with little to no vegetation and salt crusting; the area of visual impacts measured approximately 300 feet by 125 feet. Wetlands were also observed to the south of the site. The site topography is generally flat and drains to the southwest. Aboveground powerlines were observed to the north, along 107th St NW.

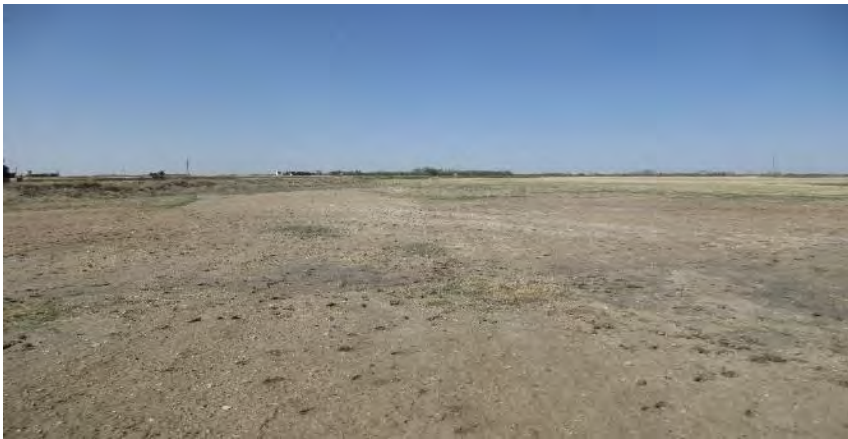
Photograph facing north showing the visually impacted area. A pad containing a wellhead can be seen in the western portion of the photograph.

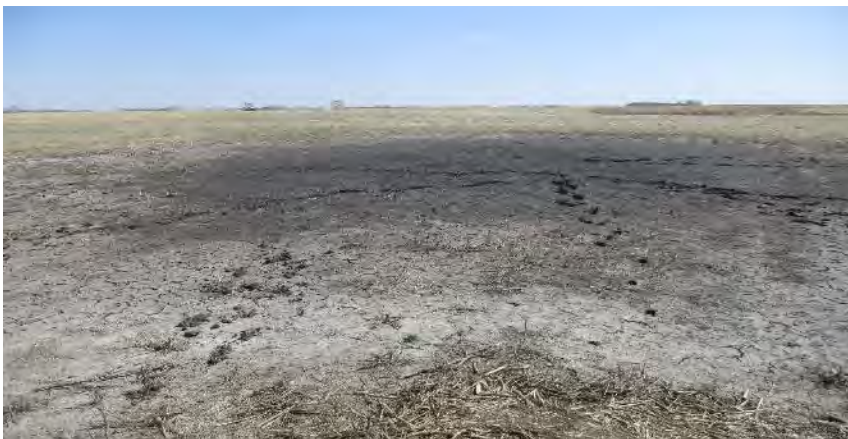
Photograph facing south showing the southern-most portion of the visually impacted area. Cracking in the soil present at the site is shown. A wetland is located in the background of the photograph.

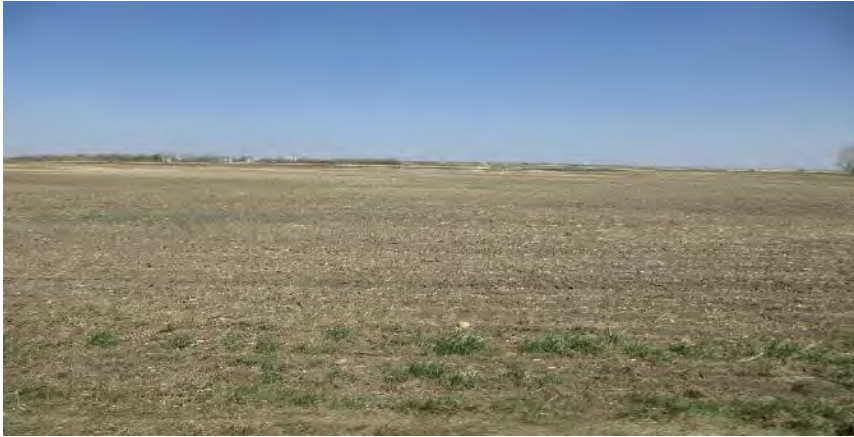
Photograph facing east off of oilfield lease road showing the visually impacted area located in a field used for agricultural purposes. Minimal stressed vegetation was observed during the site visit.

R3-1 was inspected on May 14th, 2018 and is located approximately 250 feet north of 107th St NW and 100 feet east of an oilfield lease road. The site is currently used for agricultural purposes and is surrounded by agricultural fields. Minimal visual impacts were observed, including an area with slightly stressed vegetation; the area of visual impacts measured approximately 15 feet by 15 feet. The site topography is generally flat and drains to the northwest. Aboveground powerlines were observed to the west of the site.

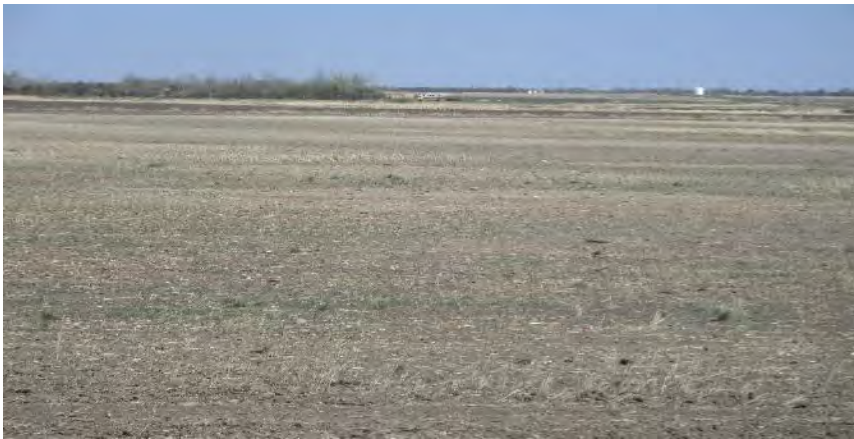
Photograph facing east off of oilfield lease road showing a close up view of the visually impacted area. The area was noted to have minimal visual impacts of slightly stressed vegetation approximately 15 feet by 15 feet in size.

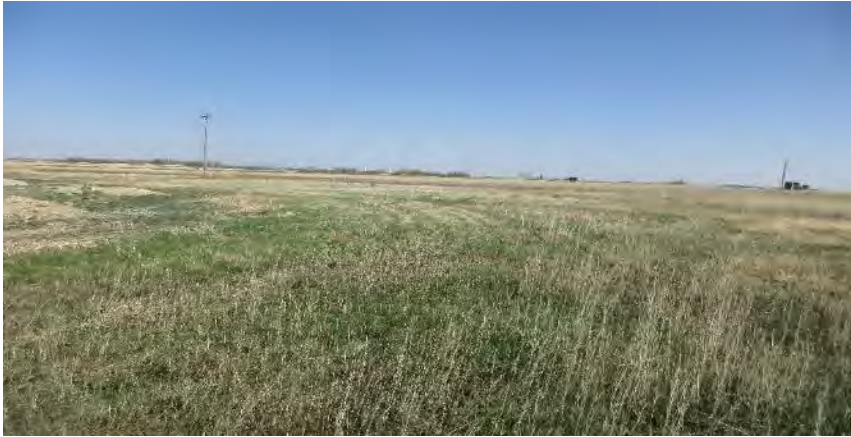
Photograph facing southeast off of an oilfield lease road showing natural grassland and land used in agricultural production. No visual impacts were observed at the time of the site inspection. An oil & gas facility is located north of site.

R3-2 was inspected on May 14th, 2018 and is located approximately 3,000 feet north of 107th St NW and just south of an oilfield lease road. The site is currently used for agricultural purposes and is surrounded by agricultural fields. An oil & gas facility was also observed immediately to the north, and consisted of three aboveground storage tanks, one heater-treater, one horizontal separator, and one pump jack. No visual impacts were observed at the time of the site visit. A wetland was observed to the northeast of the site. The site topography is generally flat and drains to the southwest. Aboveground powerlines were observed to the east of the site.

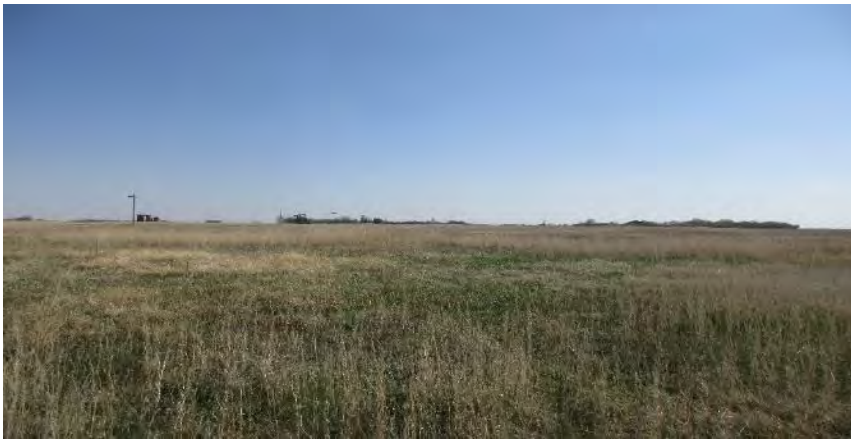
Photograph facing south to southwest off of an oilfield lease road showing natural grassland and agricultural land. No visual impacts were observed at the time of the site inspection.

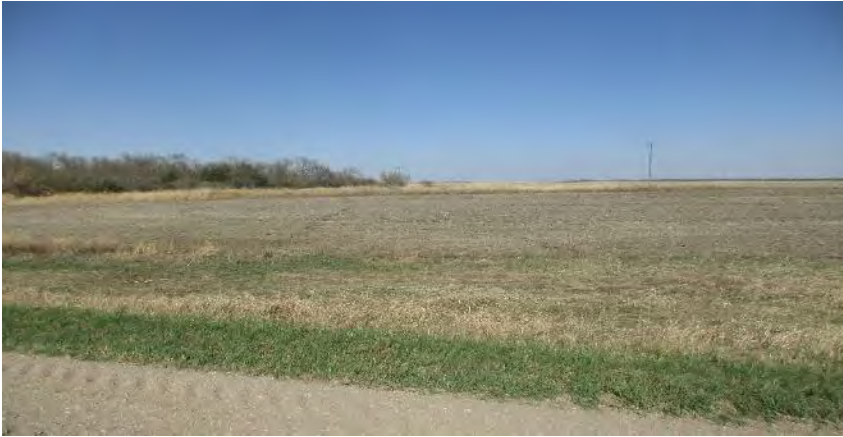
Photograph facing east off of 44th Ave NW showing the agricultural field on which the site is located. No visual impacts were observed at the time of the site visit from the road.

R3-3 was inspected on May 14th, 2018, and is located approximately 450 feet east of 44th Ave. NW. The site could not be accessed at the time of the site visit. The site is currently used for agricultural purposes. Agricultural fields lie to the east and south, and residences lie to the north and west. No visual impacts could be observed from a distance at the time of site visit. The site topography is generally flat and drains to the northwest. Aboveground powerlines were observed to the east of the site.

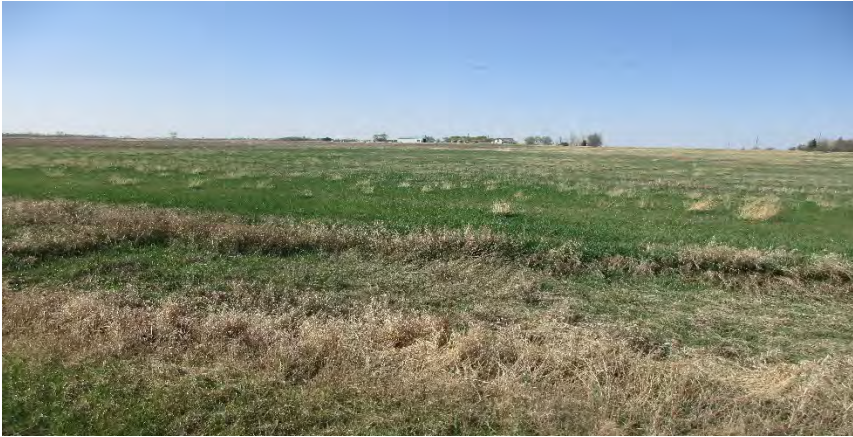
Photograph facing north off of 108th St NW. The site is native grassland and no visual impacts were observed from the road.

R3-4 was inspected on May 14th, 2018, and is located approximately 300 feet north of 108th St. NW. The site could not be accessed at the time of the site visit. The site is currently native grassland. Grasslands lie to the north and south, an agricultural field lies to the west, and a residential structure lies to the east. No visual impacts could be observed from a distance at the time of site visit. The site topography is generally flat and drains to the southwest. Aboveground powerlines were observed to the east of the site.

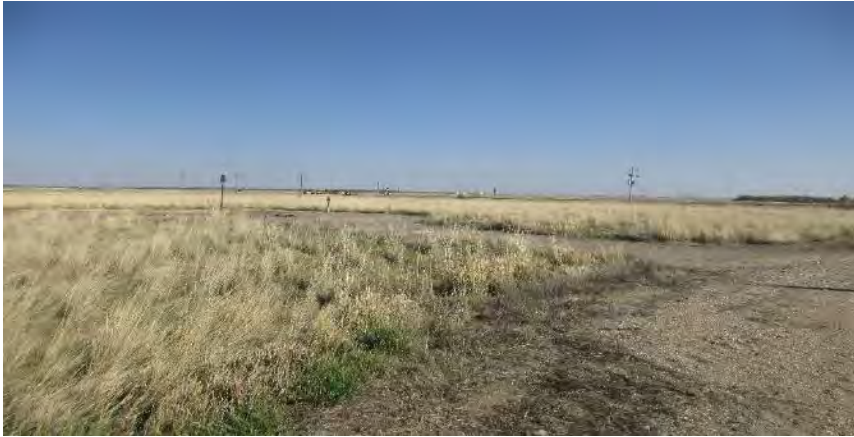
R3-5

Photograph facing southeast off of oilfield lease road showing the site. No visual impacts were observed during the site visit. A flare and flare pit can be seen in the photograph.

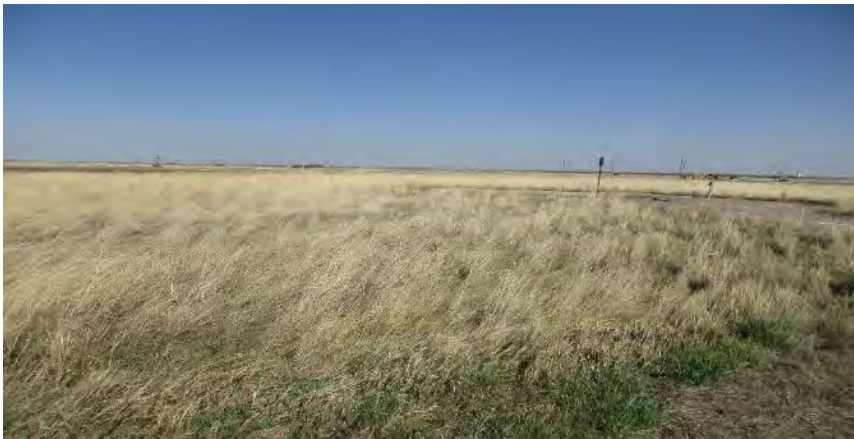
Photograph facing southeast to east off of oilfield lease road showing the site. No visual impacts were observed during the site visit. A flare and flare pit can be seen in the photograph.

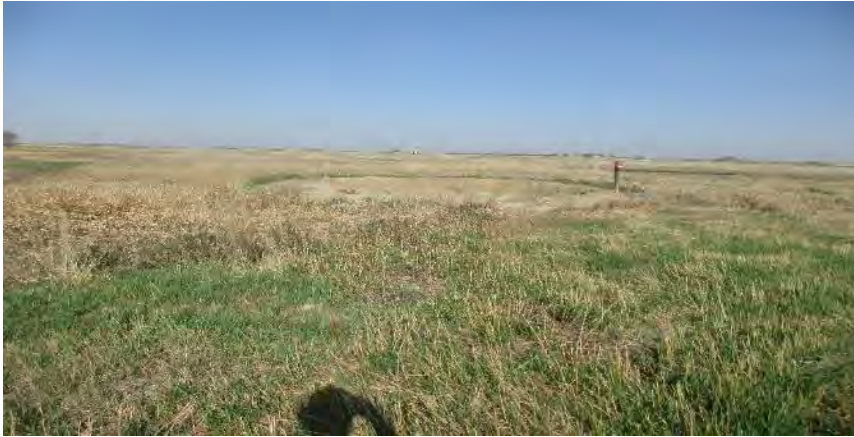
R3-6

Photograph facing west off of an oilfield lease road showing the site. No visual impacts were observed during the site inspection. A former flare pit was observed, as can be seen in the center of the photograph. Oil & gas facilities are located east of site.

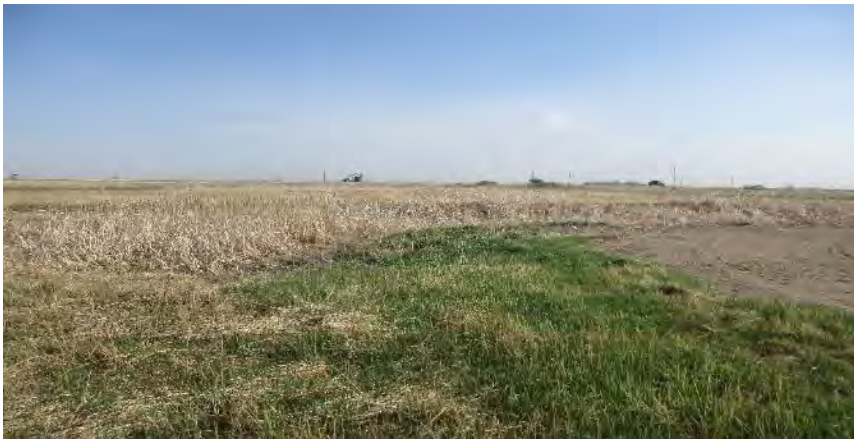
Photograph facing north off of oilfield production facility showing native grasslands and a wetland near the site. An oil & gas facility is shown on the right side of the photograph and is located directly east of the site.

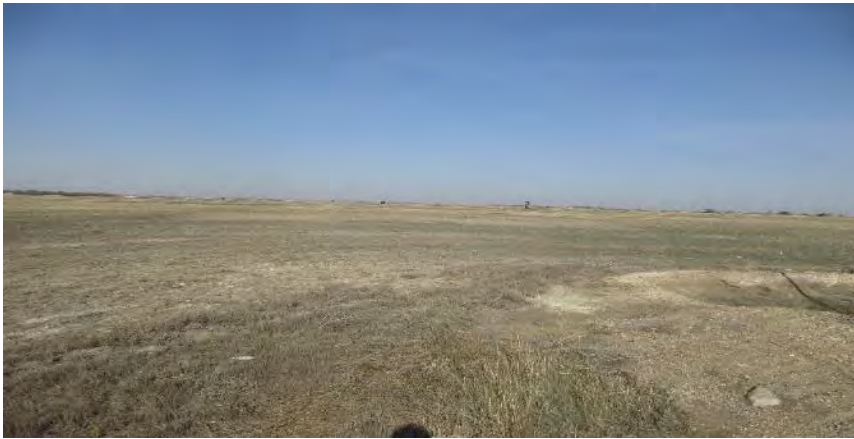
Photograph facing northwest off of an oilfield lease road showing visually impacted area with stressed vegetation; the impacted area measured approximately 150 feet by 150 feet. A flare pit can be seen in the foreground of the photograph.

R3-7 was inspected on May 15th, 2018 and is located approximately 500 feet west of 43rd Ave NW and just west of an oilfield lease road. The site is currently used in part for agricultural purposes and in part as an oil & gas facility. Agricultural fields lie to the north, south, and west. The oil & gas facility is located slightly to the east, consisting of three aboveground storage tanks, one heater-treater, and one flare pit. A wetland lies to the north of the site. Visual impacts were observed, including salt crusting and stressed vegetation; the area of visual impacts measured approximately 150 feet by 150 feet. The site topography is generally flat and slopes to the southeast. Two underground utility markers were observed to the east, and an aboveground powerline was observed to the east.

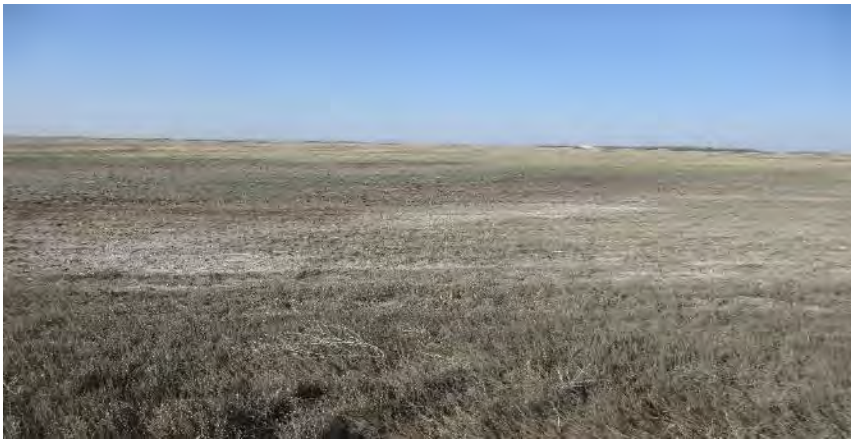
Photograph facing west off of oilfield lease road showing visually impacted area with stressed vegetation. Lighter colored soil and salt crusting can be seen in the visually impacted area.
