NDIC Brine Pond Study

Phase II: Site Assessments

June 25, 2018

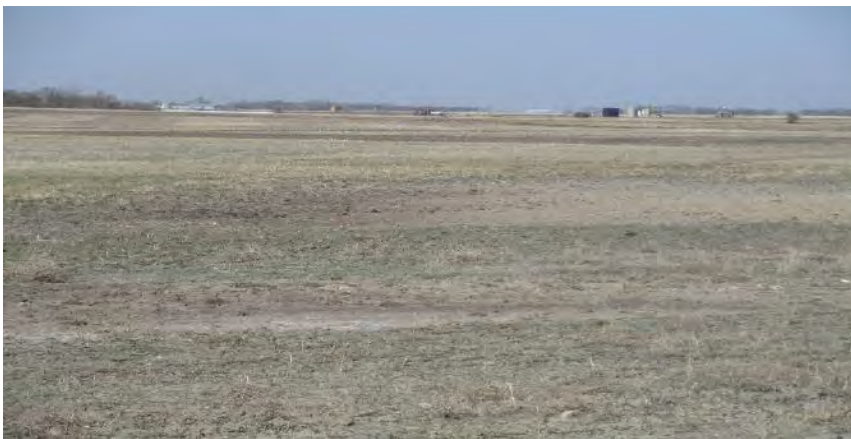
Photograph facing northwest off of oilfield lease road showing visually impacted area with stressed vegetation. Oil & gas facilities can be seen in the background.

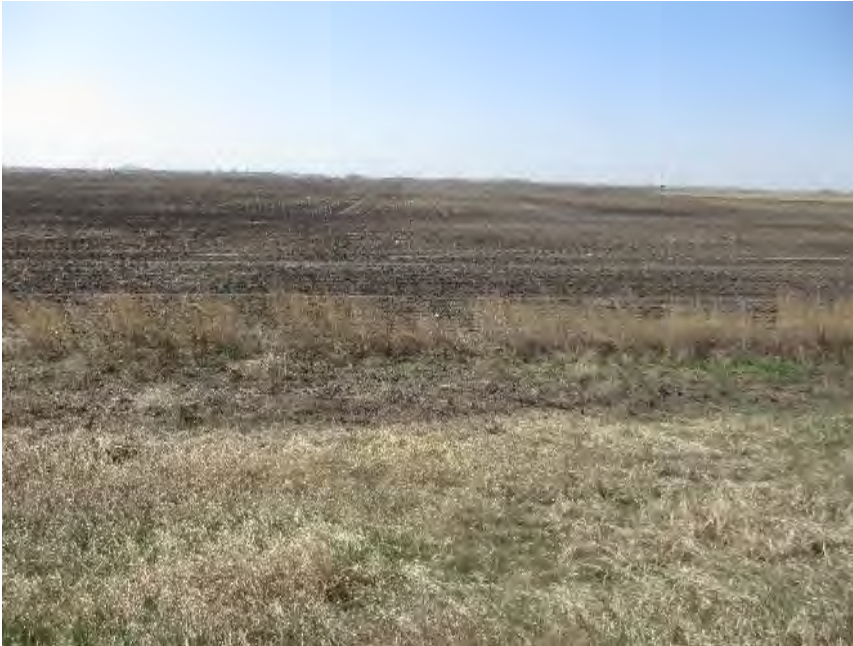
R3-8 (May 2018)

Photograph facing south off 109th St NW showing the agricultural field where the site is located. No visual impacts were observed at the time of the May 15, 2018 site visit.

R3-8 was inspected on May 15th, 2018, and is located approximately 50 feet south of 109th St. NW. The site is currently used for agricultural purposes and is surrounded by agricultural fields. Visual impacts were not observed at the time of the site visit. The site topography is generally flat and slopes to the north. An aboveground powerline was observed to the north.

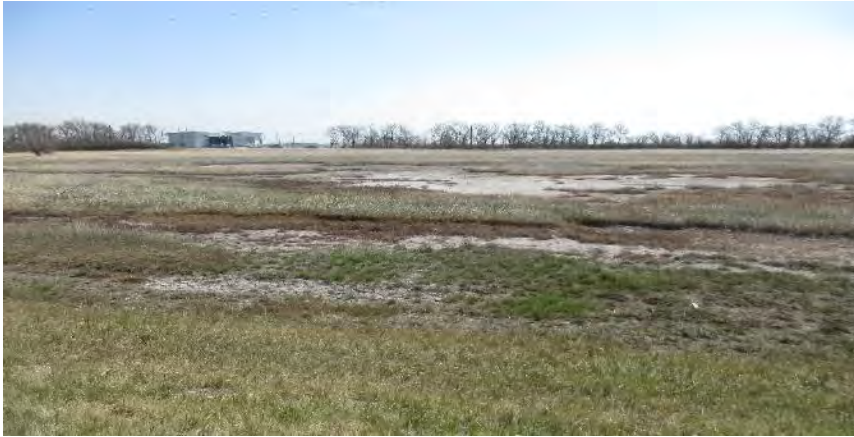
Photograph facing east/northeast off of oilfield lease road showing the visually impacted area, which measured approximately 200 feet by 75 feet in size. The Canadian border crossing can be seen in the background.

R3-9 was inspected on May 15th, 2018 and is located approximately 600 feet west of County Road 28, just east of an oilfield lease road. The Canadian border was located approximately 1,000 feet to the north. The site is currently native grassland and is surrounded by native grassland. An oil & gas facility was observed to the west, consisting of a single pump jack. Visual impacts were observed, including barren soil with little to no vegetation and salt crusting; the area of visual impacts measured approximately 200 feet by 75 feet. The site topography is generally flat and slopes to the northwest. An aboveground powerline was observed to the west.

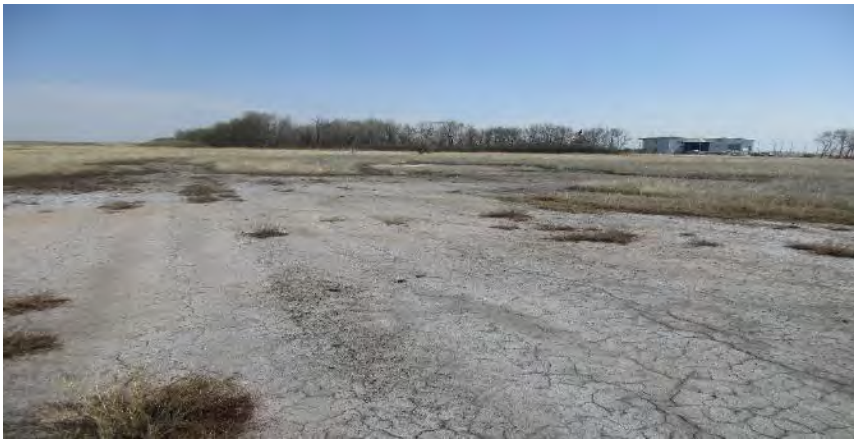
Photograph facing north/northeast showing the visually impacted area. Cracking and lighter colored soils can be seen along with the lack of vegetative growth in the area.

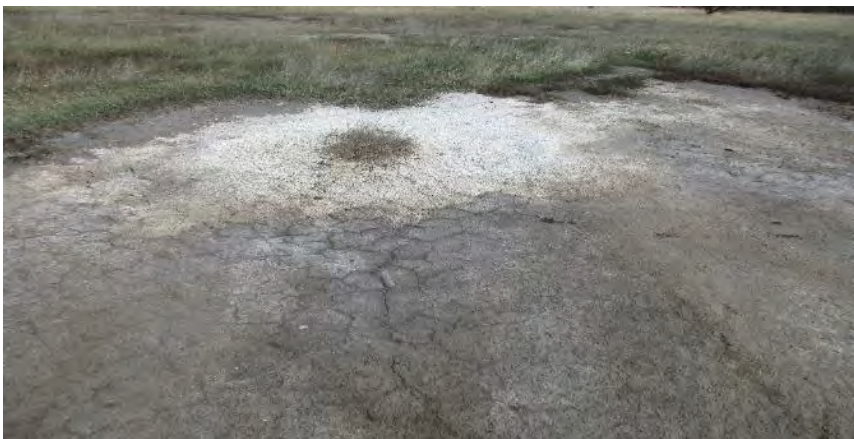
Photograph showing a close of view salt crusting and cracking soil located inside the visually impacted area.

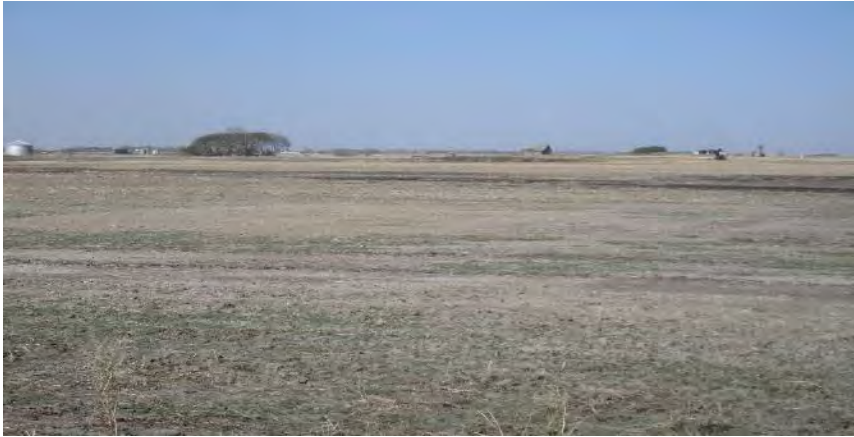
Photograph facing west off of an oilfield lease road showing visually impacted area, including lack of vegetative growth. The visually impacted area measured approximately 50 feet by 50 feet. An oil & gas facility is located east of the site.

R3-10 was inspected on May 15th, 2018 and is located approximately 500 feet west of 43rd Ave NW, just west of an oilfield lease road. The site is currently used as agricultural land and is surrounded by agricultural fields. An oil & gas facility was observed to the east and northeast, consisting of two aboveground storage tanks, a heater-treater, a pump jack, and a flare pit. A wetland was observed just north of the pump jack, to the north/northeast. Visual impacts were observed, including barren soil with little to no vegetation; the area of visual impacts measured approximately 50 feet by 50 feet. The site topography is generally flat and slopes to the northeast. An aboveground powerline was observed to the east.

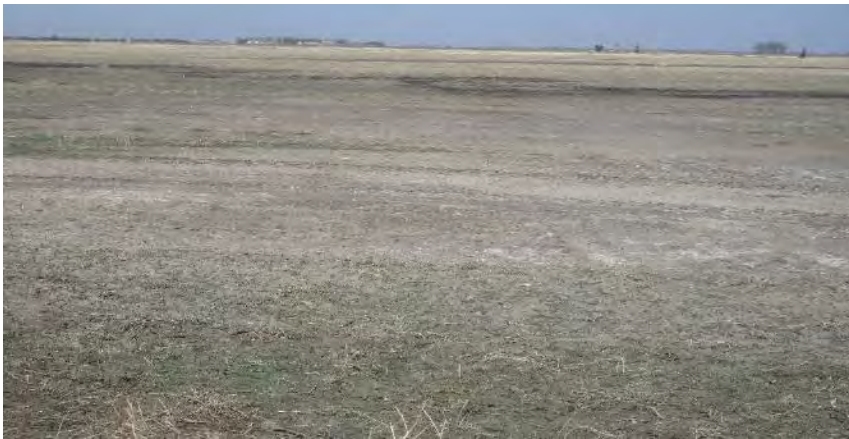
Photograph facing west off of oilfield lease road showing visually impacted area, including a lack of vegetative growth.

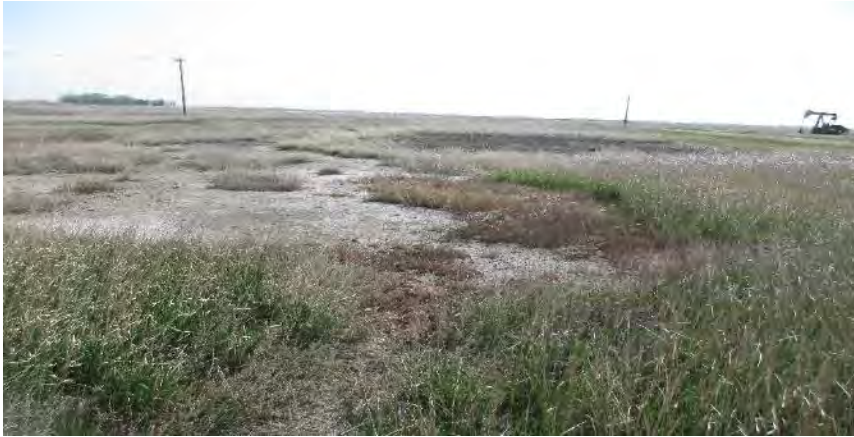
Photograph facing east off of oilfield lease road showing the visually impacted area with a lack of vegetation; the area of visual impacts measured approximately 100 feet by 20 feet. Oil & gas facilities are located west of site and a pump jack is located southeast of the site.

R3-11 was inspected on May 15th, 2018 and is located approximately 800 feet west of 44th St NW, just north of an oilfield lease road. The site is currently part grassland and part oil & gas facility. The oil & gas facility is located towards the center of the site, and consists of six aboveground storage tanks, a heater treater, and a pump jack. Grasslands surround the site otherwise. A small wetland was observed just north of the oil & gas facility. Visual impacts were observed, including barren soil with little to no vegetation and salt crusting; the area of visual impacts measured approximately 100 feet by 20 feet. The impacts appear to be migrating to the aforementioned wetland. The site topography is generally flat and slopes to the east/northeast. An aboveground powerline was observed to the north.

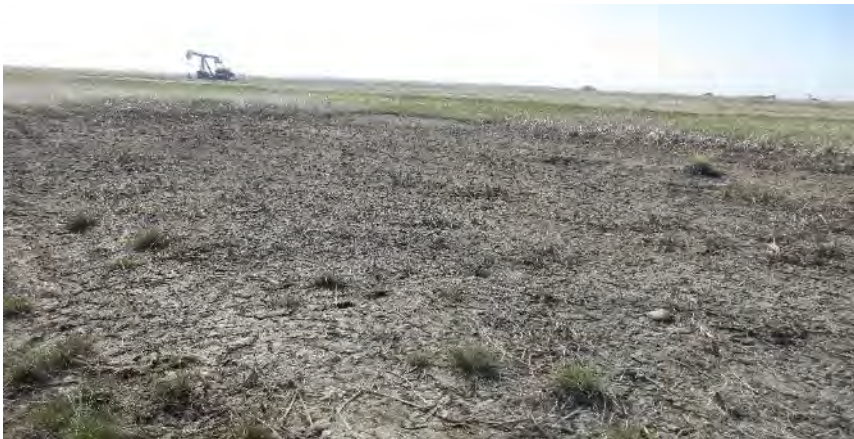
Photograph facing south east showing a visually impacted wetland. The visually impacted area appears to have migrated and affected a wetland east of the site. A pump jack and an oilfield lease road can be seen in the background.

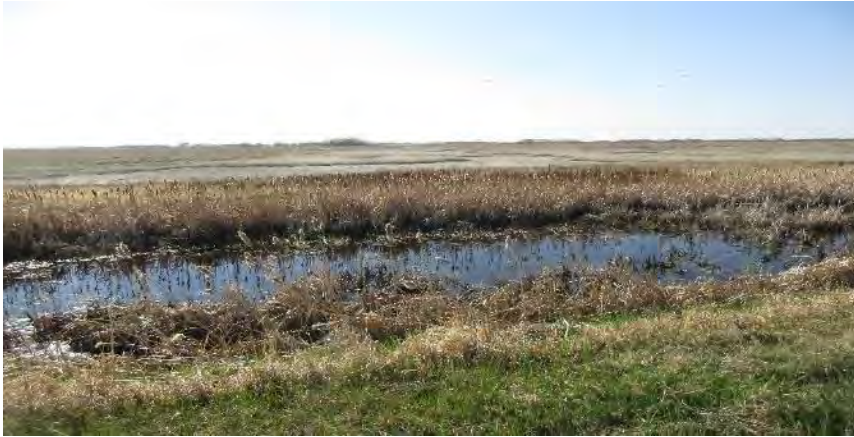
Photograph facing west off of 44th Ave NW showing the visually impacted area lacking vegetative growth. Wetlands are located to the north, east, and west of the site.

R3-12 was inspected on May 14th, 2018, and is located approximately 100 feet west of 44th Ave. NW. The site could not be accessed at the time of the site visit. The site is currently natural grassland and is surrounded by agricultural fields. Visual impacts were observed from a distance at the time of site visit. Visual impacts included an area of barren ground with stressed vegetation and salt crusting; the area of visual impacts measured approximately 150 feet by 100 feet. Wetlands were also observed to the north, west, and east of the site. The site topography is generally flat and drains to the east/southeast. Aboveground powerlines were observed to the east of the site, along 44th Ave. NW.

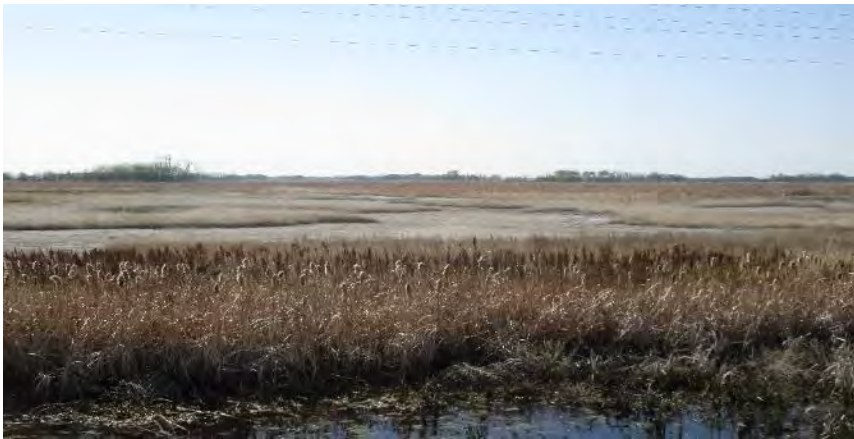
Photograph facing west off of 44th Ave NW showing a closer view of the visually impacted area lacking vegetative growth.

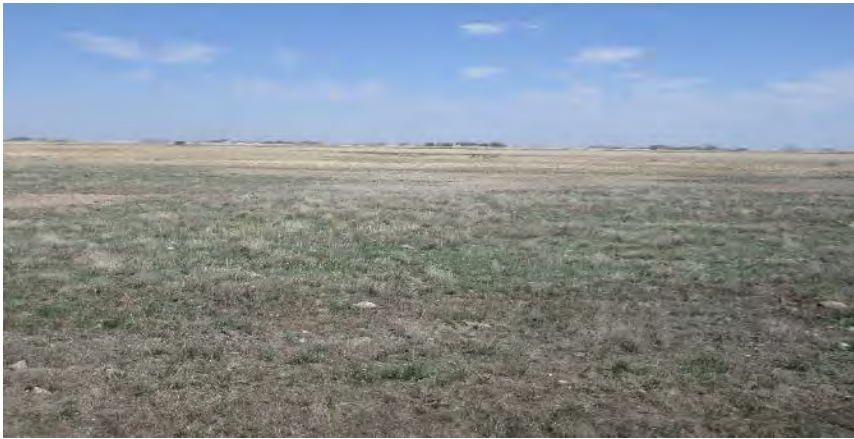
Photograph facing north off of an oilfield lease road showing visually impacted area including a lack of vegetative growth, which measured approximately 150 feet by 75 feet. A wetland is located north of the site.

R4-1 was inspected on May 15th, 2018 and is located approximately 100 feet north of an oilfield lease road. The site is currently natural grassland, and is surrounded by natural grasslands. A wetland was observed to the north of the site. Visible impacts were observed, including stressed vegetation; the area of visual impacts measured approximately 150 feet by 75 feet. The site topography is generally flat and drains to the northeast.

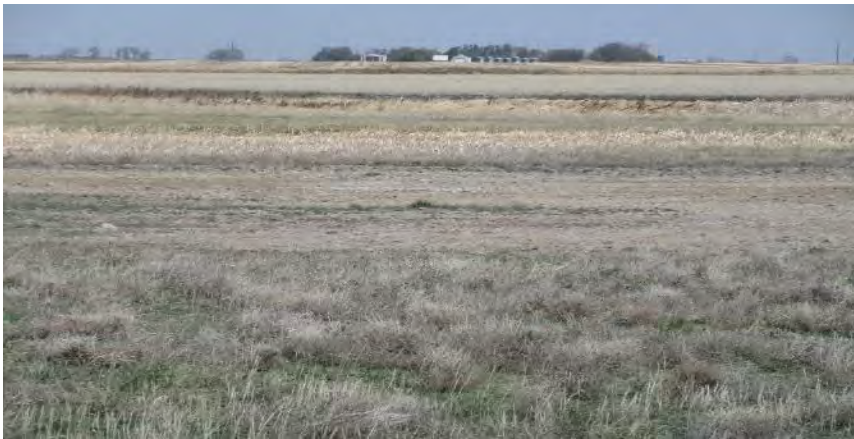
Photograph facing north off of an oilfield lease road showing a close up of the visually impacted area. A wetland is visible in the background north of the site.

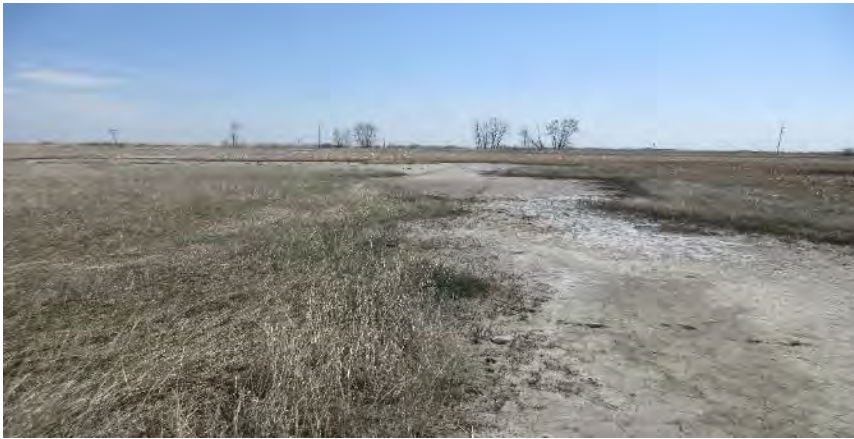
Photograph facing east off of an oilfield lease road showing the visually impacted area, including a lack of vegetative growth, cracking soils, and salt crusting. The area of visual impacts measured approximately 200 feet by 100 feet. A wetland is located to the south and east of the site.

R4-2 was inspected on May 15th, 2018, and is located approximately 200 feet south and 400 feet west of an oilfield lease road. The site is currently natural grassland, and is surrounded by natural grasslands. An oil & gas facility lies to the southwest, consisting of two aboveground storage tanks and a heater treater. A wetland was observed to the east of the site. Visible impacts were observed, including barren soils, stressed vegetation, and salt crusting; the area of visual impacts measured approximately 200 feet by 100 feet. The impacts appeared to have migrated to the wetland east of the site. The site topography is generally flat and drains to the northeast.

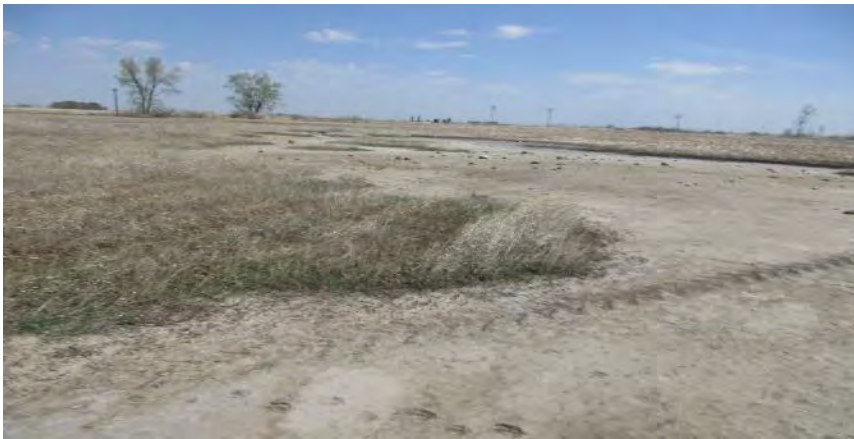
Photograph facing north off showing the visually impacted area and wetland located to the east of site. A lack of vegetative growth can be seen.

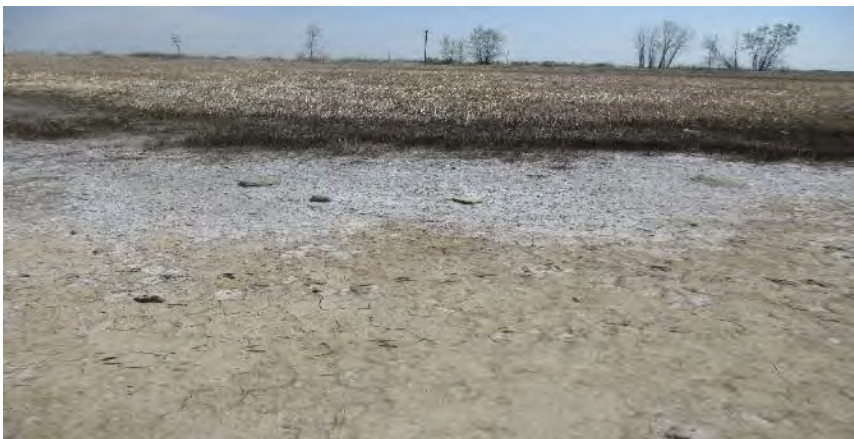
Photograph facing west on the edge of the visually impacted area near the wetland east of the site. Salt crusting and cracking soil can be seen. The impacts from the site appear to be migrating to the wetland to the east of the site.

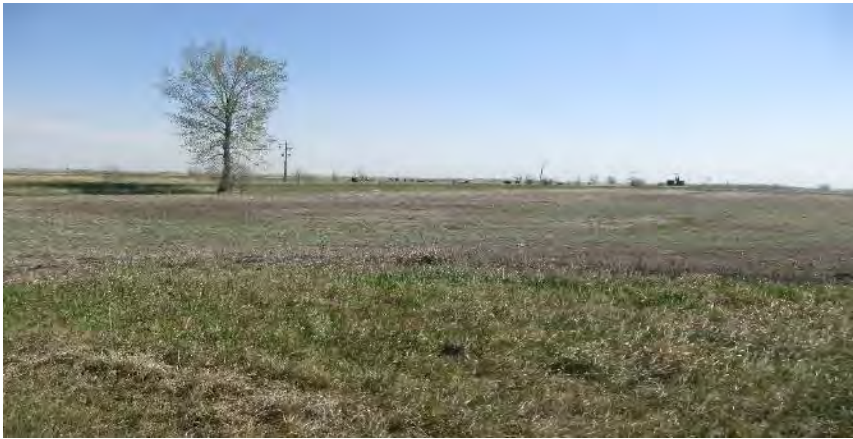
Photograph facing northeast off of an oilfield lease road showing the visually impacted area, including slightly stressed vegetation. The impacted area measured approximately 20 feet by 20 feet. An oil & gas facility is located to the west of the site.

R4-3 was inspected on May 15th, 2018 and is located approximately 150 feet south of 109th St. NW. The site is currently used for agricultural purposes. Agricultural fields lie to the east and south. Grazing pastures lie to the north. An oil & gas facility lies to the west, consisting of two aboveground storage tanks, a heater treater, a vehicle garage, a pump jack, and a flare pit. Visible impacts were observed, including slightly stressed vegetation; the area of visual impacts measured approximately 20 feet by 20 feet. The site topography is generally flat and slopes to the northwest. Aboveground powerlines were observed to the north and west of the site.

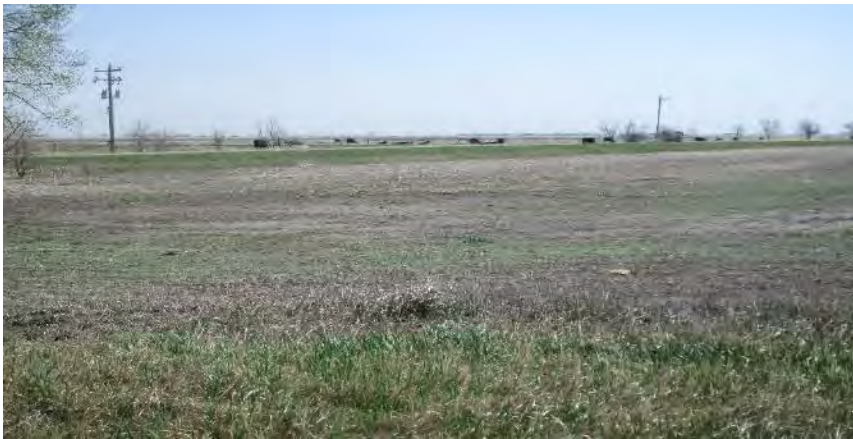
Photograph facing northeast off of an oilfield lease road showing a closer view of the visually impacted area, where slightly stressed vegetation was observed.

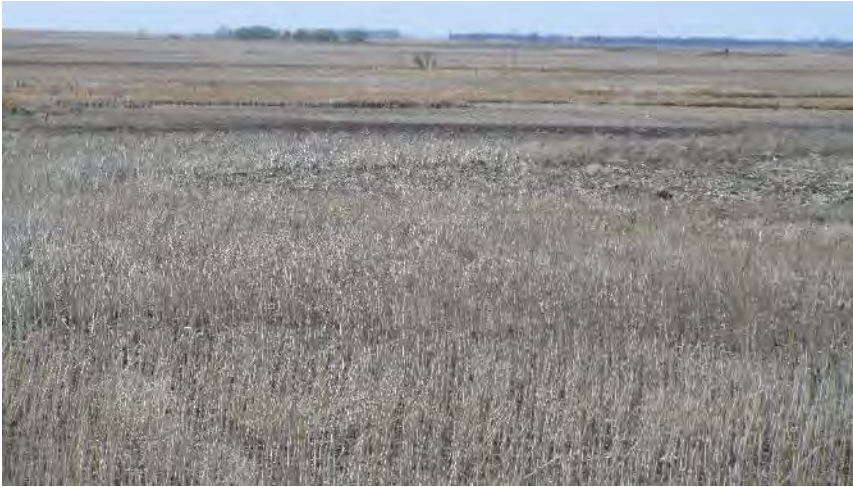
Photograph facing west from 50th Ave NW showing visually impacted area measuring approximately 200 feet by 100 feet. The site is on native grassland surrounded by agricultural fields.

R6-1 was inspected on May 9th, 2018, and is located on a private land approximately 400 feet west of 50th Ave NW. The site could not be accessed at the time of the site visit. The site is native grassland with wetlands directly northeast of site. Visual impacts were observed from a distance during the site visit. These impacts included an area with barren ground lacking vegetation. The area of visual impacts measured approximately 200 feet by 100 feet. Fields used in agricultural production surround the site. The site topography is relatively flat and drains predominantly to the southeast.

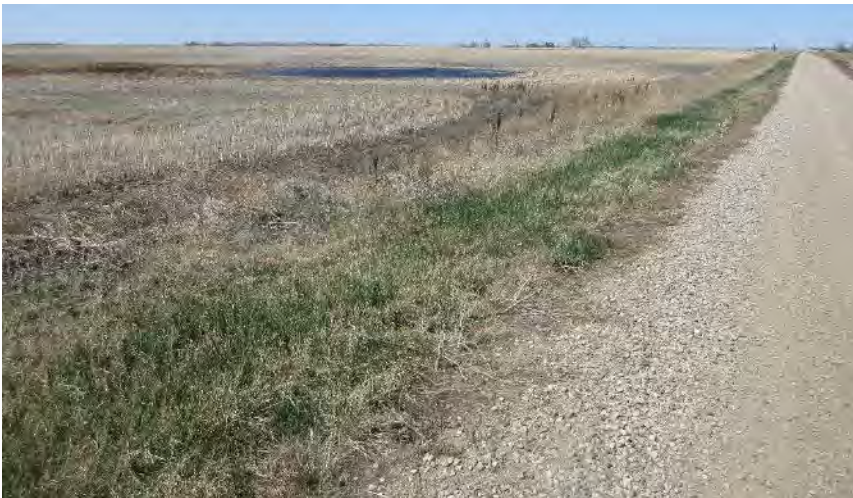
Photograph facing northwest from 50th Ave NW showing wetland adjacent to site.

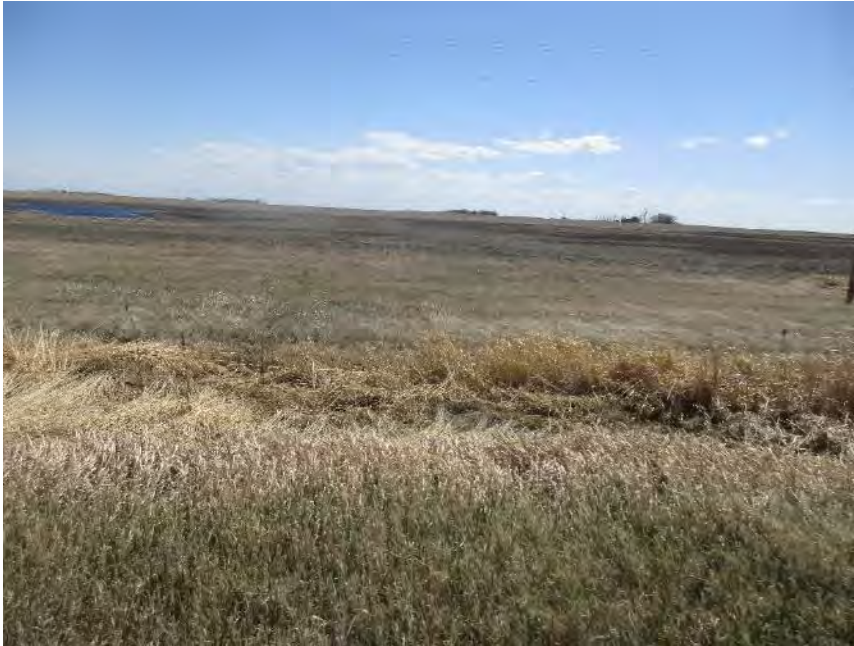
Photograph facing north from 101st St NW showing the site. No visual impacts were observed at the time of the site visit.

R6-2 was inspected on May 9th, 2018, and is located on private land approximately 500 feet north of 101st St NW. The site could not be accessed at the time of the site visit. The site is located near wetlands surrounded by agricultural fields. No major visual impacts could be observed from a distance. A small area of potentially stressed vegetation was observed from a distance, but could not be measured due to access restrictions. The site topography is relatively flat and drains predominantly to the southeast.

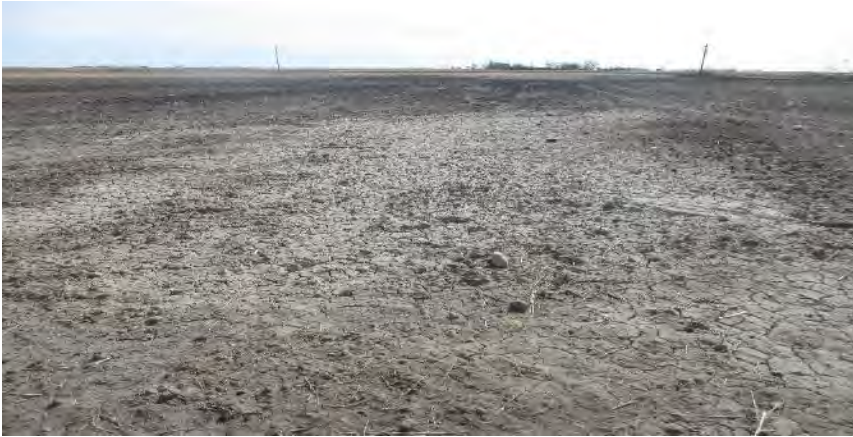
R7-1 (May 2018)

Photograph facing south showing the visual impacts at the site. The area of visual impacts measured approximately 100 feet by 100 feet.

R7-1 was inspected on May 10th, 2018 and is located approximately 300 feet north of 98th St NW and just east of an oilfield lease road. The site is currently used for agricultural purposes and is surrounded by agricultural fields. An oil & gas facility was observed to the west and consisted of a single shack. Visual impacts were observed, including patches of barren ground lacking vegetation with salt crusting; the area of visual impacts measured approximately 100 feet by 100 feet. A wetland lies to the north. The site topography is generally flat and drains to the east/northeast.

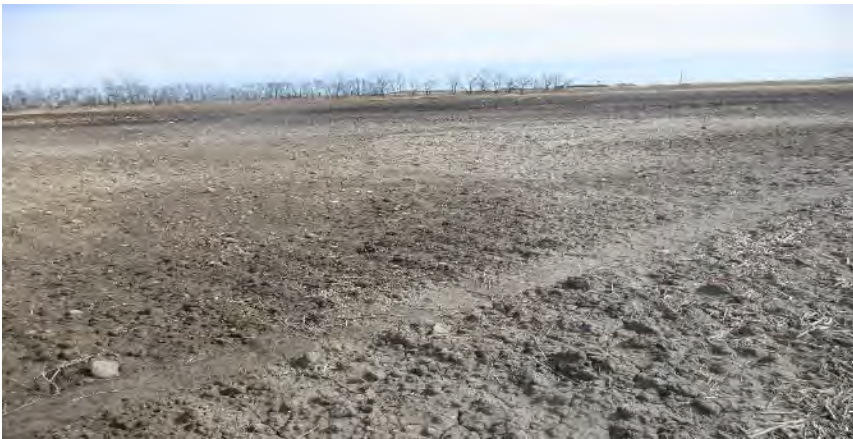
Photograph facing east showing the visual impacts located at the site. An agricultural field and tree row can be seen in the background.

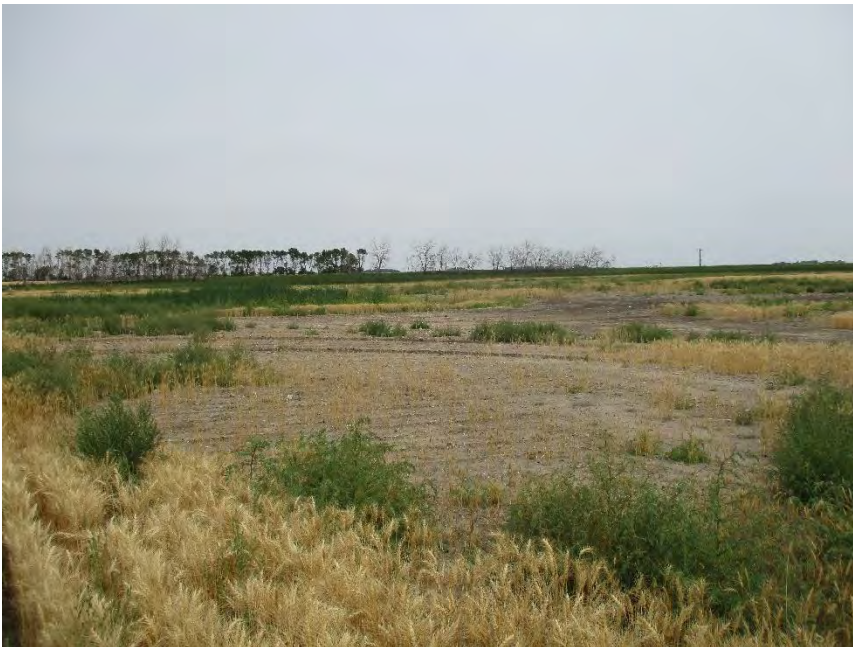
Photograph facing east showing barren ground and stressed vegetation in an area measuring approximately 100 feet by 100 feet.

R7-1 was revisited on August 20th, 2018. This follow-up investigation confirmed visual impacts consisting of barren ground and stressed vegetation in an area measuring approximately 100 feet by 100 feet as initially estimated during the May 10th, 2018 site visit.

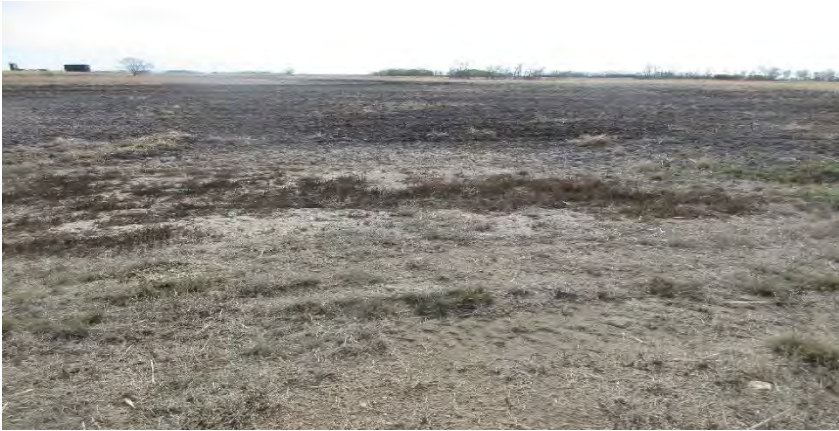
R7-2 (May 2018)

Photograph facing east from an oilfield lease road showing the visually impacted area measuring approximately 20 feet by 20 feet. The site is on agricultural land surrounded by agricultural fields and oilfield production.

R7-2 was inspected on May 10th, 2018 and is located approximately 350 feet south and 50 feet east of an oilfield lease road. The site is currently used for agricultural purposes and is surrounded by agricultural fields. An oil & gas facility was observed to the south and consisted of a single pump jack. Visual impacts were observed, including an area of lighter colored soil with no vegetation; the area of visual impacts measured approximately 20 feet by 20 feet. A wetland lies to the northeast. The site topography is generally flat and drains to the east/northeast. An aboveground powerline was observed to the west of the site.

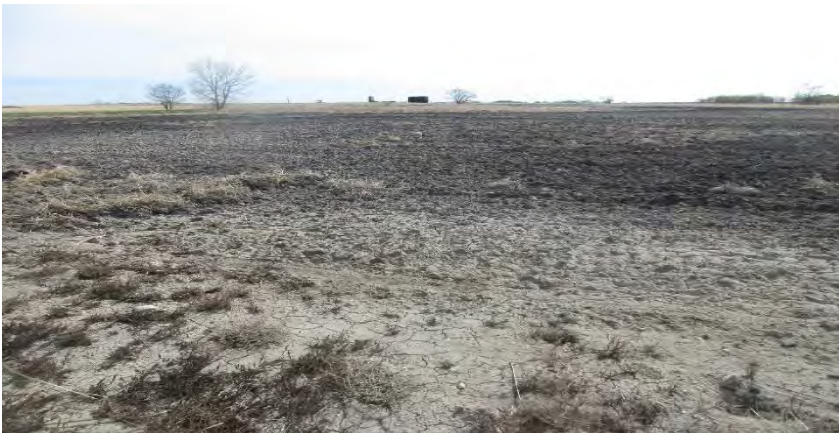
Photograph facing east from an oilfield lease road showing a closer view of the visual impacts at the site. Soil cracking and stressed vegetation can be seen. An agricultural field is in the background.

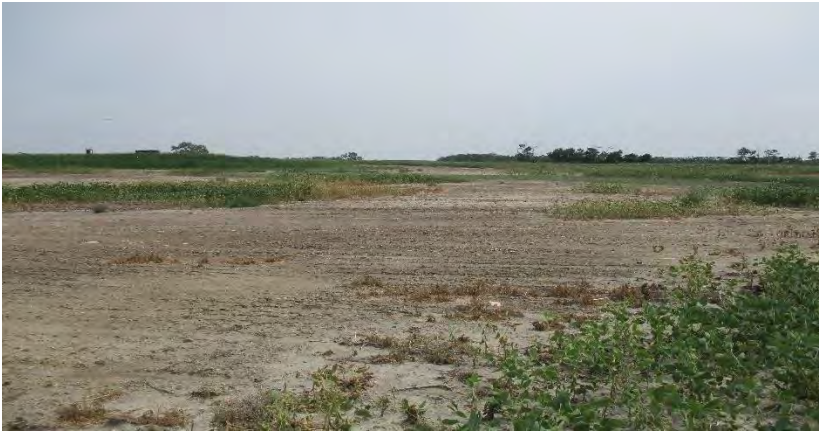
R7-2 (August 2018)

Photograph facing south from an oilfield lease road showing the visually impacted area. Barren ground and stressed vegetation were observed in an area measuring approximately 200 feet by 200 feet.

R7-2 was revisited on August 20th. During the initial inspection, the site had recently been plowed, and no impacts could be observed. This follow-up investigation identified visual impacts consisting of barren ground and stressed vegetation in an area measuring approximately 200 feet by 200 feet.

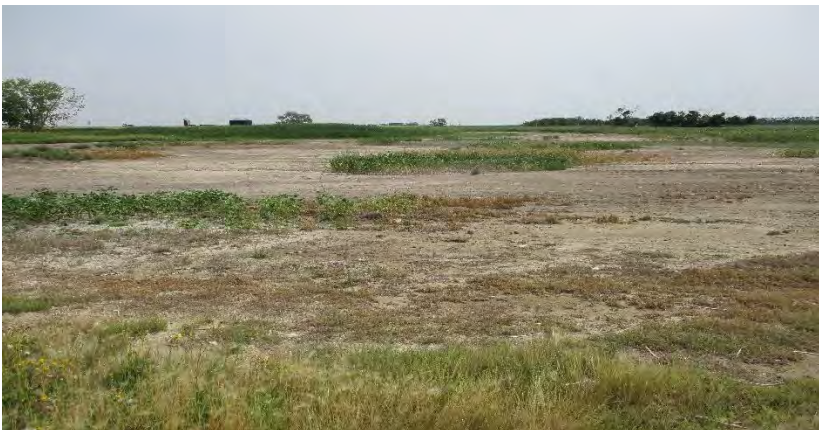
Photograph facing south from an oilfield lease road showing the visually impacted area.

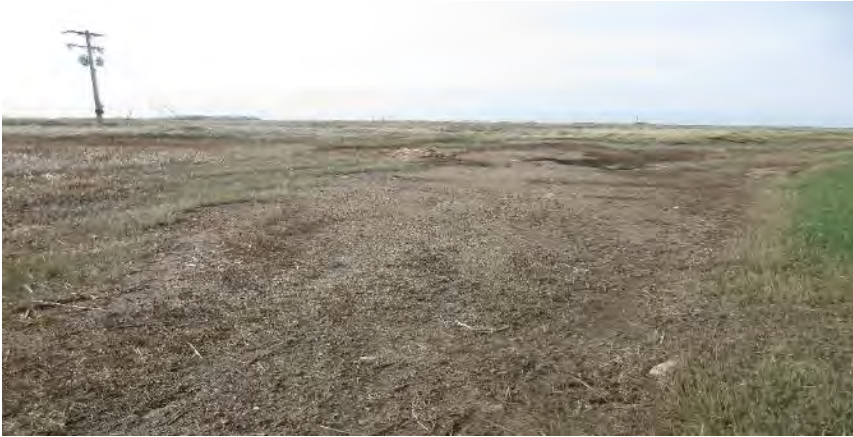
Photograph facing south from an oilfield lease road showing the visually impacted area, which measured approximately 100 feet by 20 feet. The site is on native grassland directly east of an oilfield lease road.

R7-3 was inspected on May 10th, 2018 and is located approximately 300 feet south of 97th St. NW and 50 feet east of an oilfield lease road. The site is currently a native grassland and is surrounded by agricultural fields. An oil & gas facility was observed to the west and consisted of a single shack. Visual impacts were observed, including an area of barren ground and stressed vegetation; the area of visual impacts measured approximately 100 feet by 20 feet. A wetland lies to the northeast. The site topography is generally flat and drains to the north. An aboveground powerline was observed to the south of the site.

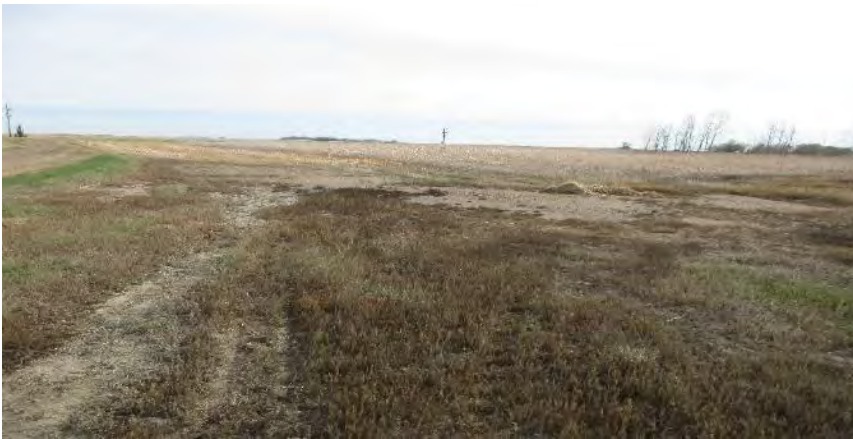
Photograph facing north showing the extents of the visually impacted area. A wetland and pump jack can be seen in the background.

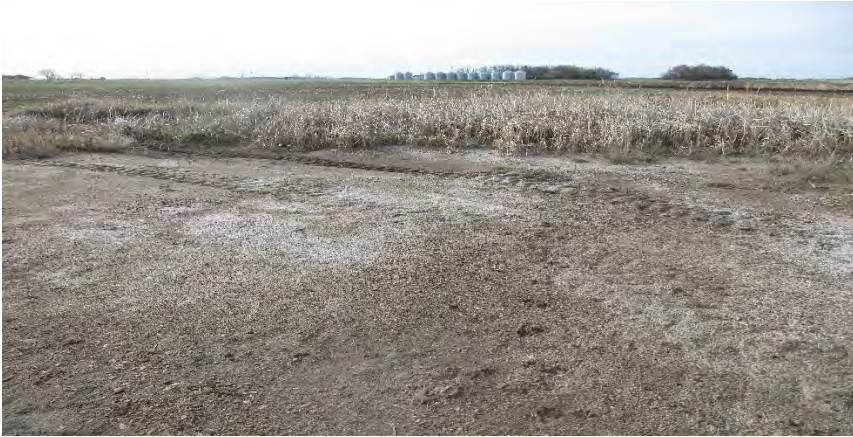
Photograph facing south from an oil & gas facility showing the visually impacted area, which measured approximately 40 feet by 15 feet. The area showed a lack of vegetation and salt crusting and lies directly north of a wetland.

R7-4 was inspected on May 10th, 2018 and is located approximately 400 feet west of 46th Ave NW and 50 feet south of an oilfield lease road. The site is currently used as an oil & gas facility. Oilfield equipment consisted of a pump jack, an aboveground storage tank, and pipeline risers. Agricultural fields lie to the north and west. Wetlands lie to the east and south, with agricultural lands beyond that. Visual impacts were observed, including an area of barren ground with no vegetation and salt crusting; the area of visual impacts measured approximately 40 feet by 15 feet. The site topography is generally flat and drains to the northeast. Utilities including an aboveground powerline and potential underground piping were observed to the north of the site.

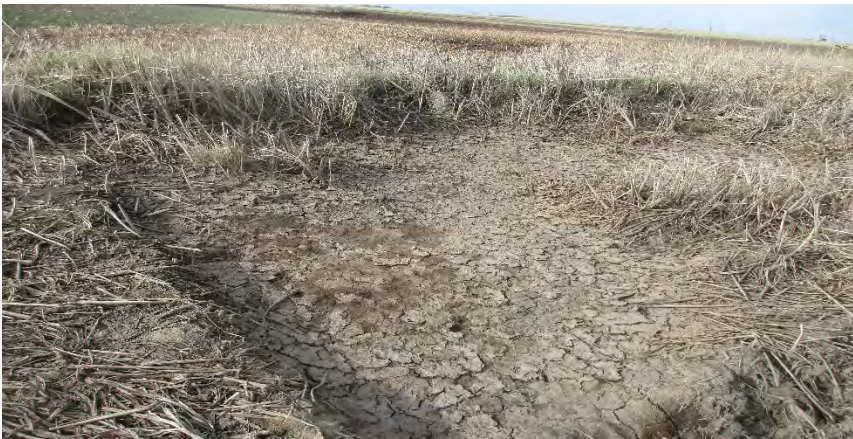
Photograph facing southwest from an oil & gas facility showing the location of the visually impacted area in relation to an adjacent wetland. Soil cracking and a lack of vegetative growth can be seen.

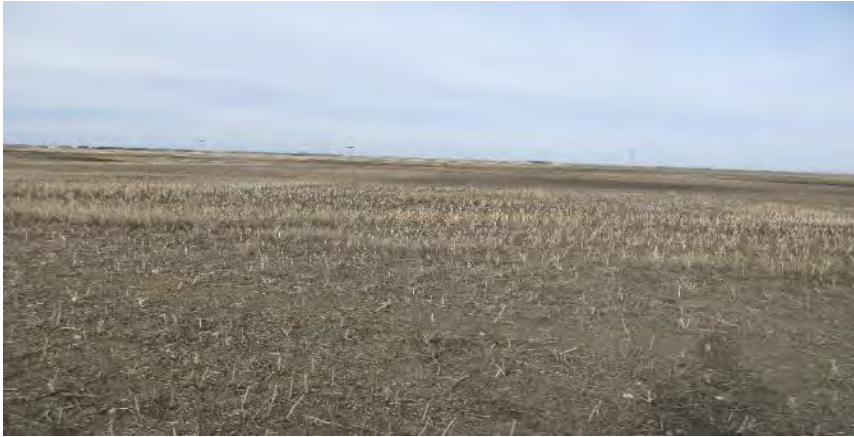
Photograph facing west from an oilfield lease road. The site is 200 feet east of the oilfield lease road and is located on agricultural land surrounded by agricultural fields. No visual impacts were observed during the site inspection.

R7-5 was inspected on May 10th, 2018 and is located approximately 500 feet north of 96th St NW and 200 feet west of an oilfield lease road. The site is currently used for agricultural purposes and is surrounded by agricultural fields. An oil & gas facility was located to the east and consisted of a single pump jack. No visual impacts were observed at the time of the site visit. A wetland lies to the south. The site topography is generally hilly and drains to the south/southeast. An aboveground powerline was observed to the west of the site.

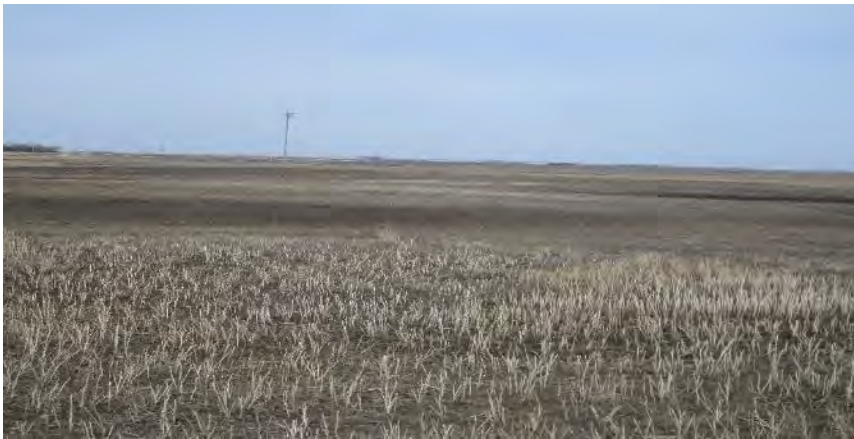
Photograph facing west from an oilfield lease road showing a closer view of the site. A wetland and above ground power pole can be seen in the background.

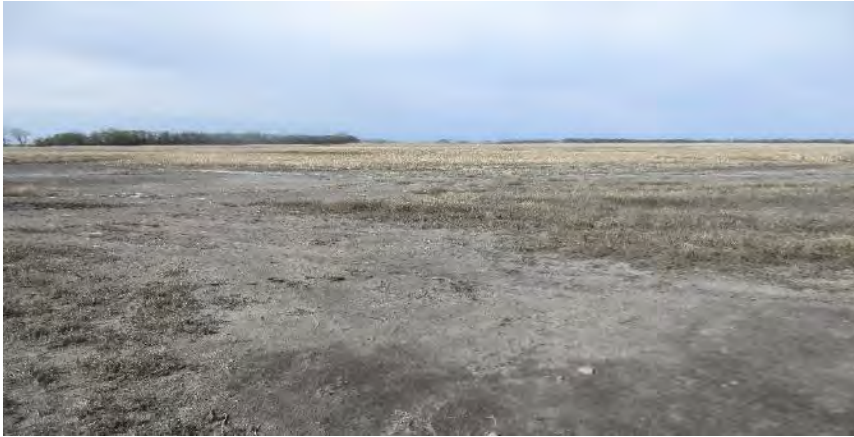
Photograph facing south from an oil & gas facility showing the visually impacted area, which measured approximately 400 feet by 100 feet. The area is currently native grassland lacking vegetation and is immediately north of a wetland.

R8-1 was inspected on May 10th, 2018 and is located approximately 500 feet south of 99th St NW and just south of an oilfield lease road. The site is currently native grassland and is surrounded by grassland. An oil & gas facility was observed to the north, and consisted of one aboveground storage tank and one heater-treater. Visual impacts were observed, including barren ground lacking vegetation with salt crusting; the area of visual impacts measured approximately 400 feet by 100 feet. Two grave markers were found in the middle of the impacted area. A wetland lies to the south of the site, and a pond lies to the northeast. The site topography is generally flat and drains to the south/southwest.

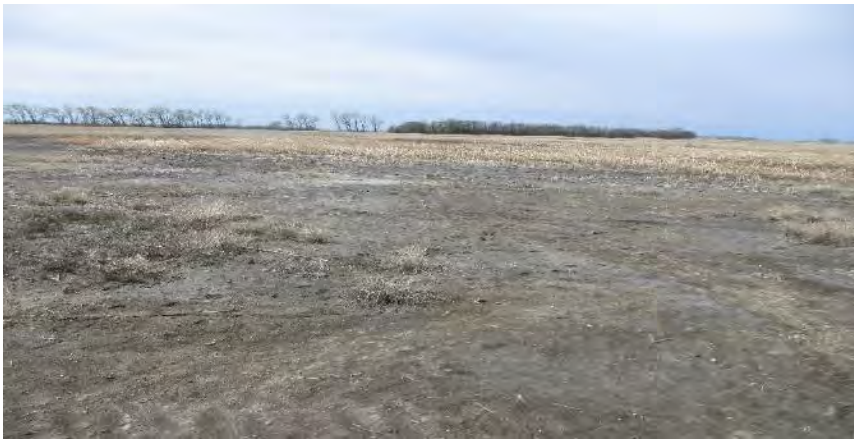
Photograph facing south from an oil & gas facility showing the visually impacted area. A wetland can be seen further to the south in the background of the photograph.

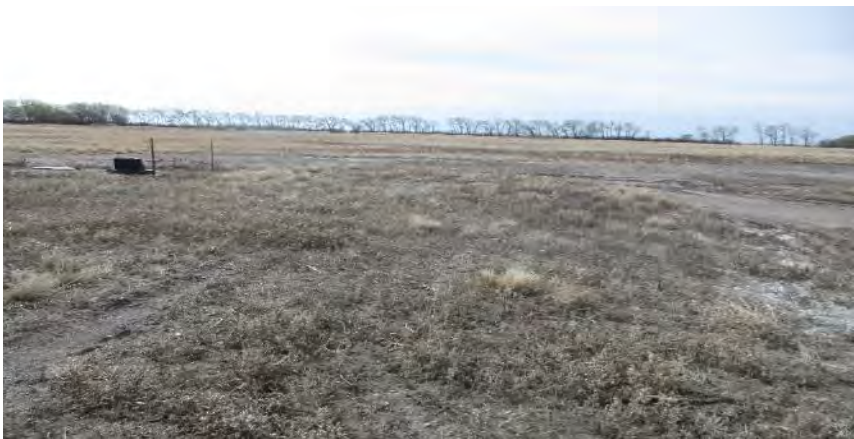
Photograph facing south from an oil & gas facility showing the visually impacted area. Two grave markers located at the site can be seen.

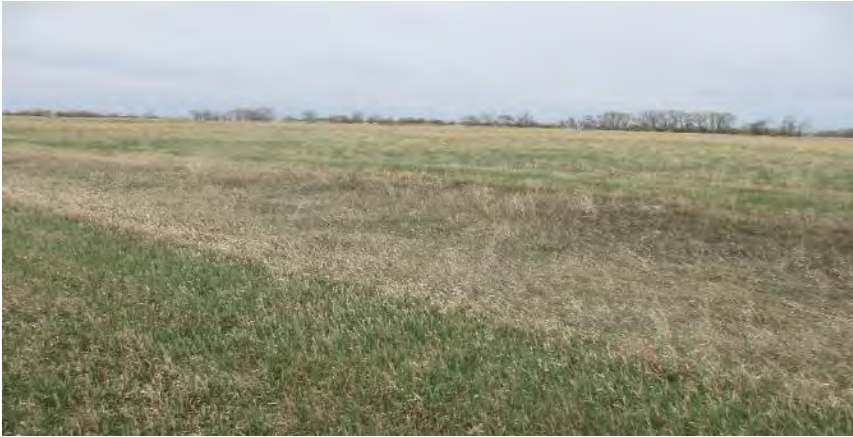
Photograph facing southwest off of 36th Ave NW. The site is located 500 feet west of 36th Ave NW. No visual impacts could be observed from the roadway.

R8-2 was inspected on May 10th, 2018, and is located approximately 500 feet west of 36th Ave NW. The site could not be accessed at the time of the site visit. The site is currently native grassland, and is surrounded by grasslands. Visual impacts could not be observed from a distance at the time of the site visit. The site topography is generally flat.

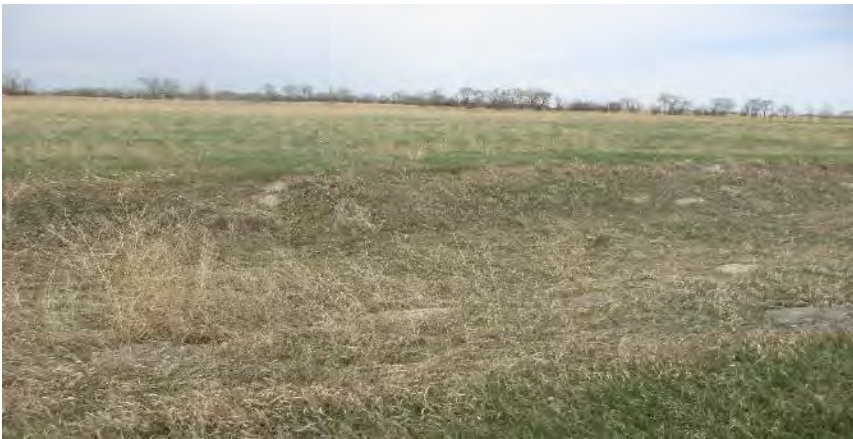
Photograph facing northwest off of 36th Ave NW. No visual impacts could be observed from the roadway.

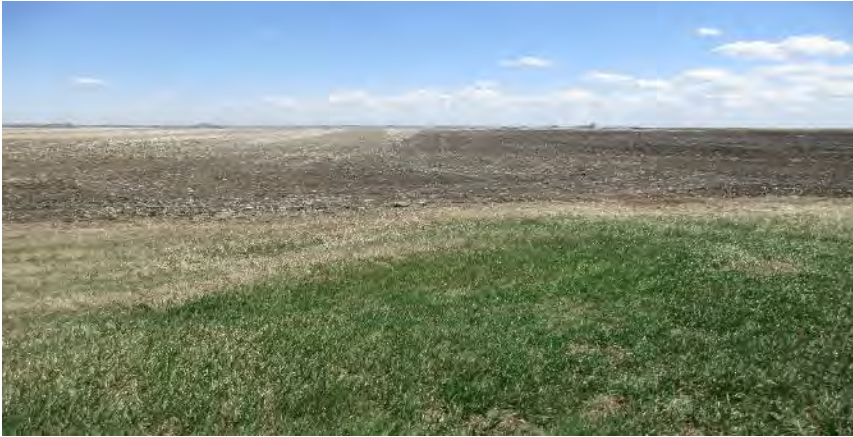
Photograph facing east off of Country Road 3 showing the site. No visual impacts could be observed from the roadway at the time of the site visit.

R10-1 was inspected on May 9th, 2018 and is located approximately 500 feet east of County Road 3. The site could not be accessed at the time of the site visit. The site is currently used for agricultural purposes. Agricultural fields surround the site. No visual impacts could be observed from a distance at the time of site visit. The site topography is generally flat and drains slightly to the west.

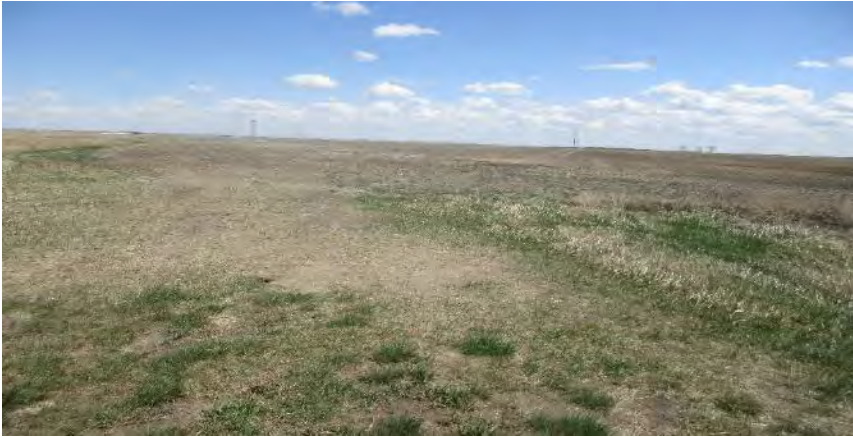
Photograph facing east off of County Road 3. The site is located 500 feet east of the roadway in an agricultural field. No visual impacts were observed from the roadway. Above ground powerlines can be seen in the background.

R10-2 was inspected on May 9th, 2018 and is located approximately 500 feet east of County Road 3. The site could not be accessed at the time of the site visit. The site is currently used for agricultural purposes. Agricultural fields surround the site. No visual impacts could be observed from a distance at the time of site visit. The site topography is generally flat and appeared to drain slightly to the northwest. Aboveground powerlines were also observed to the east of the site.

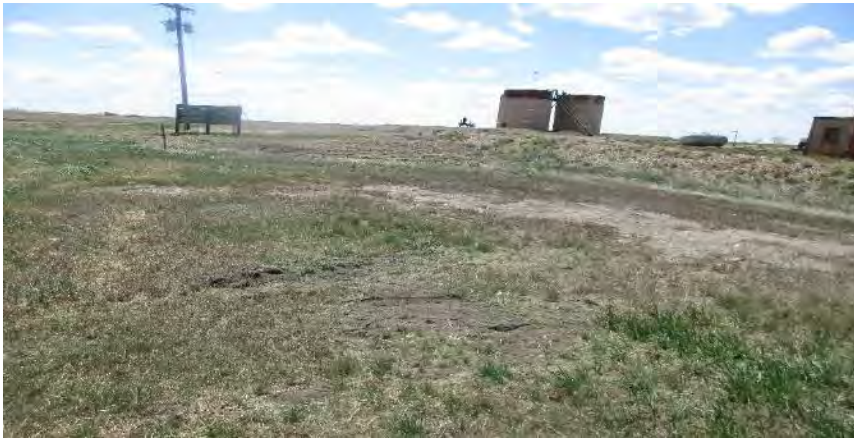
Photograph facing southwest showing the visually impacted area. Visual impacts include barren soils and stressed vegetation. The area of visual impacts measured approximately 20 feet by 10 feet. The visually impacted area is located directly east of an oil & gas facility.

R10-3 was inspected on May 9th, 2018 and is located approximately 700 feet east of 52 Ave. NW. The site is located adjacent to an oil & gas facility. The site is currently natural grassland, and is adjacent to oilfield equipment that lie to the west and south. The oilfield equipment consisted of seven aboveground storage tanks, one heater-treater, and two shacks. Agricultural fields lie to the north and east. A wetland also lies approximately 50 feet to the north. Visual impacts were observed, including barren soils and stressed vegetation; the area of visual impacts measured approximately 20 feet by 10 feet. The site topography is generally flat and drains to the southeast. Aboveground powerlines were also observed running to the southwest.

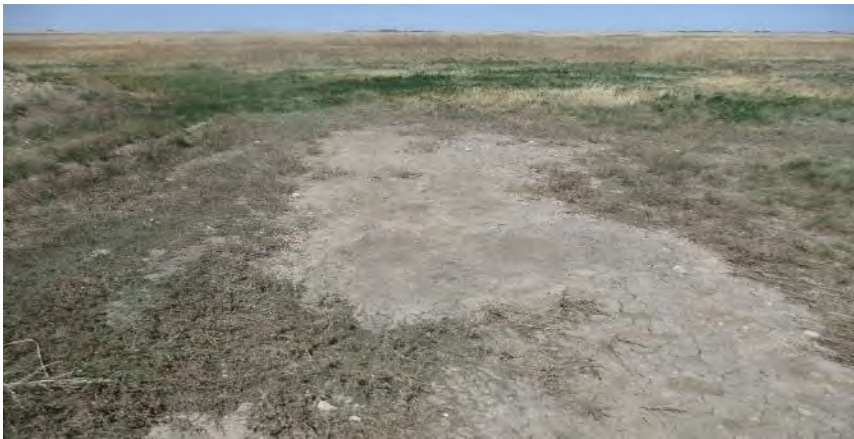
Photograph facing east showing the extents of visual impacts on the site. Grassland and an agricultural field can be seen in the background.
