NDIC Brine Pond Study

Phase II: Site Assessments

June 25, 2018

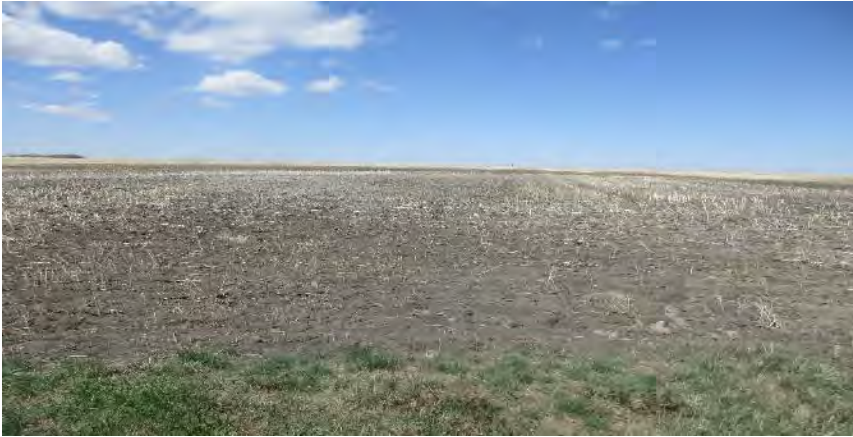
Photograph facing north off of an oil & gas facility showing the agricultural field where the site is located. No visual impacts were observed at the time of the site inspection.

R10-4 was inspected on May 9th, 2018 and is located approximately 200 feet north of an oilfield lease road. The site is currently used for agricultural purposes and is adjacent to an oil & gas facility consisting of a small shack that lies to the south. Agricultural fields surround the site to the north, west, and east. No visual impacts were observed at the time of site visit. The site topography is generally flat and drains slightly to the south.

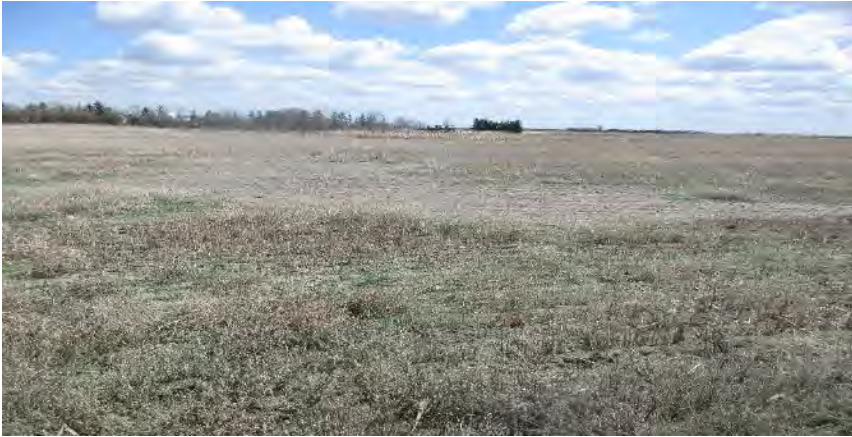
Photograph facing east off of oilfield lease road showing the visually impacted area with a lack of vegetative growth. The visually impacted area measured approximately 60 feet by 20 feet. An oil & gas facility is located west of site.

R11-1 was inspected on May 9th, 2018 and is located approximately 800 feet north of 93rd St NW and 50 feet east of an oilfield lease road. The site is currently used for agricultural purposes. Agricultural fields lie to the north, east, and south. A residence is located approximately 1,000 feet to the east. A wetland is located approximately 500 feet to the southeast. An oil & gas facility lies at the end of the lease road, to the southwest. Oilfield equipment consist of a pump jack, two aboveground storage tanks, and one heater-treater. Visual impacts were observed, including barren soils lacking vegetation and cracking soil; the area of visual impacts measured approximately 60 feet by 20 feet. The site topography is generally flat and drains to the southwest.

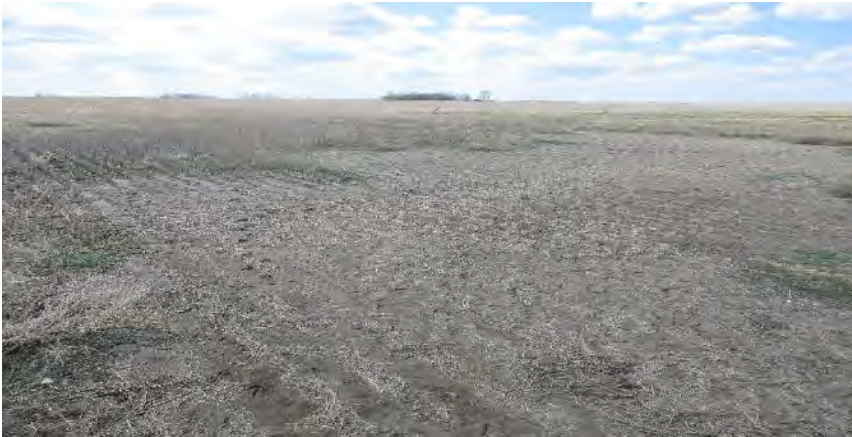
Photograph facing southwest showing the visually impacted area. A lack of vegetative growth and cracking soil can be seen.

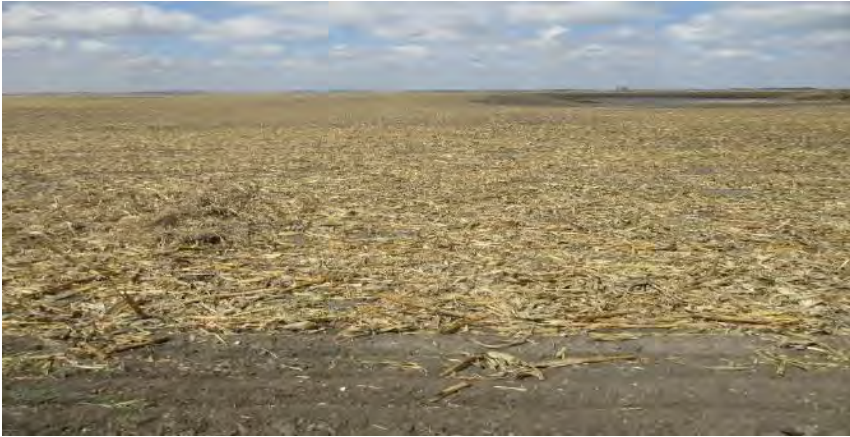
Photograph facing east off of 42nd Ave NW showing the site. No visual impacts could be observed from the roadway. A wetland can be seen in the background.

R14-1 was inspected on May 9th, 2018, and is located approximately 400 feet west of 42nd Ave NW. The site could not be accessed during the site visit. The site is currently used for agricultural purposes, and agricultural fields surround the site. No visual impacts could be observed from a distance during the site visit. The site topography is generally flat and possibly drains slightly to the south.

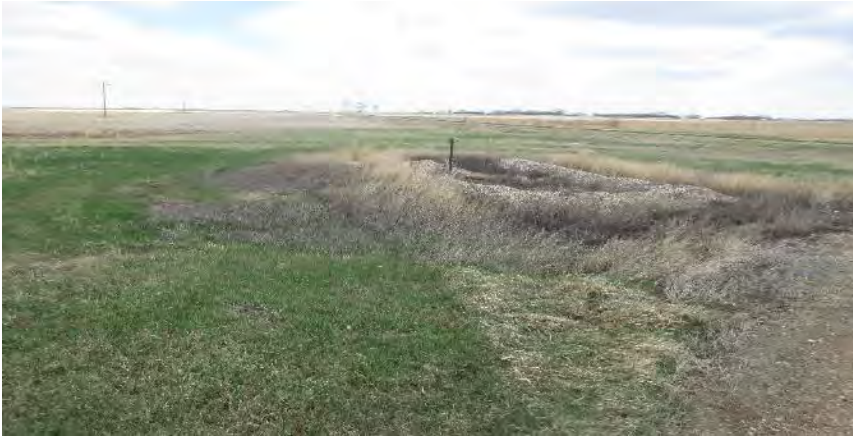
Photograph facing north off of an oil & gas facility showing the site. No visual impacts were observed during the site inspection. A flare pit can be seen in the photograph.

R14-2 was inspected on May 9th, 2018 and is located immediately west of 42nd Ave NW and northwest of an oil & gas facility. The site is currently on a native grassland. Agricultural fields lie to the north and west. The oil & gas facility was observed to the south, and consisted of two aboveground storage tanks, two heater treaters, and a flare pit. Native grassland lies to the east, past 42nd Ave NW. A wetland was also observed further north of the site. No visual impacts were observed at the site. The site topography is generally flat and drains to the northeast. Aboveground power lines were also observed to the west of the site.

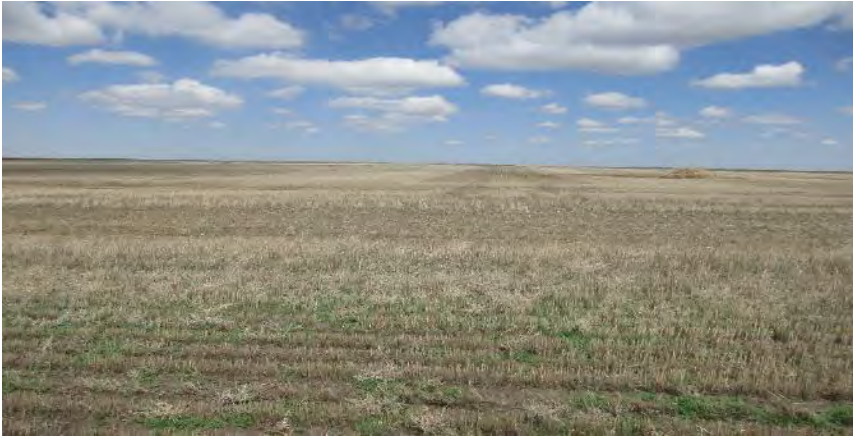
Photograph facing north off of 85th St NW showing the site. The site is located 500 feet north of 85th St NW, and no visual impacts could be observed from the roadway.

R14-3 was inspected on May 9th, 2018, and is located approximately 500 feet north of the intersection of ND-28 and 85th St. NW. The site could not be accessed at the time of the site visit. The site is currently used for agricultural purposes, and is surrounded by agricultural fields. No visual impacts could be observed from a distance during the site visit. The site topography is generally flat and drains to the southwest.

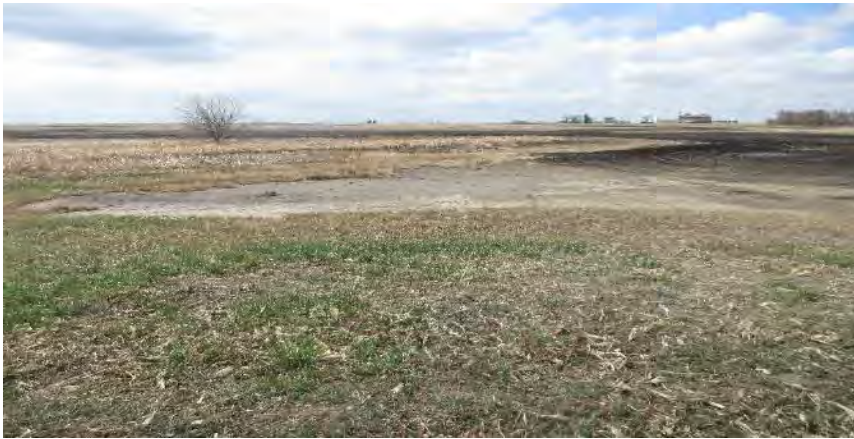
Photograph facing southeast off of oilfield lease road showing the visually impacted area lacking vegetative growth. The impacted area measured approximately 100 feet by 40 feet. An oil & gas facility is located to the northwest of the site.

R15-1 was inspected on May 9th, 2018 and is located approximately 400 feet south of 88th St NW and 25 feet south of an oilfield lease road. The site is currently used for agricultural purposes. Agricultural fields also lie to the south and east. An oil & gas facility was observed to the northwest, and consisted of three aboveground storage tanks, two heater treaters, and a pump jack. A wetland was also observed immediately southeast of the site. Visual impacts were observed, including an area lacking vegetation with grayish colored soils; the area of visual impacts measured approximately 100 feet by 40 feet. The site topography is generally flat and drains slightly to the east. Aboveground power lines were also observed to the northeast of the site.

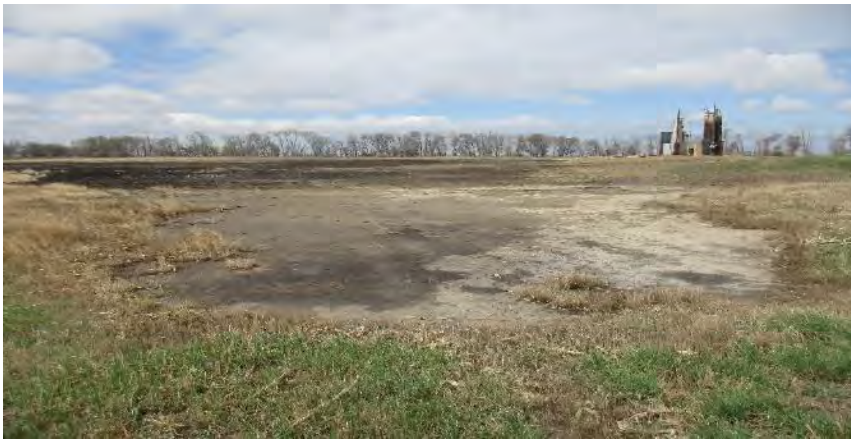
Photograph facing northwest showing the visually impacted area lacking vegetative growth. An oil & gas facility can be seen in the background.

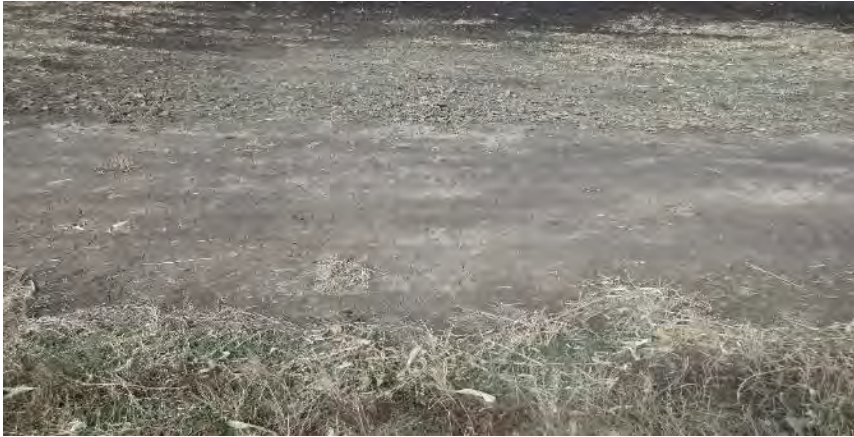
Photograph facing east off of an oilfield lease road showing the visually impacted area lacking vegetative growth with cracking soil. The impacted area measured approximately 20 feet by 10 feet. An oil & gas facility is located to the northeast of the site.

R15-2 was inspected on May 9th, 2018 and is located approximately 200 feet north of 86th St NW and immediately west of an oilfield lease road. The site is currently used for agricultural purposes, and agricultural fields surround the site. An oil & gas facility was observed to the northeast, and consisted of three aboveground storage tanks, one heater treater, and a pump jack. A wetland was also observed 30 feet to the south of the site. Visual impacts were observed, including lack of vegetation and grayish colored soils; the area of visual impacts measured approximately 20 feet by 10 feet. The site topography is generally flat and drains slightly to the south. Aboveground power lines were also observed to the east of the site.

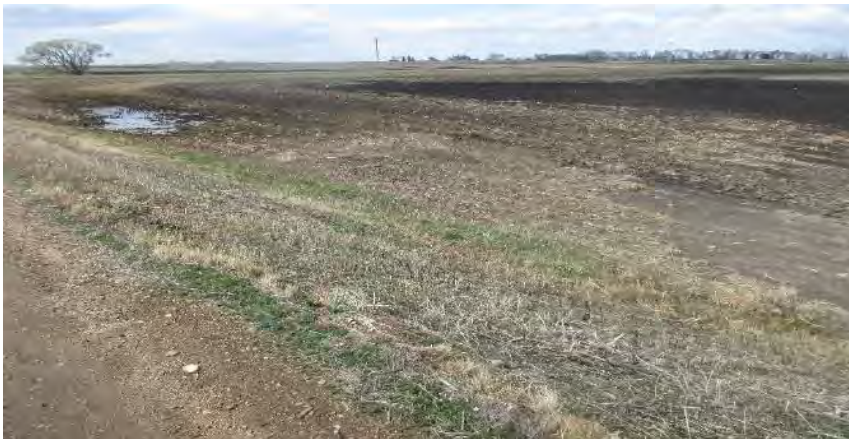
Photograph facing southwest off of oilfield lease road showing visually impacted area and the wetland located approximately 30 feet to the south of site. Aboveground powerlines running are visible in the background.

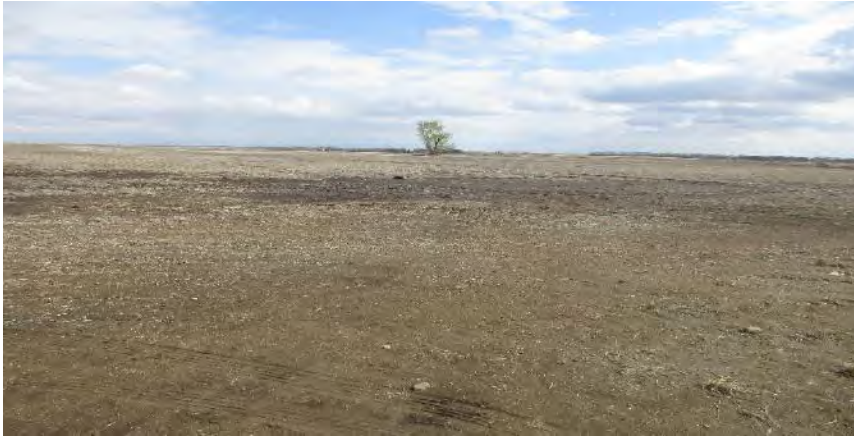
Photograph facing southeast off of an oil & gas facility showing the visually impacted area lacking vegetative growth. The visually impacted area measured approximately 70 feet by 70 feet.

R15-3 was inspected on May 9th, 2018 and is located immediately east of an oilfield lease road. The site is currently used for agricultural purposes and is surrounded by agricultural fields. An oil & gas facility was observed to the west, and consisted of three aboveground storage tanks and an injection shack. Visual impacts were observed, including a lack of vegetation and white-colored soils, the area of visual impacts measured approximately 70 feet by 70 feet. The site topography is generally flat and appeared to be a low point. An underground pipeline was observed at the site running east-west, and aboveground power lines were observed to the west of the site.

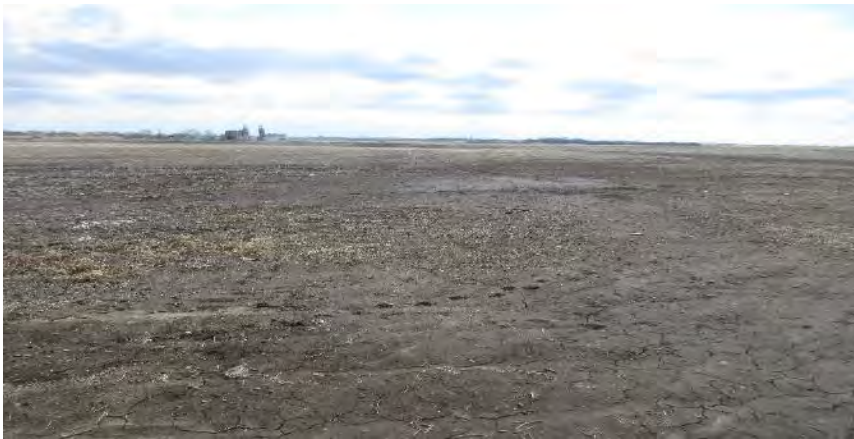
Photograph facing east off of an oil & gas facility showing the visually impacted area. White colored soils and soil cracking is present. An oil & gas facility can be seen in the background.

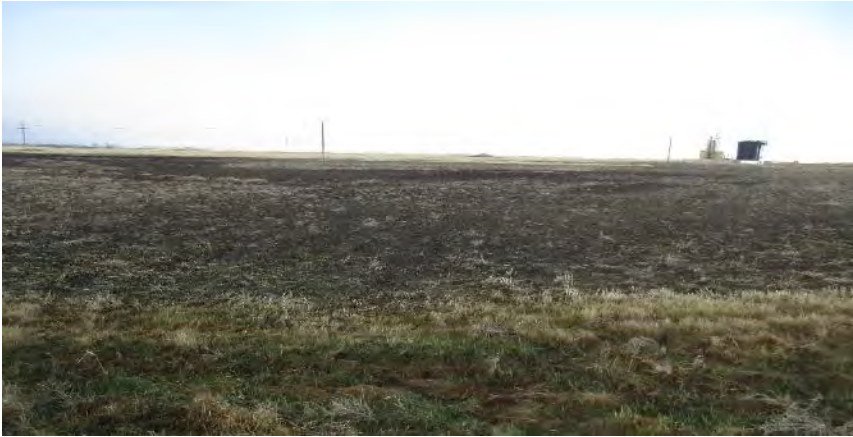
R17-1 (May 2018)

Photograph facing west/southwest off of an oilfield lease road showing the site. No visual impacts were observed at the time of the May 9, 2018 site visit. An oil & gas facility is located to the west of the site.

R17-1 was inspected on May 9th, 2018 and is located approximately 50 feet south of 80th St NW and 50 feet east of an oilfield lease road. The site is currently used for agricultural purposes and is surrounded by agricultural fields. An oil & gas facility was observed to the west and consisted of two aboveground storage tanks and a heater treater. A pump jack was also located to the southeast. No visual impacts were observed at the site during the site visit. The site topography is generally flat and drains to the northeast.

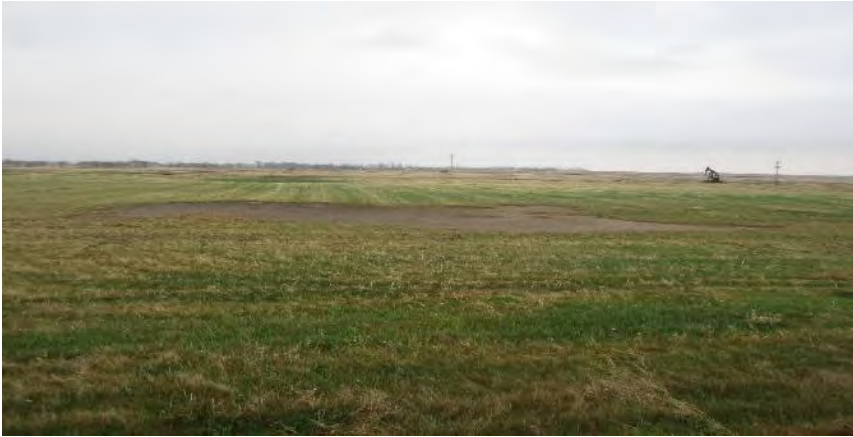
Photograph facing south off of 80th St NW showing the visually impacted area lacking vegetation. The visually impacted area measured approximately 100 feet by 50 feet. An oil & gas facility is located west of the site.

R17-2 was inspected on May 9th, 2018, and is located approximately 50 feet south of 80th St NW and 100 feet west of an 43rd Ave NW. The site is currently native grass land. Additional grassland lies to the south. Agricultural fields lie to the north and east. An oil & gas facility was observed to the west, and consisted of three aboveground storage tanks, a heater treater, and a flare pit. Visual impacts were observed, including barren ground lacking vegetation and cracking soil; the area of visual impacts measured approximately 100 feet by 50 feet. A wetland was also observed to the south. The site topography is generally flat and drains to the northwest. An aboveground power line was observed approximately 350 feet to the south of the site.

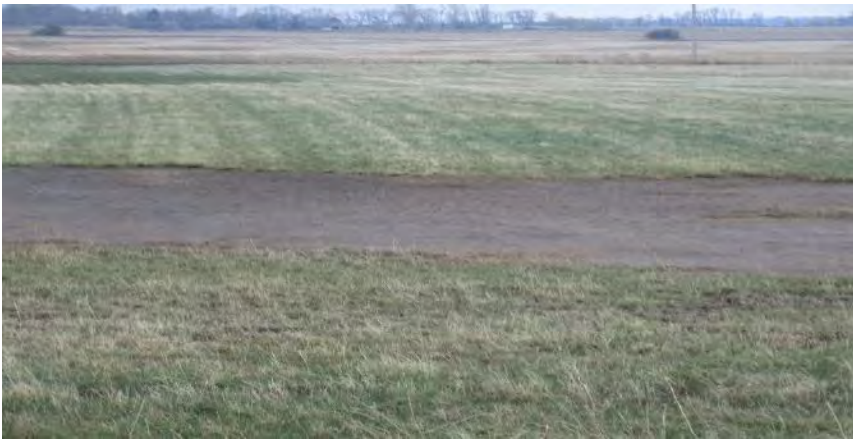
Photograph facing south off of 80th St NW showing a closer view of the visually impacted area with cracking soil. Aboveground power lines and a wetland can be seen in the background.

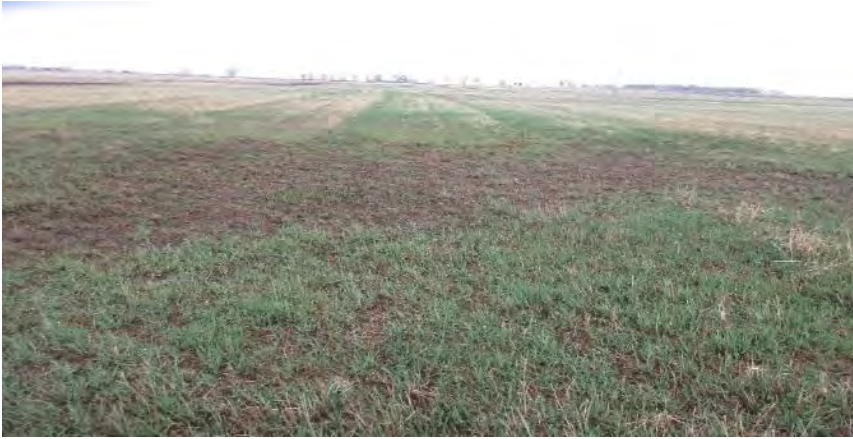
Photograph facing south off of an oilfield lease road showing the visually impacted area, including stressed vegetation. The area of visual impacts measured approximately 60 feet by 20 feet.

R17-3 was inspected on May 9th, 2018, and is located approximately 500 feet south of 80th St NW and 125 feet west of an oilfield lease road. The site is currently used for agricultural purposes, and is surrounded by agricultural fields. A pump jack was observed approximately 125 feet to the east. Visual impacts were observed, including an area of stressed vegetation; the area of visual impacts measured approximately 60 feet by 20 feet. A number of wetlands were also observed to the northwest and southeast. The site topography is generally flat and drains to the southeast. An aboveground power line was observed approximately 75 feet to the north of the site.

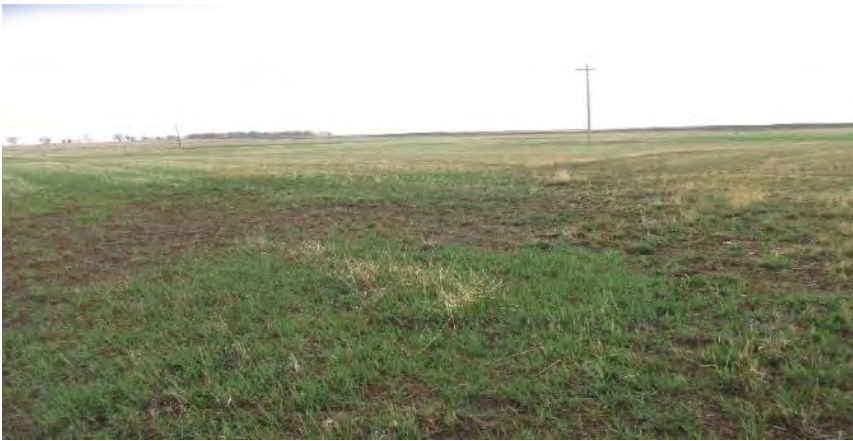
Photograph facing south east showing the visually impacted area. An aboveground power line can be seen in the background.

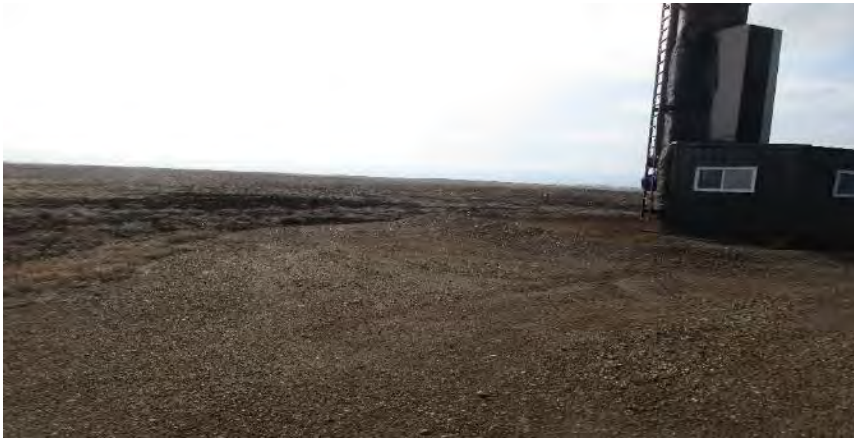
Photograph facing east off of an oil & gas facility showing the visually impacted area with a lack of vegetative growth. A heater treater can be seen immediately west of the site.

R17-4 was inspected on May 9th, 2018 and is located approximately 50 feet west of an oilfield lease road. The site is currently used for agricultural purposes and is surrounded by agricultural fields. An oil & gas facility was observed to the west and consisted of three aboveground storage tanks and one heater treater. Visual impacts were observed, including an area lacking vegetation; the area of visual impacts measured approximately 20 feet by 20 feet. The site topography is generally flat and drains to the northwest. An aboveground power line was observed to the west of the site.

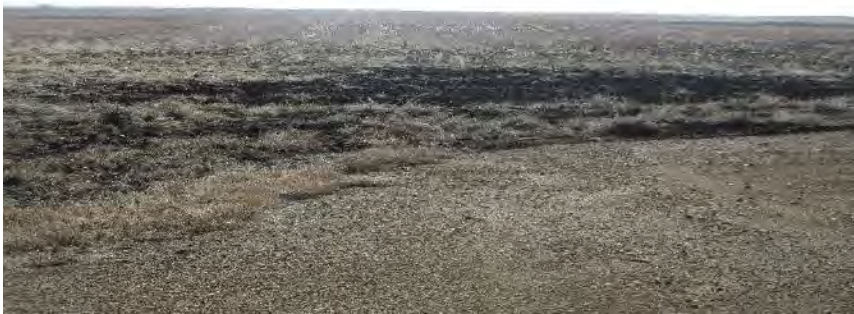
Photograph facing east off of oil & gas facility showing the visually impacted area, which measured approximately 20 feet by 20 feet.

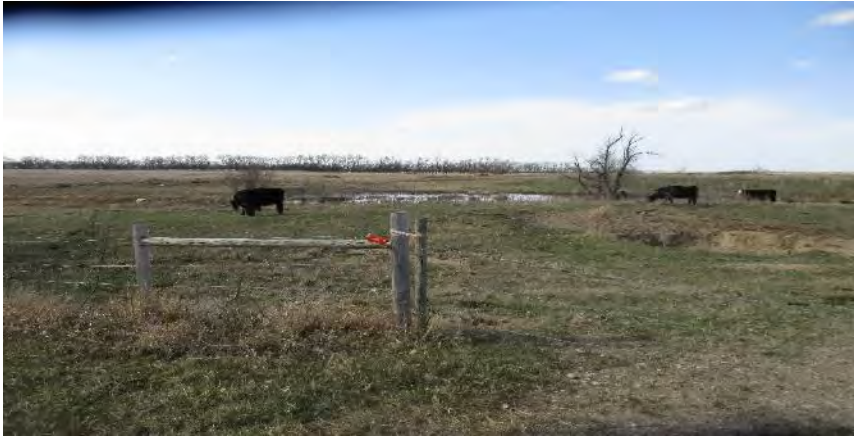
Photograph facing north off of an oil field lease road. The site was approximately 1,500 feet north of the lease road. The land is currently used as grazing land for cattle and is surrounded by a barbwire fence. No visual impacts could be seen from roadway.

R17-5 was inspected on May 8th, 2018 and is located approximately 0.2 miles east of 42nd Ave. NW. The site could not be accessed at the time of the site visit. The site is currently used as grazing land for cattle. No visual impacts could be observed during the site visit due to access limitations.

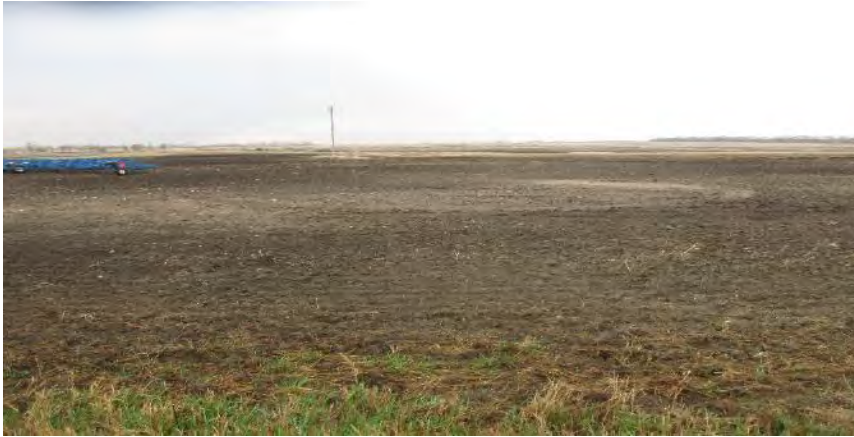
R17-6 (May 2018)

Photograph facing south off 80th St NW showing the visually impacted area. The impacted area measured approximately 100 feet by 30 feet.

R17-6 was inspected on May 9th, 2018, and is located approximately 25 feet south of 80th St. NW. The site is currently used for agricultural purposes and is surrounded by agricultural fields. The site appeared to have been worked on recently. An oil & gas facility was observed approximately 150 feet to the east and consisted of two aboveground storage tanks and one shack. Visual impacts were observed, including an area with lighter colored soils and slightly stressed vegetation; the area of visual impacts measured approximately 100 feet by 30 feet. The site topography is generally flat and drains to the north. Some ponding water was observed approximately 200 feet to the northwest. An aboveground power line was observed approximately 125 feet to the south of the site.

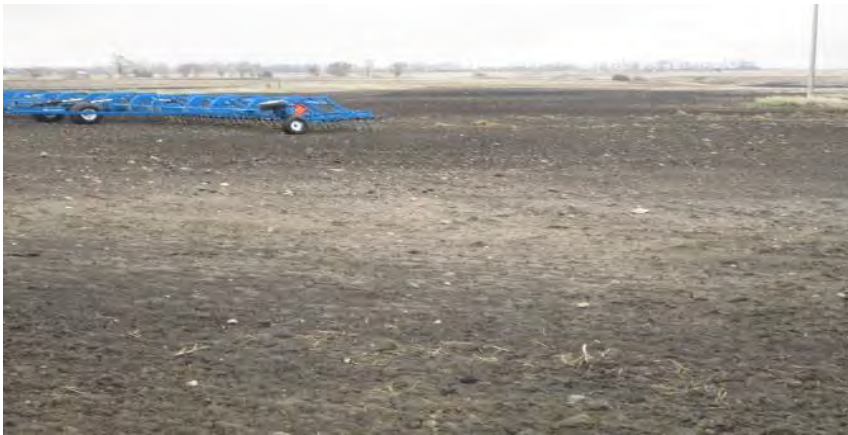
Photograph facing south off 80th St NW oilfield lease road showing the visually impacted area. Lighter colored soil can be observed.

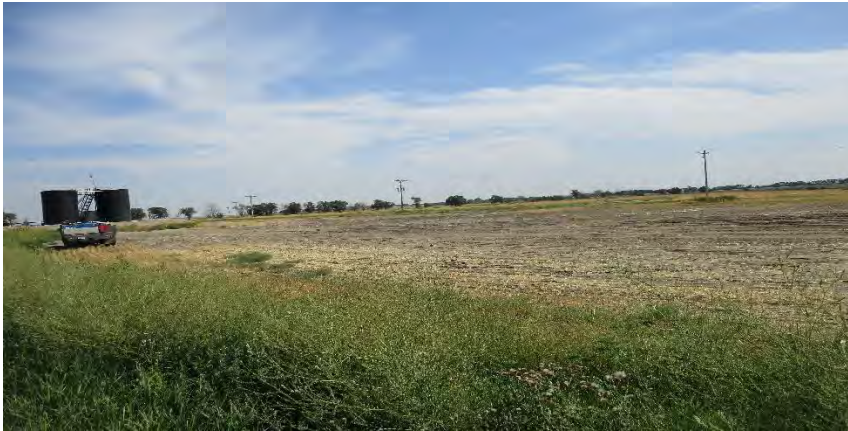
R17-6 (August 2018)

Photograph facing south off of 80th St NW showing the visually impacted area. Barren ground and were observed in an area measuring approximately 200 feet by 30 feet along the oilfield lease road.

R17-6 was revisited on August 20th, 2018. During the initial inspection, the site had recently been plowed, and minimal visual impacts were observed. This area with lighter colored soils and slightly stressed vegetation measured approximately 100 feet by 30 feet. This follow-up investigation identified visual impacts consisting of barren ground and stressed vegetation in an area measuring approximately 200 feet by 30 feet.

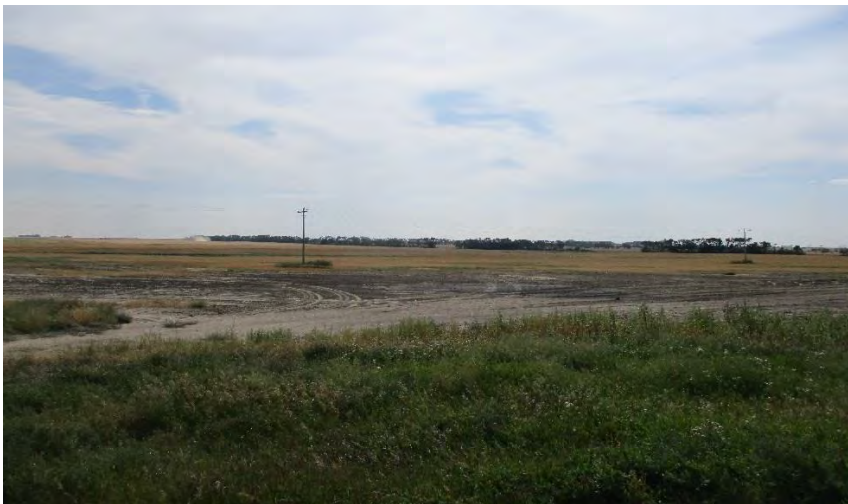
Photograph facing west off oilfield lease road showing the visually impacted area.

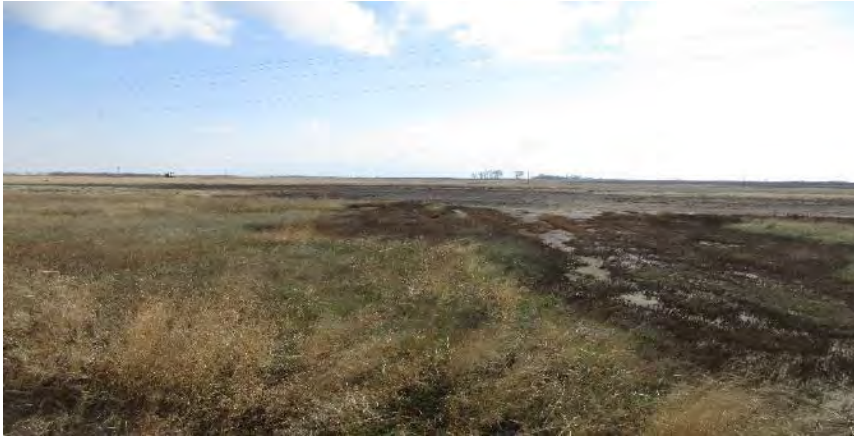
R18-1 (May 2018)

Photograph facing northeast off of an oilfield lease road showing the visually impacted area lacking vegetative growth. The visually impacted area measured approximately 300 feet by 15 feet. An oil & gas facility is located southwest of the site.

R18-1 was inspected on May 9th, 2018 and is located approximately 250 feet north of County Road 26. The site is currently used for agricultural purposes and is surrounded by agricultural fields. An oil & gas facility was observed to the west, and consisted of five aboveground storage tanks and two heater treaters. Visual impacts were observed, including an area lacking vegetation and white colored soils; the area of visual impacts measured approximately 300 feet by 150 feet. The site topography is generally flat and drains to the northwest. An aboveground power line was observed to the west of the site.

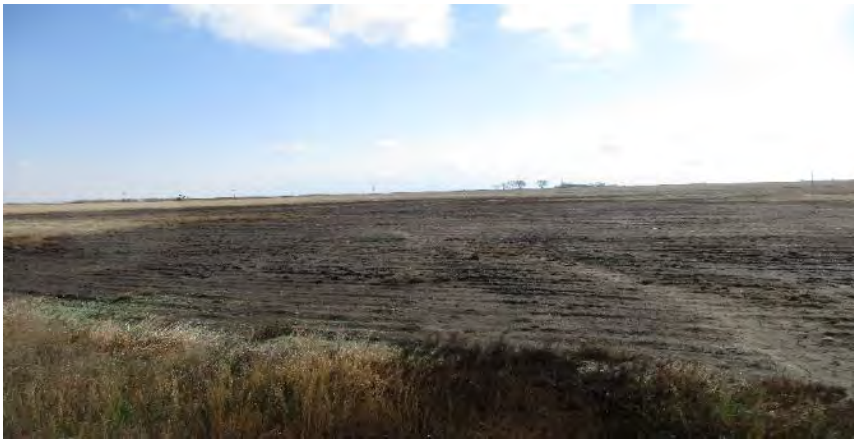
Photograph facing east showing the visually impacted area. Little to no vegetative growth was observed at the site.

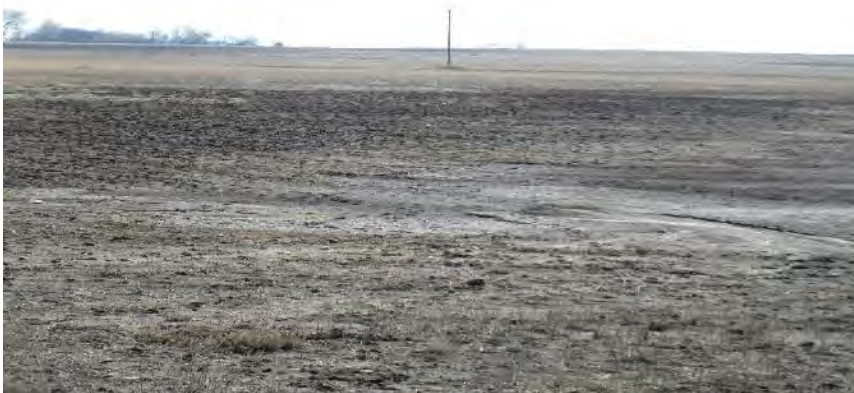
Photograph facing east showing a closer view of the visually impacted area. White colored soil lacking vegetation can be seen.

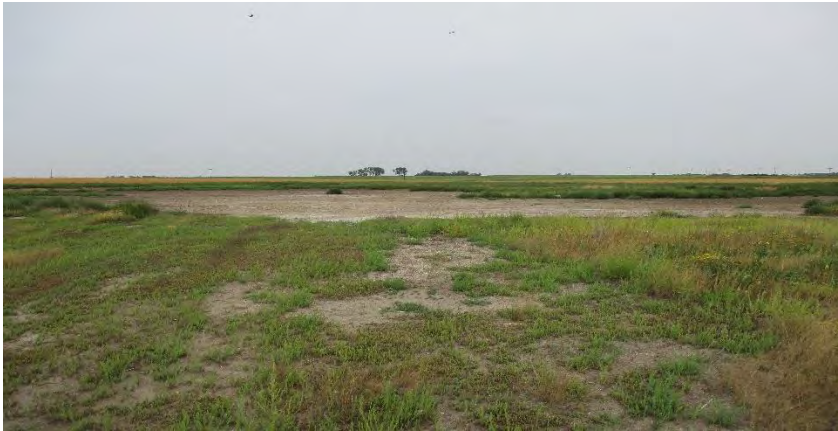
R18-1 (August 2018)

Photograph facing northeast off of an oilfield lease road showing the visually impacted area lacking vegetative growth. The visually impacted area measured approximately 300 feet by 150 feet.

R18-1 was revisited on August 20th, 2018. This follow-up investigation confirmed visual impacts consisting of barren ground and stressed vegetation in an area measuring approximately 300 feet by 150 feet as initially estimated during the May 9th, 2018 site visit.

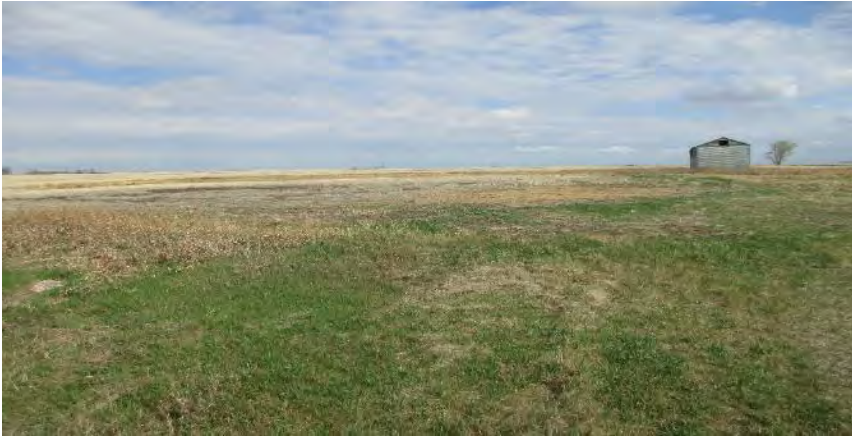
Photograph facing north off of County Road 26. No visual impacts could be observed from the roadway.

R18-2 was inspected on May 9th, 2018 and is located approximately 400 feet north of County Road 26. The site could not be accessed at the time of the site visit. The site is currently used for agricultural purposes and is surrounded by agricultural fields. A shack was observed approximately 150 feet south of the site. Visual impacts could not be observed from a distance at the time of the site visit. The site topography is generally flat and drains to the northwest.

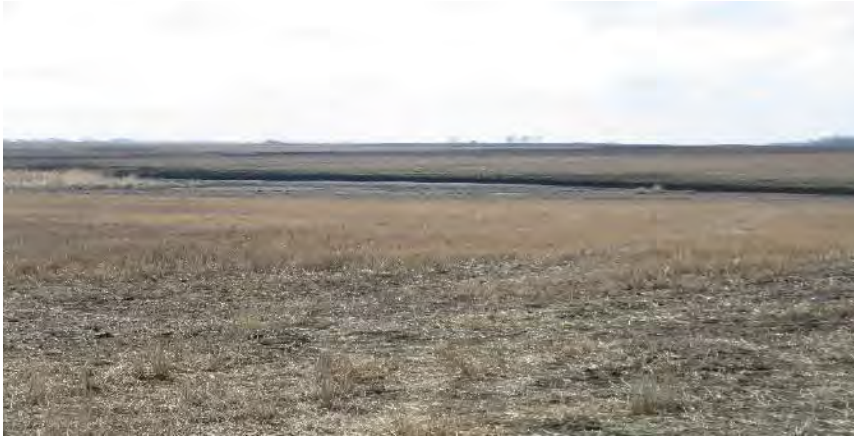
Photograph facing east off County Road 9 showing the visually impacted area as observed from a distance. The site could not be accessed at the time of the site visit.

R18-3 was inspected on May 9th, 2018, and is located approximately 500 feet west of County Road 9. The site could not be accessed at the time of the site visit. The site is currently used for agricultural purposes, and is surrounded by agricultural fields. Visual impacts were observed from a distance during the site visit, including several barren areas lacking vegetation. Visually impacted areas could not be measured due to access limitations. Several wetlands were observed on the site. The site topography is generally flat and appears to drain to the west. Aboveground powerlines were observed on the east side of County Road 9.

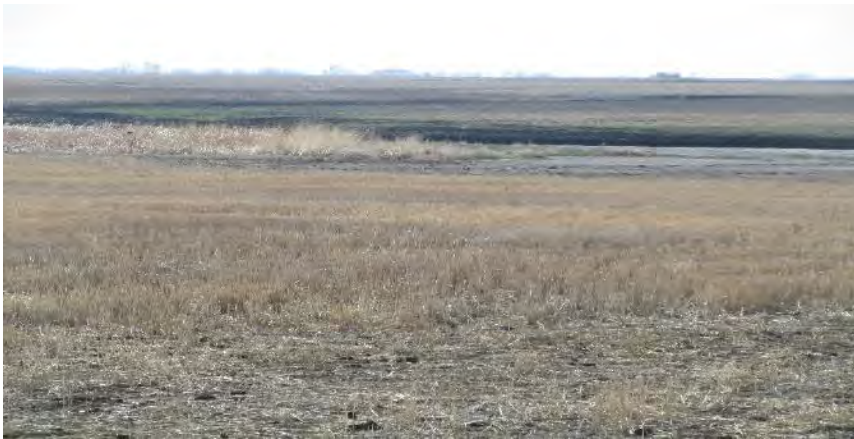
Photograph facing west off of County Road 9 showing a closer view of the visually impacted area. A wetland can be seen to the north of the site.

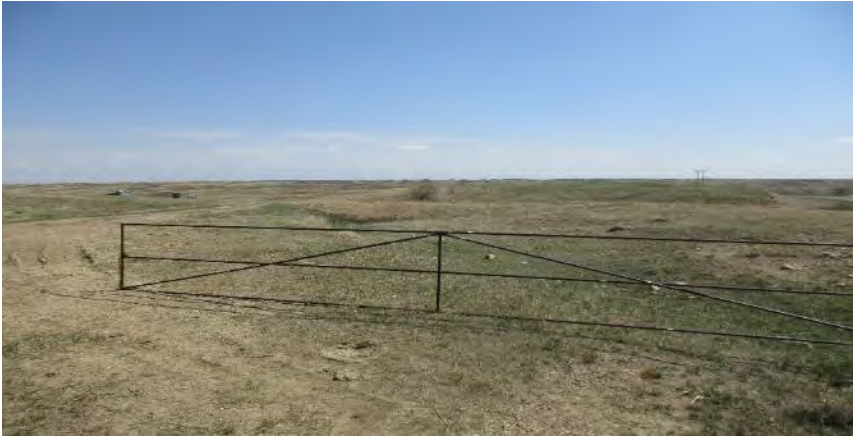
Photograph facing south east off of 50th Ave NW showing the site. A no trespassing sign was posted at the gate. No observations could be made due to access limitations.

R19-1 was inspected on May 9th, 2018, and is located approximately 0.8 miles east of 50th Ave NW. The site was unable to be accessed at the time of the site visit; a no trespassing sign was posted at the gate. No observations could be made at the time of site visit because of access limitations.

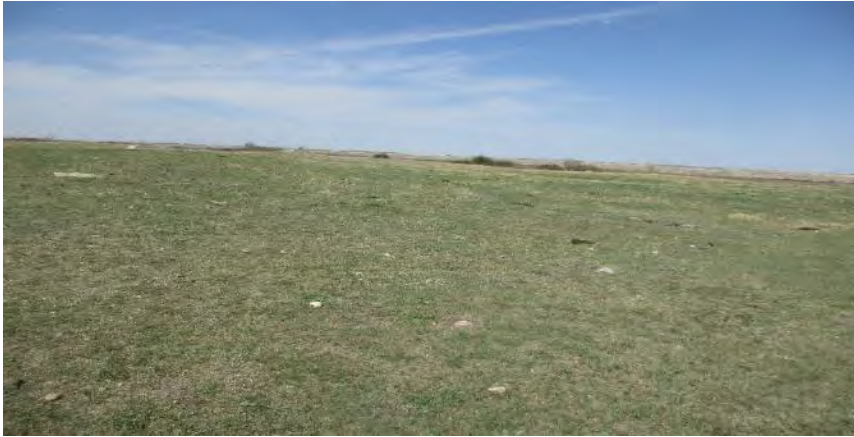
Photograph facing northeast off of an oilfield lease road showing the site. No visual impacts were observed at the time of the site inspection.

R20-1 was inspected on May 8th, 2018 and is located approximately 50 feet north of an unnamed oilfield lease road. The site is currently used as grazing pasture for cattle. Pastures lie to the north and west, and land as part of the Upper Souris National Wildlife Refuge lie to the east and south. No visual impacts were observed at the site during the time of site visit. The site topography is generally flat with slightly undulating flows to the northeast.

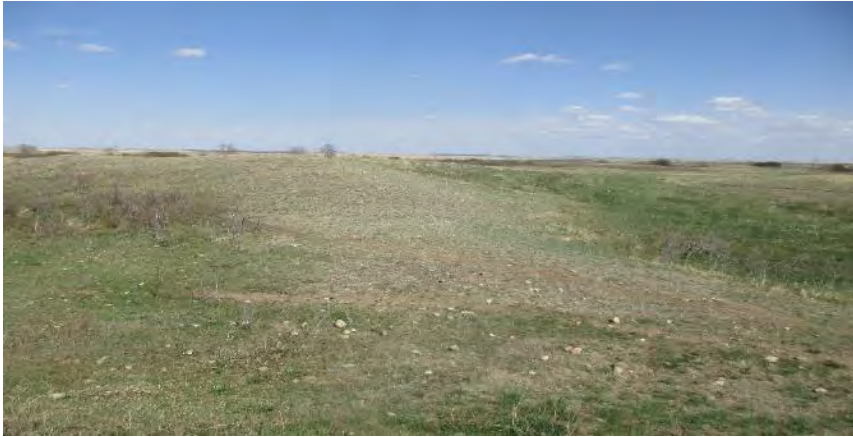
Photograph facing east off of an oilfield lease road showing a visually impacted area with slightly stressed vegetation. The visually impacted area measured approximately 20 feet by 20 feet.

R20-2 was inspected on May 8th, 2018 and is located approximately 50 feet east of an oilfield lease road. The site is currently natural grassland, and is surrounded by grassland. Visual impacts were observed, including slightly stressed vegetation; the area of visual impacts measured approximately 20 feet by 20 feet. A pond was also observed 50 feet north of the site. The site topography is hilly and drains to the south. An aboveground powerline was also observed to the west.

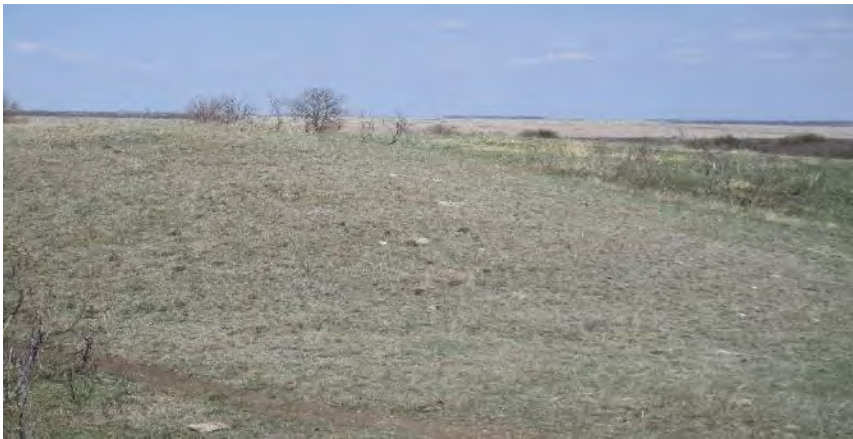
Photograph facing east off of an oilfield lease road showing a closer view of the visually impacted area with slightly stressed vegetation.

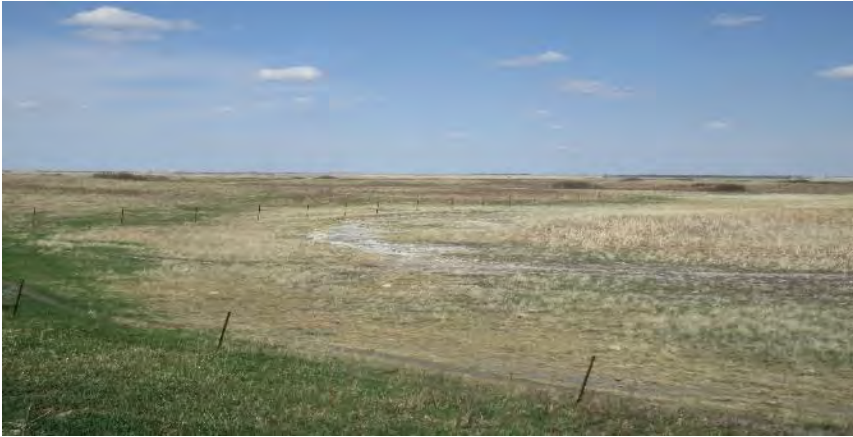
Photograph facing east off of an oil & gas facility showing a visually impacted area lacking vegetative growth north of a wetland. The visually impacted area measured approximately 50 feet by 50 feet.

R20-3 was inspected on May 8th, 2018 and is located approximately 100 feet east of an oilfield lease road. The site is currently natural grassland and is surrounded by grassland. An oil & gas facility was observed to the west, and consisted of one pump jack, eight aboveground storage tanks, two heater-treaters, and one flare. Visual impacts were observed, including three areas of barren ground with little to no vegetation. These areas measured approximately 50 feet by 50 feet, 70 feet by 60 feet, and 70 feet by 20 feet. A pond and several wetlands were also observed near the center of the site, and additional wetlands were also observed further to the south of the site. A strong hydrogen sulfide odor was observed at the time of the site visit. The site topography is generally flat and drains to the west.

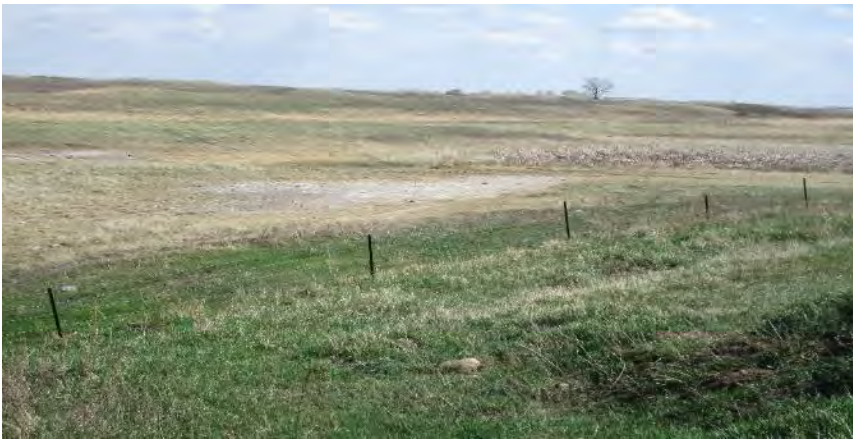
Photograph facing southeast off of an oil & gas facility showing a second visually impacted area lacking vegetative growth north of a wetland. The second visually impacted area measured approximately 70 feet by 60 feet.

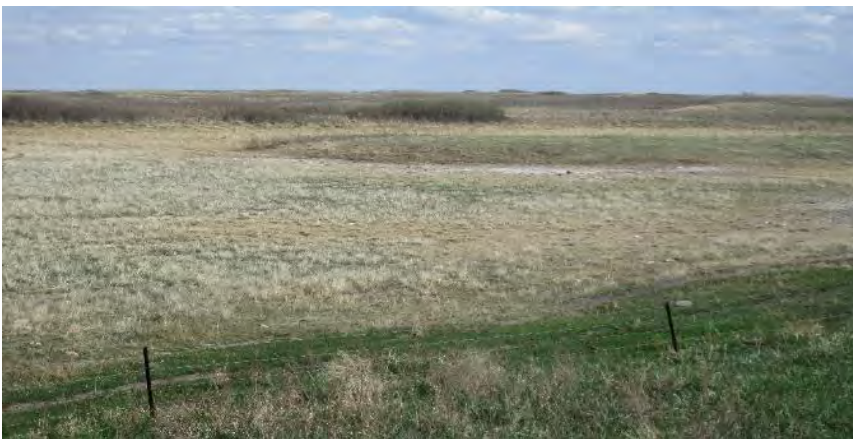
Photograph facing southeast off of an oil & gas facility showing a third visually impacted area lacking vegetative growth. The third visually impacted area measured approximately 70 feet by 20 feet.

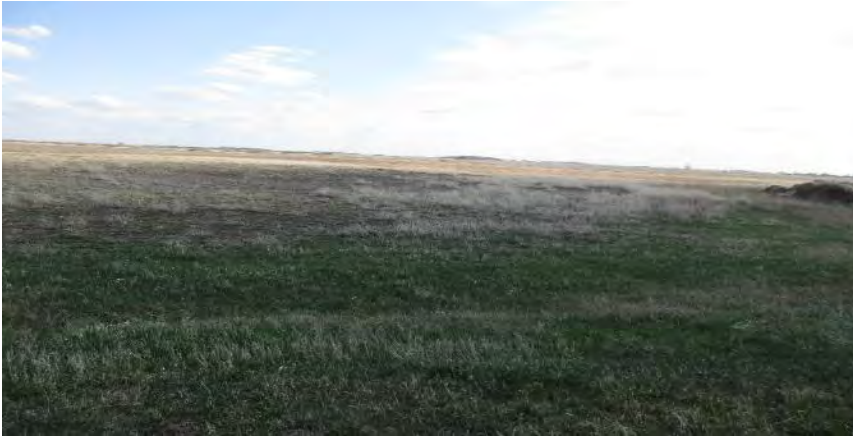
Photograph facing south off of 77th St NW showing the visually impacted area with stressed vegetation. The impacted area measured approximately 100 feet by 100 feet.

R20-4 was inspected on May 8th, 2018, and is located approximately 75 feet south of 77th St. NW. The site is currently used for agricultural purposes, and is surrounded by agricultural fields to the north, west, and south. Grasslands lie to the east. Visual impacts were observed, including an area of stressed vegetation; the area of visual impacts measured approximately 100 feet by 100 feet. Wetlands were also observed to the south and to the northeast of the site. The site topography is generally flat and drains to the north.

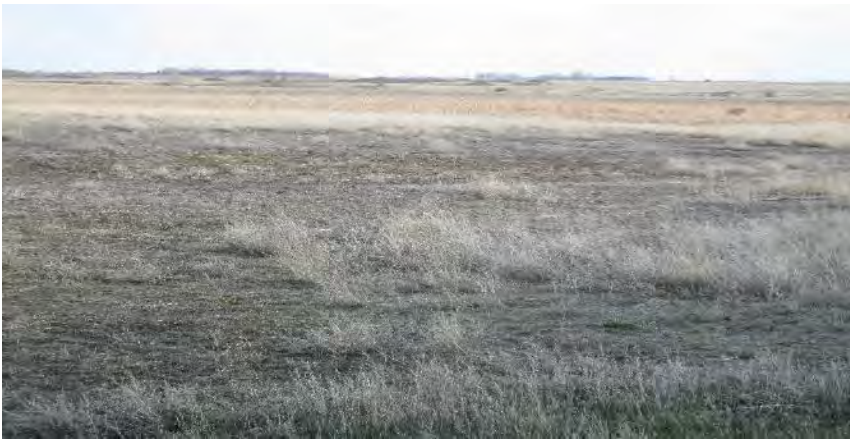
Photograph facing south off of 77th St NW showing a closer view of the visually impacted area. A wetland can be seen in the background.

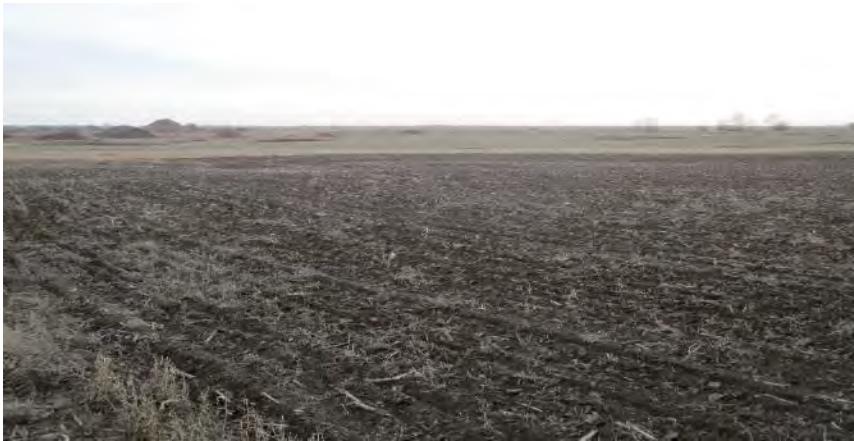
R23-1 (May 2018)

Photograph facing southwest off of an oilfield lease road showing the site. Visual impacts were observed, including slightly stressed vegetation and lighter colored soils; the area of visual impacts measured approximately 50 feet by 50 feet.

R23-1 was inspected on May 4th, 2018 and is located approximately 500 feet south of 78th St NW and 200 feet west of an oilfield lease road. The site is currently used for agricultural purposes, and is surrounded by agricultural fields. An oil & gas facility was observed to the east, consisting of eight aboveground storage tanks, a pump jack, and other miscellaneous oilfield equipment. A wetland is located approximately to the southwest. Visual impacts were observed, including slightly stressed vegetation and lighter colored soils; the area of visual impacts measured approximately 50 feet by 50 feet. The site is generally flat and drains to the south. The visually impacted area appeared to be a topographical low point.

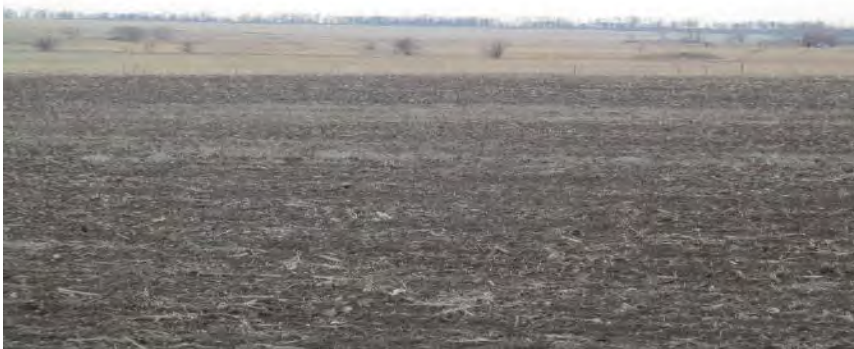
Photograph facing southwest showing a closer look at the visual impacts noted during the inspection. Slight slumping soil with a lighter color than the surrounding soil was noted.

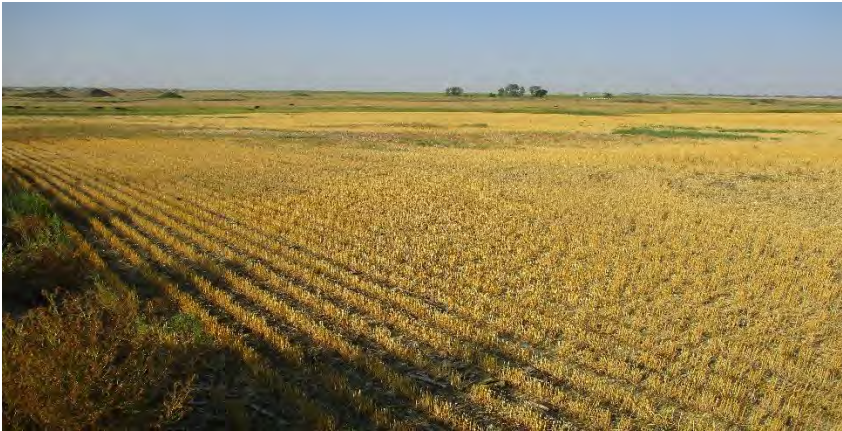
R23-1 (August 2018)

Photograph facing southwest off of an oilfield lease road showing the visually impacted area. Visual impacts included stressed vegetation and lighter colored soils in an area measuring approximately 50 feet by 20 feet.

R23-1 was revisited on August 20th, 2018. Visual impacts initially observed during the May investigation included an area of stressed vegetation and lighter colored soils. The area of visual impacts measured approximately 50 feet by 50 feet. This follow-up investigation revealed an area of barren ground and stressed vegetation measuring approximately 50 feet by 20 feet.

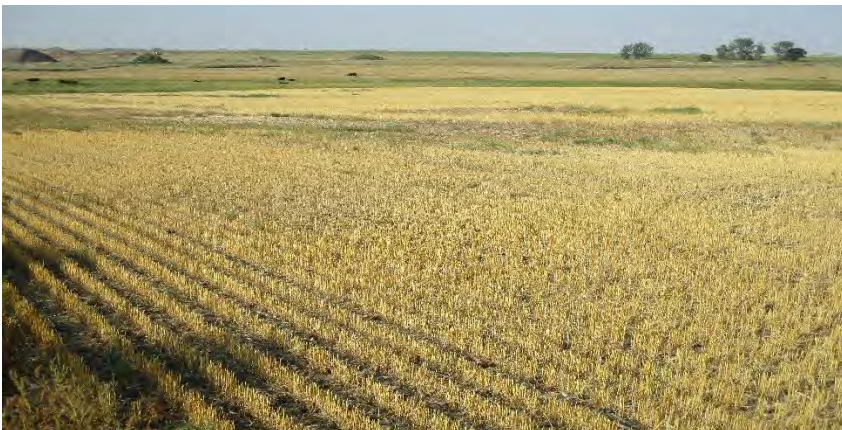
Photograph facing southwest showing a closer view of the visual impacts noted during the inspection.
