NDIC Brine Pond Study

Phase II: Site Assessments

June 25, 2018

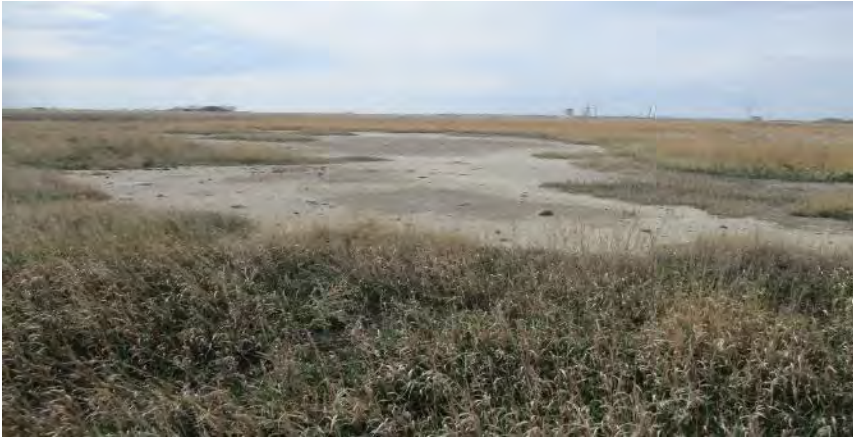
Photograph facing north showing the visually impacted area. Little to no vegetative growth was observed. A wetland can be seen in the background.

R23-3 was inspected on May 1st, 2018, and is located approximately 450 feet south of 77th St NW and 150 feet west of an oilfield lease road. The site is currently native grassland with agricultural land and oilfield development in the surrounding area. An oil & gas facility was observed to the southeast, consisting of an aboveground storage tank and miscellaneous oilfield equipment. A wetland is located just north of the visually impacted area. Visual impacts were observed, including barren soils with no vegetation and soil cracking; the area of visual impacts measured approximately 100 feet by 100 feet. The area of visual impacts appears to be a topographical high point in the area, with drainage at the site flowing away from this high point.

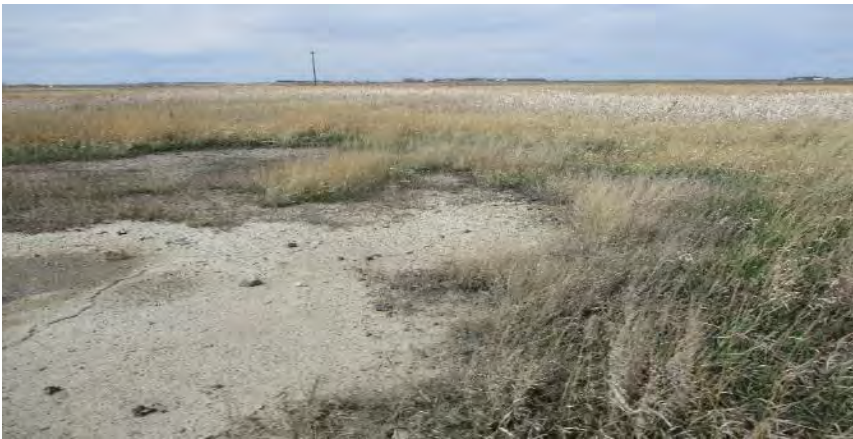
Photograph facing north showing the visually impacted area and its proximity to the northern wetland. Aboveground power lines can be seen in the background.

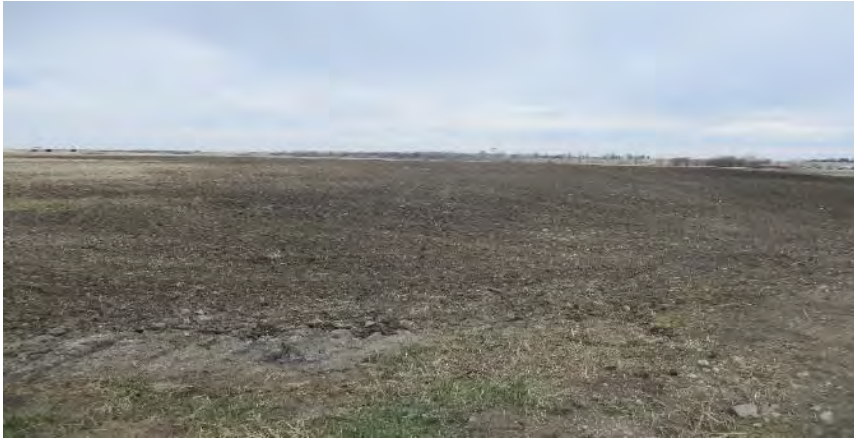
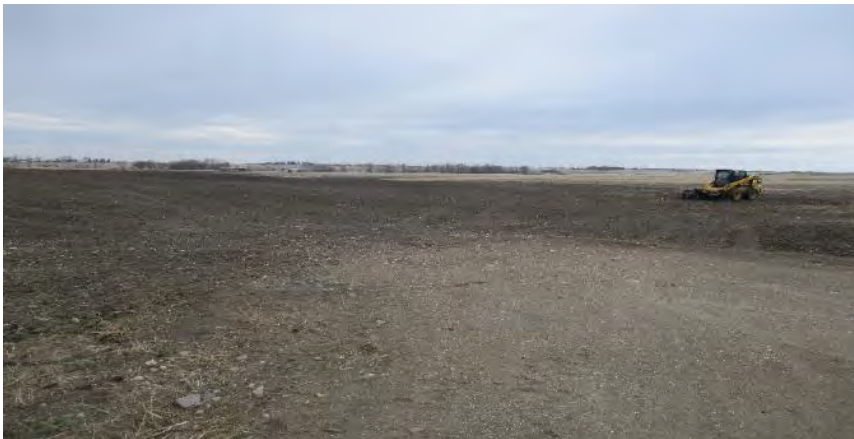
Photograph facing south off of 77th St NW showing reclaimed area where an oilfield production facility and lease road previously existed.

Photograph facing southwest off of 77th St NW showing reclaimed area where an oilfield production facility and lease road previously existed.

R23-4 was inspected on May 1st, 2018, and is located approximately 650 feet south of 77th St NW. The site appeared to have recently been reclaimed. An oil & gas facility and lease road that were previously located at the site appeared to have been reclaimed. Due to the recent reclamation activity, no visual impacts could be observed at the site.

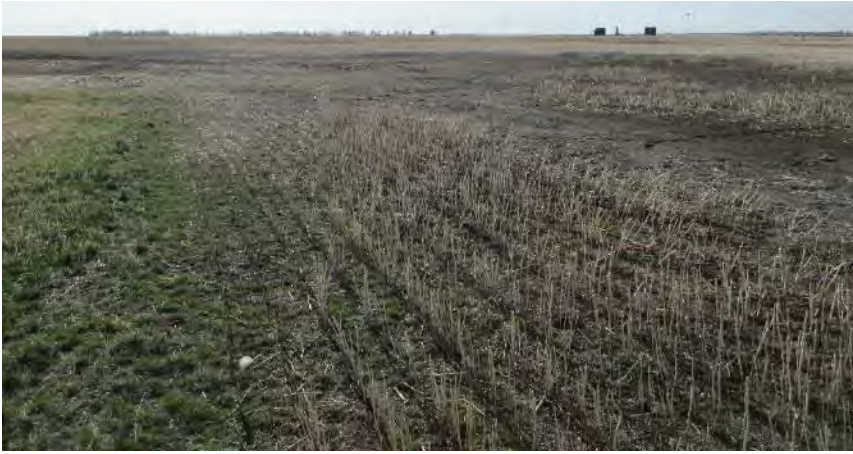
Photograph facing southeast off of an oilfield production pad showing an area of visual impacts, including barren soils, stressed vegetation, and erosion.

R23-5 was inspected on May 4th, 2018, and is located approximately 2,000 feet west of 23rd Ave NW and just south of an oilfield lease road. The site is currently used for agricultural purposes and is surrounded by agricultural fields. An oil & gas facility was observed immediately to the west, consisting of five aboveground storage tanks, a pump jack, and other miscellaneous oilfield equipment. A wetland was observed to the south. Visual impacts were observed, including a barren area of no vegetative growth, soil cracking, and salt crusting; the area of visual impacts measured approximately 50 feet by 50 feet. The site topography is generally flat with drainage predominantly to the southwest.

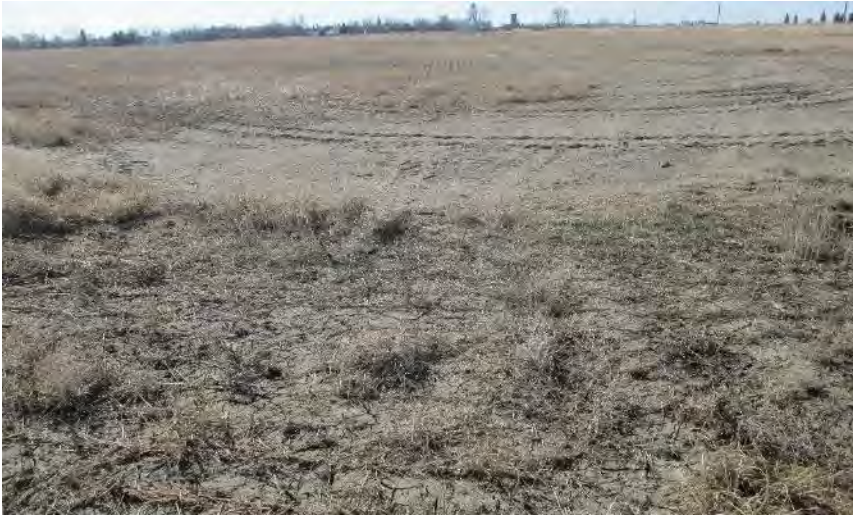
Photograph facing south off of an oilfield lease road showing visual impacts, including dead zones, soil cracks, stressed vegetation, and tan soils.

R23-6 was inspected on May 4th, 2018, and is approximately 100 feet east of 24th Ave NW and 50 feet south of an oilfield lease road. The site is currently used for agricultural purposes, and is surrounded by agricultural fields. An oil & gas facility was observed to the north, consisting of three aboveground storage tanks. A wetland was observed to the west, along 24th Ave NW. Visual impacts were observed, including barren soils with no vegetative growth, soil cracking, and lighter colored soils; the area of visual impacts measured approximately 50 feet by 30 feet. The site topography is generally flat and slopes slightly to the north.

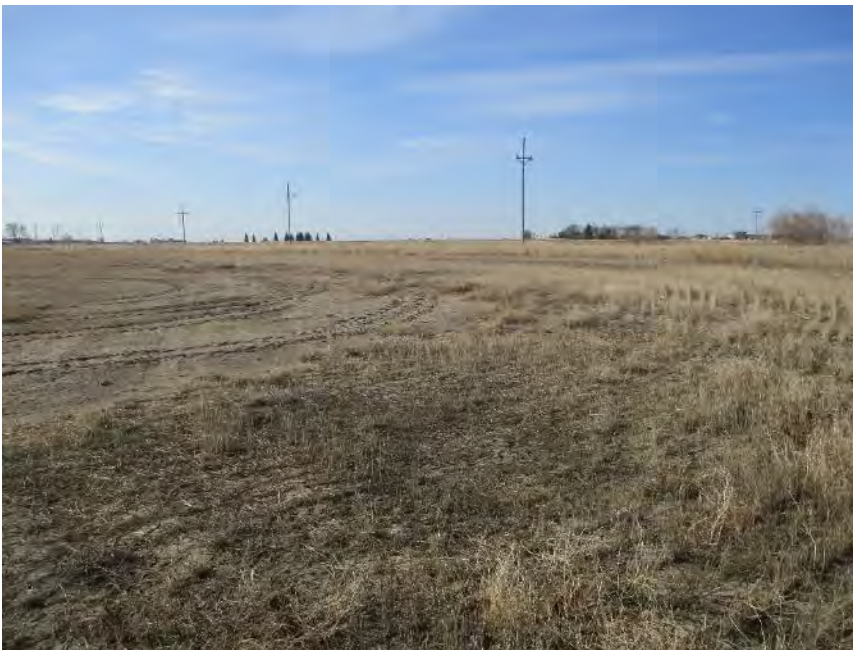
Photograph facing southwest off of an oilfield lease road showing a wetland approximately 75 feet from site and running along 24th Ave NW. Aboveground powerlines were observed west of the site.

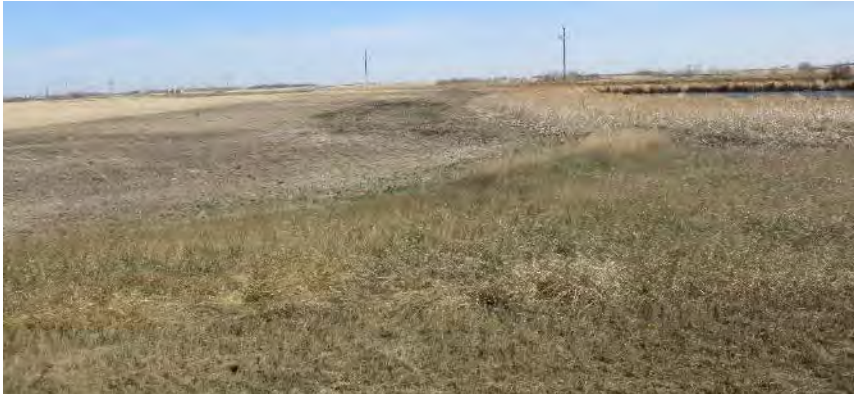
Photograph facing northeast from 76th St NW showing stressed vegetation and tan soils on the edge of an agricultural field. Wetlands were observed east of the site.

R23-7 was inspected on May 4th, 2018, and is approximately 400 feet north of 76th St NW and 900 feet east of 24th Ave NW. The site is currently used for agricultural purposes and is surrounded by agricultural fields. Wetlands and a pond were observed to the east, and residential properties were observed approximately 1,000 feet to the east. Visual impacts were observed, including an area of barren ground with stressed vegetation; the area of visual impacts measured approximately 20 feet by 20 feet. The site topography is predominantly flat and drains to the east. Aboveground powerlines were observed east of the site.

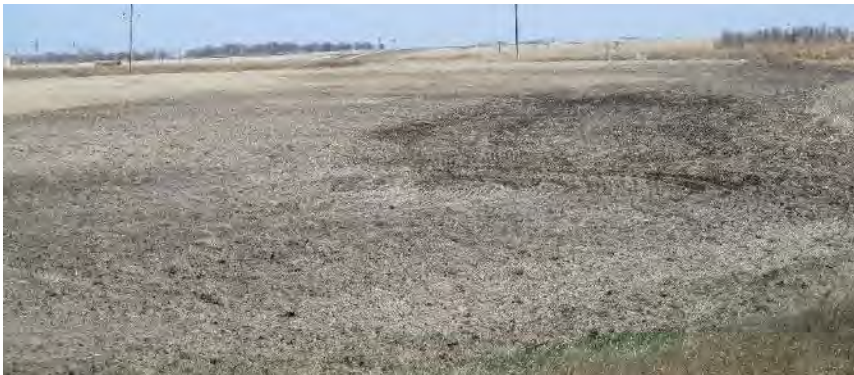
Photograph facing north from 76th St NW showing a closer view of the impacted area. Aboveground powerlines were observed east of the site.

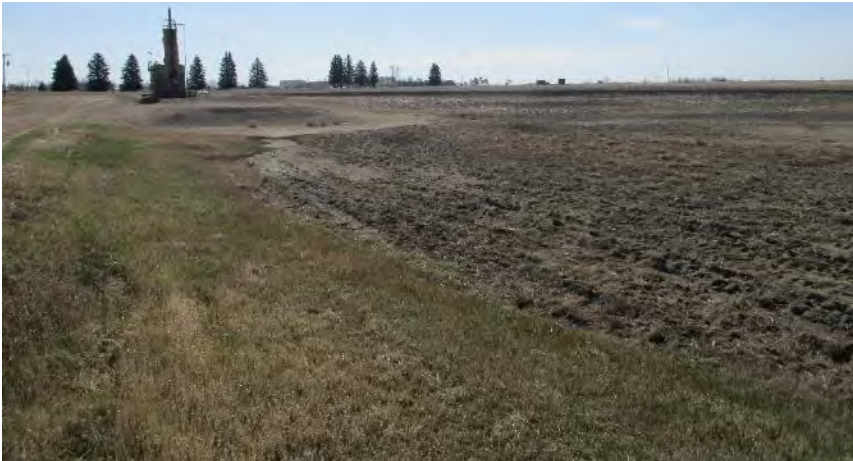
Photograph facing east off an oilfield lease road showing oil & gas facility next to agricultural fields. The town of Glenburn is visible in the background and is approximately 3,000 feet to the northeast.

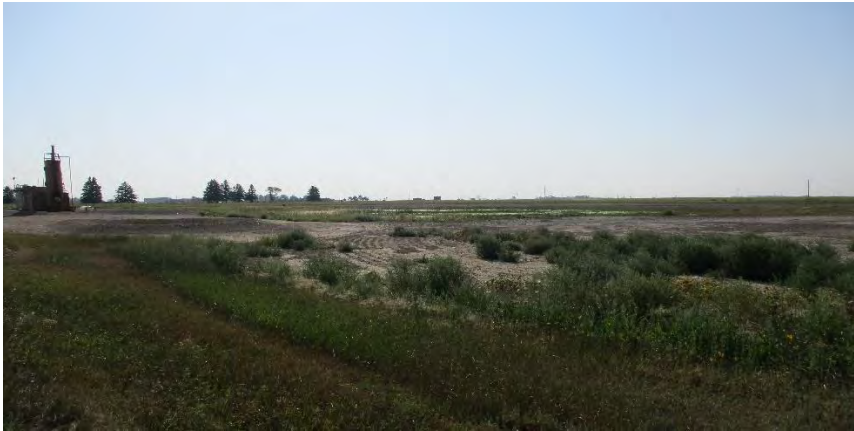
R23-8 (August 2018)

Photograph facing southeast off of an oilfield lease road showing visual impacts, including dead zones, salt crusts, soil cracks, and stressed vegetation. The area of visual impacts measured approximately 300 feet by 100 feet.

R23-8 was revisited on August 20th, 2018. During the initial site visit, visual impacts were observed, including extensive dead zones, salt crusts, and soil cracking; the area of visual impacts measured approximately 100 feet by 50 feet. This follow-up investigation identified a larger area of barren ground with spots of stressed vegetation measuring approximately 300 feet by 100 feet.

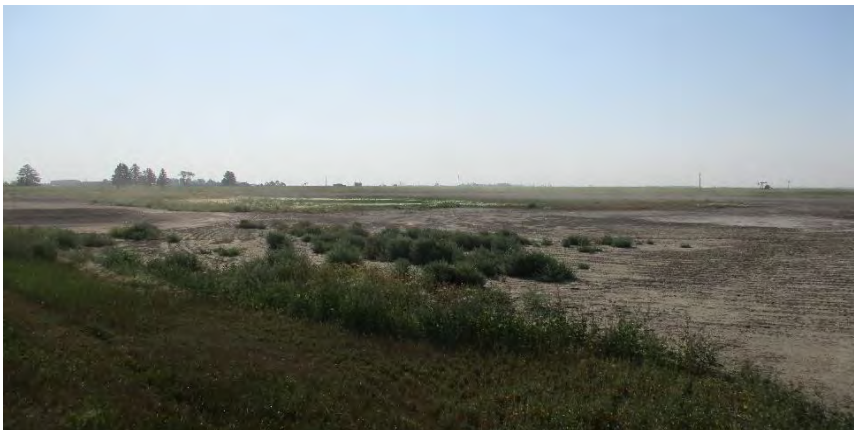
Photograph facing southeast off an oilfield lease road showing the area of barren ground and stressed vegetation.

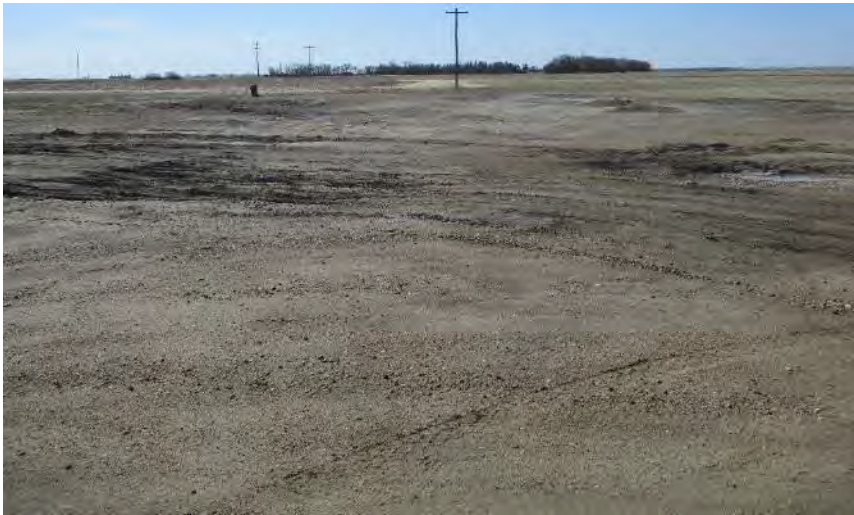
Photograph facing southeast off of an oil & gas facility showing visual impacts, including extensive dead zones, salt crusts, soft soils and soil cracking. The site is located next to an oil & gas facility and adjacent to a large pond.

R23-9 was inspected on May 4th, 2018, and is located approximately 500 feet south of 75th St NW and 30 feet west of an oilfield lease road. The site is used in part as agricultural land and in part as an oil & gas facility. The oil & gas facility is located immediately to the east, and consisted of four aboveground storage tanks and miscellaneous oilfield equipment. Native grasslands lie to the north and further east, and agricultural fields lie to the south. A large pond was observed to the west. Visual impacts were observed, including extensive dead zones with barren soils and no vegetation, salt crusting, and soil cracking; the area of visual impacts measured approximately 100 feet by 50 feet. A hydrogen sulfide odor was noted during the site visit. The site topography is generally flat, lightly undulating, and drains to the south/southwest.

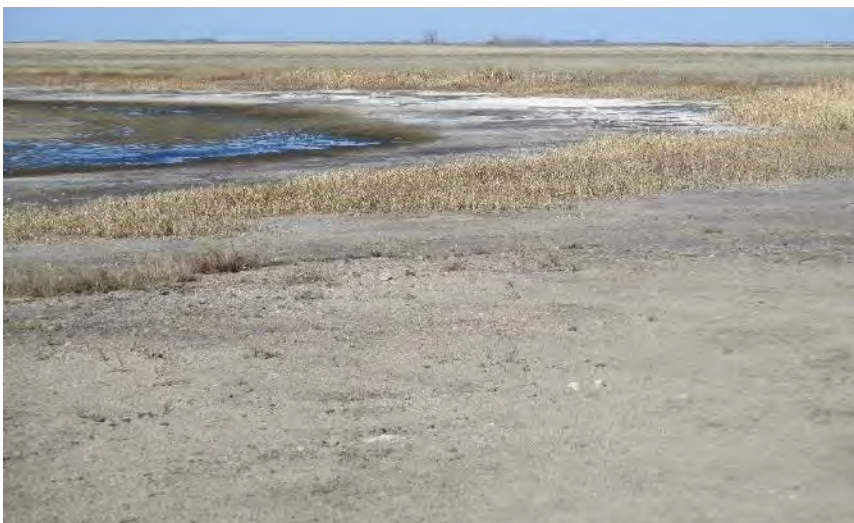
Photograph facing northwest off of an oil & gas facility showing pond with salt crusts on the shore. Also shown are barren soils on site.

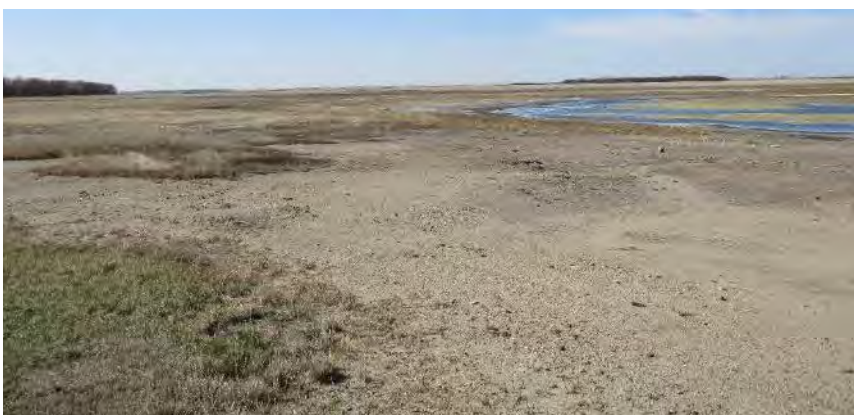
Photograph facing southwest off of the oil & gas facility showing pond and extensive dead zones in the foreground.

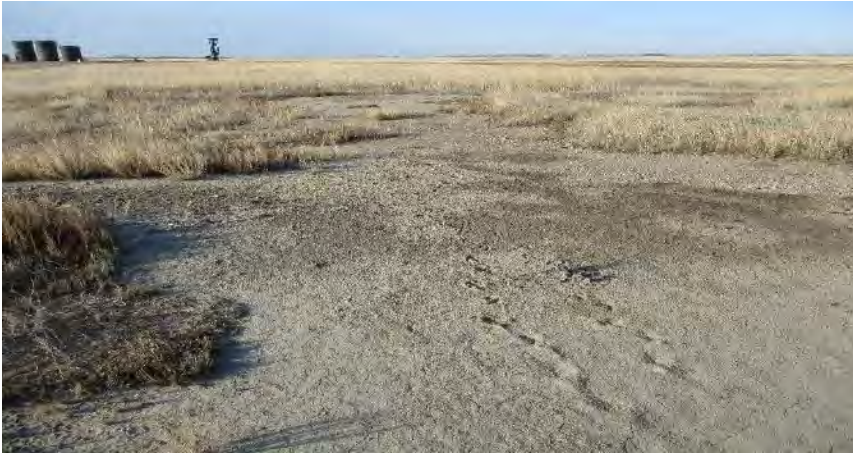
Photograph facing south taken from the center of the visually impacted area. Barren ground with little to no vegetation growth was observed. A pump jack and aboveground storage tanks can be seen in the background.

R24-1 was inspected on May 4th, 2018 and is located approximately 100 feet south of 78th St NW and 20 feet west of an oilfield lease road. The site is currently native grassland with grasslands to the south and surrounded by agricultural fields. An oil & gas facility was observed to the southeast, consisting of three aboveground storage tanks and a pump jack. A pond was located to the north, past 78th St NW. Wetlands were observed to the west and east of the site. Visual impacts were observed, including barren ground with no vegetation, cracking soils, and lighter colored soils. Two areas of visual impacts were noted, the first measuring approximately 60 feet by 15 feet, and the second measuring approximately 20 feet by 20 feet. The site topography is generally flat and drains to the east. Aboveground powerlines were observed to the southeast of the site.

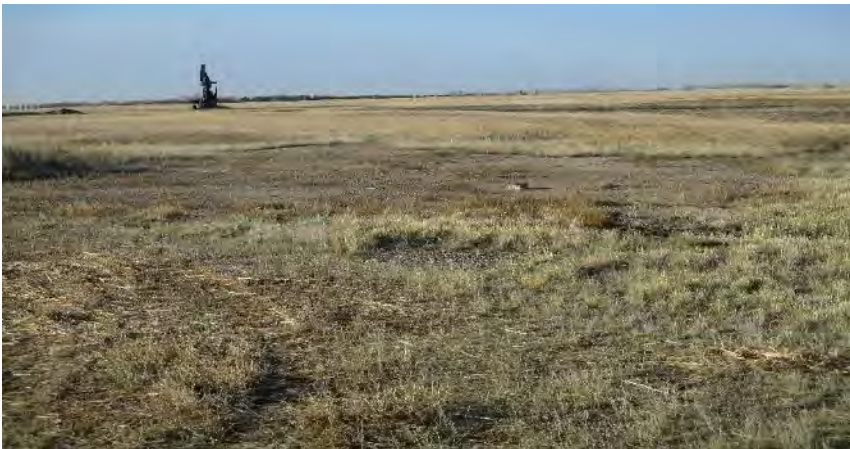
Photograph facing southwest of a second visually impacted area showing little to no vegetative growth. A pump jack and a wetland can be seen in the background.

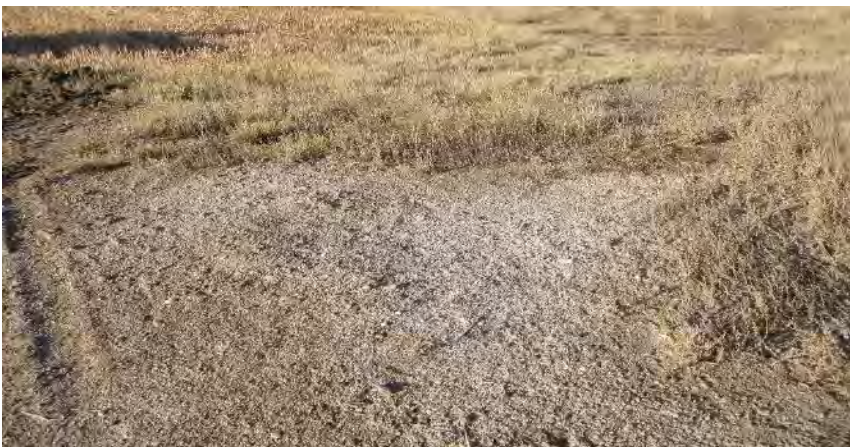
Photograph of a closer view of the second visually impacted area. Lighter colored and white soil can be seen next to the native vegetative growth in the area.

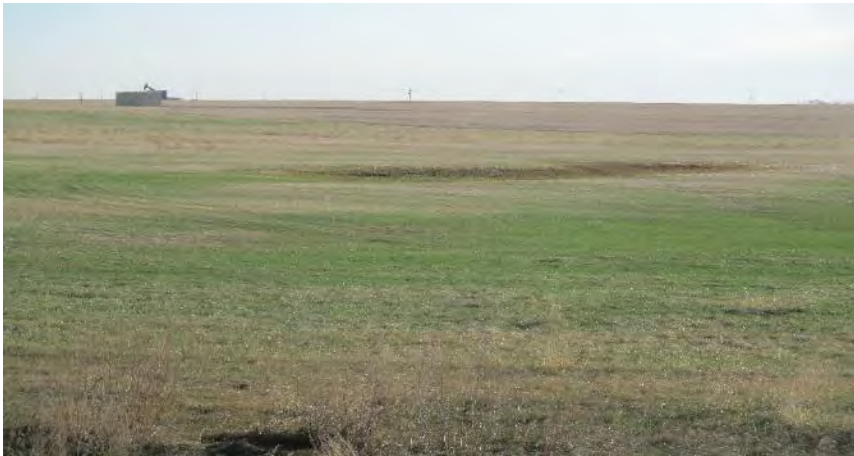
Photograph facing east taken from 22nd Ave. NW. The site could not be accessed at the time of the site visit. The site was observed with signs of slight sloughing and some standing water. Oilfield equipment can be seen in the background.

R24-2 was inspected on May 4th, 2018 and is located approximately 150 feet west of 22nd Ave NW and 400 feet south of an oilfield lease road. The site is located on private land and could not be accessed at the time of the site visit. The site is currently native grassland and is surrounded by agricultural fields to the north, west, and east. Grasslands were observed to the south. An oil & gas facility consisting of a single shack was observed to the north. No visual impacts could be observed at the time of the site visit due to access restrictions. However, signs of slight sloughing and standing water were observed at the site. The site topography is generally flat and appeared to drain towards the depression observed with standing water.

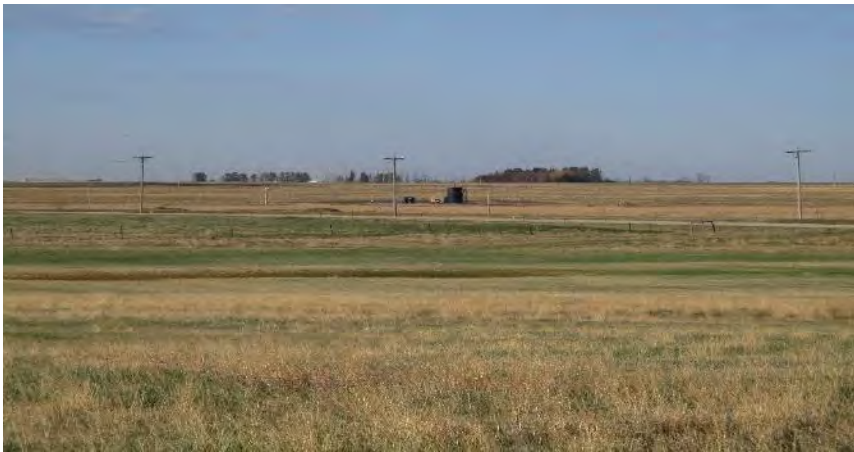
Photograph facing southwest taken from an oilfield lease road. An aboveground storage tank and oilfield facility can be seen in the background.

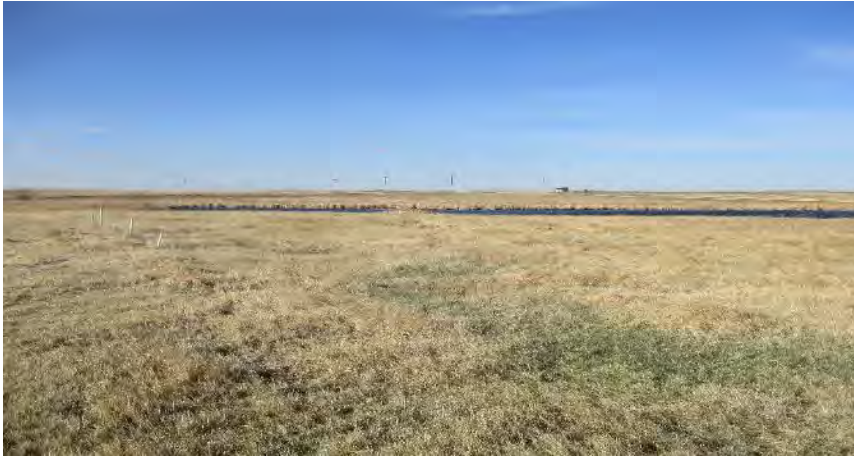
Photograph facing south showing the site. A wetland/pond can be seen in the background.

R24-3 was inspected on May 4th, 2018 and is located approximately 300 feet east of 22nd Ave NW and 400 feet south of an oilfield lease road. The site is currently native grassland and surrounded by grasslands. An oil & gas facility was observed to the east, consisting of one pump jack. A pond/wetland was observed to the south. Visual impacts were observed, including slightly stressed vegetation with scoria remnants; the area of visual impacts measured approximately 30 feet by 30 feet. The site topography is generally flat and drains to the south/southwest.

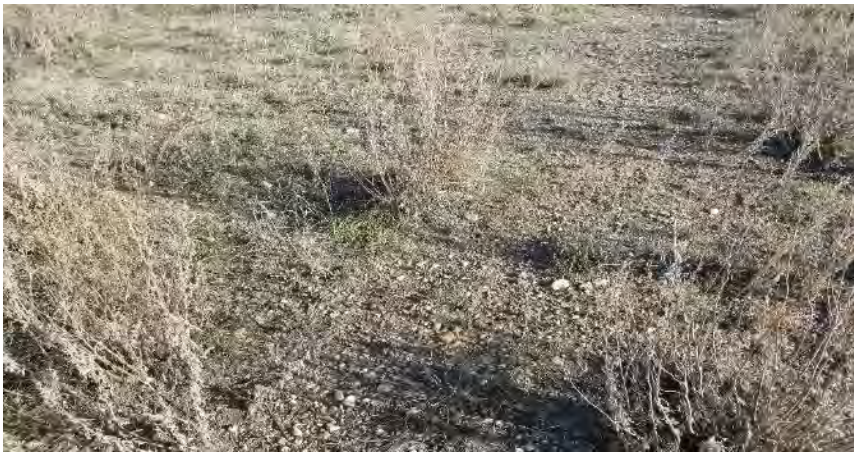
Photograph showing slightly stressed vegetation at the site.

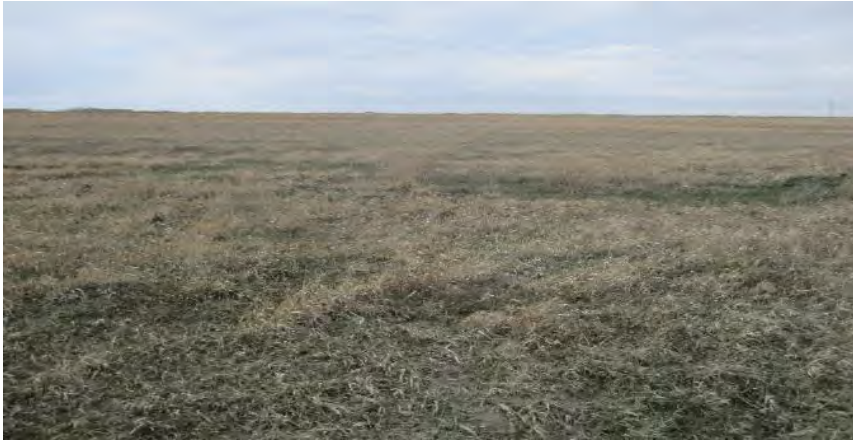
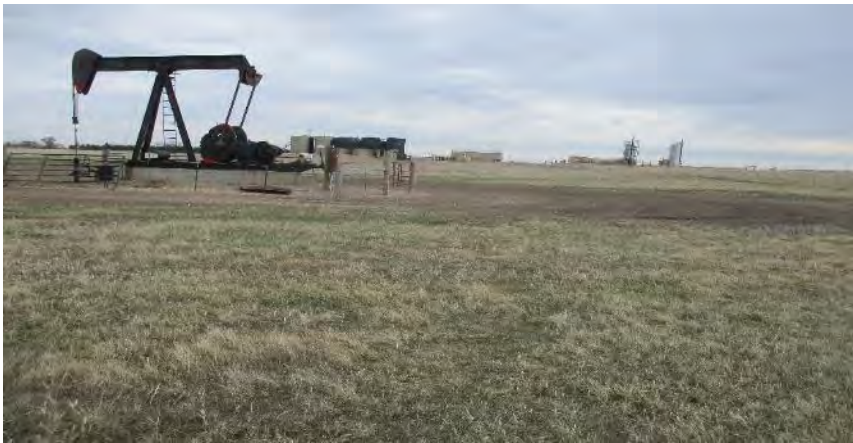
Photograph facing north showing native grasslands. No visually impacted areas were observed at the site.

Photograph facing south showing native grasslands. No visually impacted areas were observed at the site. A pump jack and an oil field production facility can be seen in the background.

R24-4 was inspected on May 1st, 2018, and is located approximately 1,700 feet east of 22nd Avenue NW and 50 feet north of an oilfield lease road. The site is currently native grassland, and is surrounded by grasslands. An oil & gas facility was observed to the south, consisting of one pump jack. No visual impacts were observed at the time of the site visit. The site is generally flat and drains to the southwest.

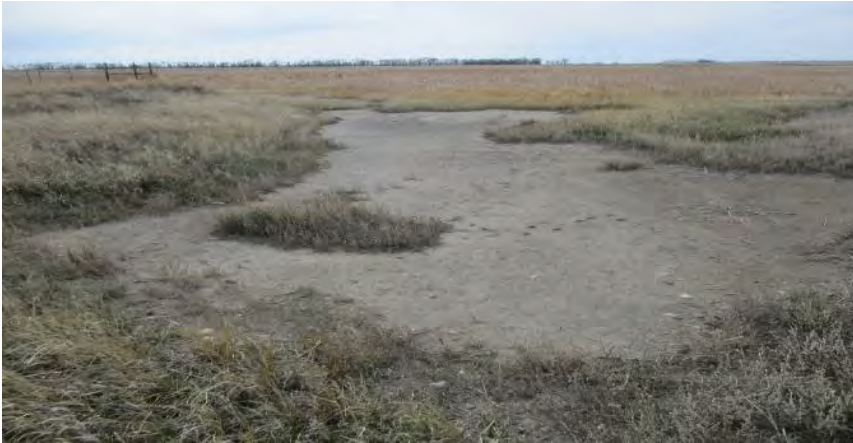
Photograph facing west showing visually impacted area, including barren soils with no vegetation. A wetland bordering the western portion of the visually impacted area can be seen in the background.

R24-5 was inspected on May 1st, 2018, and is located just north of an oilfield lease road and an injection facility. The site is currently used for agricultural purposes. Agricultural fields lie to the north, west, and east. Several aboveground storage tanks and a holding pond were observed at the injection facility, located just south of the site. An earthen berm separates the site from the injection facility. A wetland was observed to the west of the site. Visual impacts were observed, including an area of barren soils lacking vegetation; the area of visual impacts measured approximately 75 feet by 20 feet. The topography of the site is generally flat and drains to the west toward the wetland.

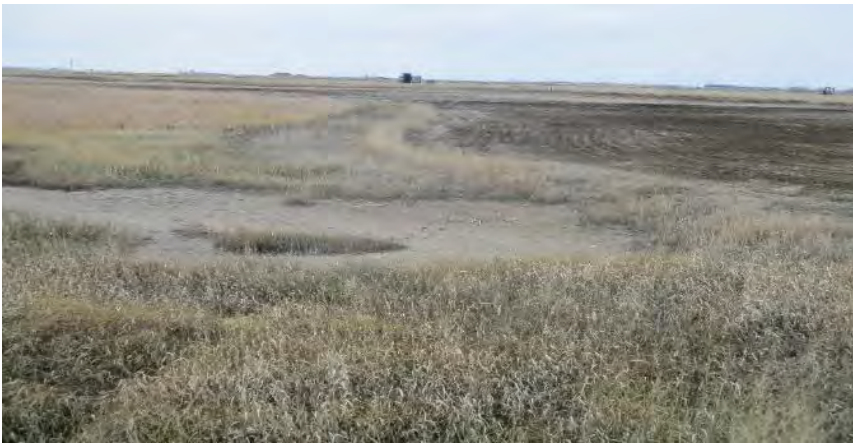
Photograph facing north showing visually impacted area and a field used in agricultural production. Oilfield production equipment can be seen in the background.

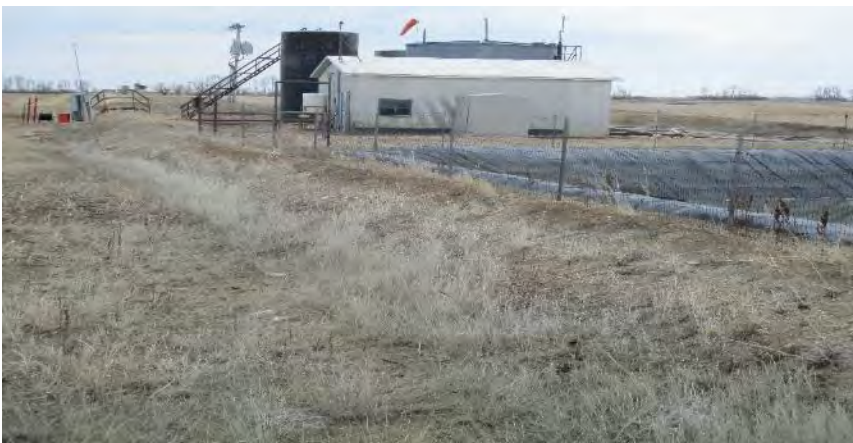
View facing south west showing injection facility directly south of the site. The injection facility consists of several aboveground storage tanks and a holding pond. An earthen berm separates the site from the injection facility.

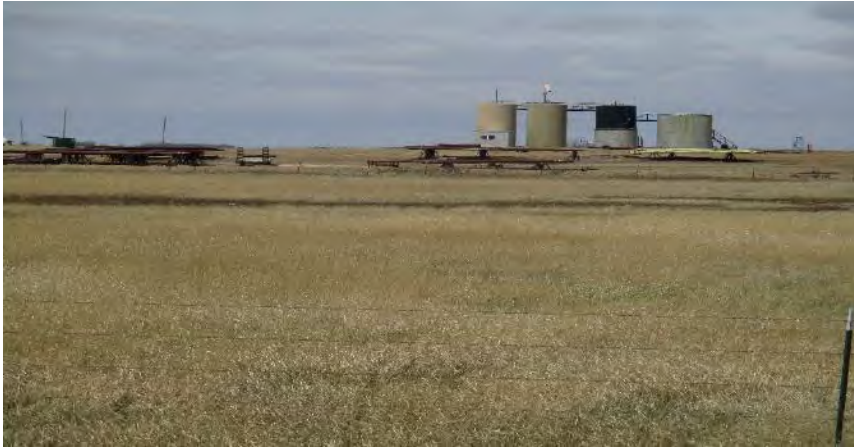
Photograph facing north off of 76th St NW. A visually impacted area lacking vegetation was observed between the barbed wire fence and the oilfield production facility in the background.

R24-6 was inspected on May 1st, 2018, and is located approximately 500 feet north of 76th St NW and just south of an oil & gas facility. The site is located on private land and could not be accessed at the time of the site visit. The site appeared to be used as a staging area for oil & gas activities, and is surrounded by agricultural fields to the east, west, and south. The oil & gas facility to the north consisted of four aboveground storage tanks and a heater treater. A wetland was observed to the west of the site. Visual impacts were observed from a distance at the time of the site visit, including an area lacking vegetation; the area of visual impacts measured approximately 150 feet by 100 feet. Steven Eldevik, the landowner, was interviewed at the time of the site inspection. Mr. Eldevik noted that the visually impacted area was a result of a recent saltwater release from the oilfield production facility to the north, and not from historical impacts. The site topography is generally flat and slopes slightly to the southwest. Aboveground powerlines were observed to the south and to the west.

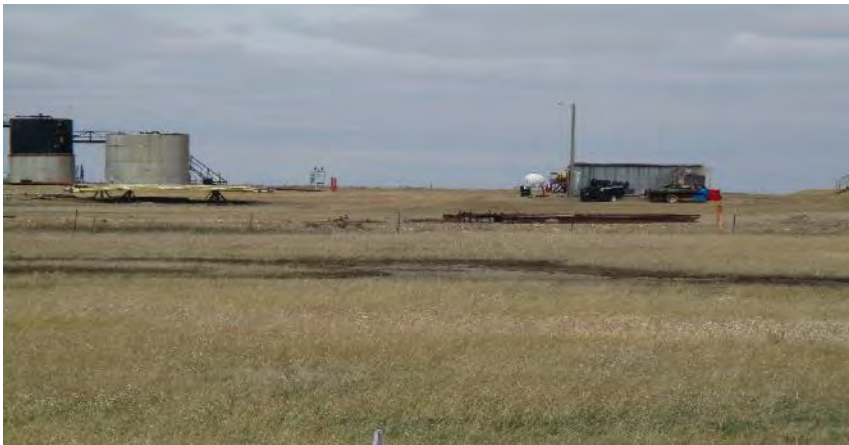
Photograph facing north showing a closer view of the visually impacted area.

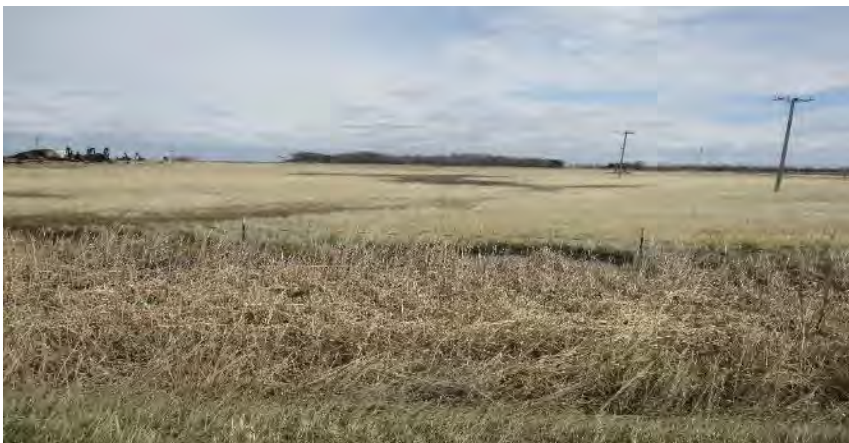
View facing east showing the visually impacted area. A wetland and barbed wire fence can be seen in the foreground. Aboveground powerlines and oilfield equipment can be seen in the background.

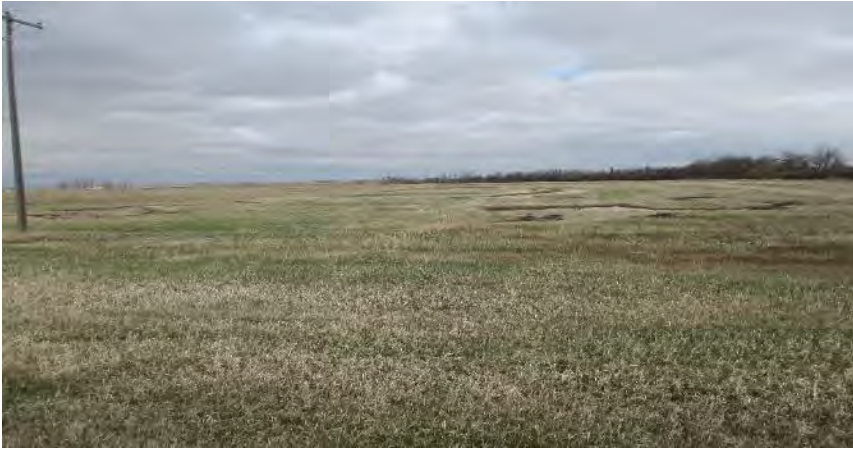
Photograph facing east off of 21st Ave. NW. A visually impacted area lacking vegetation can be observed. Aboveground powerlines can be seen in the foreground.

R24-7 was inspected on May 1st, 2018, and is located approximately 400 feet northeast of the intersection of 76th St NW and 21st Ave NW. The site could not be accessed at the time of the site visit. The site is currently native grassland, and surrounded by agricultural fields to the north and east. Grasslands lie to the south. A residential property with agricultural equipment and numerous grain bins lies to the west, across 21st Ave NW. Visual impacts were observed from a distance during the site visit. These impacts included an area lacking vegetative growth, which was estimated to measure approximately 225 feet by 150 feet. The site appeared to be a slightly depressed area in relation to the rest of the surrounding areas. Aboveground powerlines were observed to the west of the site.

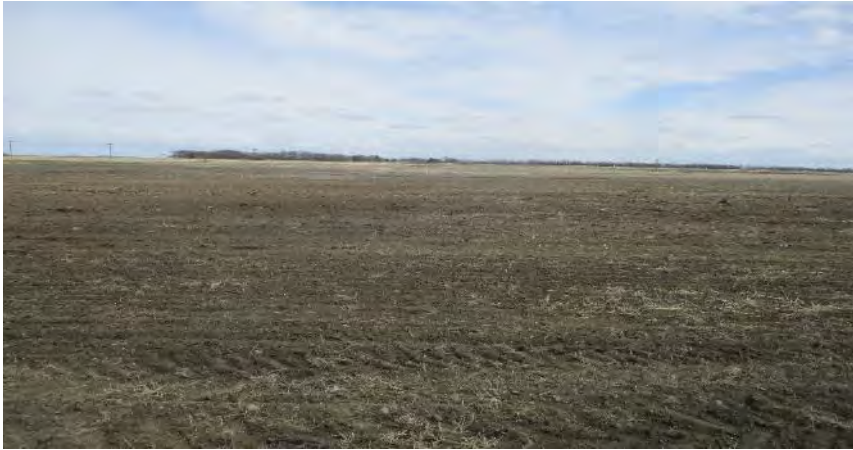
R24-8 (May 2018)

Photograph facing east taken off an oilfield lease road showing the site. No visual impacts were observed at the time of the May 1, 2018 site visit.

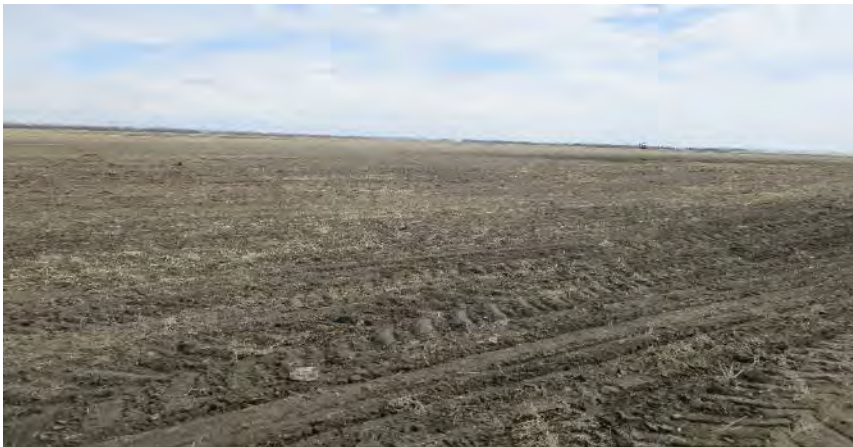
Photograph facing southeast taken off an oilfield lease road showing the site. The site had recently been plowed and no signs of visual impacts were observed.

R24-8 was inspected on May 1st, 2018 and is located approximately 300 feet south off 76th St NW. The site could not be accessed at the time of the site visit. The site is currently used for agricultural purposes and was observed to have been recently plowed at the time of the site visit. Agricultural fields lie to the north, east, and south. A wetland is located to the south of the site. An oil & gas facility was observed to the west, consisting of five aboveground storage tanks, a shack, and other miscellaneous oilfield equipment. Visual impacts were not observed from a distance at the time of the site visit. The site is generally flat and slopes slightly to the northwest. Aboveground powerlines were observed to the west of the site.

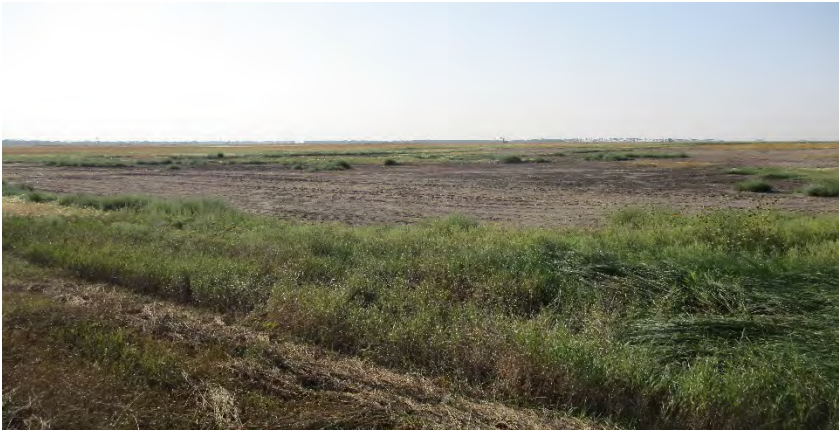
R24-8 (August 2018)

Photograph facing east taken off of an oil lease road showing the visually impacted area. An area of barren ground and stressed vegetation measuring approximately 300 feet by 200 feet was observed.

R24-8 was revisited on August 20th, 2018. During the initial inspection, the site had recently been plowed, and no impacts could be observed. This follow-up investigation identified visual impacts consisting of barren ground and stressed vegetation in an area measuring approximately 300 feet by 200 feet.

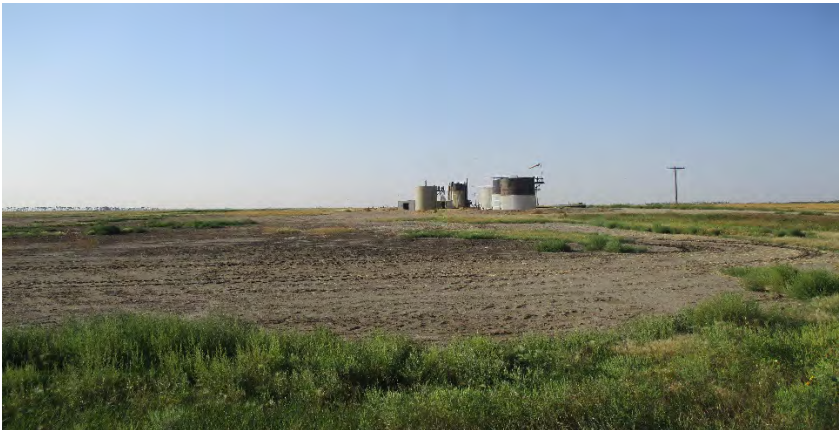
Photograph facing southwest taken off of 76th St NW showing the visually impacted area.

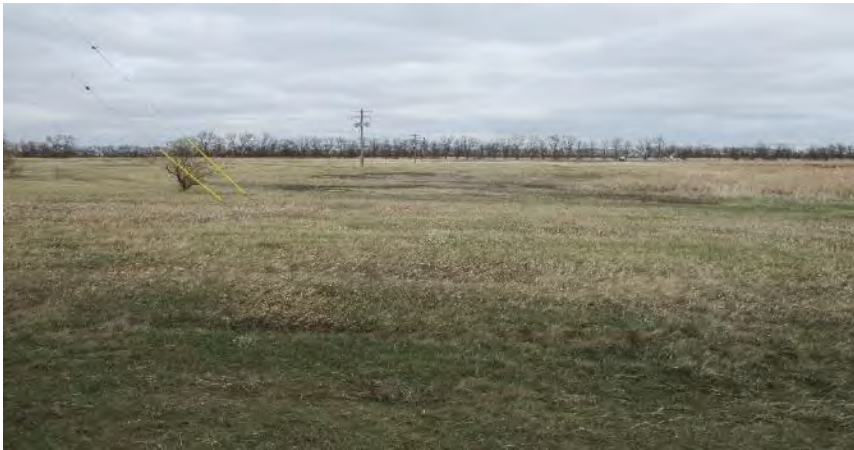
Photograph facing east taken off of 21st Ave NW. A visually impacted area lacking vegetation was observed north of a wetland/pond. Aboveground powerlines can be seen in the foreground and background.

R24-9 was inspected on May 1st, 2018 and is located approximately 150 feet east of 21st Ave NW and just south of an oilfield lease road. The site could not be accessed at the time of the site visit. The site is currently native grassland and is surrounded by agricultural fields. Oil & gas facilities were located to the west and south. Each of these facilities consists of one pump jack. A pad used for industrial purposes was also observed to the east. A wetland/pond is located to the south of the site. Visual impacts were observed from a distance at the time of the site visit, including an area of barren soils lacking vegetation. The area was estimated to measure approximately 150 feet by 60 feet. It appears the impacts may have migrated south towards the wetland. The site topography is generally flat and slopes slightly to the south. Aboveground powerlines are located to the north and west of the site. An underground petroleum pipeline was observed to the north of the site, just north of the oilfield lease road.

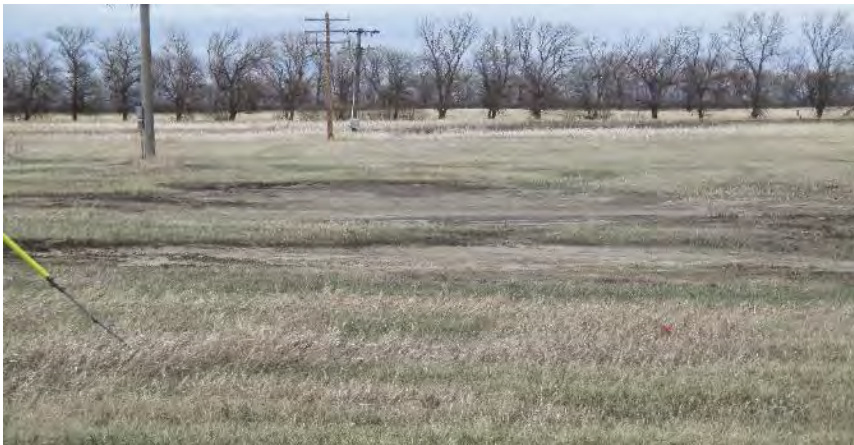
Photograph facing east taken off of 21st Ave NW, showing a closer view of the visually impacted area lacking vegetation.

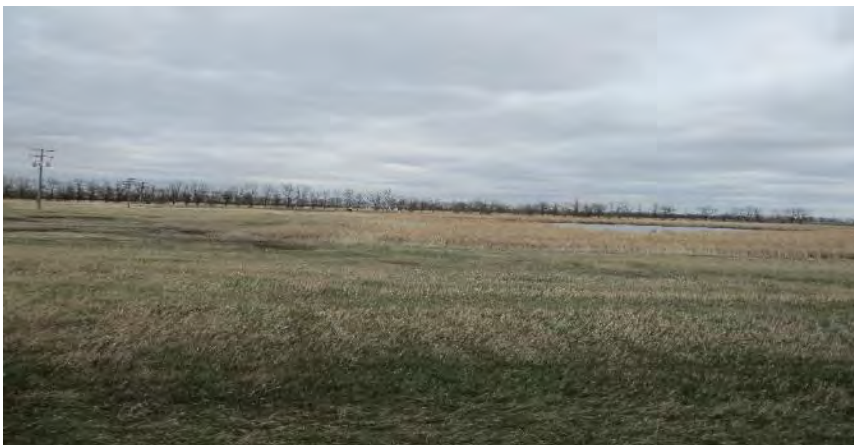
View facing southeast showing the visually impacted area. The proximity of the visually impacted area to the wetland/pond can be seen. Above ground power lines can be seen in the background.

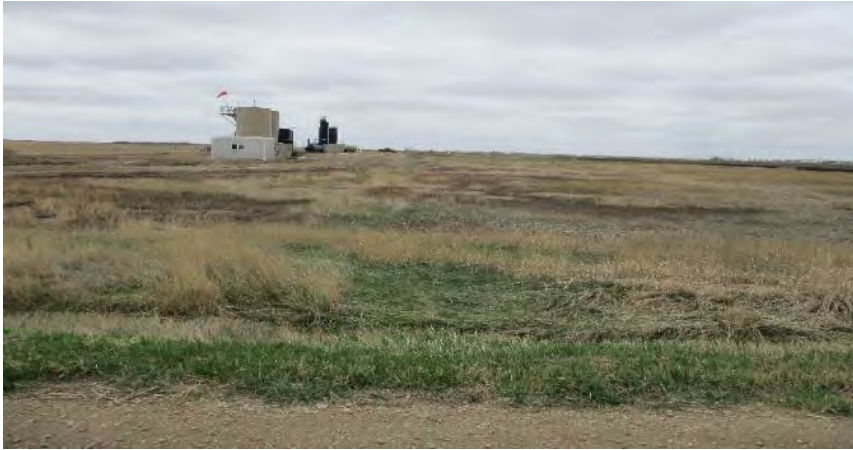
Photograph facing west taken off of 21st Ave NW. A visually impacted area lacking vegetation was observed. An oil & gas facility can be seen in the background.

R24-10 was inspected on May 1st, 2018 and is located approximately 250 feet west of 21st Ave NW and just south of an oil & gas facility. The site is currently used for agricultural purposes and surrounded by agricultural fields. An oil & gas facility was observed to the south, consisting of four aboveground storage tanks, two heater treaters, two horizontal separators, and a flare pit. Visual impacts were observed from a distance, including numerous areas with barren soils lacking vegetation; the area of visual impacts was estimated to measure approximately 250 feet by 50 feet. The site topography is generally flat and slopes slightly to the east and southeast. An underground petroleum pipeline was observed to the south. Hydrogen sulfide odors were observed during the site visit.

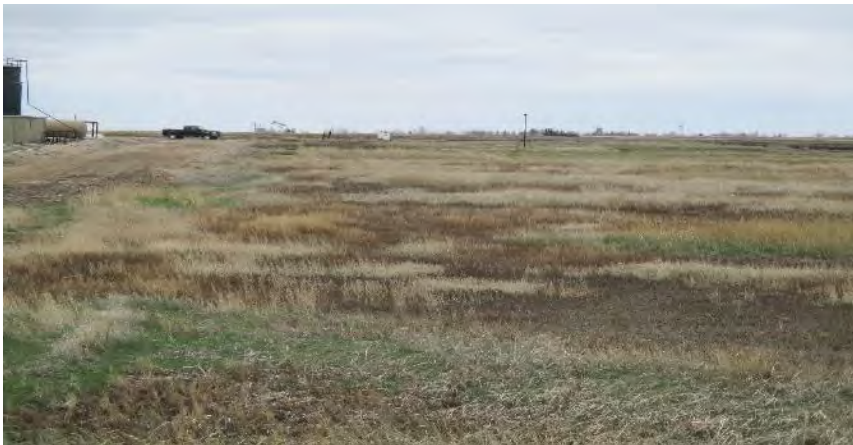
Photograph facing west taken off of 21st Ave NW showing a closer view of the impacted area.

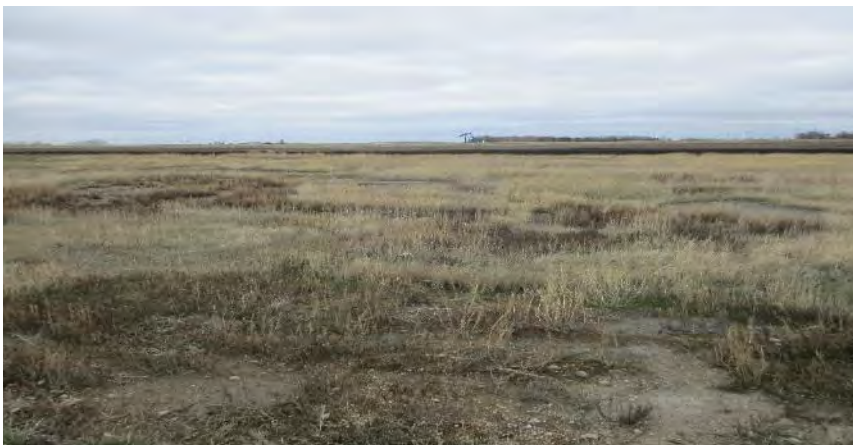
Photograph facing north taken from an oilfield lease road showing the visually impacted area.

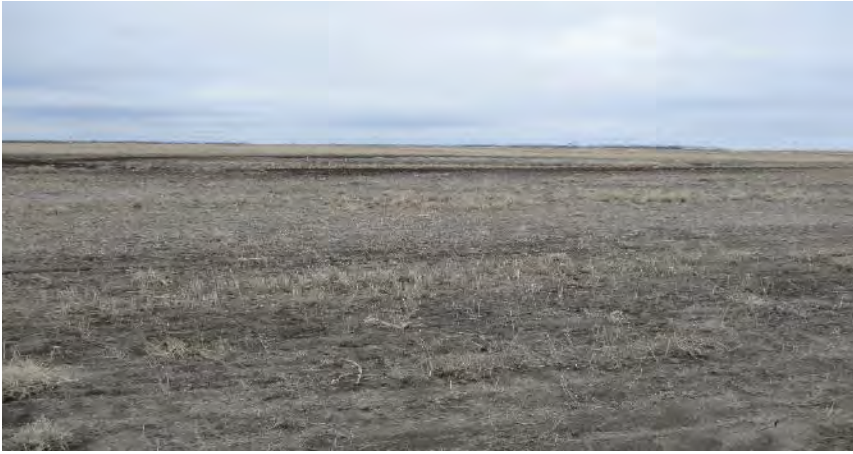
Photograph facing east taken off of 22nd Ave NW. Visual impacts including an area lacking vegetation can be seen in the foreground. A wetland east of the impacted area can be seen in the background.

R24-11 was inspected on May 1st, 2018 and is located approximately 125 feet east of 22nd Ave NW. The site could not be accessed at the time of the site visit. The site is currently used for agricultural purposes, and is surrounded by agricultural fields. A wetland was observed to the east. Visual impacts were observed from a distance, including an area slightly lacking vegetation. The area was estimated to measure approximately 100 feet by 75 feet. The site topography is generally flat, with the impacted area appearing to be a low spot compared to the surrounding areas. Aboveground powerlines were observed to the west.

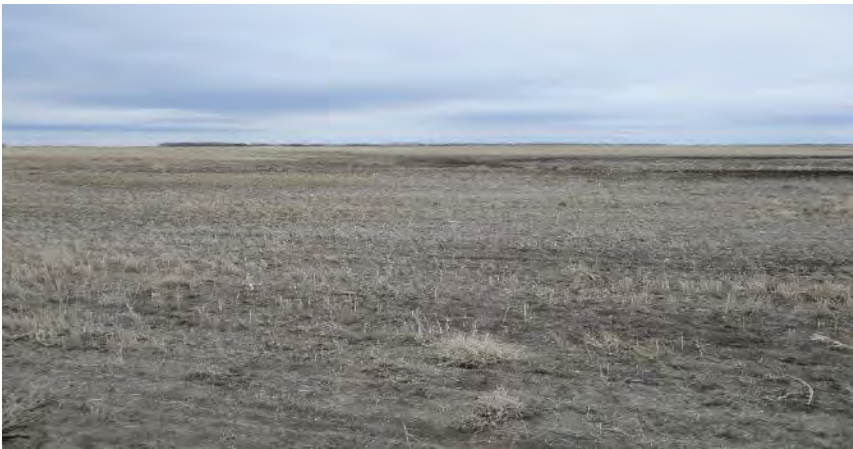
Photograph facing northeast taken off of 22nd Ave NW. The area lacking vegetation can be seen in the foreground. A wetland east of the impacted area is located in the background.

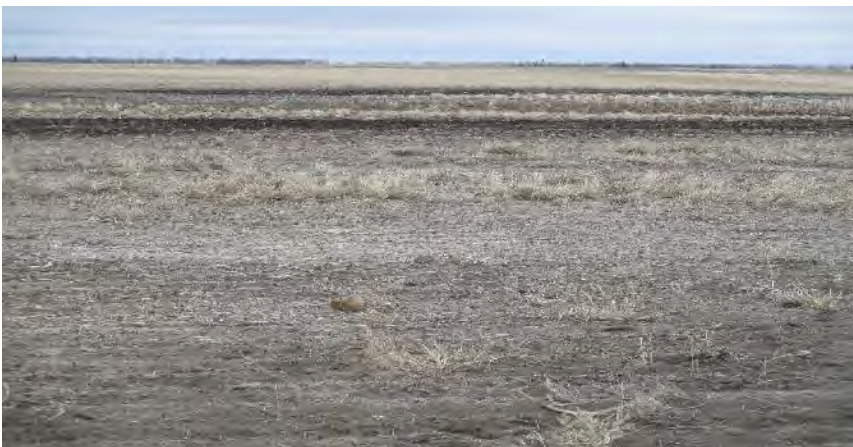
Photograph facing east taken off of 22nd Ave NW showing a closer view of the area lacking vegetation.
