NDIC Brine Pond Study

Phase II: Site Assessments

June 25, 2018

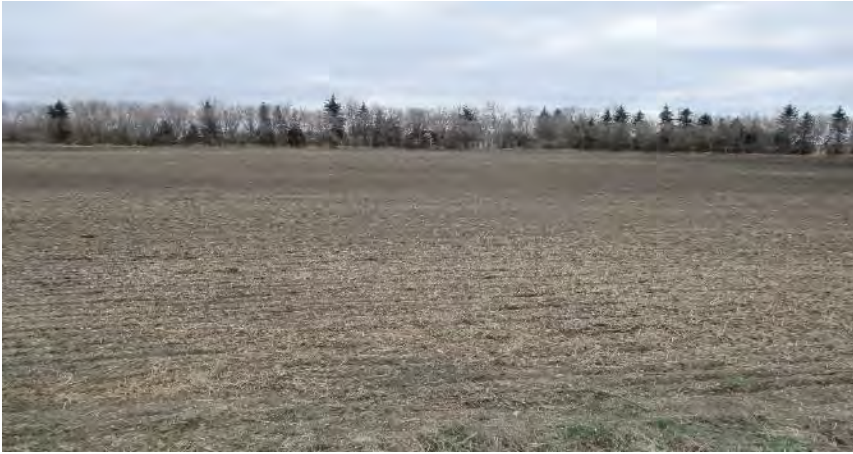
R24-12 (May 2018)

Photograph facing south taken off of an oilfield lease road. No visual impacts were observed at the time of the May 1, 2018 site visit.

R24-12 was inspected on May 1st, 2018 and is located approximately 350 feet east of 21st Ave NW and just south of an oilfield lease road. The site could not be accessed at the time of the site visit. The site is currently used for agricultural purposes and appeared to be recently plowed. Agricultural fields surround the site. An oil & gas facility was observed to the northeast, consisting of a single shack. A wetland lies to the north, just past the oilfield lease road. Visual impacts were not observed from a distance during the site visit. The site topography is generally flat and slopes slightly to the west. An underground petroleum pipeline was observed to the north.

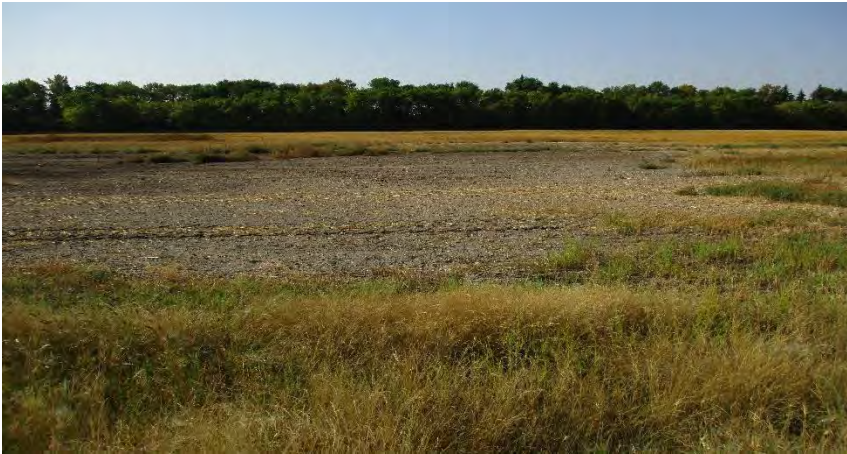
R24-12 (August 2018)

Photograph facing south taken off of an oilfield lease road showing the visually impacted area. Barren ground with stressed vegetation was observed in an area measuring approximately 45 feet by 35 feet.

R24-12 was revisited on August 20th, 2018. During the initial inspection, the site had recently been plowed, and no impacts could be observed. This follow-up investigation identified visual impacts consisting of barren ground and stressed vegetation in an area measuring approximately 45 feet by 35 feet.

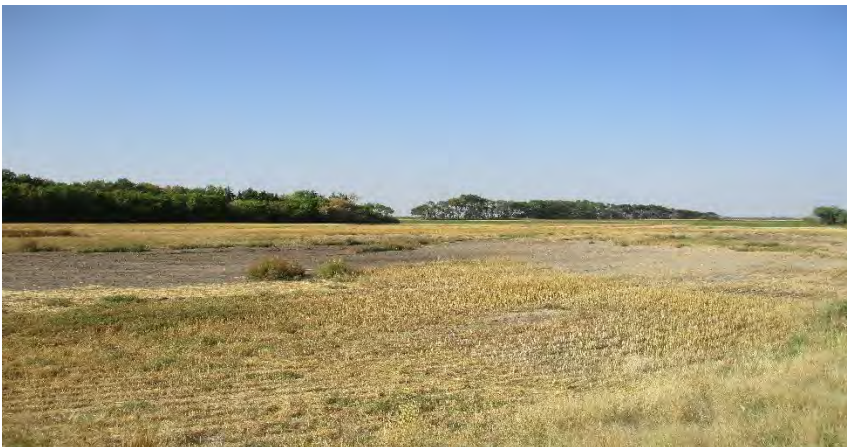
Photograph facing southeast taken off of an oilfield lease road, showing the visually impacted area.

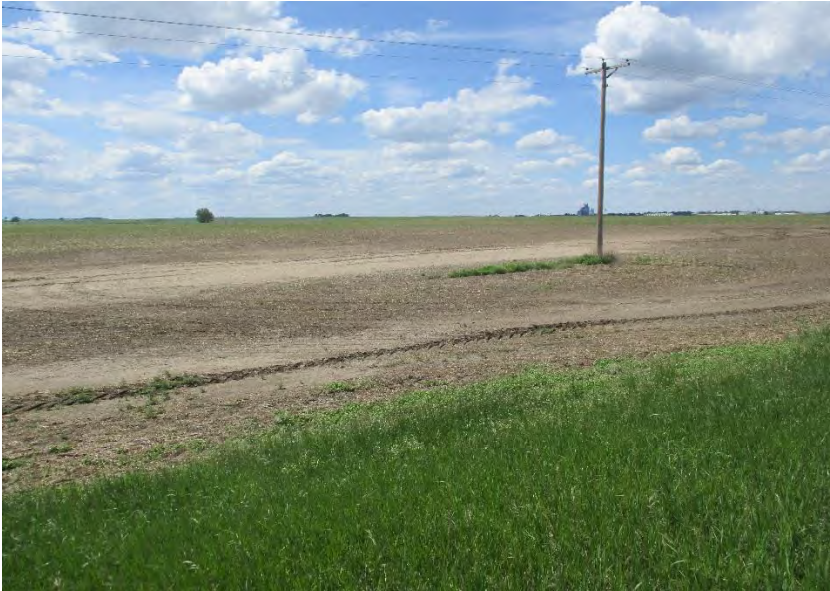
Photograph facing northwest from 268th St NW towards the Ward-2 site. Visual impacts including barren soils with salt crusting were observed. Note the area of discoloration and lacking vegetation inside the visually impacted area as seen in the center of the photograph.

Ward-2 was inspected on June 19th, 2018, and is located approximately 200 feet west of 268th St NW. The site is currently used as agricultural land, and is surrounded by agricultural fields. Visual impacts were observed, including an area of barren soil with salt crusting, lacking vegetation. The area of visual impacts measured approximately 200 feet by 25 feet. A wetland was also observed to the east of the site across 268th St NW. During the site inspection, multiple areas in the surrounding landscape showed indicators of alkaline soil similar to condition noted at the Ward-2 site. The site is at a topographical low point with drainage patterns sloping towards the visually impacted area. Aboveground powerlines were observed running north and south along 268th St NW.

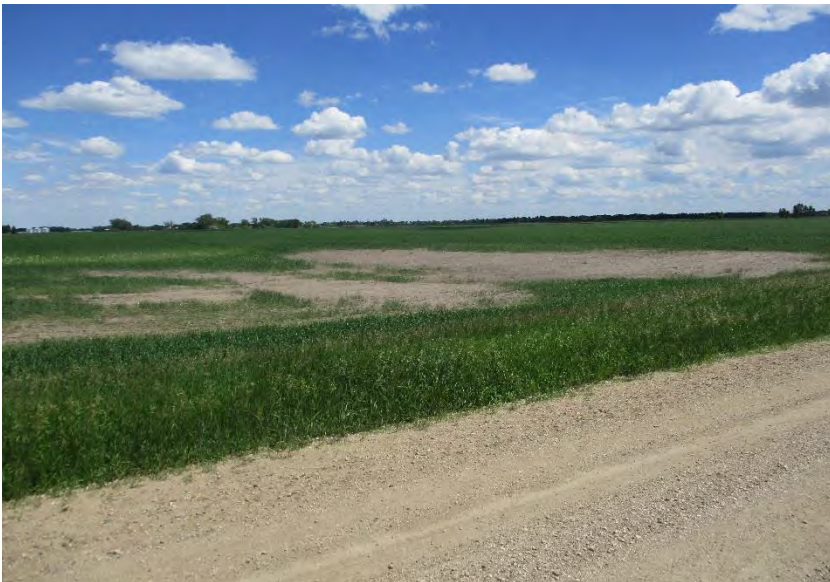
Photograph facing southeast showing ground conditions of an agricultural field adjacent to the Ward-2 site. The field lies across 268th St NW to the east. Indicators of alkaline soils were present in the surrounding landscape similar to conditions noted at the Ward-2 site.
