IceJams,Landslides,andtheNorthern Pacific Railway Bridge at Bismarck

by Ed Murphy

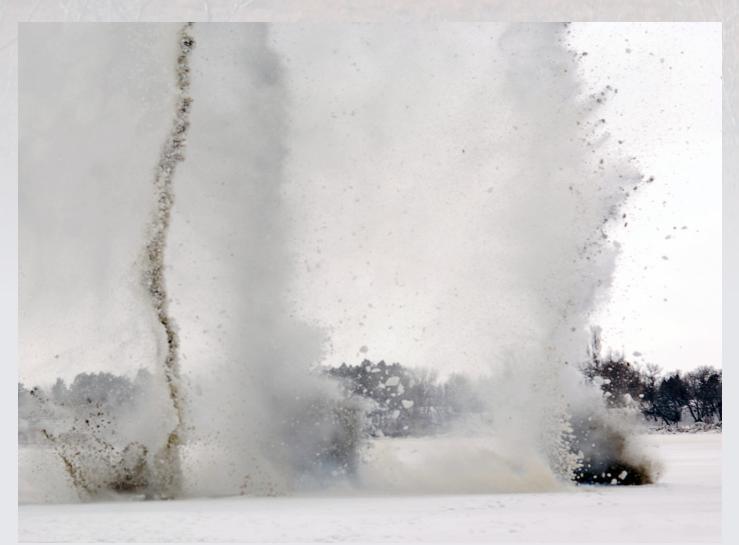
Figure 1. Demolition crews set off a series of charges to weaken the southern ice jam on the Missouri River at Bismarck on March 25, 2009. A second series of charges and salt were used to further weaken the ice. Photo courtesy of the Bismarck Tribune.

Two ice jams on the Missouri River near Bismarck, one to the south and the other to the north, dominated local and national news in March of 2009 (fig. 1). The southern ice jam caused flood waters from the Missouri River to rise to 1,634 feet (above sea level). An elevation of 1,634.28 feet (a 16 foot-reading in the Bismarck stream gauge) is considered flood stage. This was the highest river level seen at Bismarck since 1952, one year prior to completion of Garrison Dam. The dam is located on the Missouri River 75 miles upstream from Bismarck. The northern ice jam, ten miles north of Bismarck, held water back and, in all likelihood, prevented the flood waters at Bismarck from rising to higher elevations.

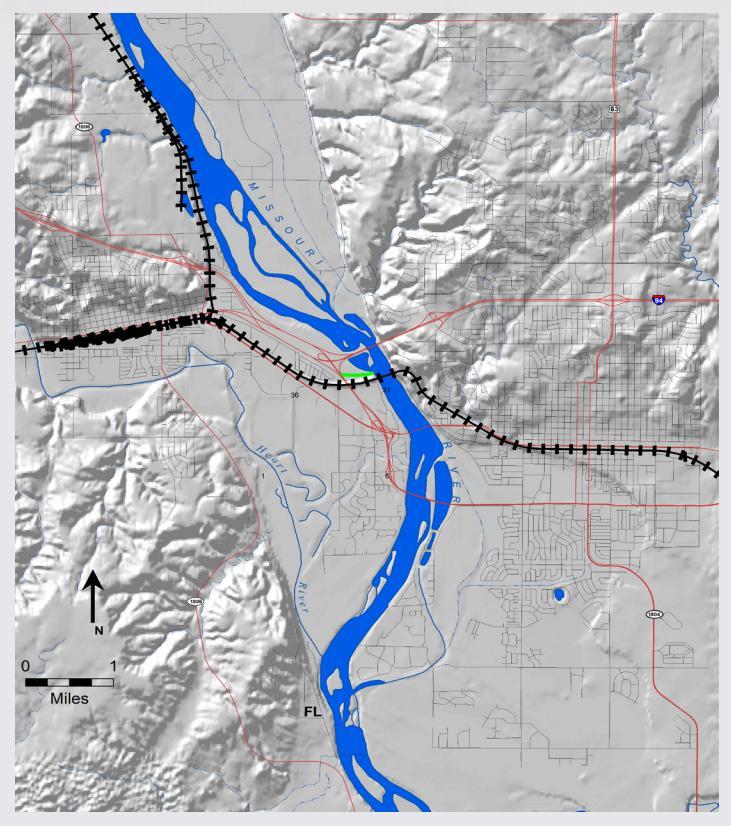
Figure 2. Shaded relief map of the Bismarck-Mandan area. George Morison's dike (green line) narrowed the Missouri River channel and constrained it against its east bank for more than one mile near the bridge site. The location of Fort Abraham Lincoln noted by FL.

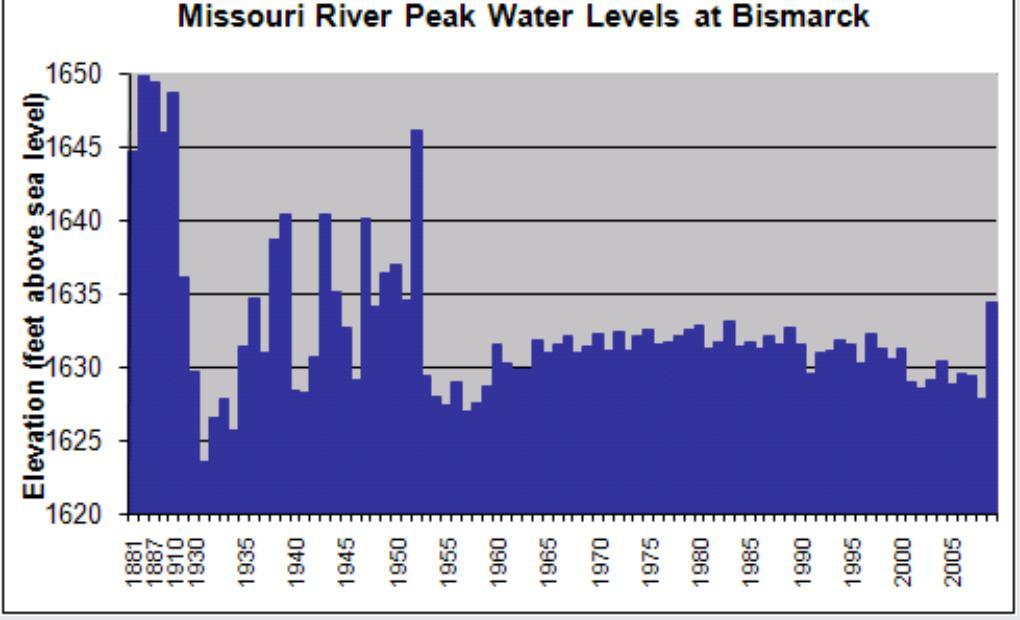
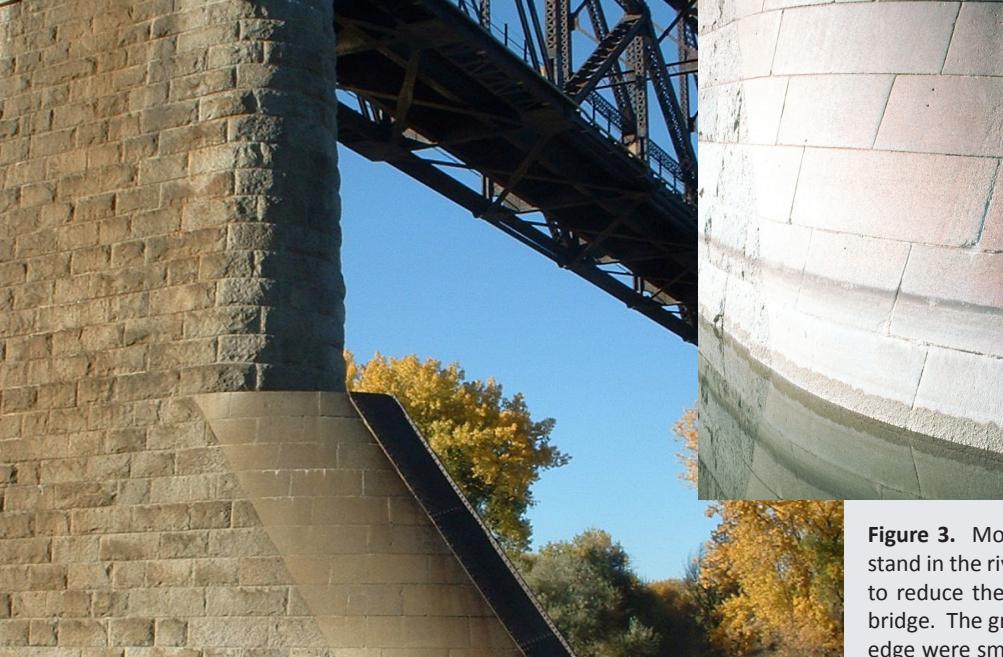
Figure 3. Morison designed the two middle piers that stand in the river with a steel edge to "plow" through ice to reduce the chance of ice jams forming beneath the bridge. The granite blocks along either side of the metal edge were smoothed to encourage ice movement away from the pier. The photographs were taken in the fall of 2003 when the Missouri River was very low.

The development of spring ice jams on the Missouri River would not have come as a surprise to George Shattuck Morison, the bridge engineer that designed and built the Northern Pacific Railway bridge on the Missouri River between Bismarck and Mandan in the early 1880s. Morison, a resident of New York City, came to Bismarck in the spring of 1880 to scout for a suitable bridge location and to obtain first hand knowledge of the Missouri River. After all, this was to be the first bridge to span the Upper Missouri River. While in Bismarck he witnessed a massive ice jam and noted that blocks of ice had piled up to a thickness of 20 feet in some places. An ice jam the following spring between Bismarck and Fort Abraham Lincoln caused flood waters to spill out over the bottomland to a height of 1,644.4 feet (fig. 2). These ice jams greatly concerned Morison and played a significant role in his bridge design. To minimize the chance that his bridge would be swept away by ice, Morison reduced the width of the Missouri River at the bridge site with a dike, permanently altering the river in the Bismarck area, and spaced the piers 400 feet apart. As a result, he only had to place two of his four massive granite bridge piers in the water where they would be vulnerable to ice. To protect these two middle piers, he designed them with 30-foothigh ice breaker sections on the upstream portion so that they could literally plow through the ice. In addition, he strengthened the ice breaker sections by doweling all of the granite stones into the underlying layer and plating the nose of the ice-breakers with ¾-inch steel. He also had the stonemasons smooth the stones around the ice cutters to promote downstream movement of the ice (fig. 3).

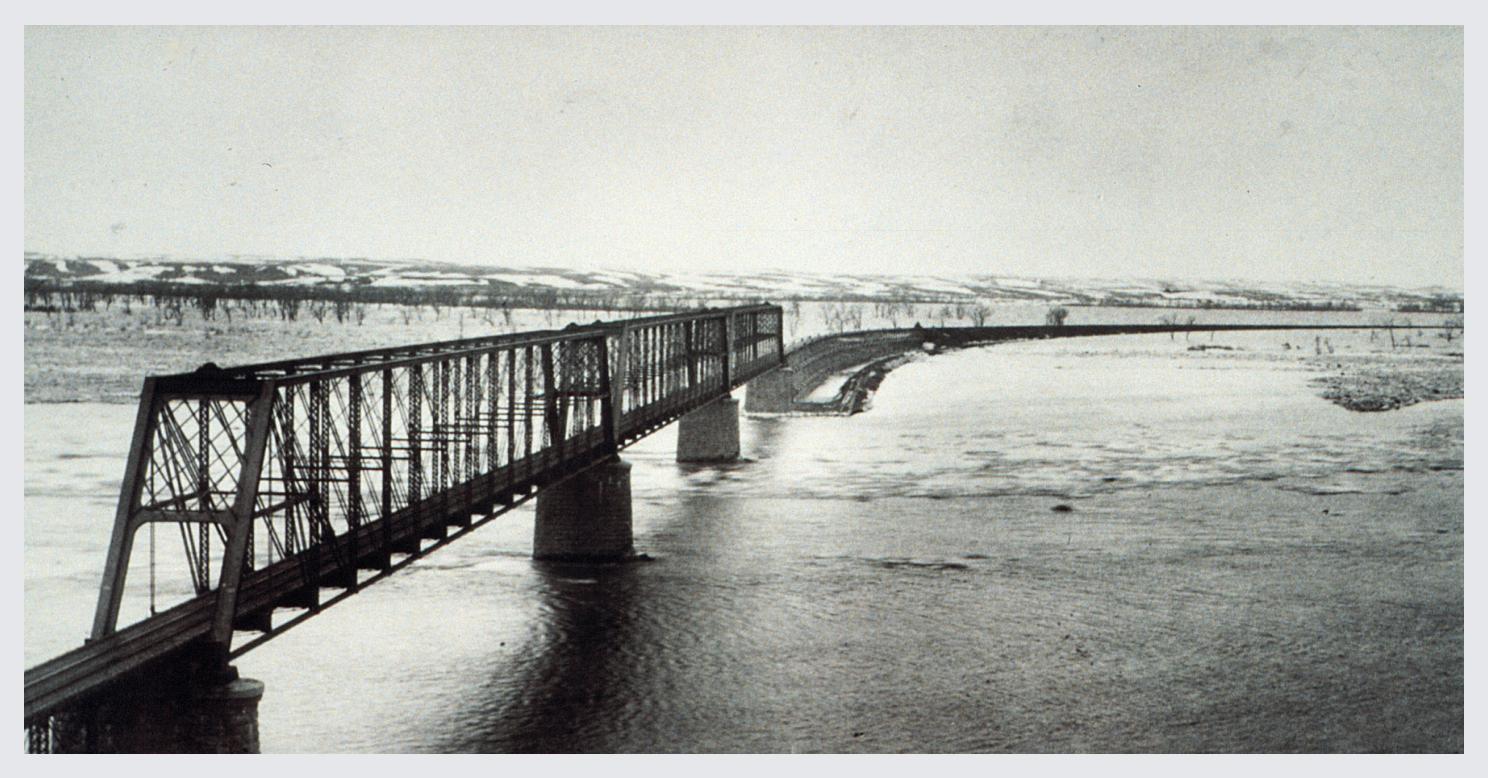
Figure 5. The Missouri River flooding in the spring of 1884. Water extends all the way from the railroad bridge west to the present location of ND Highway 1806 south of Mandan. The ice breakers on the middle piers are under water indicating that the water level exceeded 1,644.4 feet. These original bridge spans were replaced in 1905 because they could no longer safely support the ever-increasing weight of locomotives. Photo courtesy of the State Historical Society of North Dakota.

recorded in Bismarck during that time period (fig. 4). Morison did not have to wait long to see how his bridge would stand up against high water. The Missouri River reached a record high of 1649.88 feet in 1883 followed closely by a near-record level of 1,649.38 in 1887 (fig. 5).

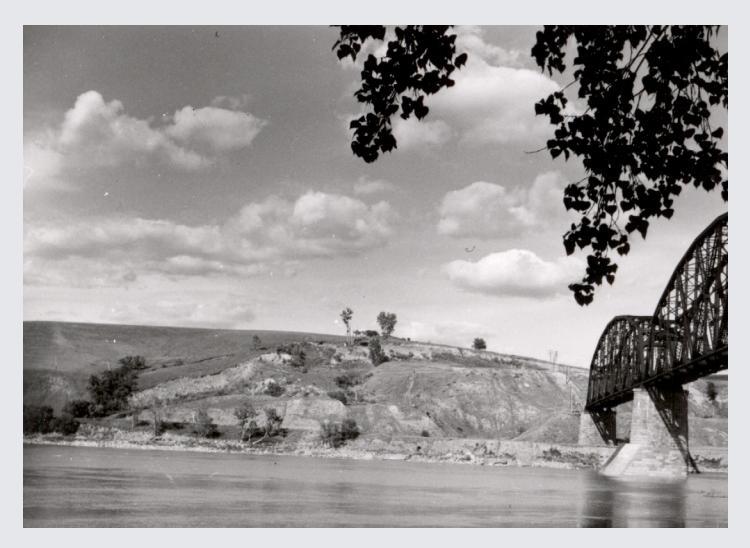
Figure 6. Several landslide scarps are visible along the east slopes of the Missouri River Valley above the Bismarck Railroad Bridge. The top of a City of Bismarck water reservoir is visible just below the largest tree at the top of the east slope. Photograph taken by Ralph Peck in 1951.

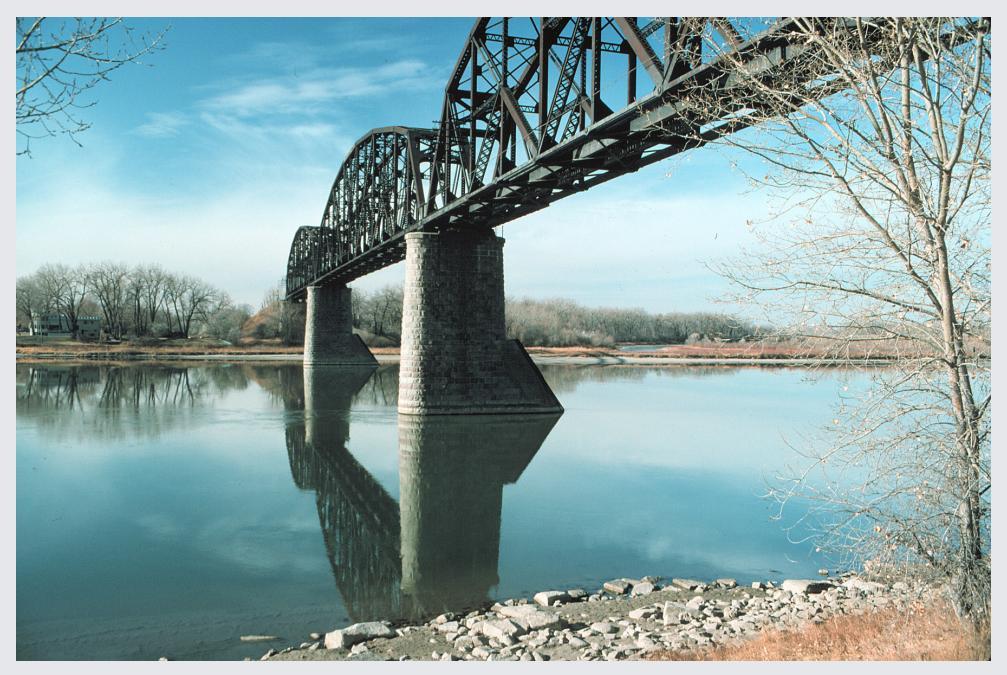
Figure 7. A photograph looking west to the Northern Pacific Railway Bridge on the Missouri River between Bismarck and Mandan, North Dakota. The photo was taken in the fall when water levels in the Missouri River were relatively low. For a more complete article on the bridge see: Murphy, E.C., 1995, The Northern Pacific Railway Bridge at Bismarck: North Dakota History, Journal of the Northern Plains, State Historical Society of North Dakota, Vol 62, No. 2, p. 2-19.

It is appropriate that after nearly seven decades of confounding and frustrating engineers this slope stability problem would finally be solved by one of the most famous civil engineers that ever lived, Ralph B. Peck. By the late 1940s, the east approach to the bridge had to be straightened because the large locomotives of the 1930s and 1940s had difficulty negotiating it. At that time, the Association of American Railroads had a contract with the Engineering Department at the University of Illinois to investigate slope stability problems. Ralph Peck, an engineering professor at the University of Illinois and co-author of two of the most influential text books in geotechnical engineering, Soil Mechanics in Engineering Practice and Foundation Engineering, took over the project. Peck's first response was to initiate a subsurface boring investigation to identify the sediments in the problem area and to determine their soil properties (fig. 6). He used the results of that investigation to determine the factor of safety (the angle of a slope below which it should not fail) for the slope above the pier. Peck seized the opportunity that was afforded during the straightening of the railroad track to remove a considerable amount of the hillside above the east pier and reduce the remaining slope to within his desired factor of safety. Finally, after all of those years, his efforts resulted in relative stability of the slope above the east bridge pier (fig. 7).
