# Areas of Landslides

## Shell Creek Bay Quadrangle, North Dakota

**Edward C. Murphy**

**2010**

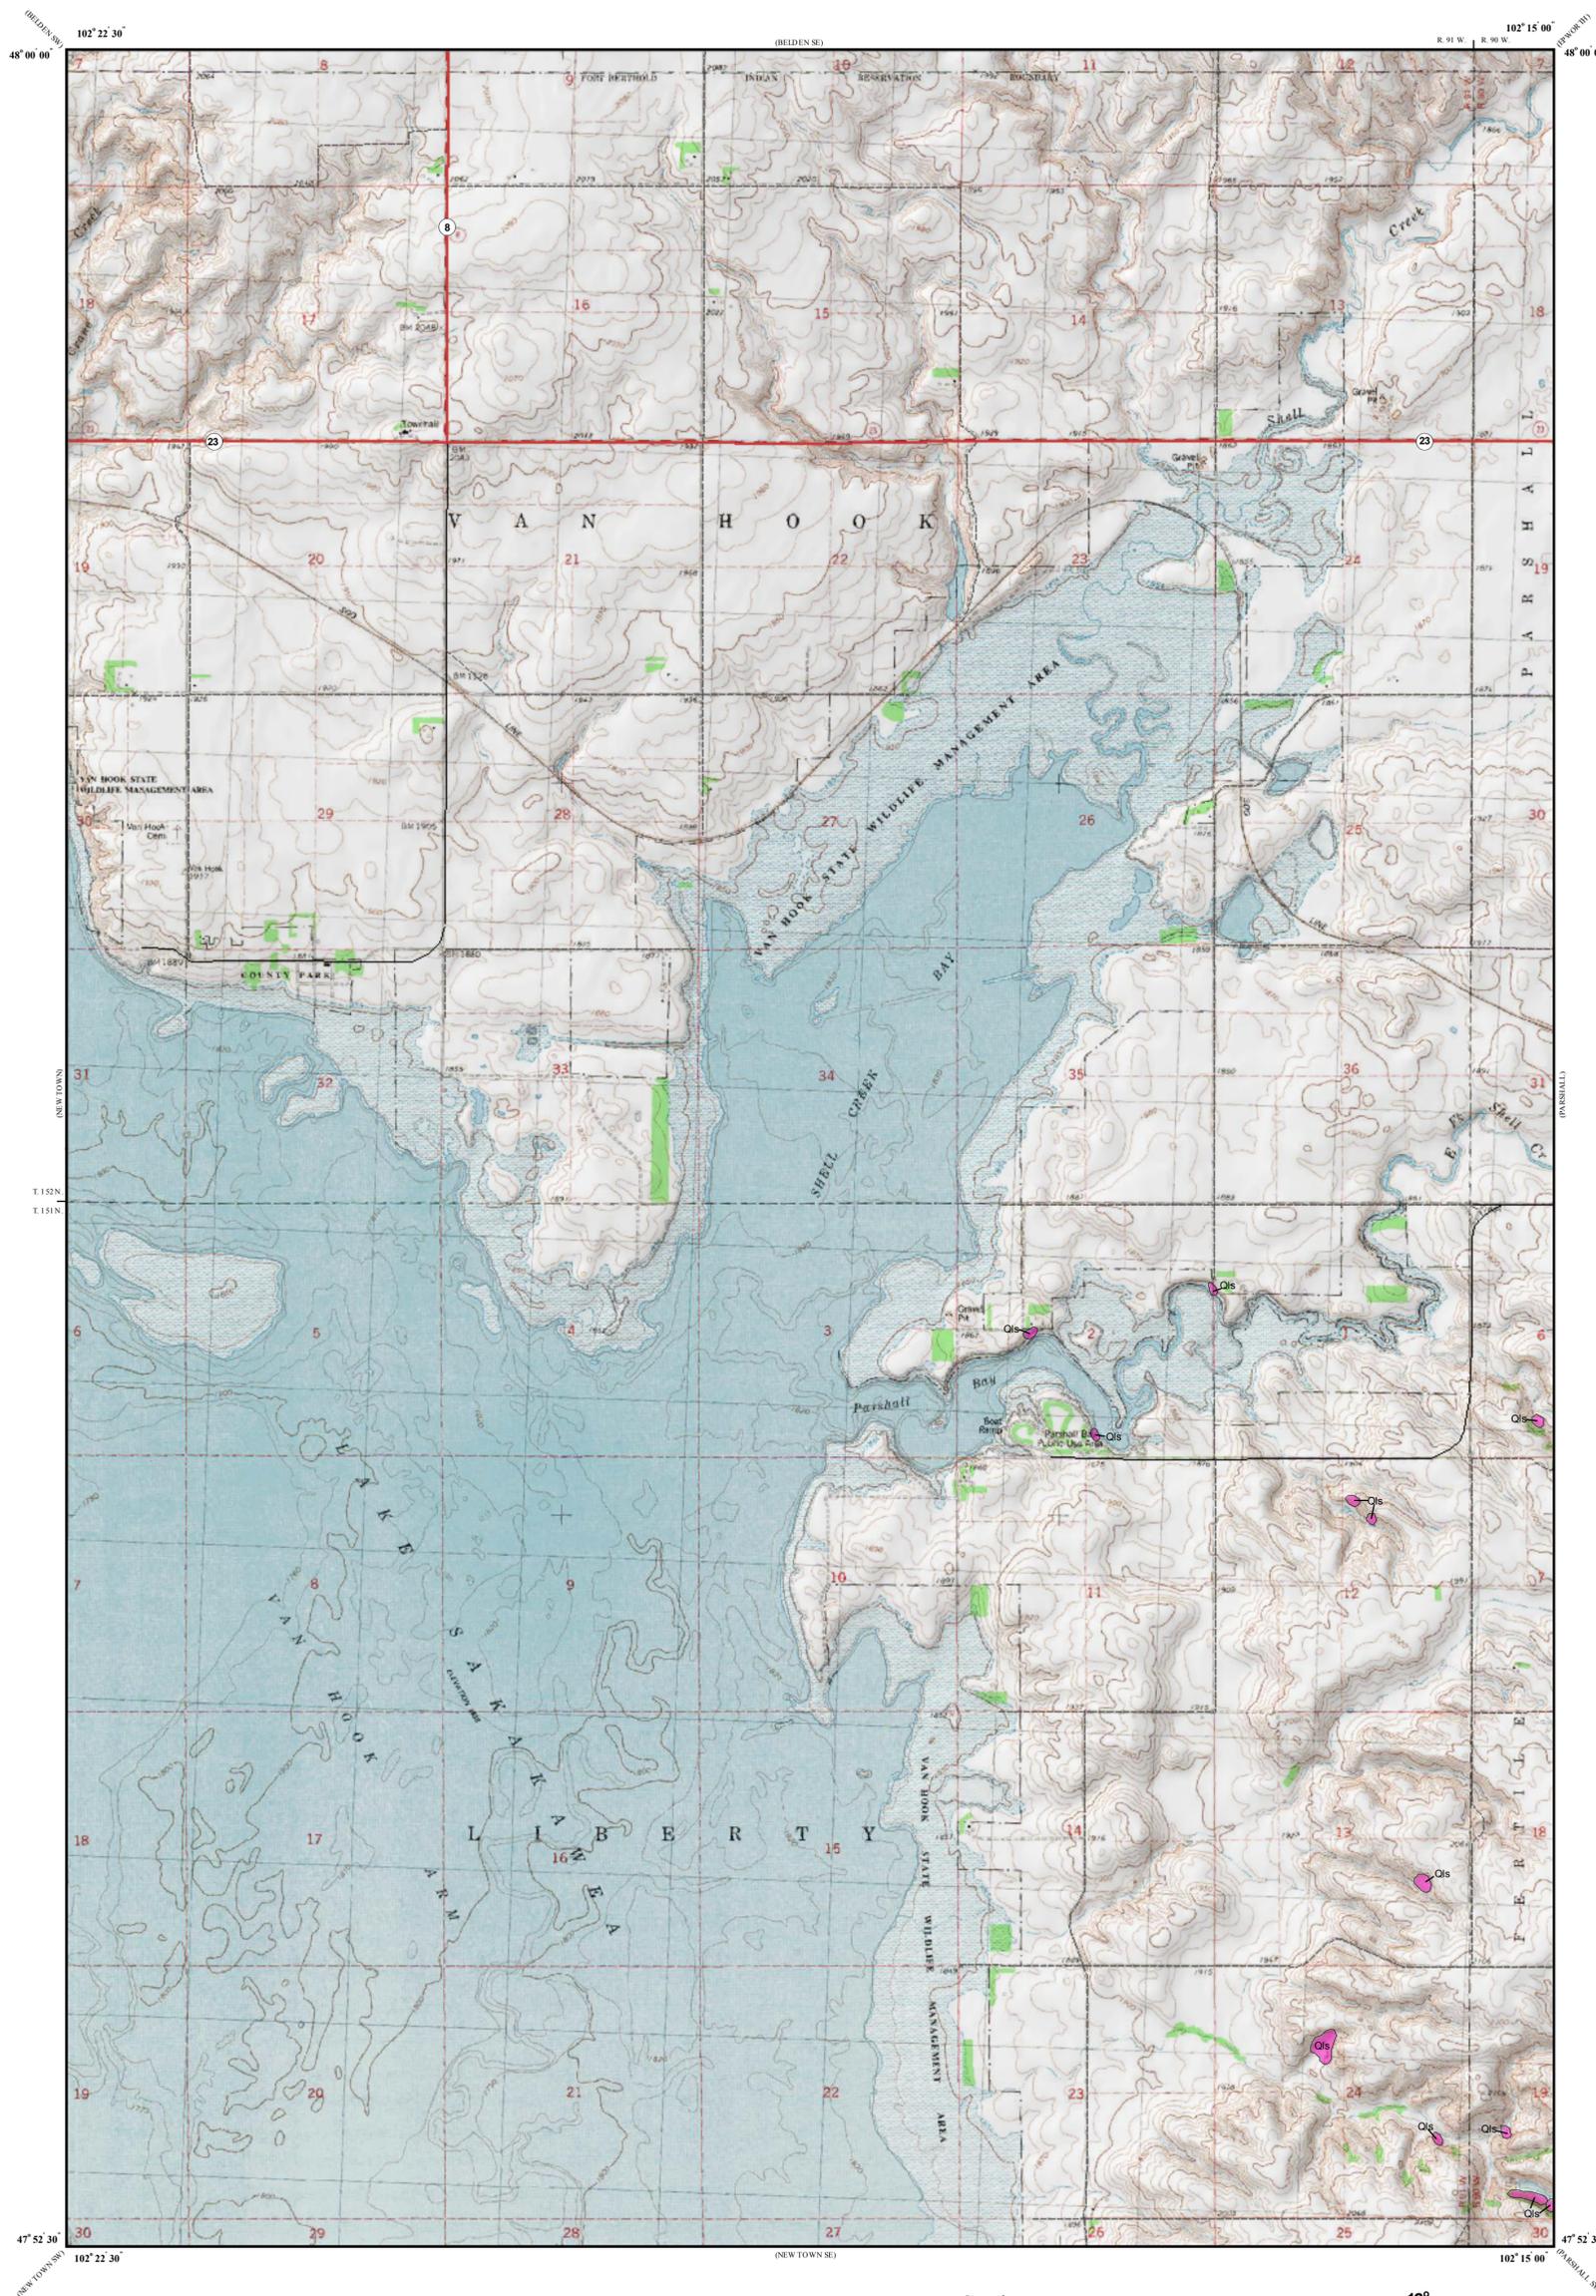
Shell Creek Bay Quadrangle, North Dakota

Variable mixture of strata and deposits that have slid to the base of steep slopes.

Landslides identified on this quadrangle were mapped from stereo pairs, black and white 1:20,000 scale aerial photographs flown between 6-6-58 and 9-7-58. As a result these maps can be used to identify areas that are vulnerable to slope failure, but are not an up to date assessment of all landslides for the area.
