# Areas of Landslides

## Ray Quadrangle, North Dakota

Jordan R. Dahle  
&  
Christopher A. Maike

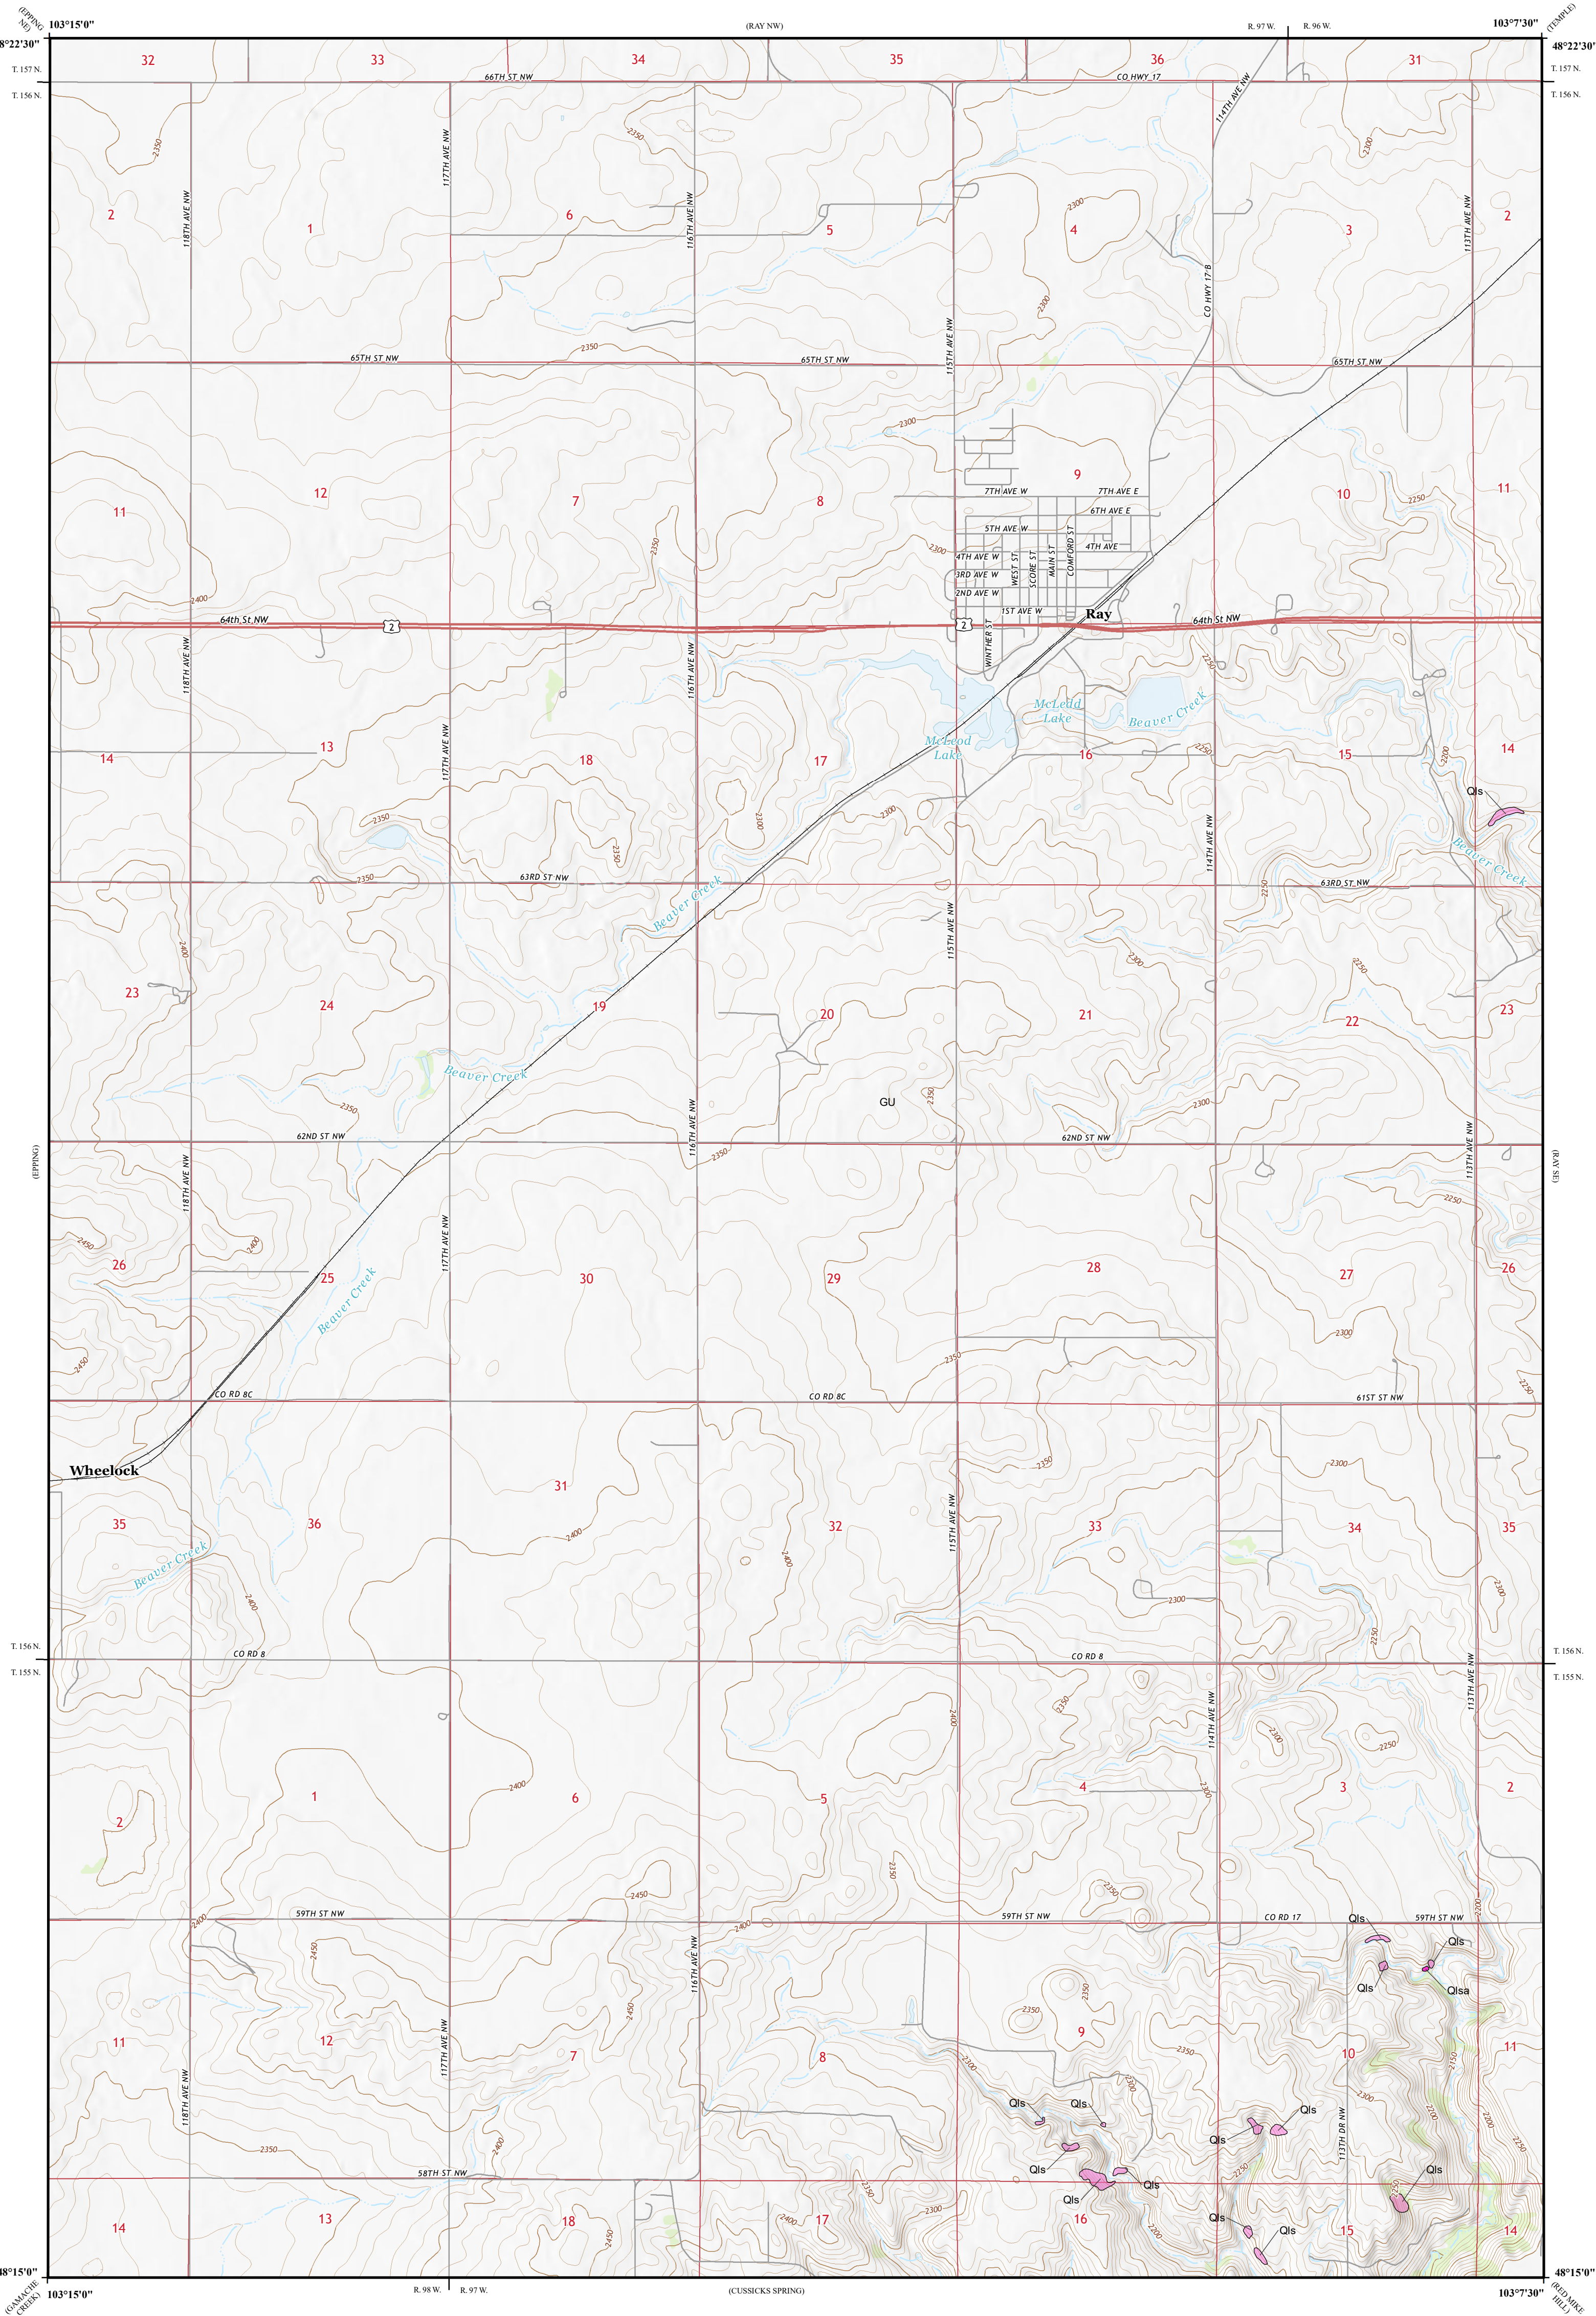
#### Qlsa Areas of Recently Active Landslides

Landslide areas showing movement between 2008 and 2017.

#### Qls Landslide Deposits

A mass of material that has moved downslope. Includes earth flows, slumps, and areas of soil creep.

Landslides identified on this quadrangle were mapped from stereo pairs, black and white 1:20,000 scale aerial photographs flown in 1958 by the United States Department of Agriculture (USDA). Additional data sources include digital orthophotography from the USDA National Agriculture Imagery Program (NAIP) flown in August to September 2024 and the North Dakota Geological Survey LiDAR Map Series, which compiles raw data flown in May 2017 from the North Dakota State Water Commission.

Areas of recently active landslides (Qlsa) mapped on this quadrangle were identified from changes between the 2008 and 2017 LiDAR elevation datasets observed on an elevation subtraction raster. Noise introduced from data precision (typically within a foot between the LiDAR datasets) is removed on this raster by excluding the signal from elevation change in the +/- 1 foot interval. Geologists interpret areas of landslide movement in geomorphic context (typically a decrease in elevation near a landslide headscarp paired with an increase in elevation downslope near the toe) and delineate those areas within the larger landslide dataset. Landslides not identified as recently active may have also experienced movement relatively recently, but did not show discernable signs of movement during the 2008 to 2017 window between LiDAR collects.
