# Areas of Landslides

## Senger Lake North Quadrangle, North Dakota

Jordan R. Dahle  
&  
Fred J. Anderson

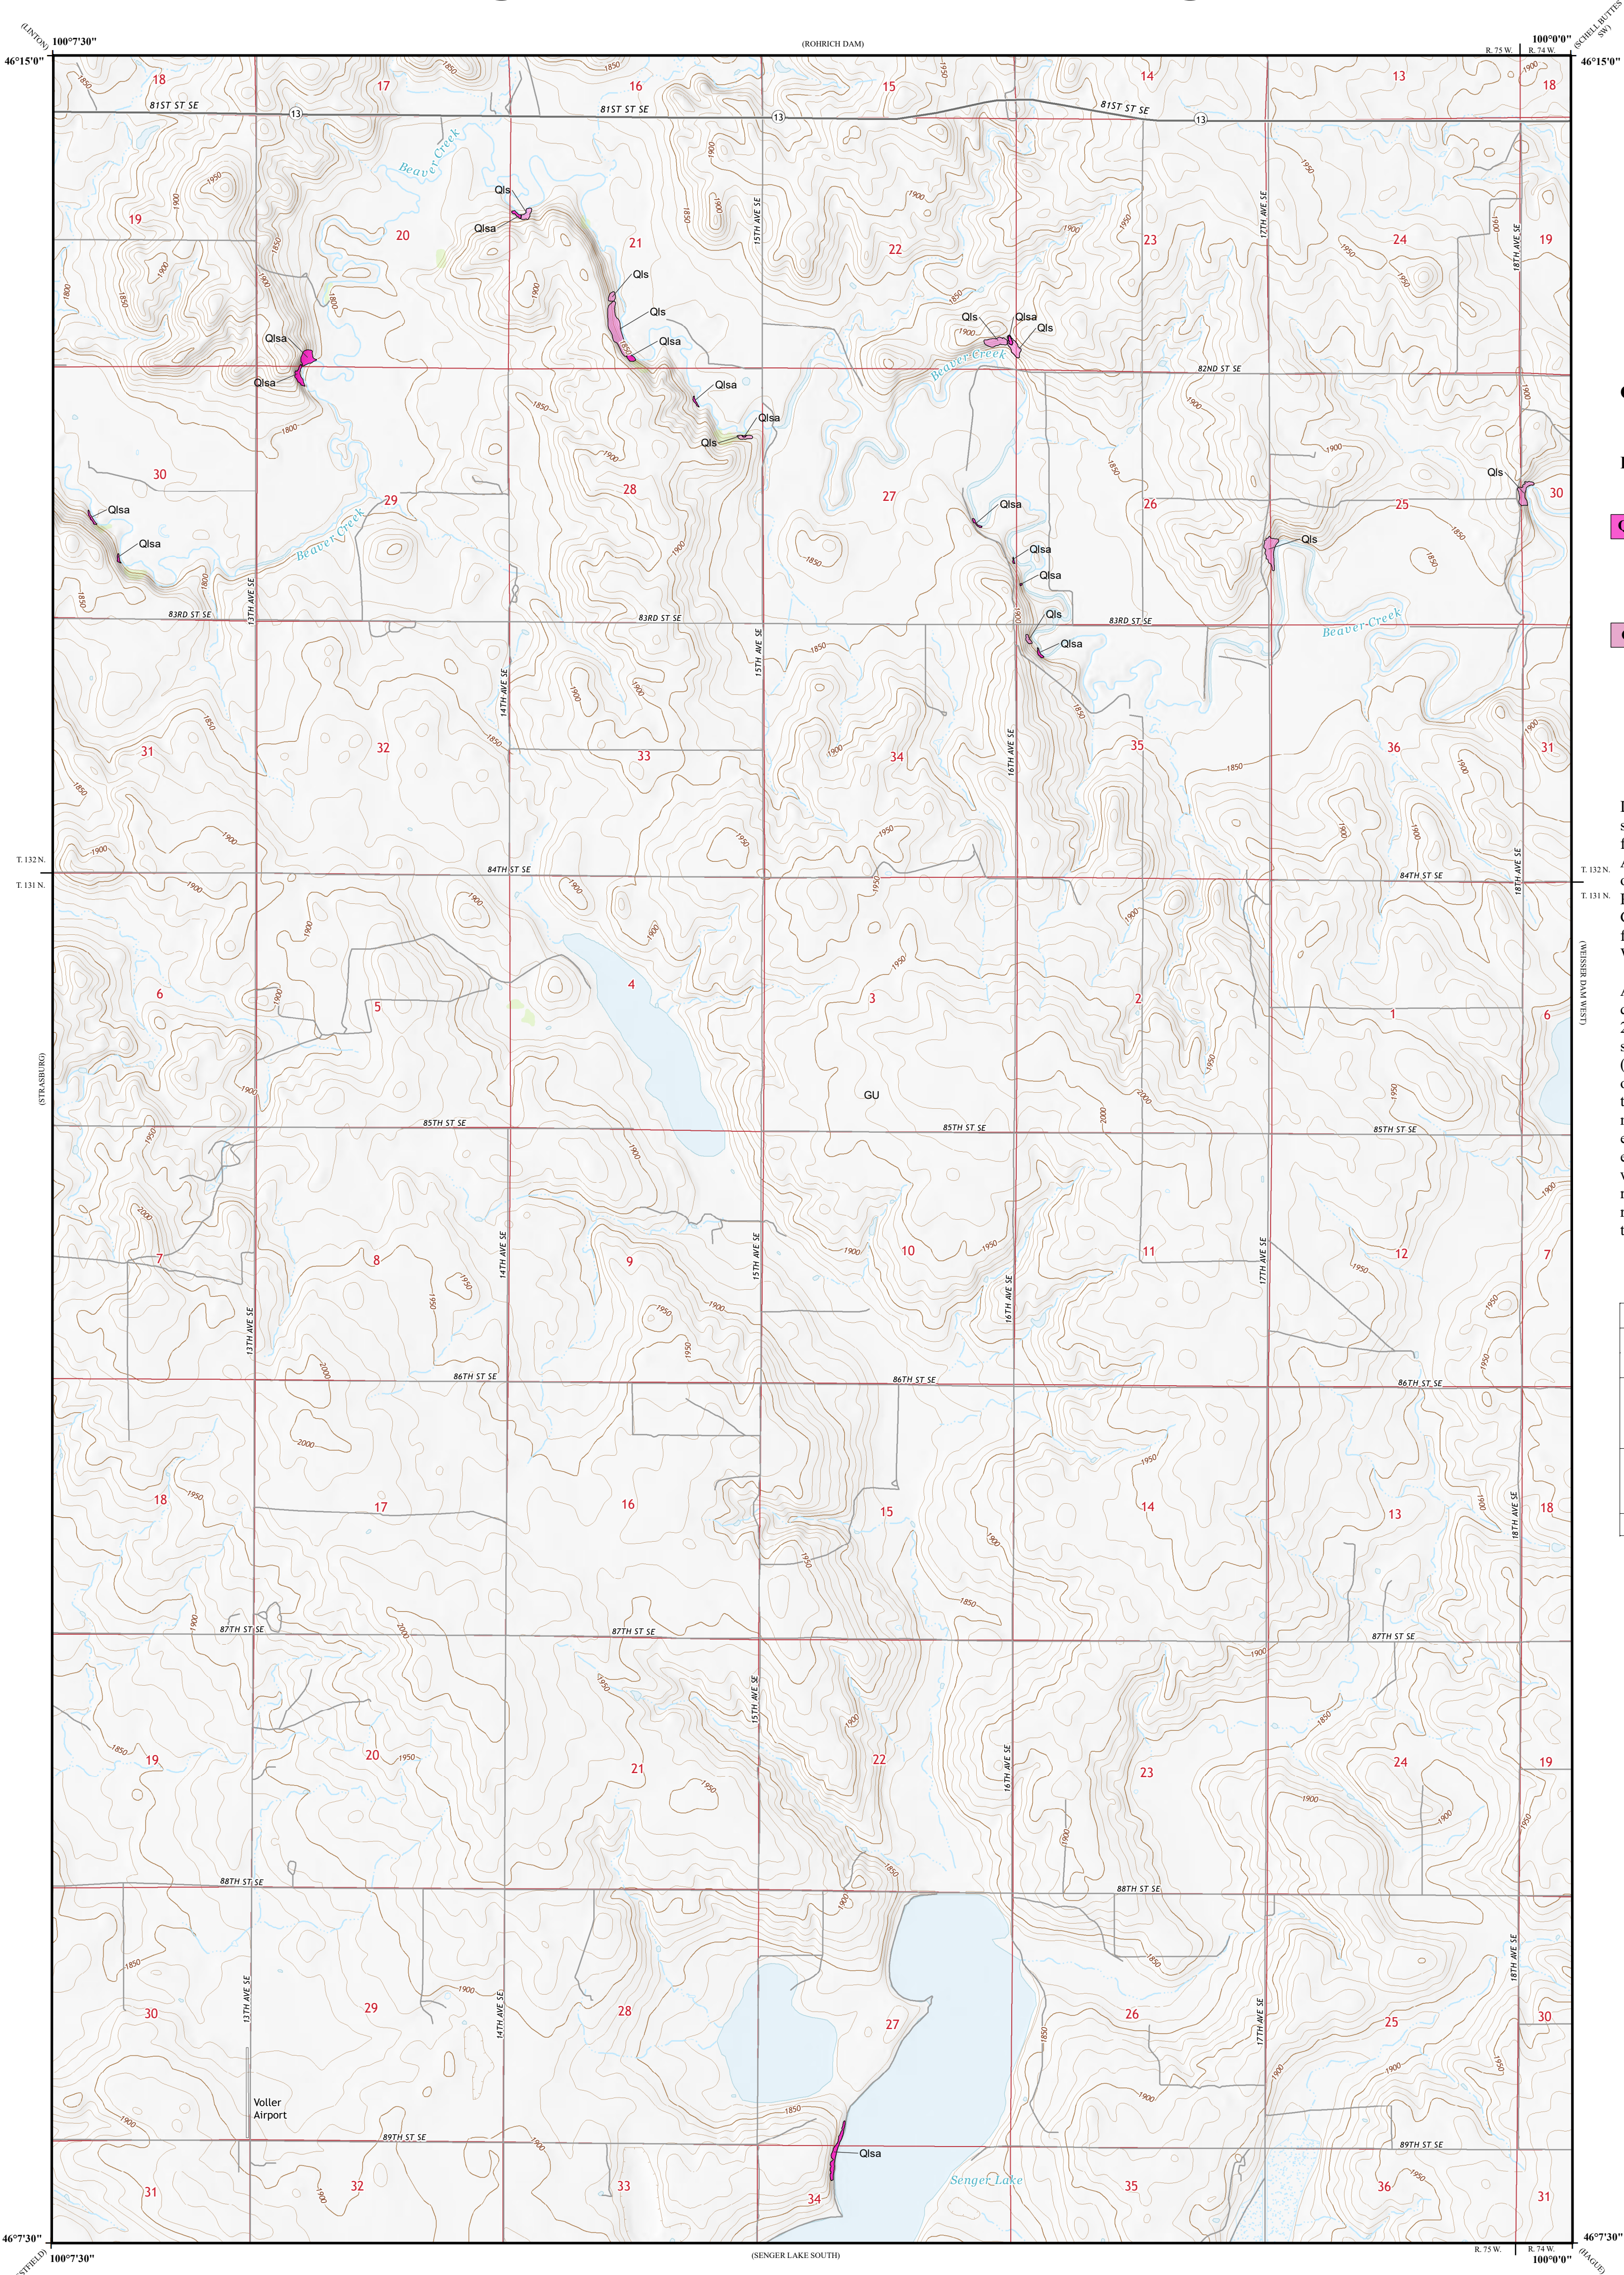
##### Qlsa Areas of Recently Active Landslides

Landslide areas showing movement between 2008 and 2023.

##### Qls Landslide Deposits

A mass of material that has moved downslope. Includes earth flows, slumps, and areas of soil creep.

Landslides identified on this quadrangle were mapped from stereo pairs, black and white 1:20,000 scale aerial photographs flown in July 1960 by the United States Department of Agriculture (USDA). Additional data sources include digital orthophotography from the USDA National Agriculture Imagery Program (NAIP) flown in September 2024 and the North Dakota Geological Survey LiDAR Map Series, which compiles raw data flown in May to November 2023 from the North Dakota State Water Commission.

Areas of recently active landslides (Qlsa) mapped on this quadrangle were identified from changes between the 2008 and 2023 LiDAR elevation datasets observed on an elevation subtraction raster. Noise introduced from data precision (typically within a foot between the LiDAR datasets) is removed on this raster by excluding the signal from elevation change in the +/- 1 foot interval. Geologists interpret areas of landslide movement in geomorphic context (typically a decrease in elevation near a landslide headscarp paired with an increase in elevation downslope near the toe) and delineate those areas within the larger landslide dataset. Landslides not identified as recently active may have also experienced movement relatively recently, but did not show discernable signs of movement during the 2008 to 2023 window between LiDAR collects.

31.9% of the mapped landslide area was active between 2008 and 20 23
