# Areas of Landslides

## Wilton SE Quadrangle, North Dakota

Wilton SE Quadrangle, North Dakota

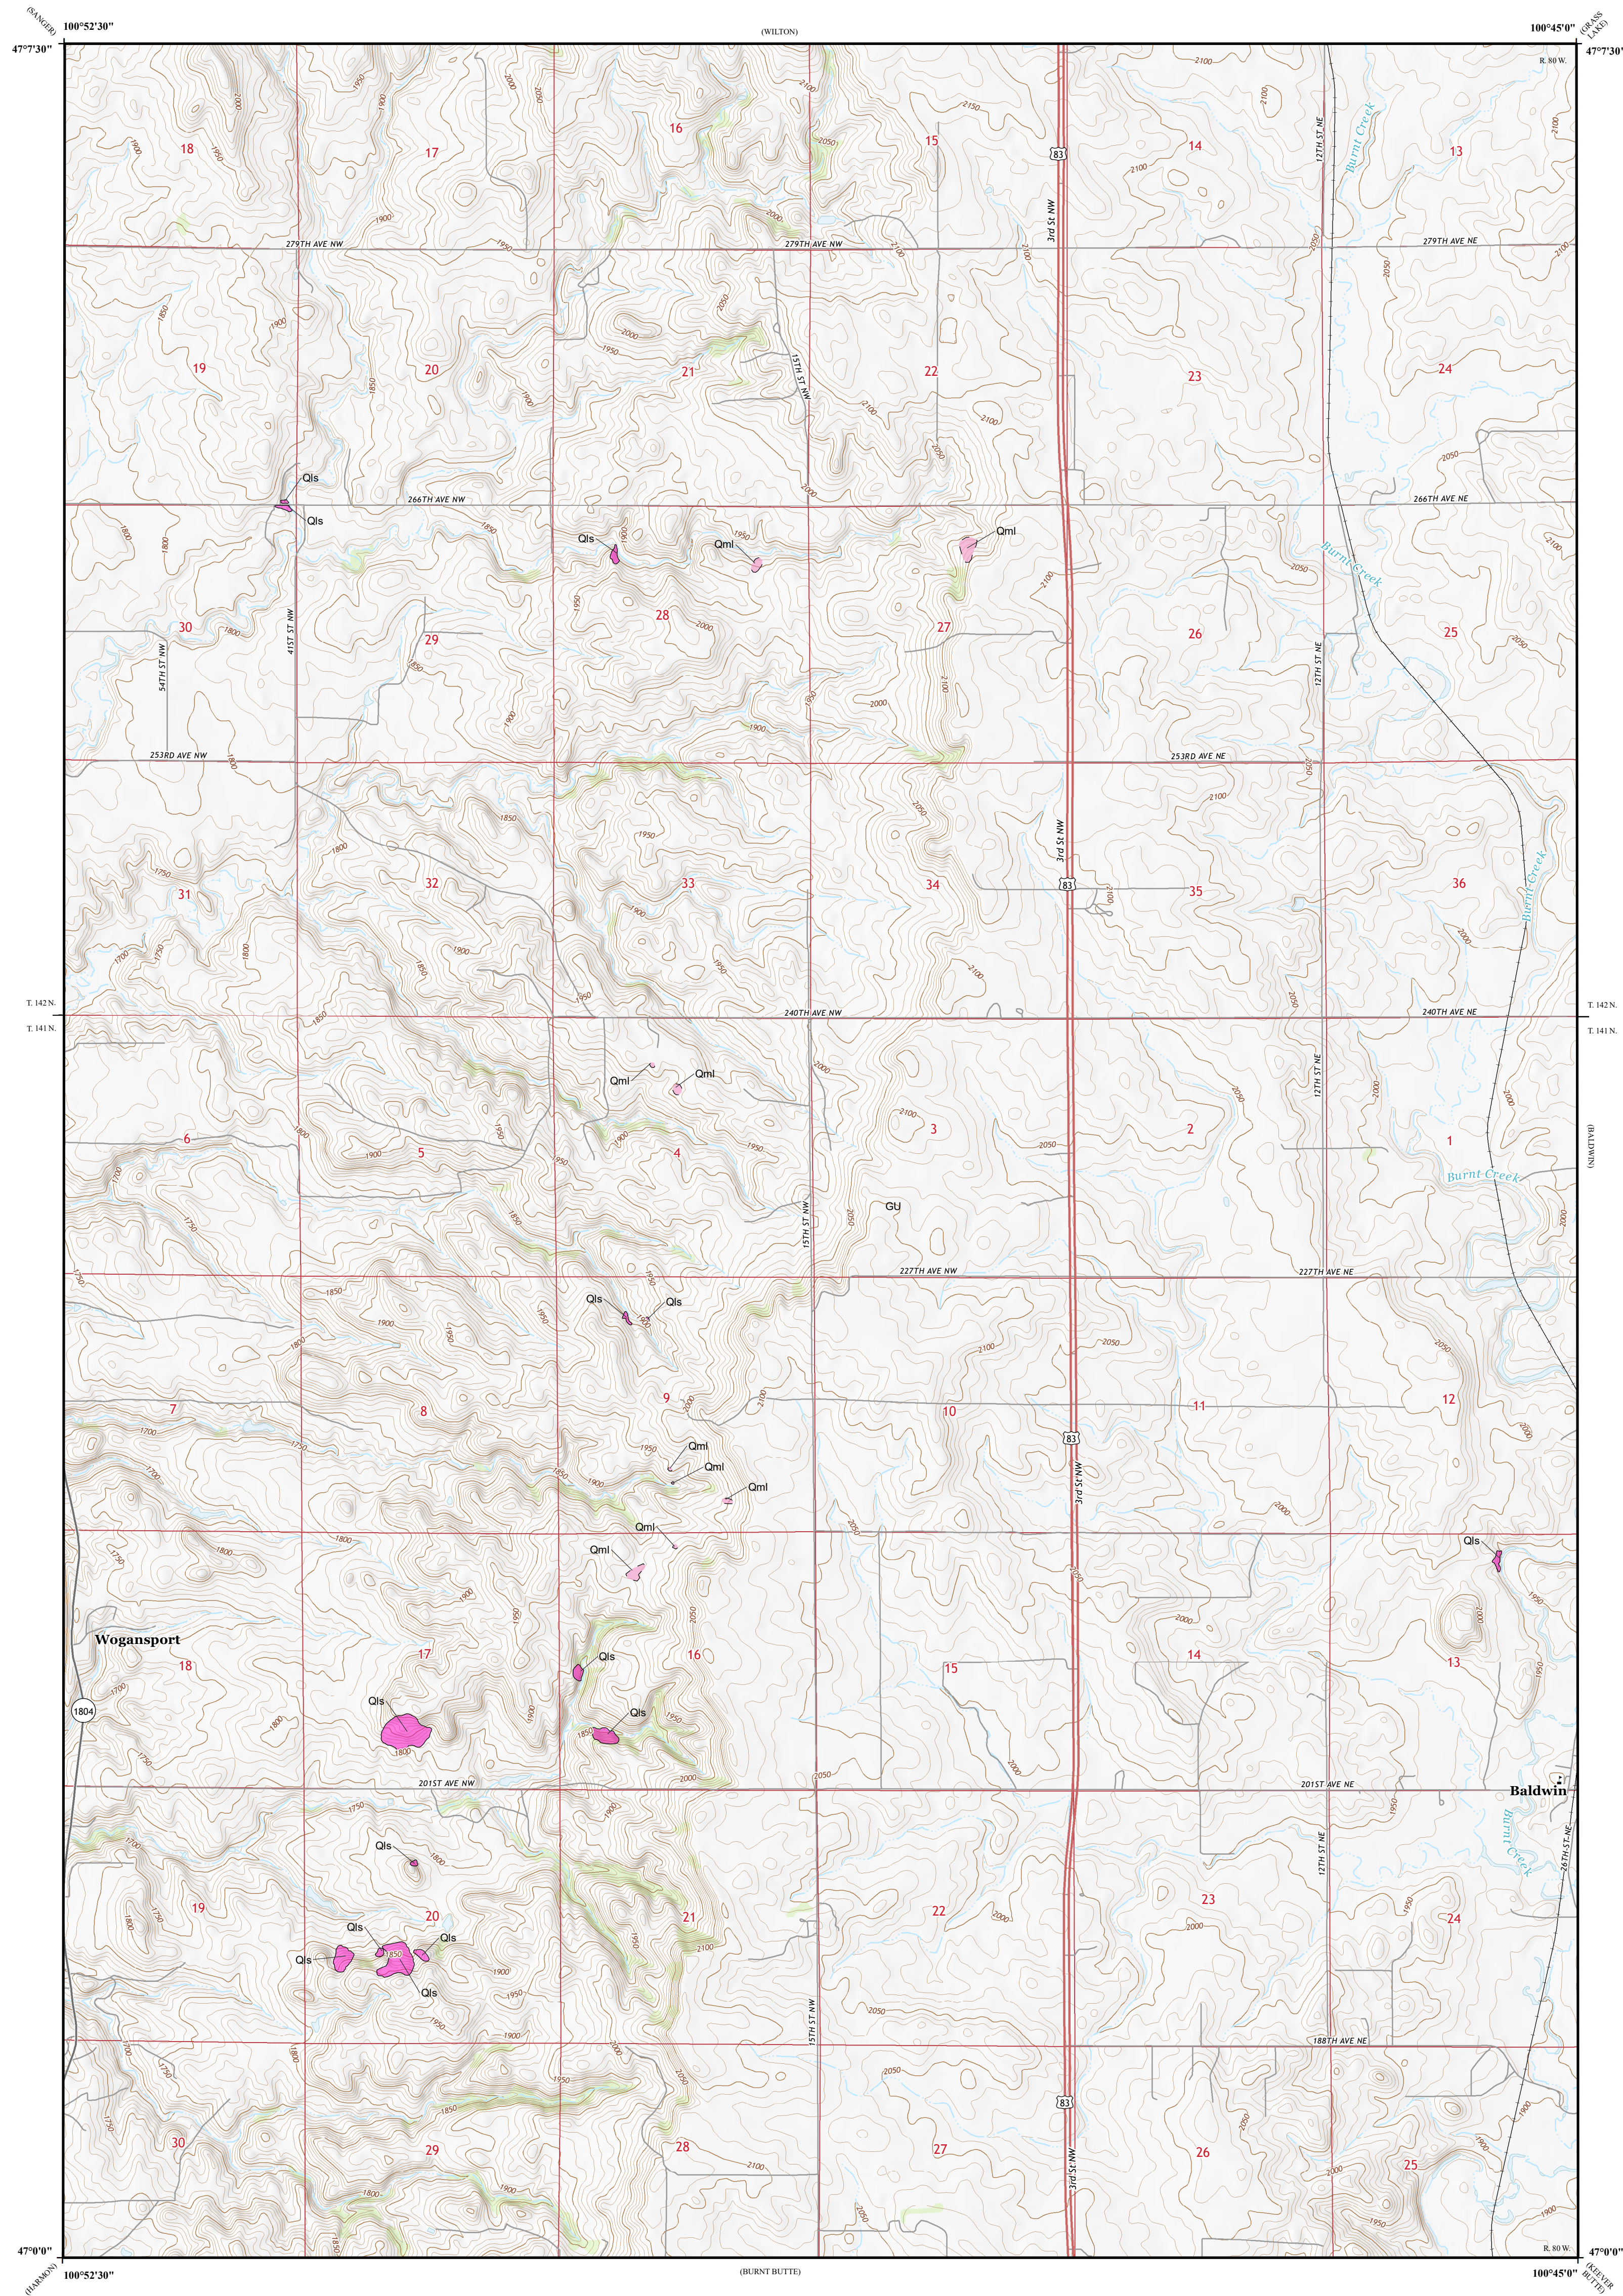
Landslides identified on this quadrangle were mapped from stereo pairs, black and white 1:20,000 scale aerial photographs flown in 1957 by the United States Department of Agriculture (USDA). Additional data sources include digital orthophotography from the USDA National Agriculture Imagery Program (NAIP) flown in September 2024 and the North Dakota Geological Survey LiDAR Map Series, which compiles raw data flown in November 2020 to May 2024 from the North Dakota State Water Commission.

Scale 1:24,000  
0 0.5 1  
Miles  
Lambert Conformal Conic Projection  
North American 1983 Datum  
USGS 7.5 Minute Topo Map  
Standard Parallels 47°00'N, 47°7'30"N  
NGVD 1988  
Contour Interval 10 Feet
