A HIGHLIGHT OF ENGINEERING GEOLOGIC ISSUES IN FARGO, NORTH DAKOTA

By Fred J. Anderson

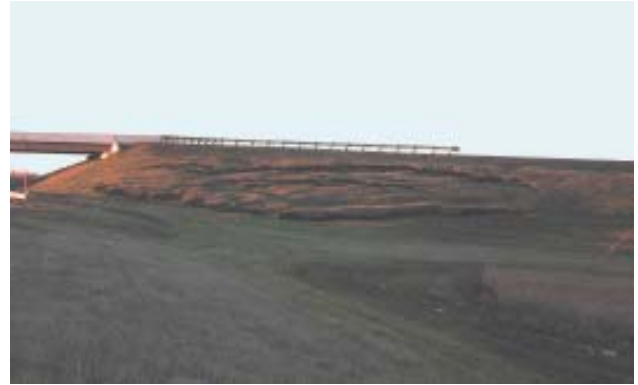
Figure 1. Failure of engineered fill soils on the eastern ramp of the Business Hwy 94 overpass just west of the City of West Fargo. Failure occurred after recent heavy rainfall in the area during the fall of 2004 (Photo by Anderson).

The application of geology to the supporting factors of engineered works is the sub-discipline of geology known as Engineering Geology. Engineering Geology is an applied facet of the science of geology. The engineering geologist seeks to investigate, understand, predict, and communicate the relationships between particular geological aspects of an area, region, or site, that bear consideration on the construction of engineered works such as roads, bridges, foundations, and buildings (Figure 1).

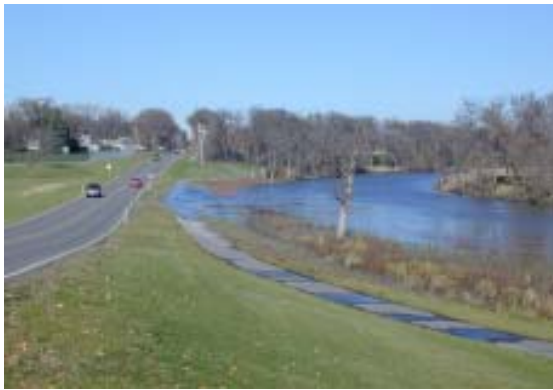
Figure 2. View to the north along North Elm Street in Fargo. High water levels in the Red River encroaching upon local transportation routes (Photo by Anderson).

The Red River of the North incises this *relatively* featureless plain and periodically delivers a healthy amount of overbank fines to the area during seasonal flooding events (Figure 2).

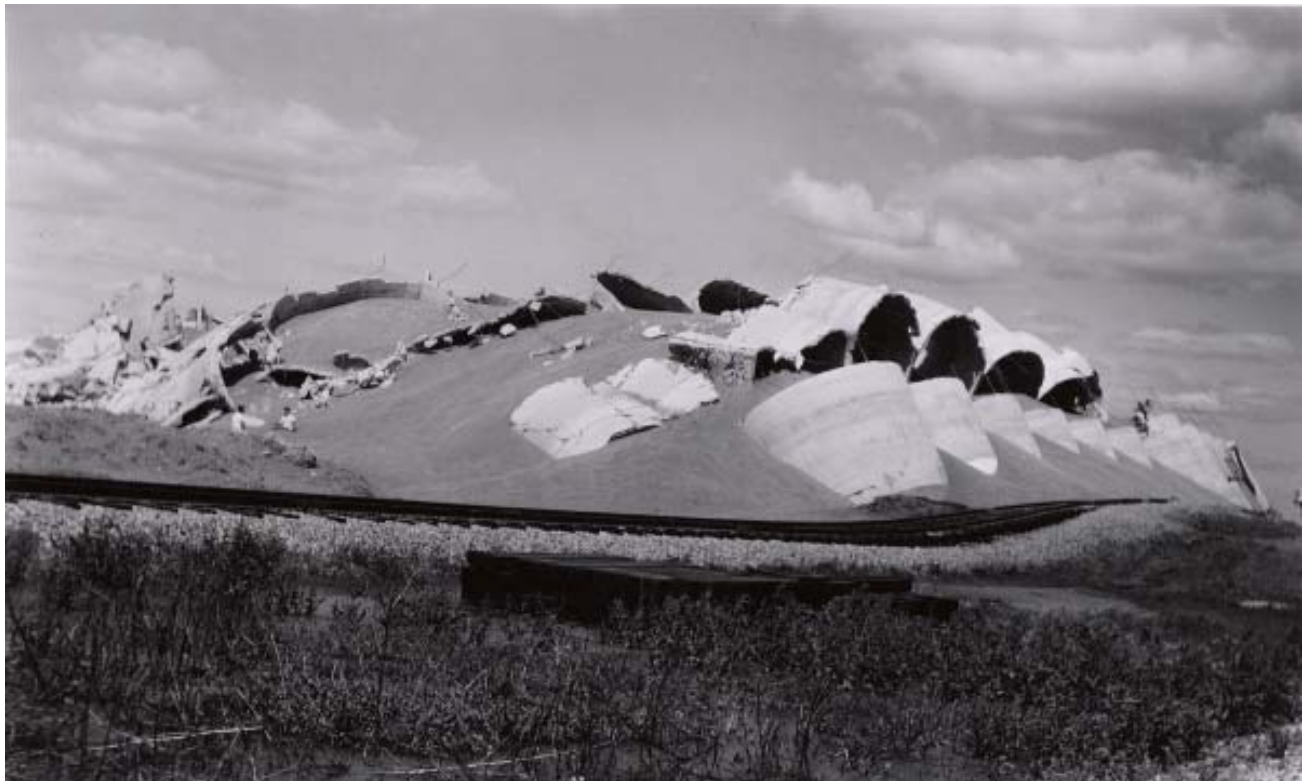
Figure 3. View of the collapsed Fargo Grain Elevator after subsurface soil failure in 1955. (Photo from the Institute for Regional Studies, NDSU, Fargo).

Elastic deformation of clay-rich soils has been documented throughout the Red River Valley. It has been shown that under certain cases of loading and unloading, such as in the construction, use, and subsequent failure of the Fargo grain elevator in 1955 (Figure 3), soils beneath the structure have been shown to deform in response to the increased load upon them, deforming as a consequence and resulting in an adverse structural effect. Upon removal of the load, these materials have been shown to restore to their previous condition.

Many structural failures have occurred due to the inherent weakness of clay-rich soils in the Red River Valley and their inability to accept uniform or differential loads. Three significant failures noted include the Transcona Elevator in Winnipeg, Manitoba, the Fargo Grain Elevator in 1955 and the failure of the NP railroad grade best chronicled by Schwert (1997).

These types of failures have occurred simply by the overloading of unstable foundation soils in the subsurface, which deformed through compaction under increasing loads with further expansion of materials around the structures (much like placing a brick in a box of mud).

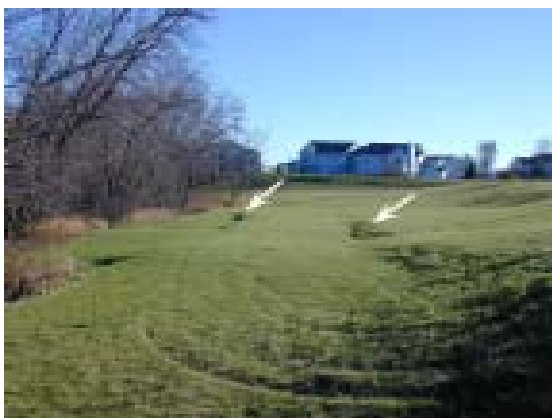
Figure 4. View to the south along the eastern bank of the Red River depicting earthflow, soil slumping, and bank failure near residential developments in north Fargo. Note the subvertical orientation of trees and presence of developing scarps in the foreground (Photo by Anderson).

Mass movements of unstable soils within the Fargo area have also been extensively documented by Harris, (2003) and Schwert, (2003). It has been noted that failures of materials along the banks of the Red River are persistent and common and are related to the inherent instability of underlying Brenna Formation sediments undergoing plastic deformation in the subsurface with the resultant block failure of overlying Sherack and recent alluvial sediments (Figures 4 & 5).

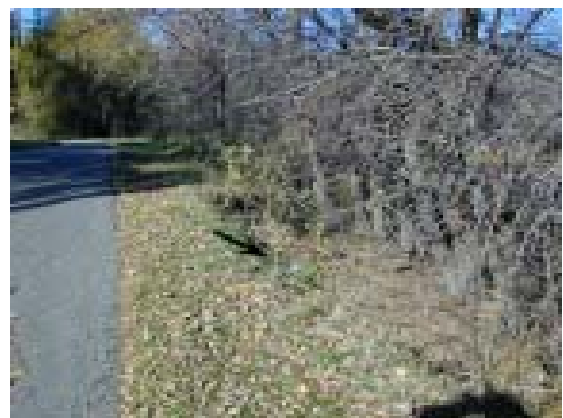
Figure 5. View to the north of failed cutbank along a meander of the Red River in north Fargo. Note the presence of a well defined failure scarp and the subvertical orientation of nearby trees (Photo by Anderson).
