CLINKER (“SCORIA”) AS ROAD SURFACING MATERIAL IN WESTERN NORTH DAKOTA

EDWARD C. MURPHY

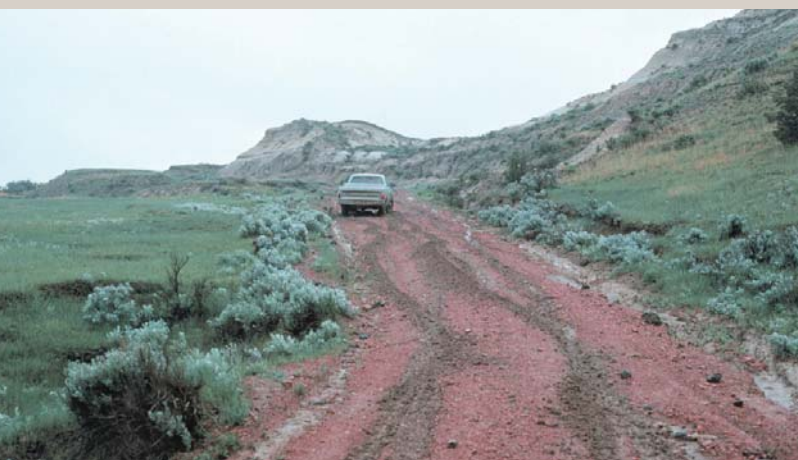
Figure 1. A NDGS pickup truck struggles for traction on East River Road south of Medora in 1982. I had to back down the wet clinker road and put on tire chains.

The reddish roads and red-mud-caked pickup trucks are part of the fabric of the western North Dakota landscape. However, anyone who has ever slipped and slid on a wet clinker road, generated a massive red cloud of dust on a dry clinker road, had their tires cut to pieces while driving on a newly surfaced clinker road, or bounced across washboard grooves on a well-worn clinker road may have a hard time seeing the romantic side of this road surfacing material. That some clinker can start out razor sharp and wear down relatively quickly to a powder illustrates the relative shortcoming of this rock as a road material (fig. 1).

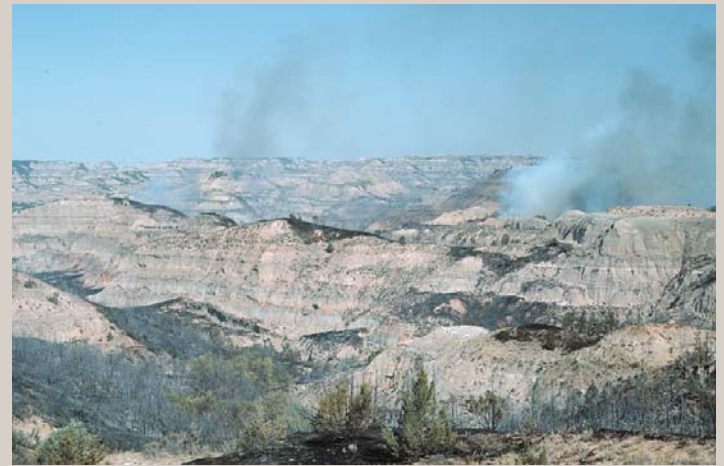
Figure 2. A brief summer storm that contained intense lightning started a number of fires in central Billings County (Buck Hill, Mikes Creek, Ash Coulee, etc.) in July 1988.

phenomenon was witnessed when the Buck Hill, Mikes Creek, and Ash Coulee fires of 1988, the Halloween “Gap” Fire of 1999, and the Deep Creek Fire of 2007 each ignited a number of lignite beds that burned for a number of years (figs. 2 and 3). The Gap Fire started an estimated 30 coal seam fires and at least \$64,000 was spent suppressing some of those burning seams (Bruce Beechie, 2012, ND Public Service Commission, personal communication).

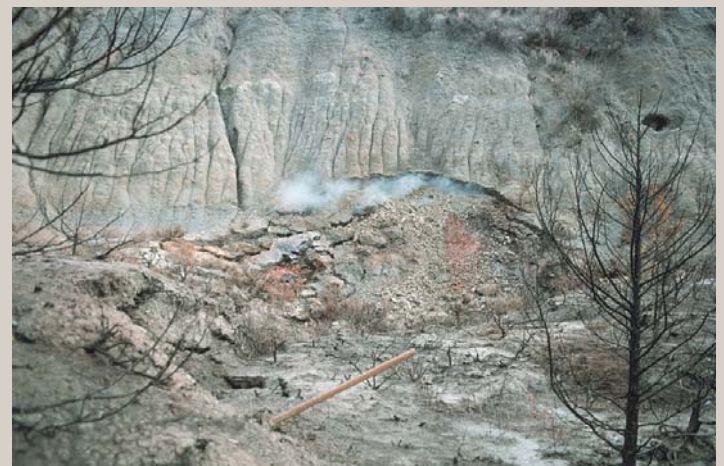
Figure 3. A burning coal seam ignited by the Buck Hill fire emits smoke and is baking the overlying rock as evidenced by scattered clinker. The picture was taken in December 1988; five months after the seam began burning.

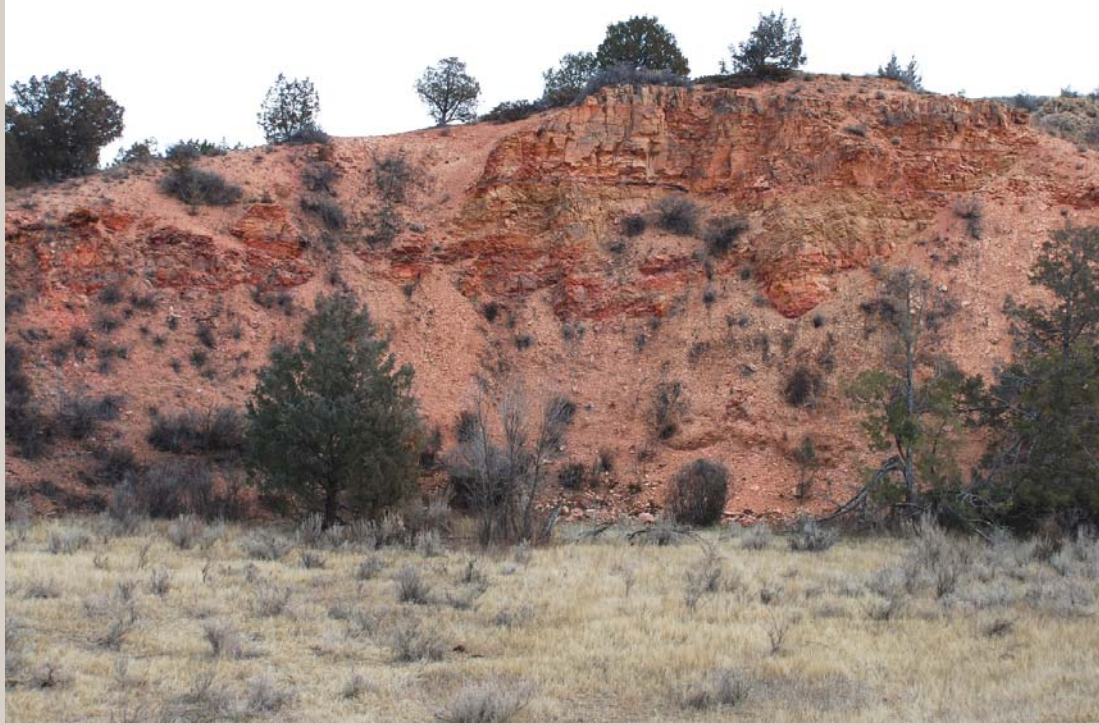
Figure 4. Thirty-five feet of clinker exposed along Deep Creek in Slope County, North Dakota.

While clinker may look very uniform and consistent when spread on a road or at first glance in outcrop, it typically is not (fig. 4). There are a number of variables that go into the creation of clinker including the original rock type, the intensity of the burn, and distance from the burning seam. Before it was baked, clinker consisted of alternating beds of claystone, mudstone, siltstone, sandstone, and lignite. The majority of clinker (60-80%) formed from fine-grained rocks (claystone, mudstone, and siltstone) because they are the most common rocks in the Fort Union Group and in a typical stratigraphic sequence they directly overlie the

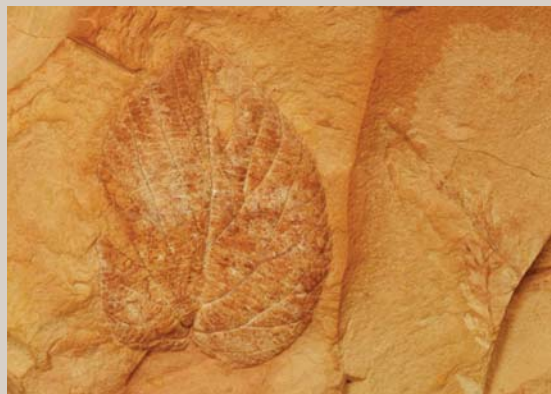
Figure 5. Fossil leaf preserved in clinker.

coal. At times the baking process fuses these lithologies into a nondescript red rock. At other times both large and small scale bedding features are left visually intact. This appears especially true when the original beds were siltstone or sandstone. The organics in clinker are typically baked away, but the molds of fossil leaves are sometimes well preserved (fig. 5).

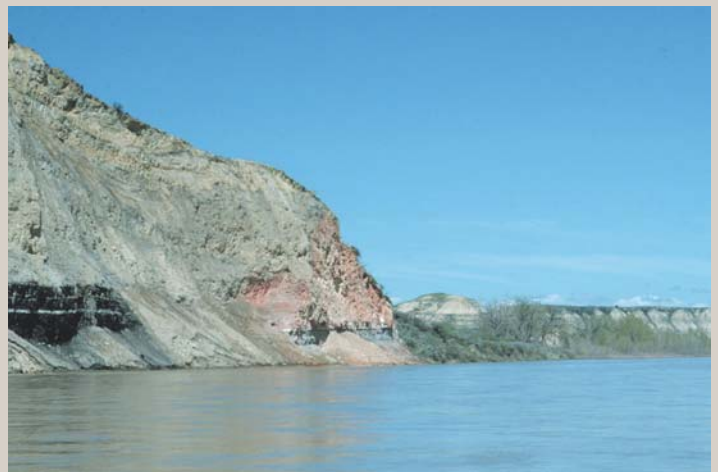
Figure 6. This lignite seam had burned along the right side of the outcrop and all that remains is a thin white ash layer visible at the base of the clinker. A white volcanic ash layer (tonstein) is visible in the upper one third of the coal seam on the left. Unfortunately, the contact between the unburned coal and the adjacent clinker is obscured by an apron of slopewash. Photograph taken from a canoe in June 1982 when the Little Missouri River was in floodstage.

An outcrop of a typical coal burn contains a thin white ash layer at the base which is often all that remains of the original coal bed (fig. 6). A ten-foot-thick lignite seam is typically reduced to a foot or two of ash. It is not uncommon to find multiple ash layers within a given clinker deposit where overlying coals were ignited by the burning of an underlying coal. It is often evident in outcrop that the base of the clinker has been subjected to the highest heat

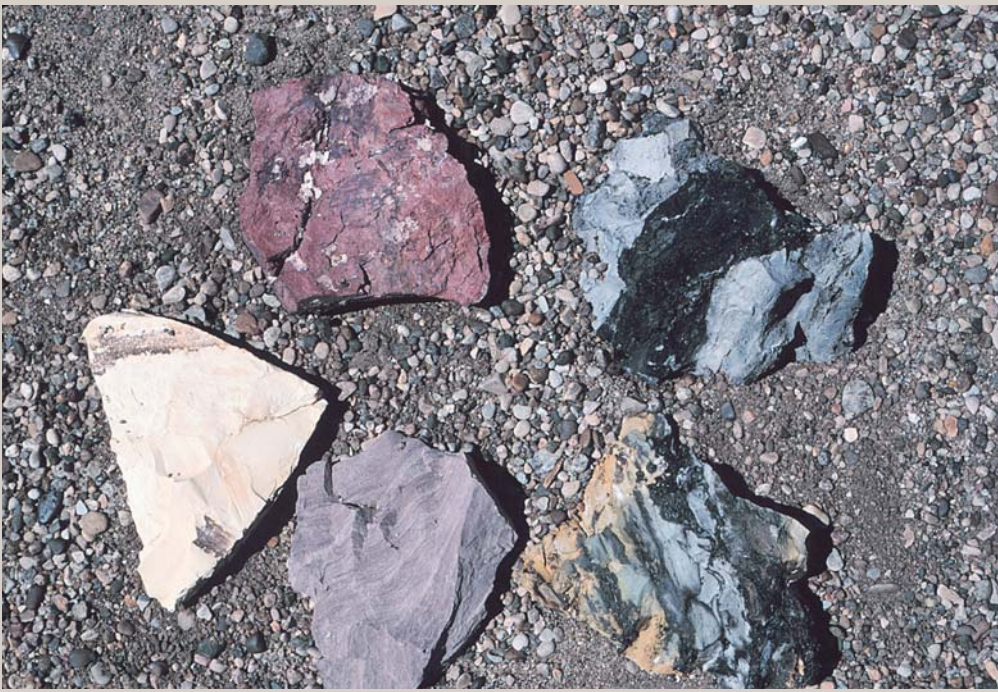
Figure 7. Examples of clinker from western North Dakota.

because it is typically highly fused – sometimes glassy, variously colored, and often vesicular (contains small voids) resembling true volcanic scoria (fig. 7). Although clinker occasionally comes in a variety of colors, the vast majority is reddish orange to reddish brown. As the plant manager of the Hebron Brick plant can attest to, if you place the green, blue, white, yellow, purple, brown, or gray clays of western North Dakota into a kiln and bake them, you invariably end up with a standard red brick. This explains why the vast majority of brick plants operating throughout North Dakota in the late 1800s and early 1900s produced red bricks that stand preserved today along the main streets of the state. The iron oxide content of the clay is primarily responsible for the red color of these bricks just as it is for the predominantly red color of the “naturally baked” clinker.

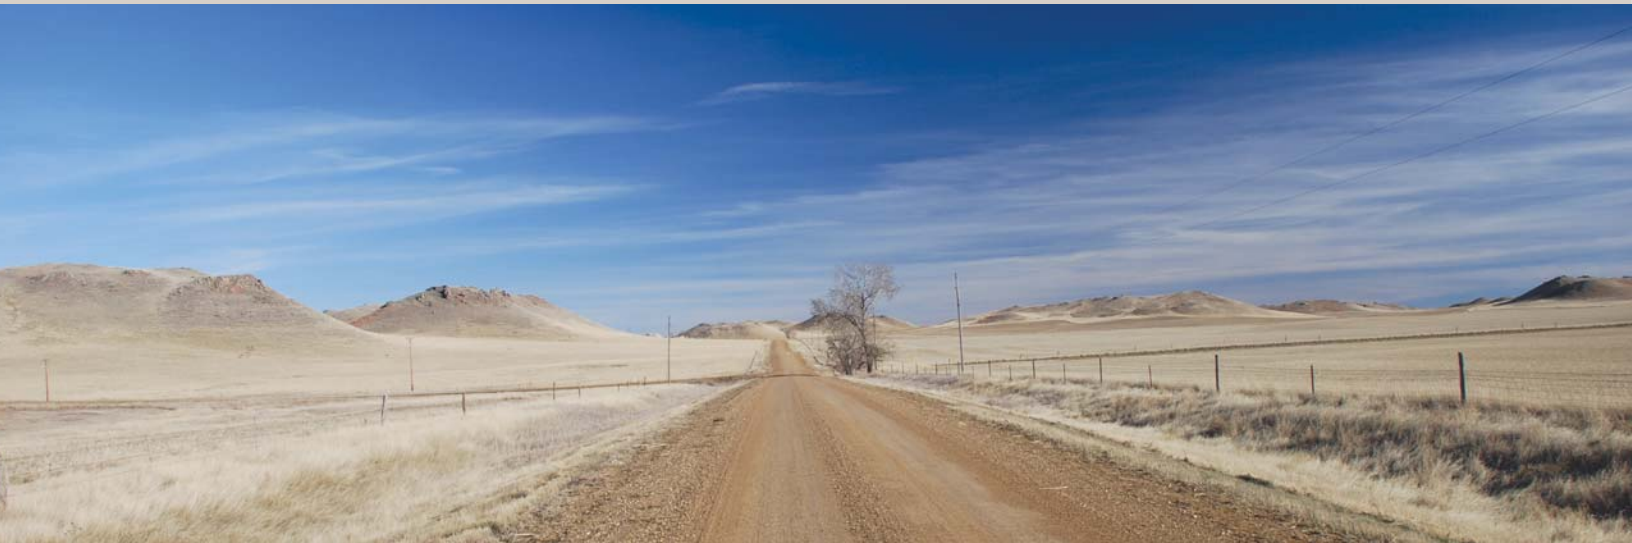
Figure 8. Harmon clinker capping hills and small buttes east of Deep Creek in Slope County.

buttes in western North Dakota. In these cases, the clinker caprock has protected the underlying softer rock (claystone, mudstone, siltstone, sandstone, and lignite) from the elements even as these surrounding rocks eroded away. The hardened or fused rock is also very susceptible to fracturing and is typically riddled with cracks and void spaces as prairie rattlesnakes discovered thousands of years ago. In some areas of western North Dakota, an individual coal seam is largely responsible for all of the clinker found in a given area. When that is the case, that clinker is very useful to geologists as a stratigraphic marker. For example, the Harmon coal burned over large areas of south-central Slope and north-central Bowman counties and the resulting clinker caps hills and buttes throughout this area (fig. 8).
