# Areas of Landslides

## Doaks Butte Quadrangle, North Dakota

Christopher A. Maike

2024

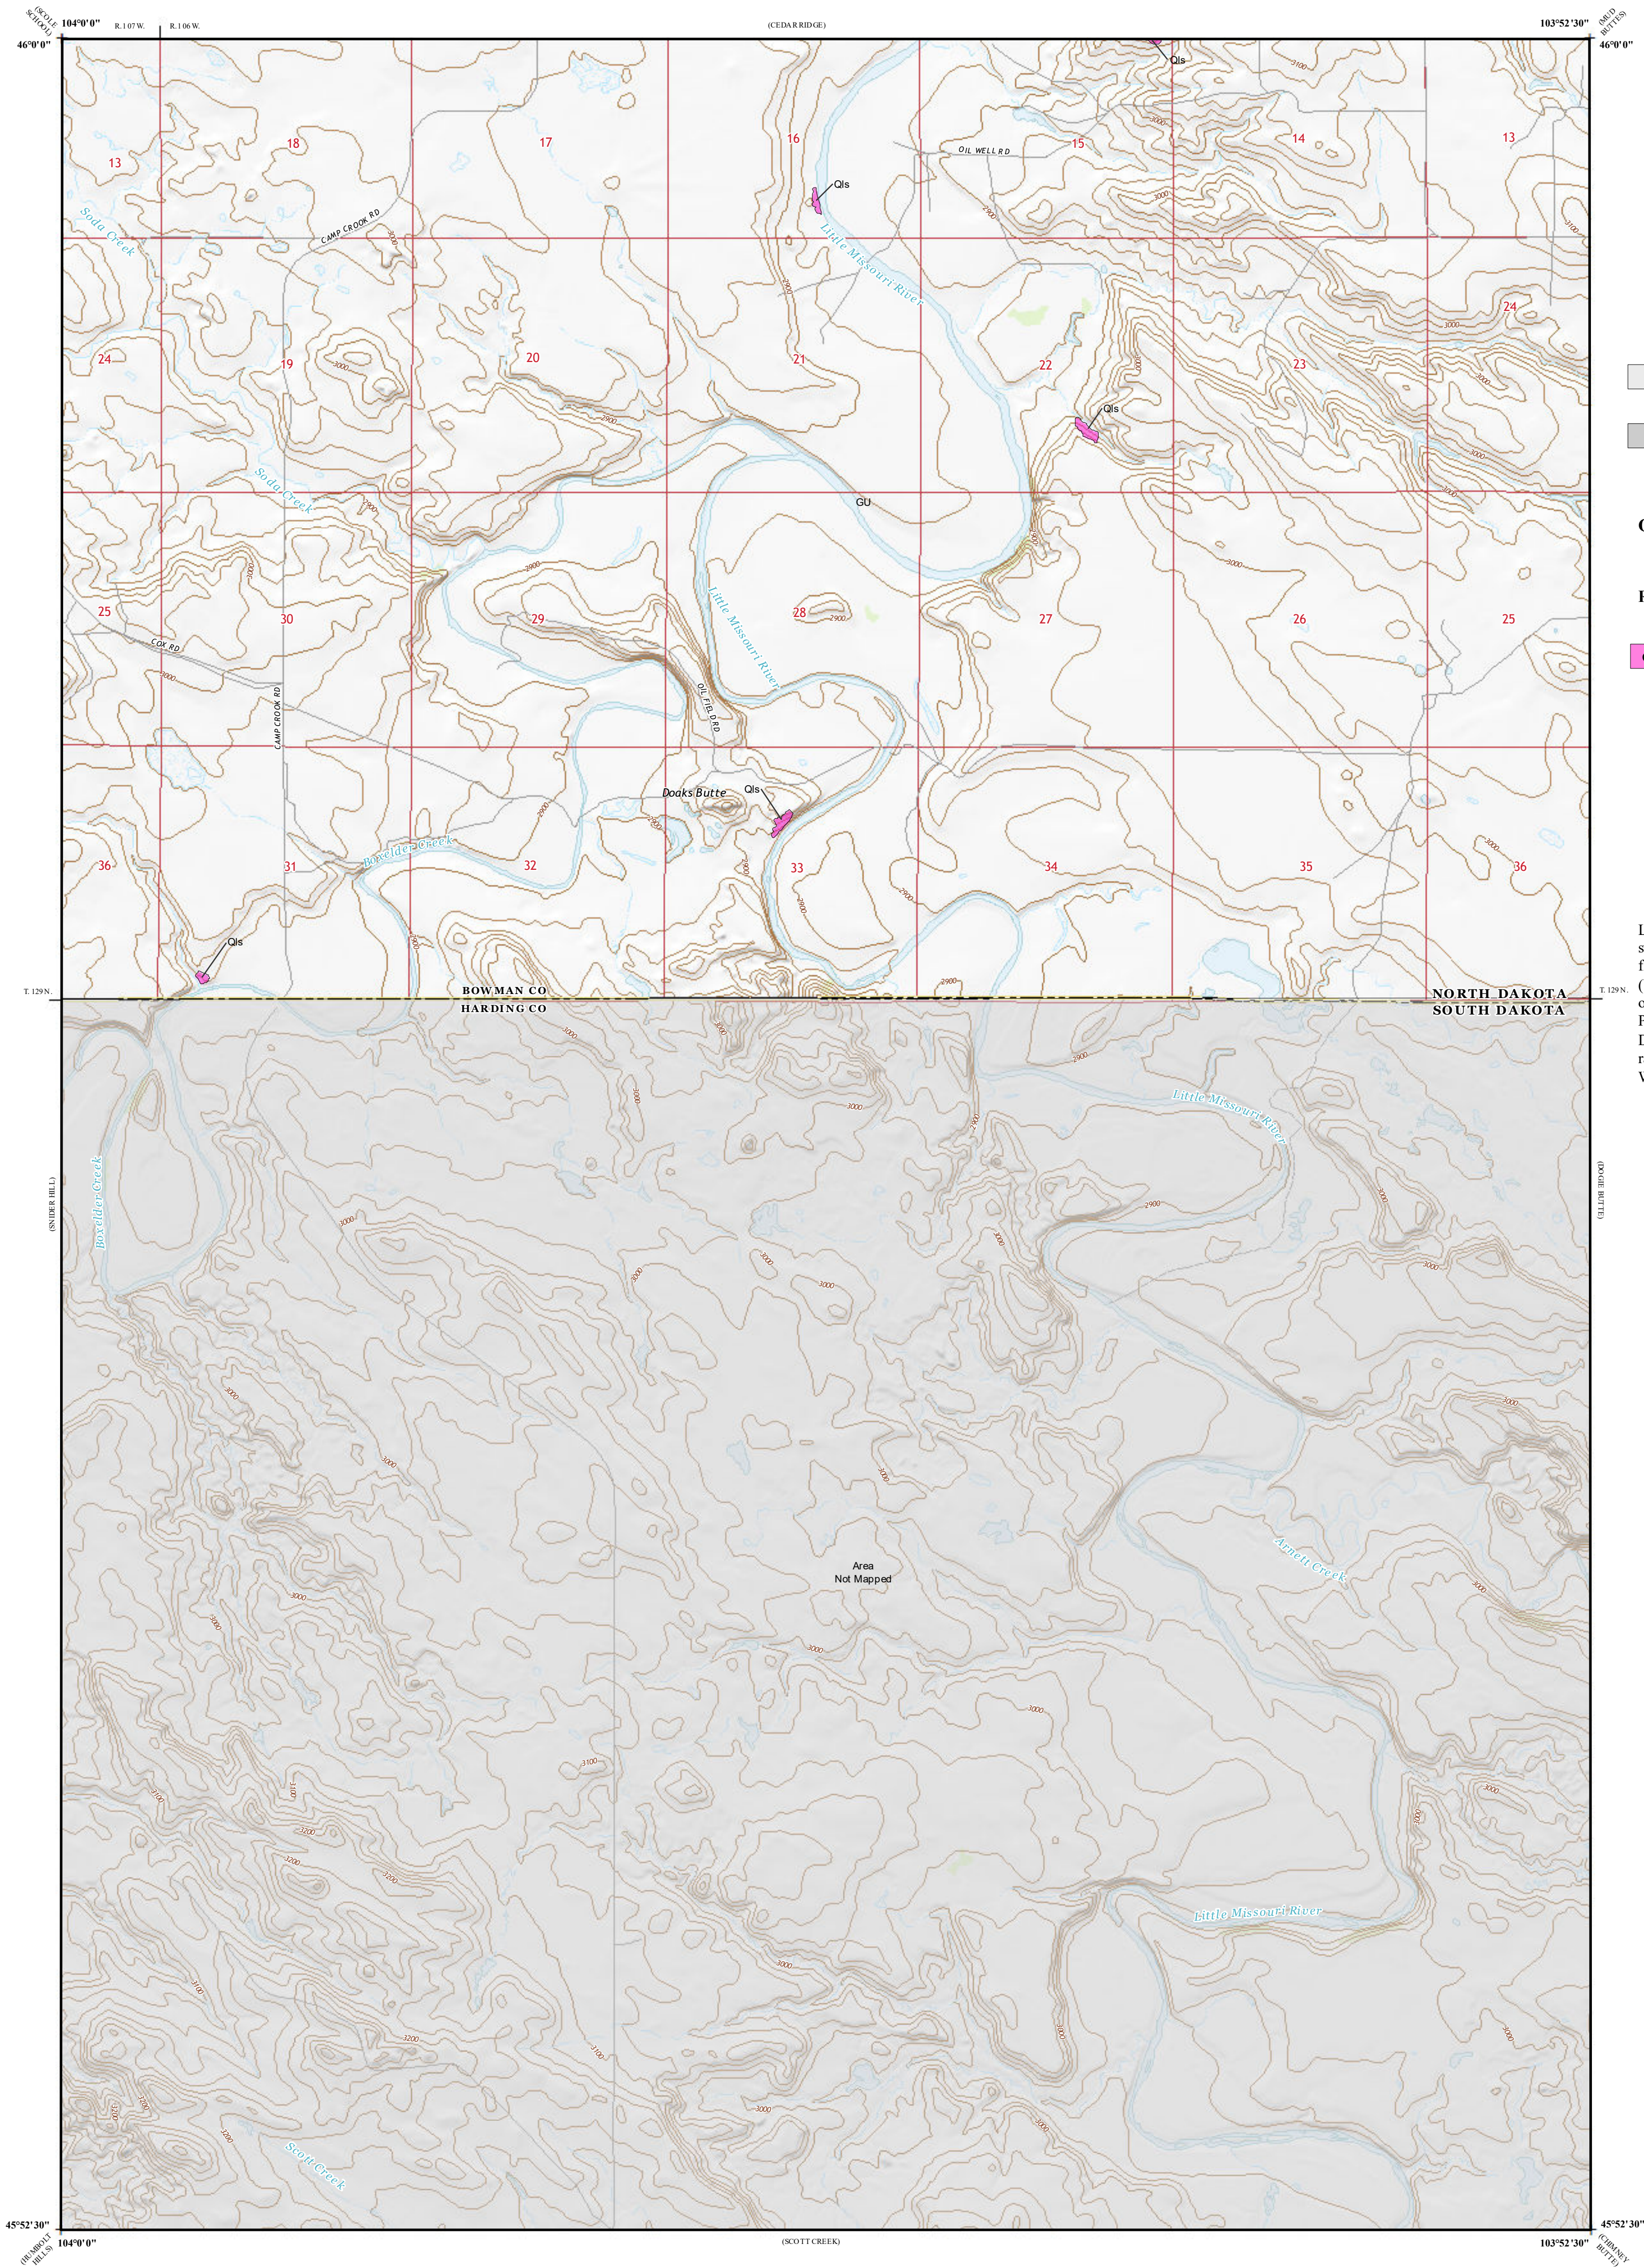
- Qls** Landslide Deposits
- A mass of material that has moved downslope. Includes earth flows, slumps, and areas of soil creep.

Landslides identified on this quadrangle were mapped from stereo pairs, black and white 1:20,000 scale aerial photographs flown in 1957 by the United States Department of Agriculture (USDA). Additional data sources include digital orthophotography from the USDA National Agriculture Imagery Program (NAIP) flown in July to August 2022 and the North Dakota Geological Survey LiDAR Map Series, which compiles raw data flown in November 2021 from the North Dakota State Water Commission.
