Areas of Landslides

Kenmare Quadrangle, North Dakota

Fred J. Anderson

2012

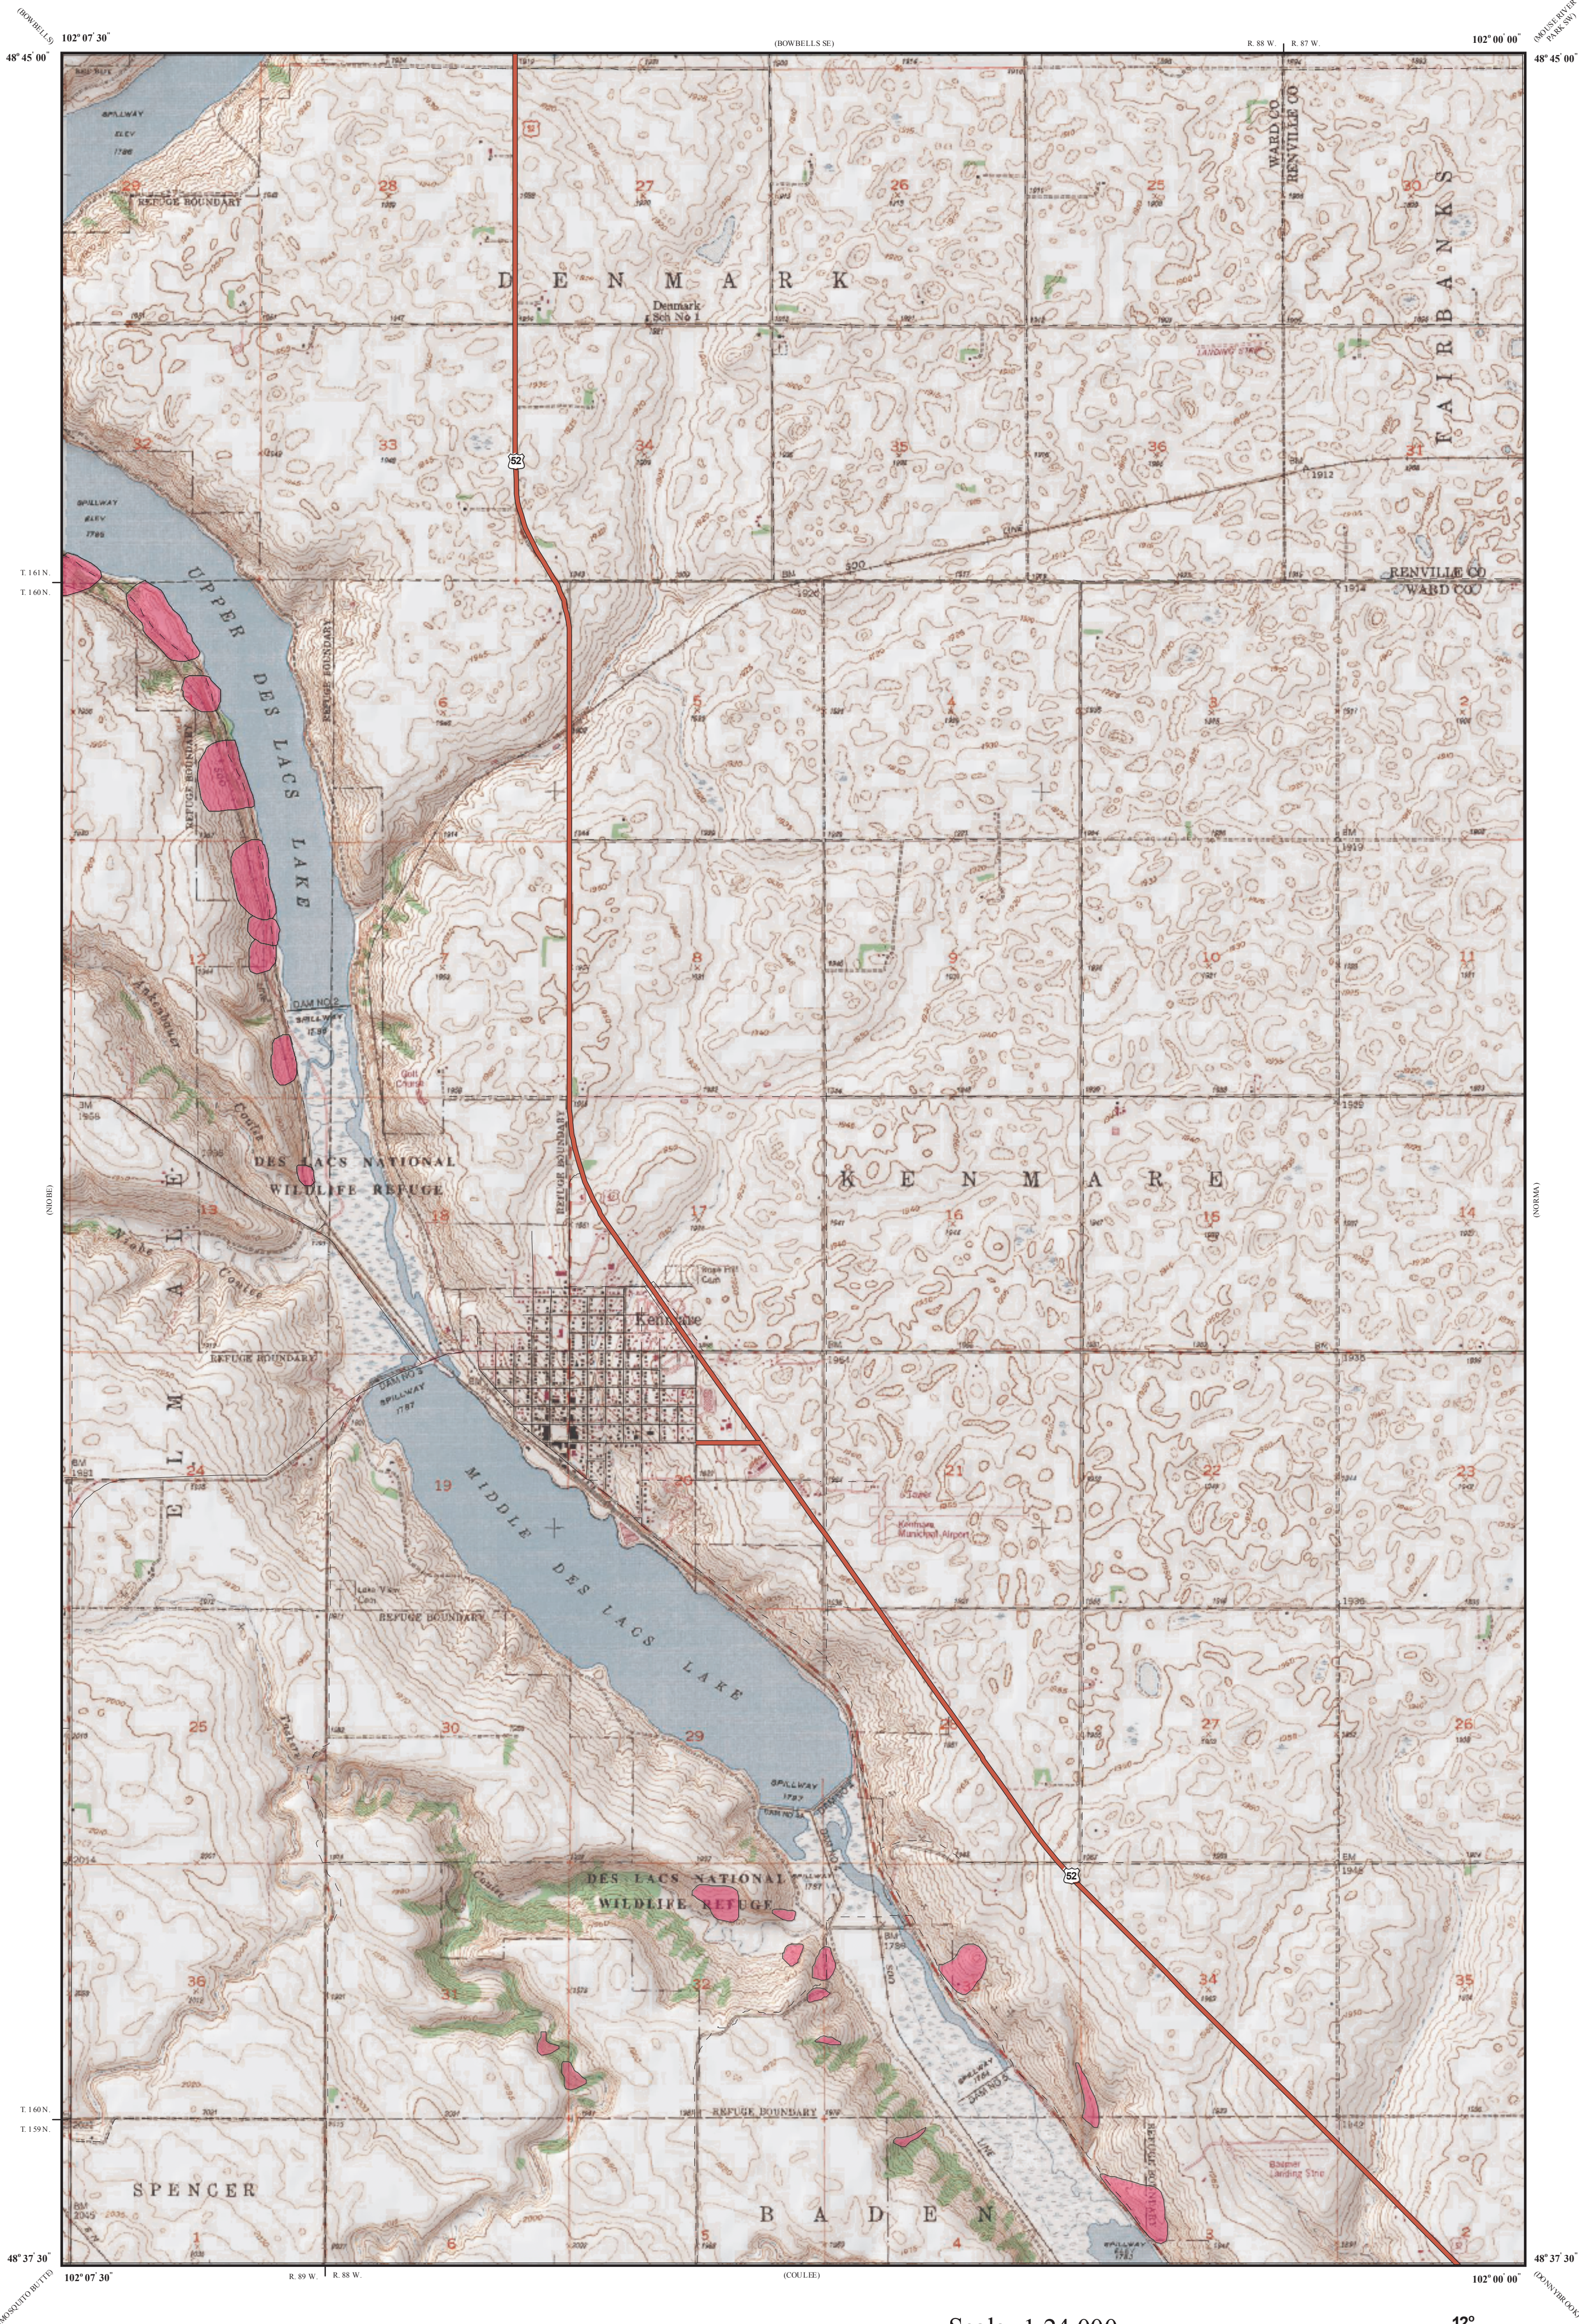
Landslides identified on the quadrangle were mapped from stereo pairs, black and white 1:20,000 scale aerial photographs flown between 6-21-58 and 9-7-58. As a result these maps can be used to identify areas that are vulnerable to slope failure, but are not an up to date assesment of all landslides for the area.
