Areas of Landslides

Kreiser Lake Quadrangle, North Dakota

Levi D. Moxness

2023

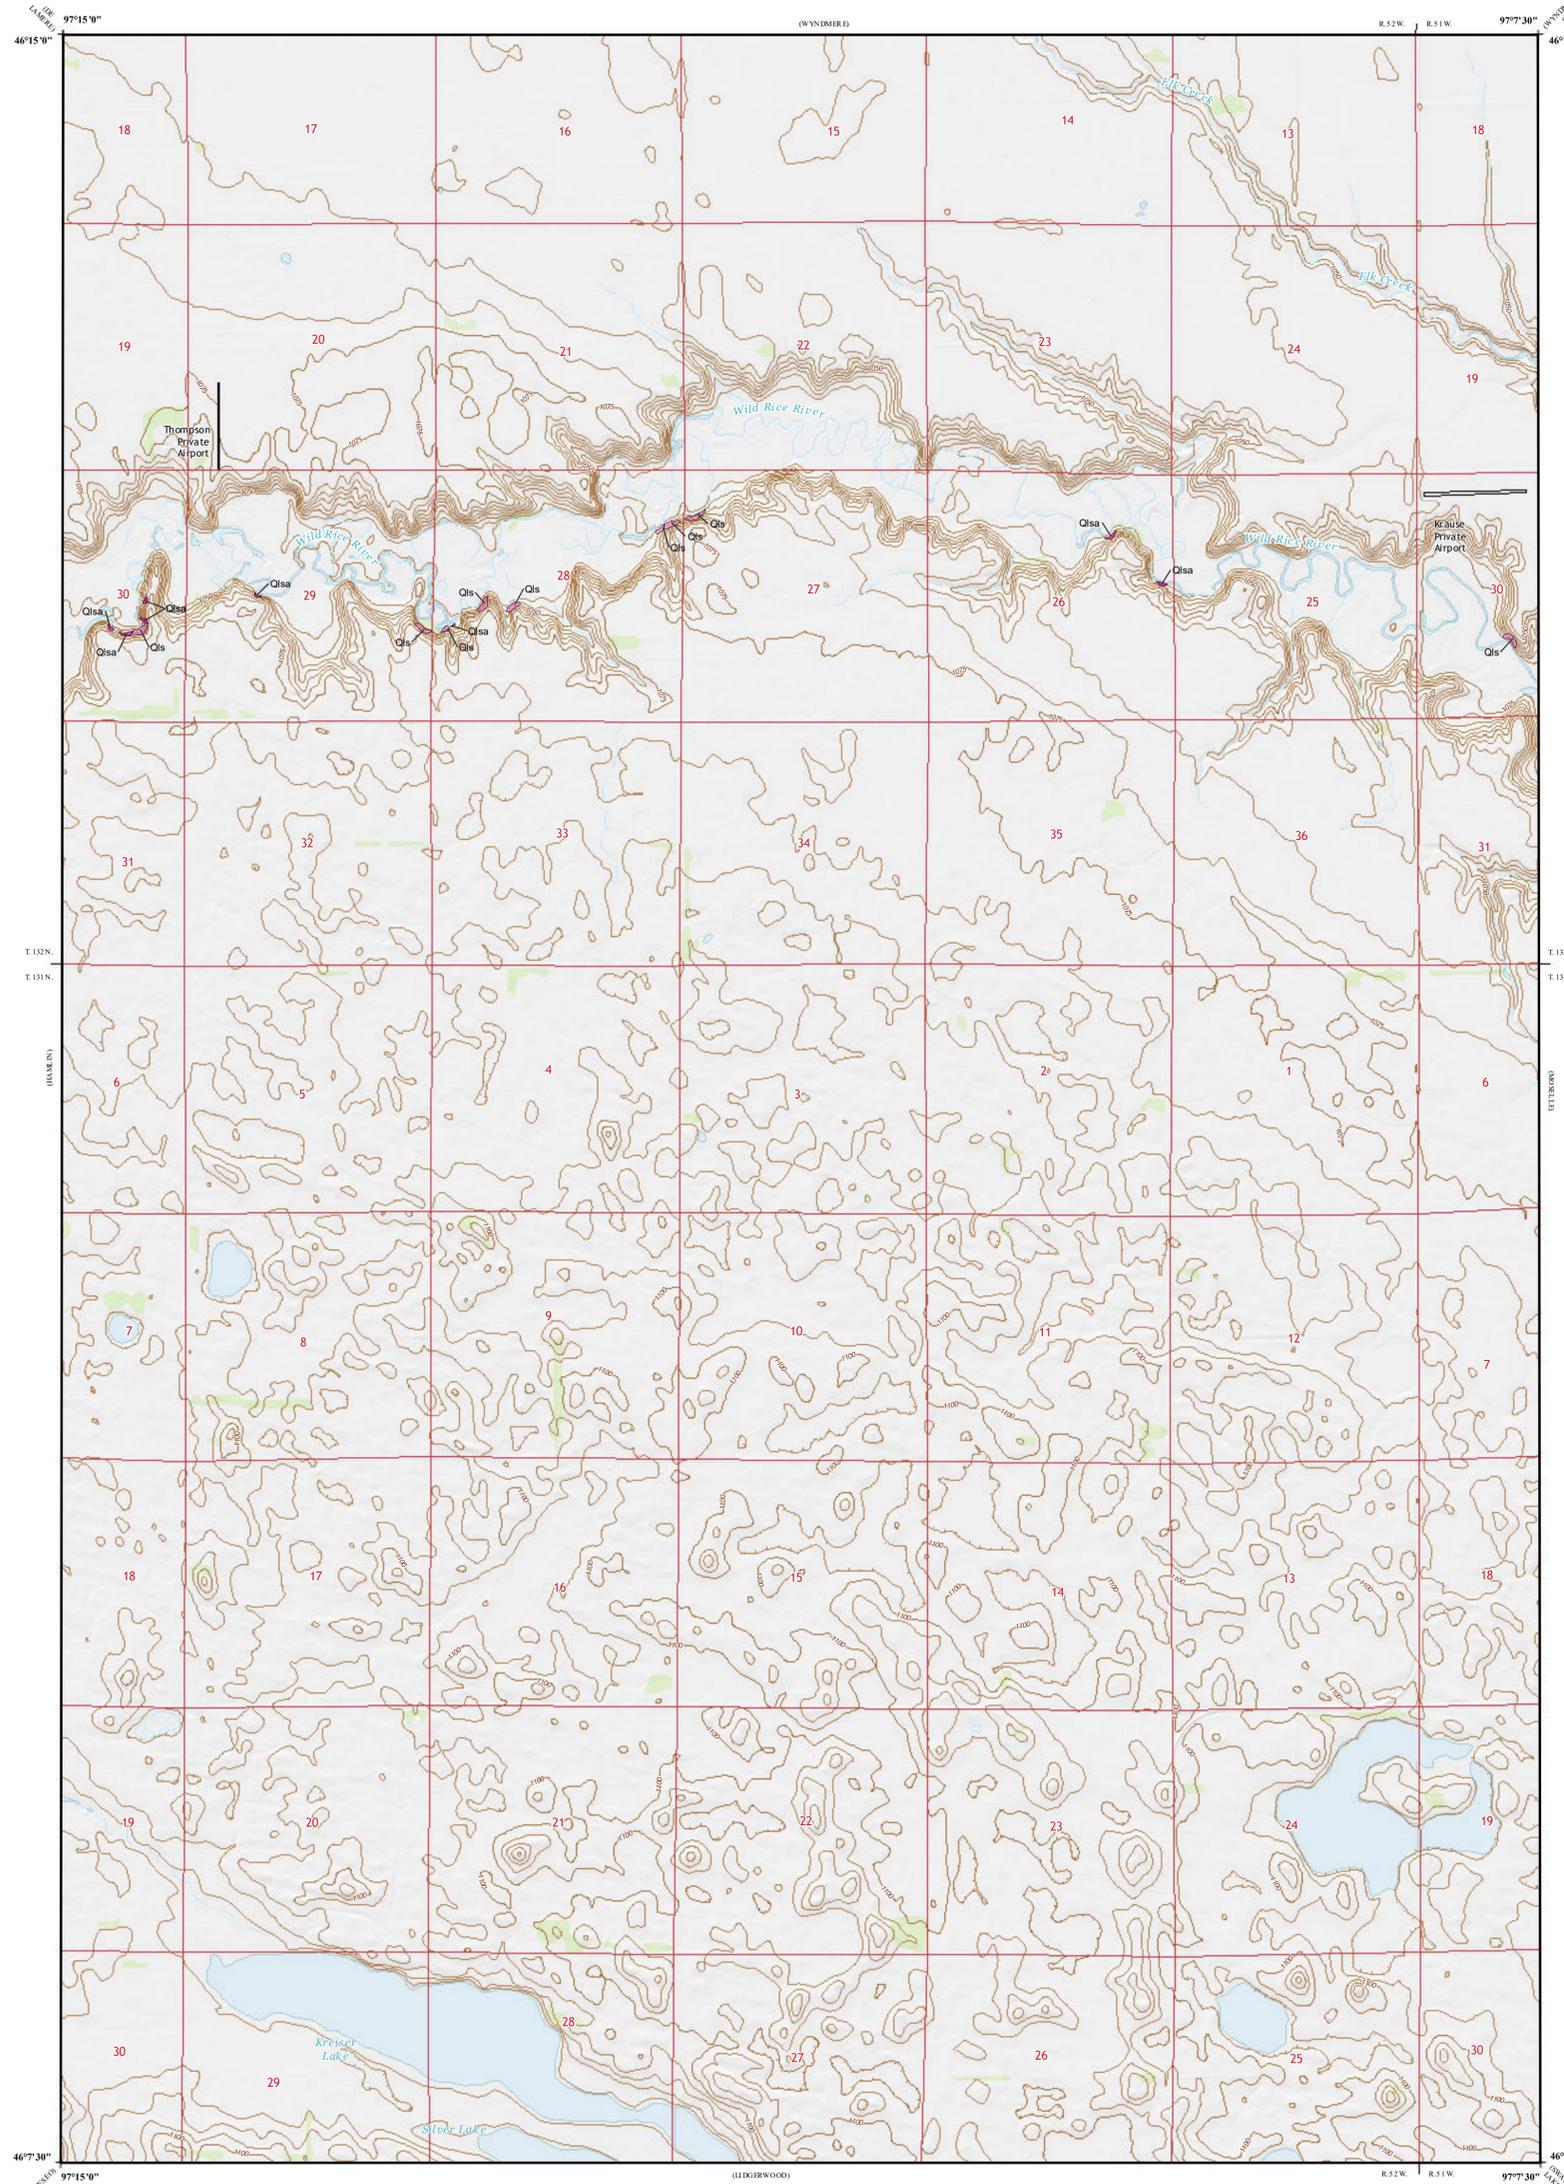
Kreiser Lake Quadrangle, North Dakota

Qlsa Areas of Recently Active Landslides

Landslide areas showing movement between 2008 and 2019.

Qls Landslide Deposits

A mass of material that has moved downslope. Includes earth flows, slumps, and areas of soil creep.

Landslides identified on this quadrangle were mapped from stereo pairs, black and white 1:20,000 scale aerial photographs flown in August to September 1952 by the United States Department of Agriculture (USDA). Additional data sources include digital orthophotography from the USDA National Agriculture Imagery Program (NAIP) flown in September 2021 and the North Dakota Geological Survey LiDAR Map Series, which compiles raw data flown in June 2019 from the North Dakota State Water Commission.

Areas of recently active landslides (Qlsa) mapped on this quadrangle were identified from changes between the 2008 and 2019 LiDAR elevation datasets observed on an elevation subtraction raster. Noise introduced from data precision (typically within a foot between the LiDAR datasets) is removed on this raster by excluding the signal from elevation change in the +/- 1 foot interval. Geologists interpret areas of landslide movement in geomorphic context (typically a decrease in elevation near a landslide headscarp paired with an increase in elevation downslope near the toe) and delineate those areas within the larger landslide dataset. Landslides not identified as recently active may have also experienced movement relatively recently, but did not show discernable signs of movement during the 2008 to 2019 window between LiDAR collects.

Slope Failure Statistical Summary				
Map Unit	No. of Landslides	Mapped Landslide Area		Map Area %
		acres	m ²	
Total Landslides (Qls & Qlsa)	17	8	32,635	0.02
Recently Active Landslides (Qlsa)	8	2	6,922	0.005

21.2% of the mapped landslide area was active between 2008 and 2020
