# Areas of Landslides

## Cedar Lake Quadrangle, North Dakota

Christopher A. Maike  
&  
Levi D. Moxness

2025

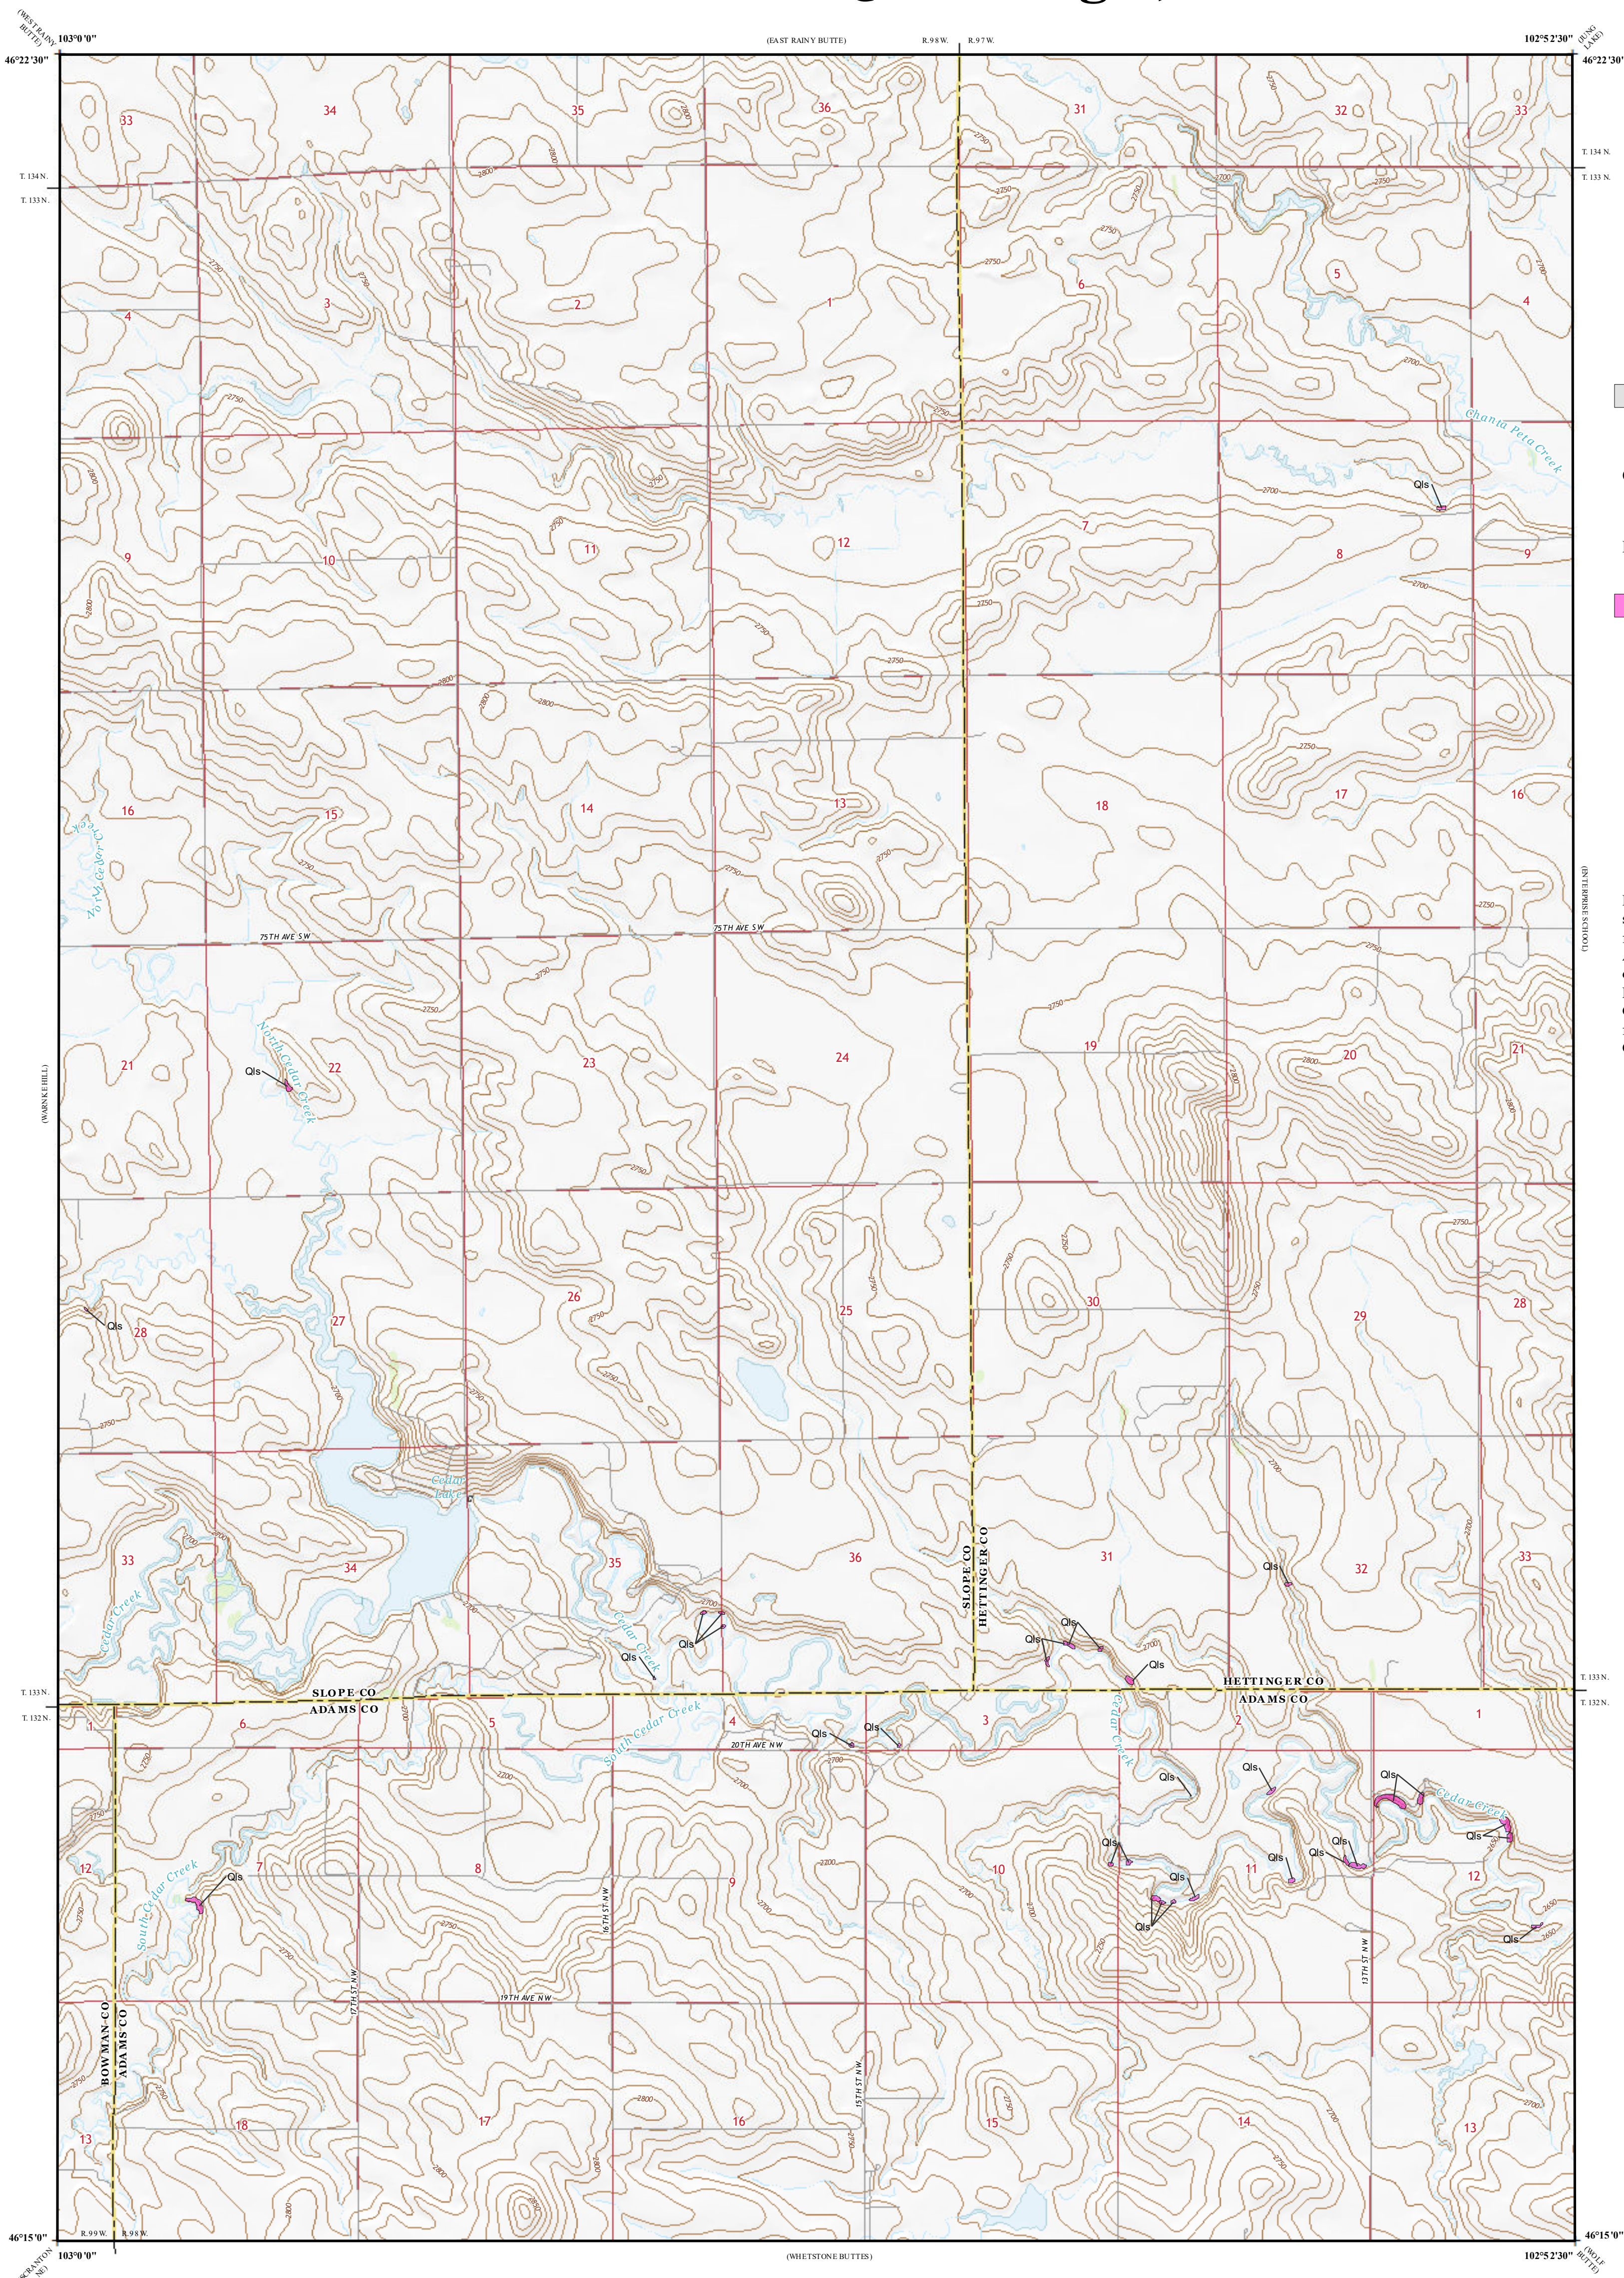
Cedar Lake Quadrangle, North Dakota

Qls Landslide Deposits

A mass of material that has moved downslope. Includes earth flows, slumps, and areas of soil creep.

Landslides identified on this quadrangle were mapped from stereo pairs, black and white 1:20,000 scale aerial photographs flown in July 1957 by the United States Department of Agriculture (USDA). Additional data sources include digital orthophotography from the USDA National Agriculture Imagery Program (NAIP) flown in August 2022 and the North Dakota Geological Survey LiDAR Map Series, which compiles raw data flown in November 2021 from the North Dakota State Water Commission.
