# Areas of Landslides

## Gamache Creek Quadrangle, North Dakota

Jordan R. Dahle  
&  
Fred J. Anderson

2026

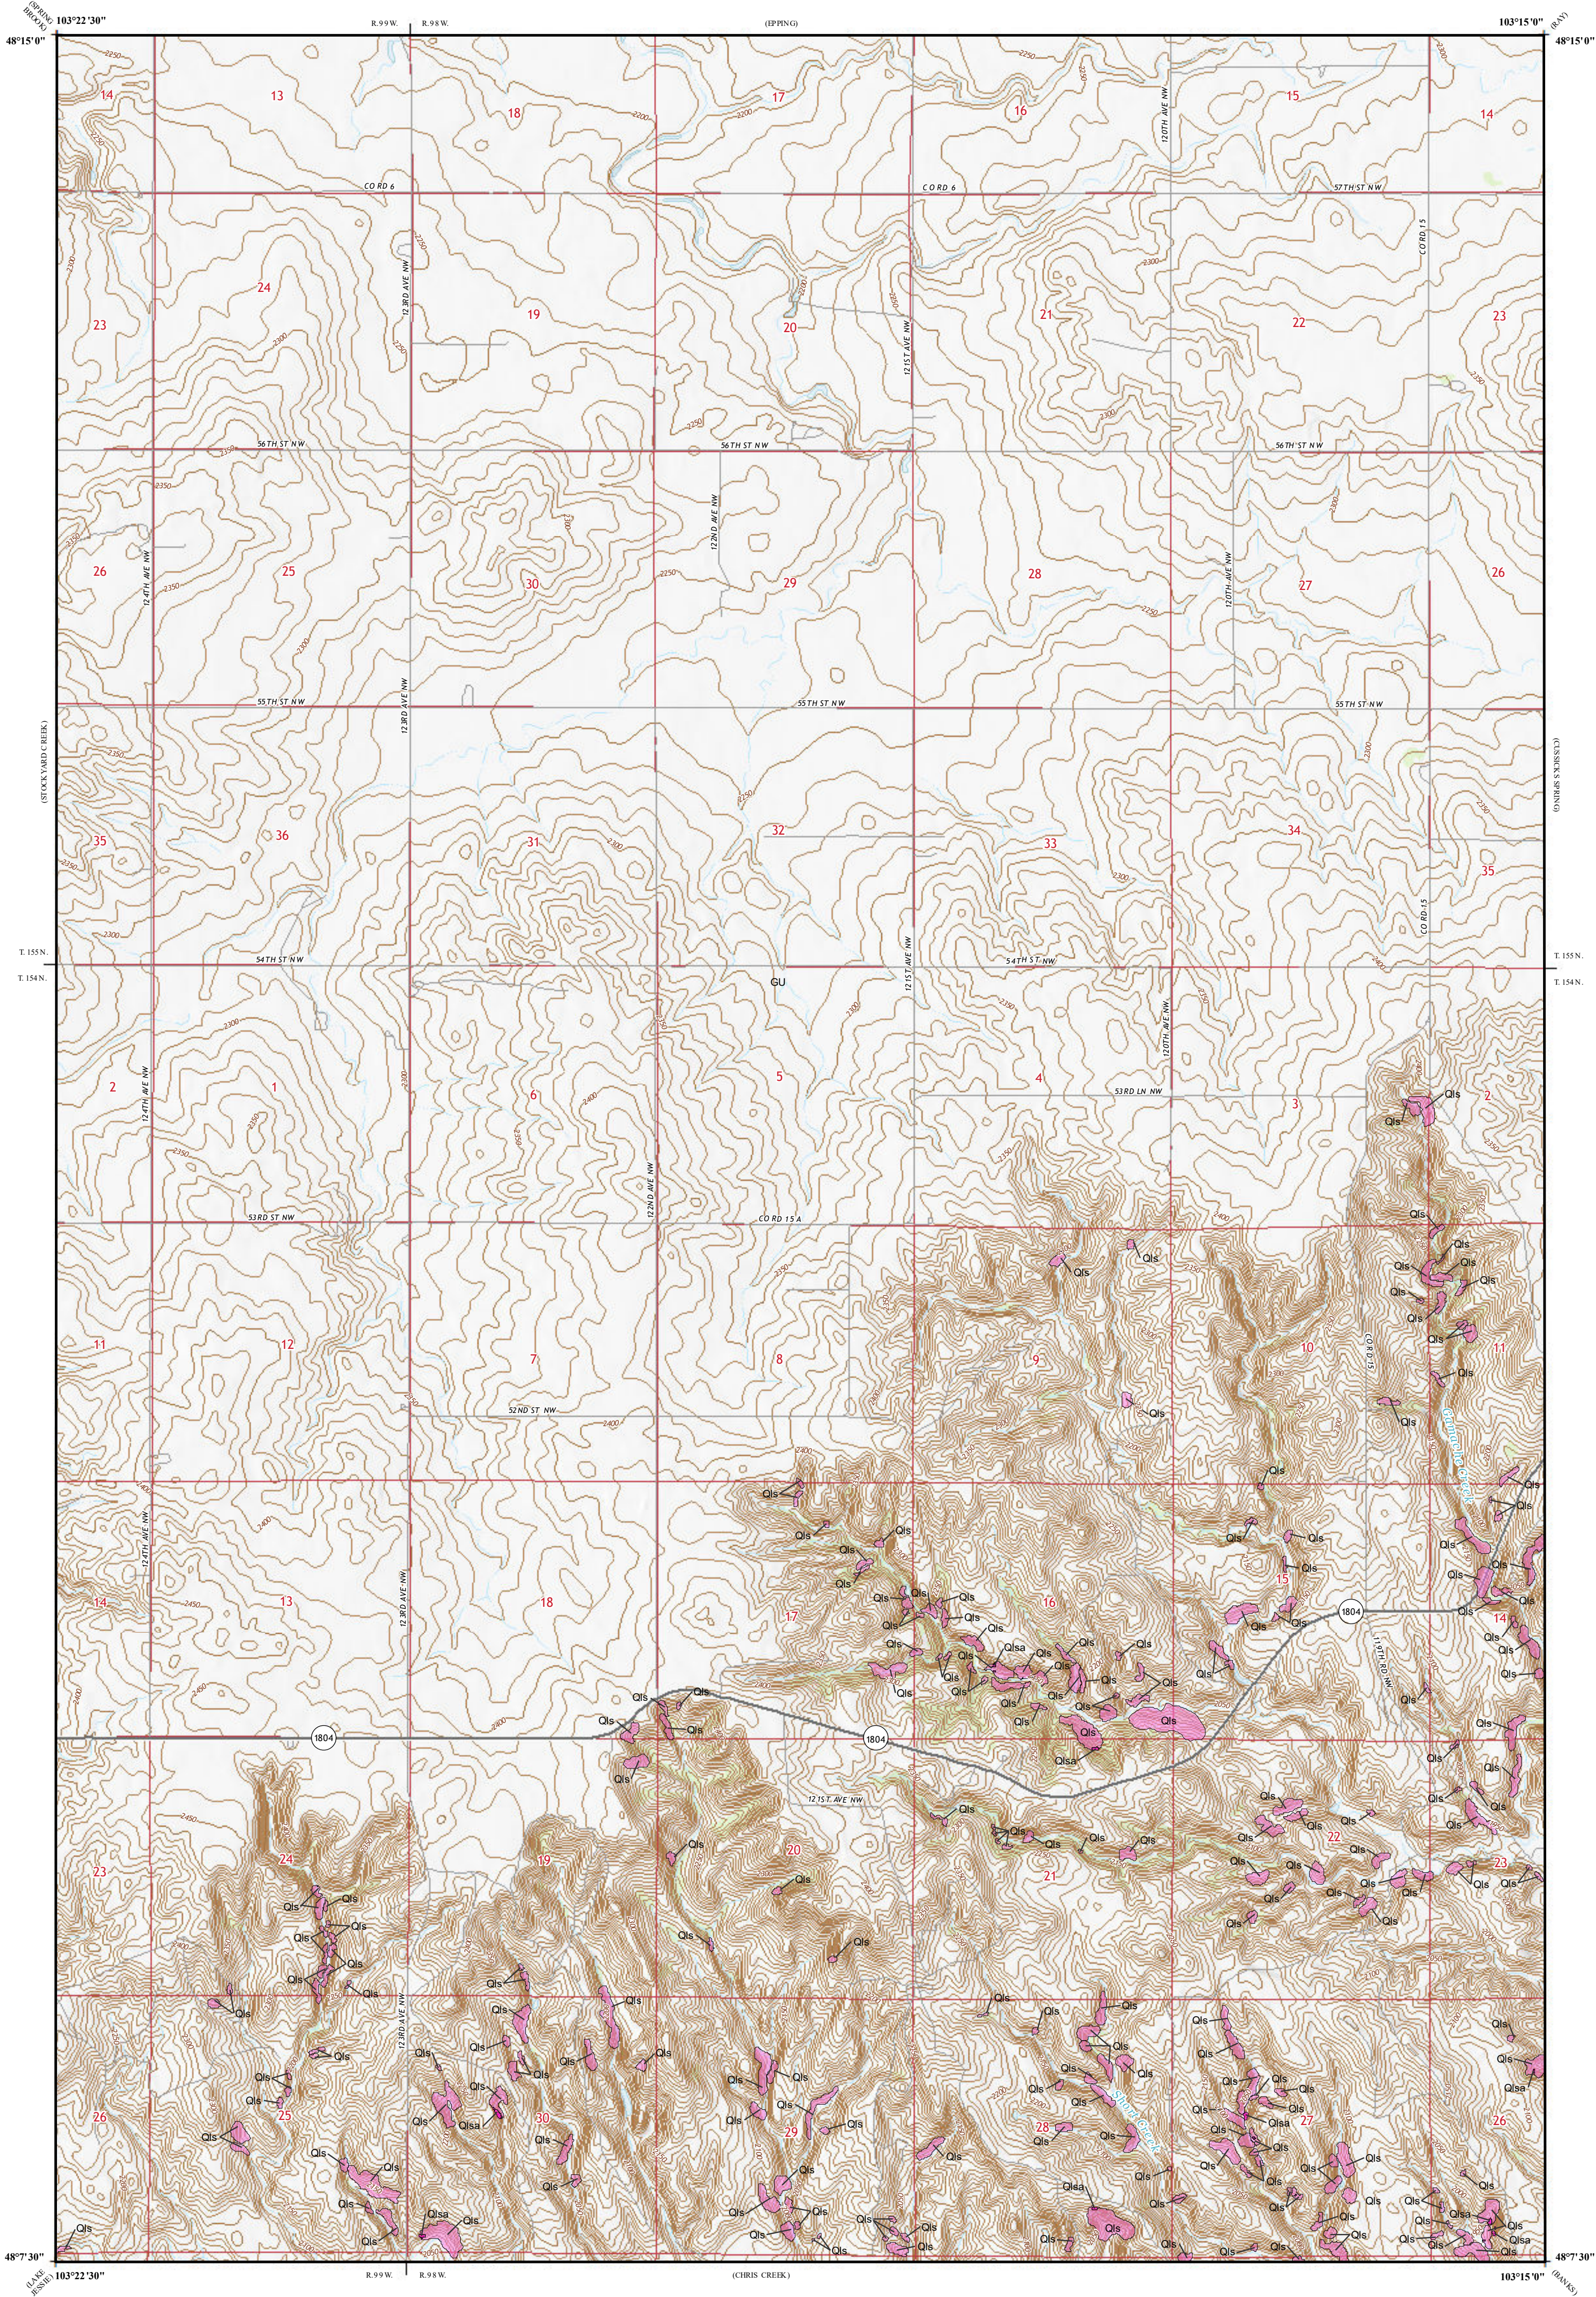
Gamache Creek Quadrangle, North Dakota

##### Qlsa Areas of Recently Active Landslides

Landslide areas showing movement between 2008 and 2023.

##### Qls Landslide Deposits

A mass of material that has moved downslope. Includes earth flows, slumps, and areas of soil creep.

Landslides identified on this quadrangle were mapped from stereo pairs, black and white 1:20,000 scale aerial photographs flown in September 1958 by the United States Department of Agriculture (USDA). Additional data sources include digital orthophotography from the USDA National Agriculture Imagery Program (NAIP) flown in August to September 2024 and the North Dakota Geological Survey LiDAR Map Series, which compiles raw data flown in November 2016 to May 2023 from the North Dakota State Water Commission.

Areas of recently active landslides (Qlsa) mapped on this quadrangle were identified from changes between the 2008 and 2023 LiDAR elevation datasets observed on an elevation subtraction raster. Noise introduced from data precision (typically within a foot between the LiDAR datasets) is removed on this raster by excluding the signal from elevation change in the +/- 1 foot interval. Geologists interpret areas of landslide movement in geomorphic context (typically a decrease in elevation near a landslide headscarp paired with an increase in elevation downslope near the toe) and delineate those areas within the larger landslide dataset. Landslides not identified as recently active may have also experienced movement relatively recently, but did not show discernable signs of movement during the 2008 to 2023 window between LiDAR collects.
